SCHOOL-RELATED CRASH-INFRASTRUCTURE REVIEW

Location: Garland Avenue at Domer Avenue

Local Case No.: 240059266

Review Date: July 15, 2025

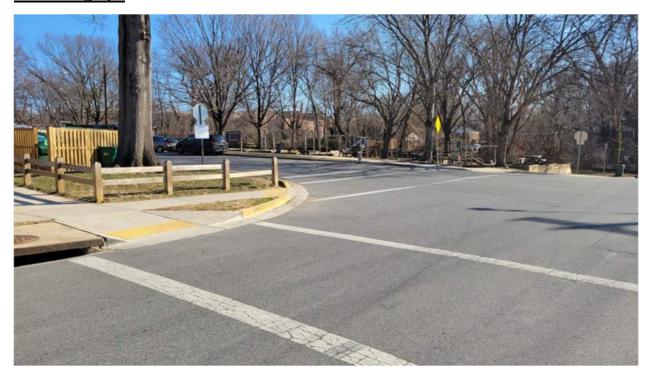
Photo 1. Taken from southwest corner looking northbound along Garland Ave at the west leg crossing. Approximate crash location.

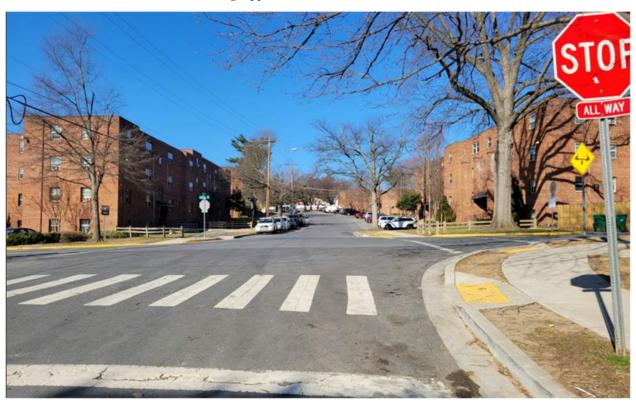
Photo 2. Intersection view from Domer Avenue eastbound approach.

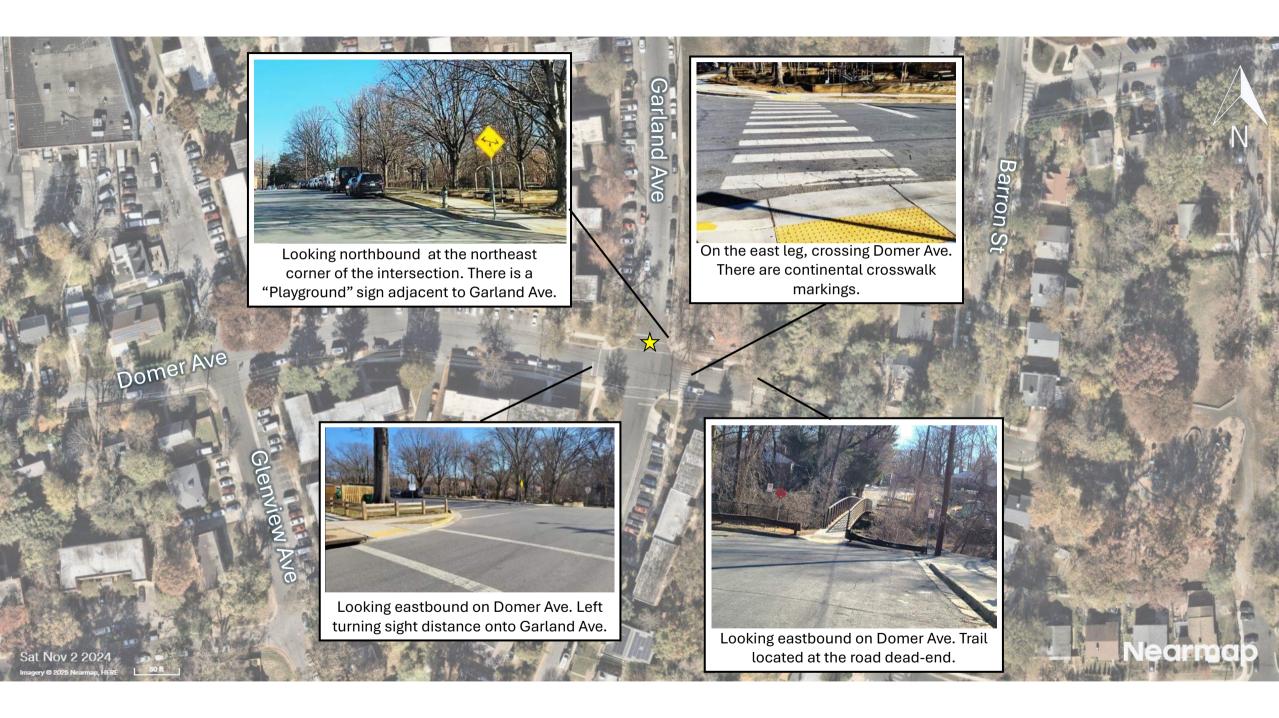
Domer Avenue is classified as a neighborhood connector, is approximately 32 feet wide, and is oriented in the east-west direction. Domer Avenue is less than ½ mile long, beginning at Silgo Creek Parkway to the west and terminating at Long Branch Trail to the east. At the crash location, Domer Avenue has buffered sidewalks on both sides of the street and a park located on the northeast corner. Parking spaces are offset from the roadway on the north leg and do not minimize the width of the corridor. Street parking is permitted on the south leg.

The Domer Avenue corridor was evaluated to identify potential infrastructure, maintenance activities, and road user behaviors that contribute to increased safety risk at and in the vicinity of the school-related crash location. The Domer Avenue corridor was reviewed between Silgo Creek Parkway to the west and Long Branch Trail to the east. Please refer to **Figure 1** for additional information.

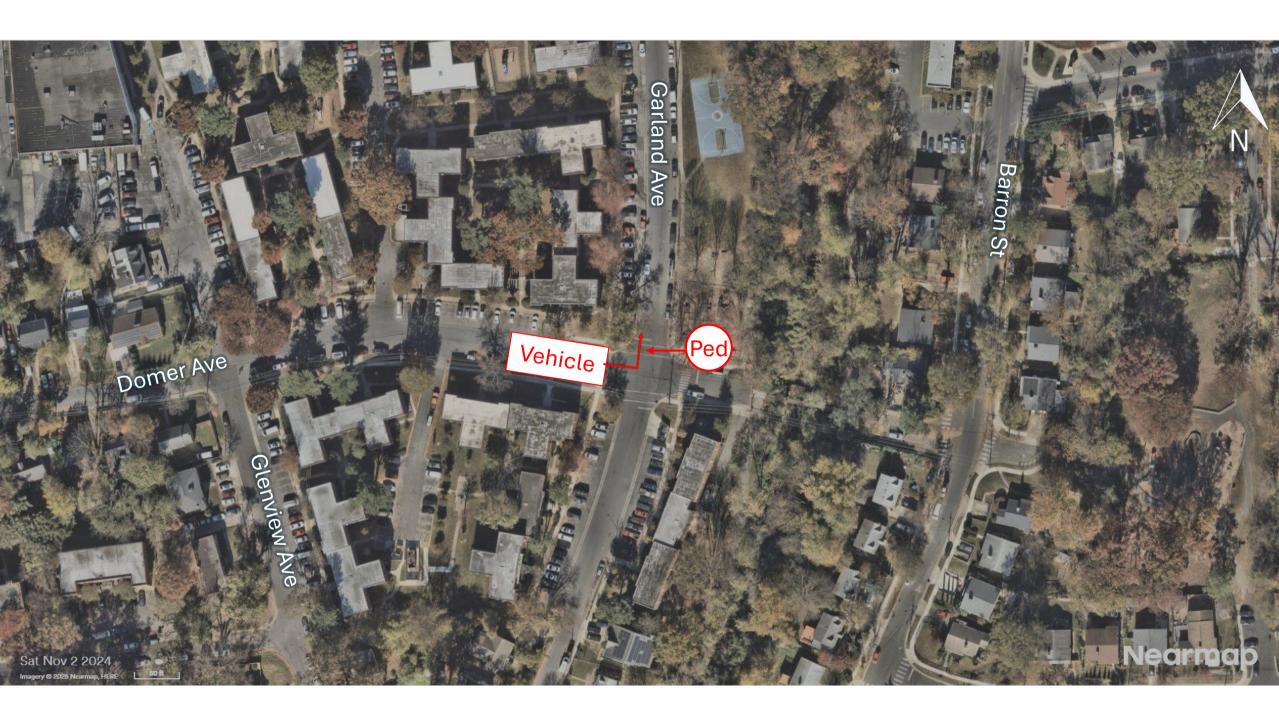
Figure 2 – Crash Diagram

On Wednesday, December 11, 2024, at approximately 3:52 PM, a pedestrian was traveling westbound across Garland Avenue along the marked crossing. A motorist traveling eastbound on Domer Avenue made a left turn onto Garland Avenue and struck the pedestrian crossing the north leg of the intersection. The crash report indicated that the pedestrian suffered minor injuries. Daytime weather conditions were rainy, and the roadway surface was wet.

Figure 2 illustrates the crash location and direction of pedestrian and vehicle travel.

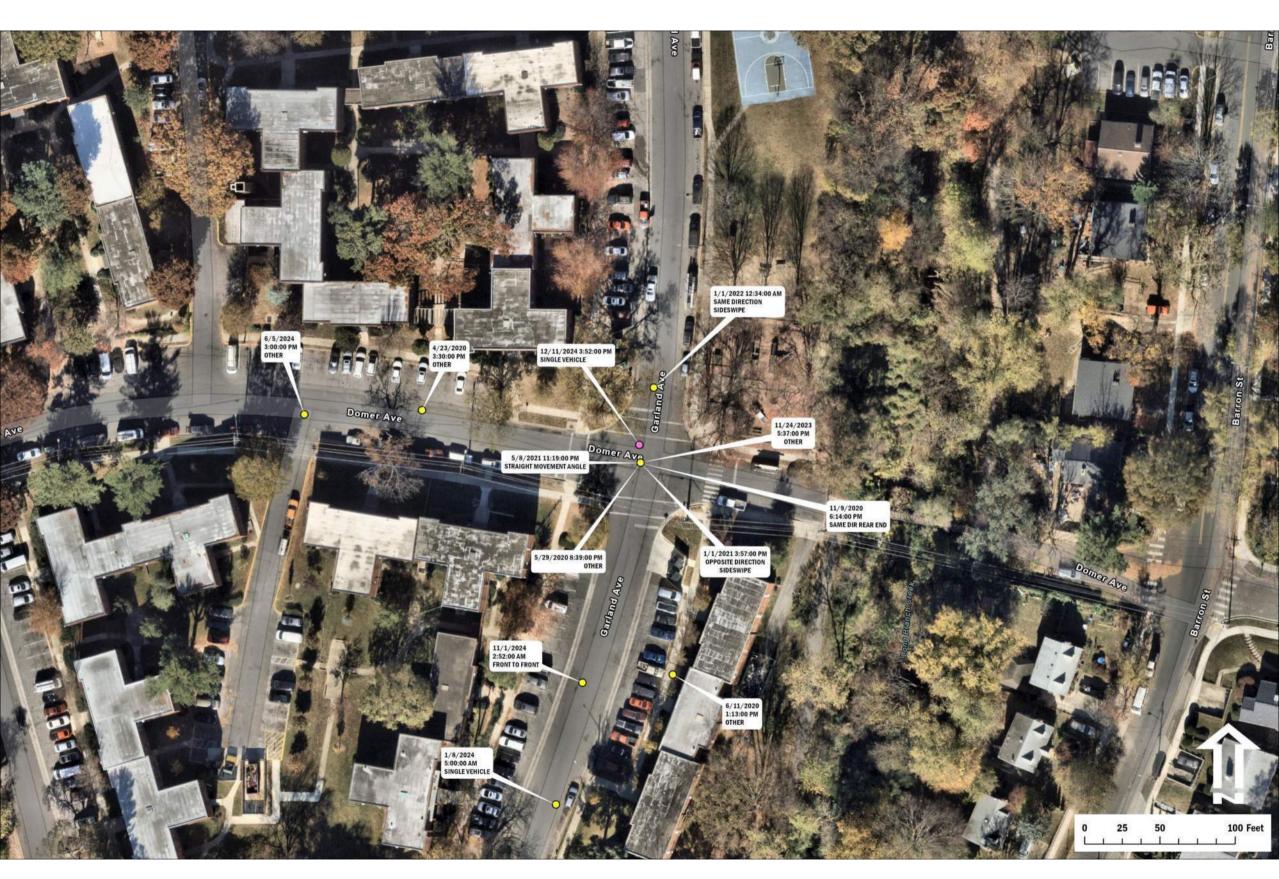
Figure 3 – Crash History (2020-2024)

Crash data obtained from dataMontgomery indicates that 12 incidents occurred within the vicinity of the crash site between January 2020 and December 2024, including the subject crash. Of these 12 incidents, seven (7) crashes occurred at the intersection of Garland Avenue and Domer Avenue. These seven (7) crashes include three (3) injury crashes and four (4) property damage crashes. The crash types consist of two (2) sideswipe collisions, one (1) rear end collision, one (1) angle collision, and two (2) classified as "other". The only pedestrian-related crash that occurred at this intersection was the subject crash. Three (3) of the incidents occurred during wet pavement conditions and six (6) occurred in the dark/dusk.

The five (5) other crashes occurred along Garland Avenue to the south or Domer Avenue to the west. All five (5) of these crashes were property damage crashes, with one (1) head on collision, one (1) single vehicle collision, and three (3) classified as "other". Of these five (5) collisions at the subject location, two (2) occurred in the dark/dusk, and two (2) occurred during wet pavement conditions.
