SCHOOL-RELATED CRASH INFRASTRUCTURE REVIEW

Location: Montgomery Village Avenue at Center Stage Apartments
Crash Date: March 20, 2025
Crash Time: 3:50 PM
School Name: Watkins Mill High School
School Walkshed Boundary (☒ **Inside** ☐ **Borderline** ☐ **Just Outside**)
Local Case No: 250013061
Review Date: October 10, 2025

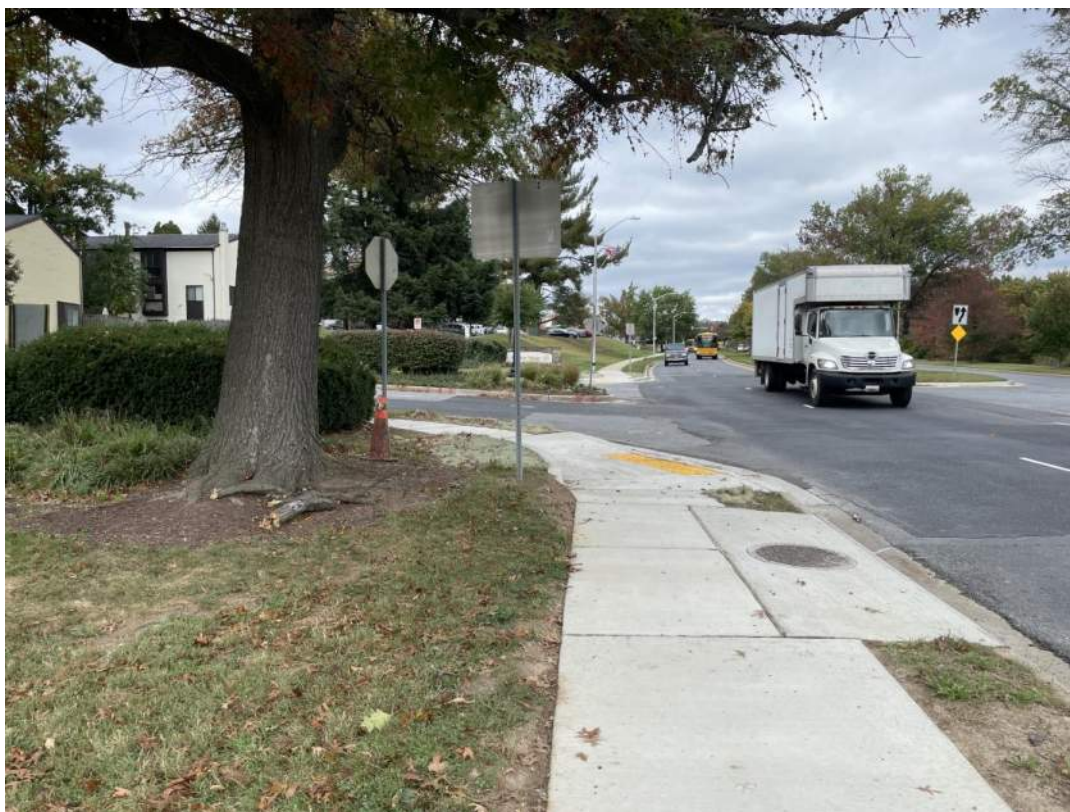
On Thursday, March 20, 2025, at approximately 3:50 PM, a pedestrian on a scooter was struck on the west leg while crossing the apartment complex driveway from south to north by an eastbound right turning vehicle. The crash report indicated the crash occurred within the intersection at an unmarked crosswalk. The pedestrian suffered a possible injury and the driver was found at fault for looking away (likely looking at oncoming traffic on southbound Montgomery Village Avenue without looking for northbound pedestrians). Daytime weather conditions were clear, and the roadway surface was dry.

- **Visibility / Obstructions:**
There is a tree and some shrubs, but they do not appear to obstruct visibility once at the stop line. A median in the driveway entrance obstructs part of the intended walking path, which pushes pedestrians towards vehicular traffic on Montgomery Village Avenue as they cross the driveway entrance.

There is no crosswalk across the west leg approach as well as the presence of the west leg median forces pedestrians into the street when crossing. While the subject crash was attributed to the fault of the driver, additional pedestrian facilities may increase vehicular awareness of pedestrians at the subject location.

Figure 1A: West Leg Crossing, Facing Northbound, where the Crash Occurred

1. This location has been approved for the installation of a PHB on the south leg crosswalk.
2. Cut back the median or create an opening for the crossing on the west leg.

1. Stripe high visibility continental crosswalks on the south and west legs of the intersection.

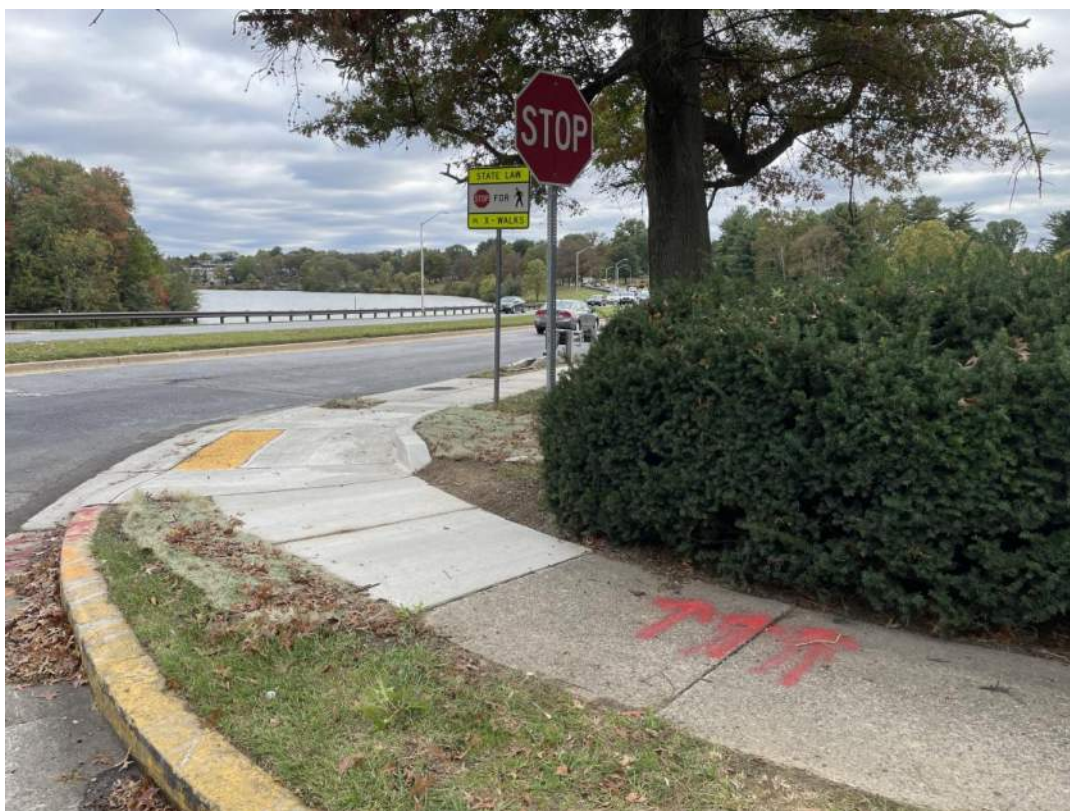
Figure 1B: View of Westbound Vehicle Looking Southbound at Stop Line

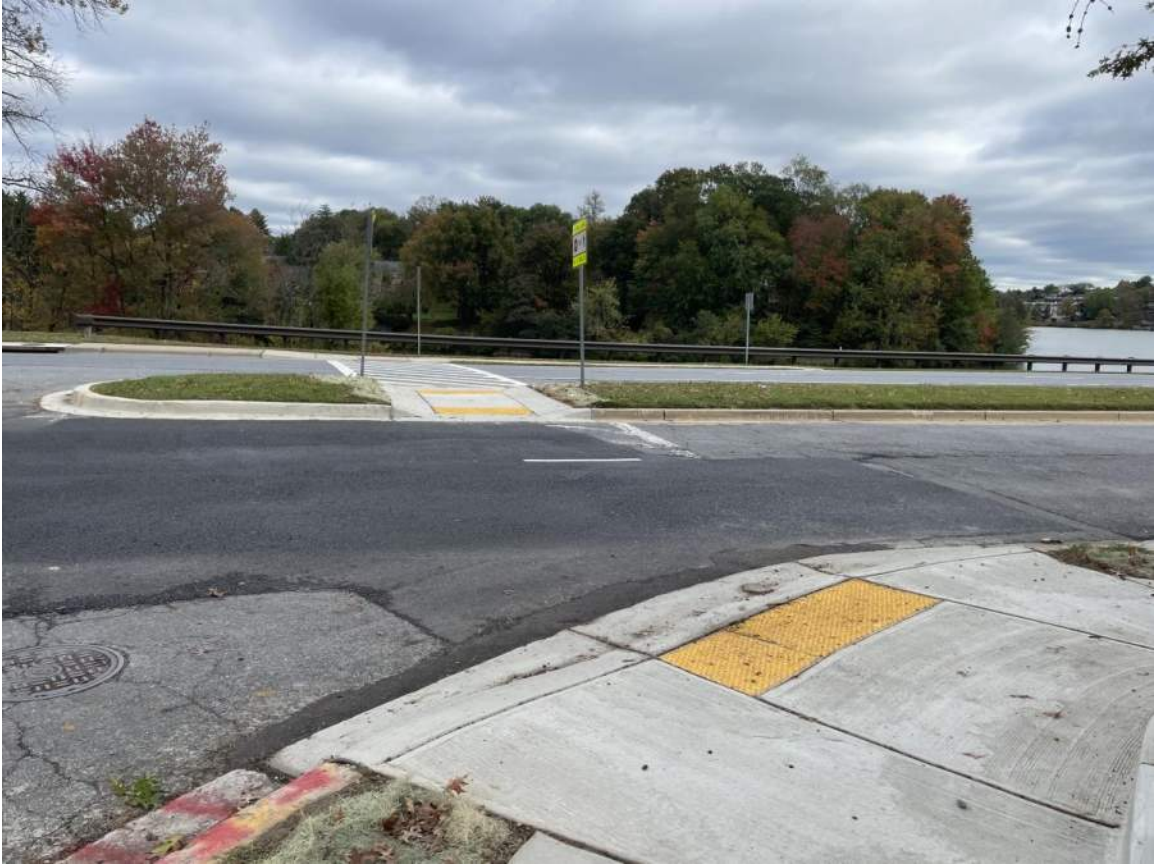
Figure 1C: South Leg Crosswalk where Approved PHB is Proposed

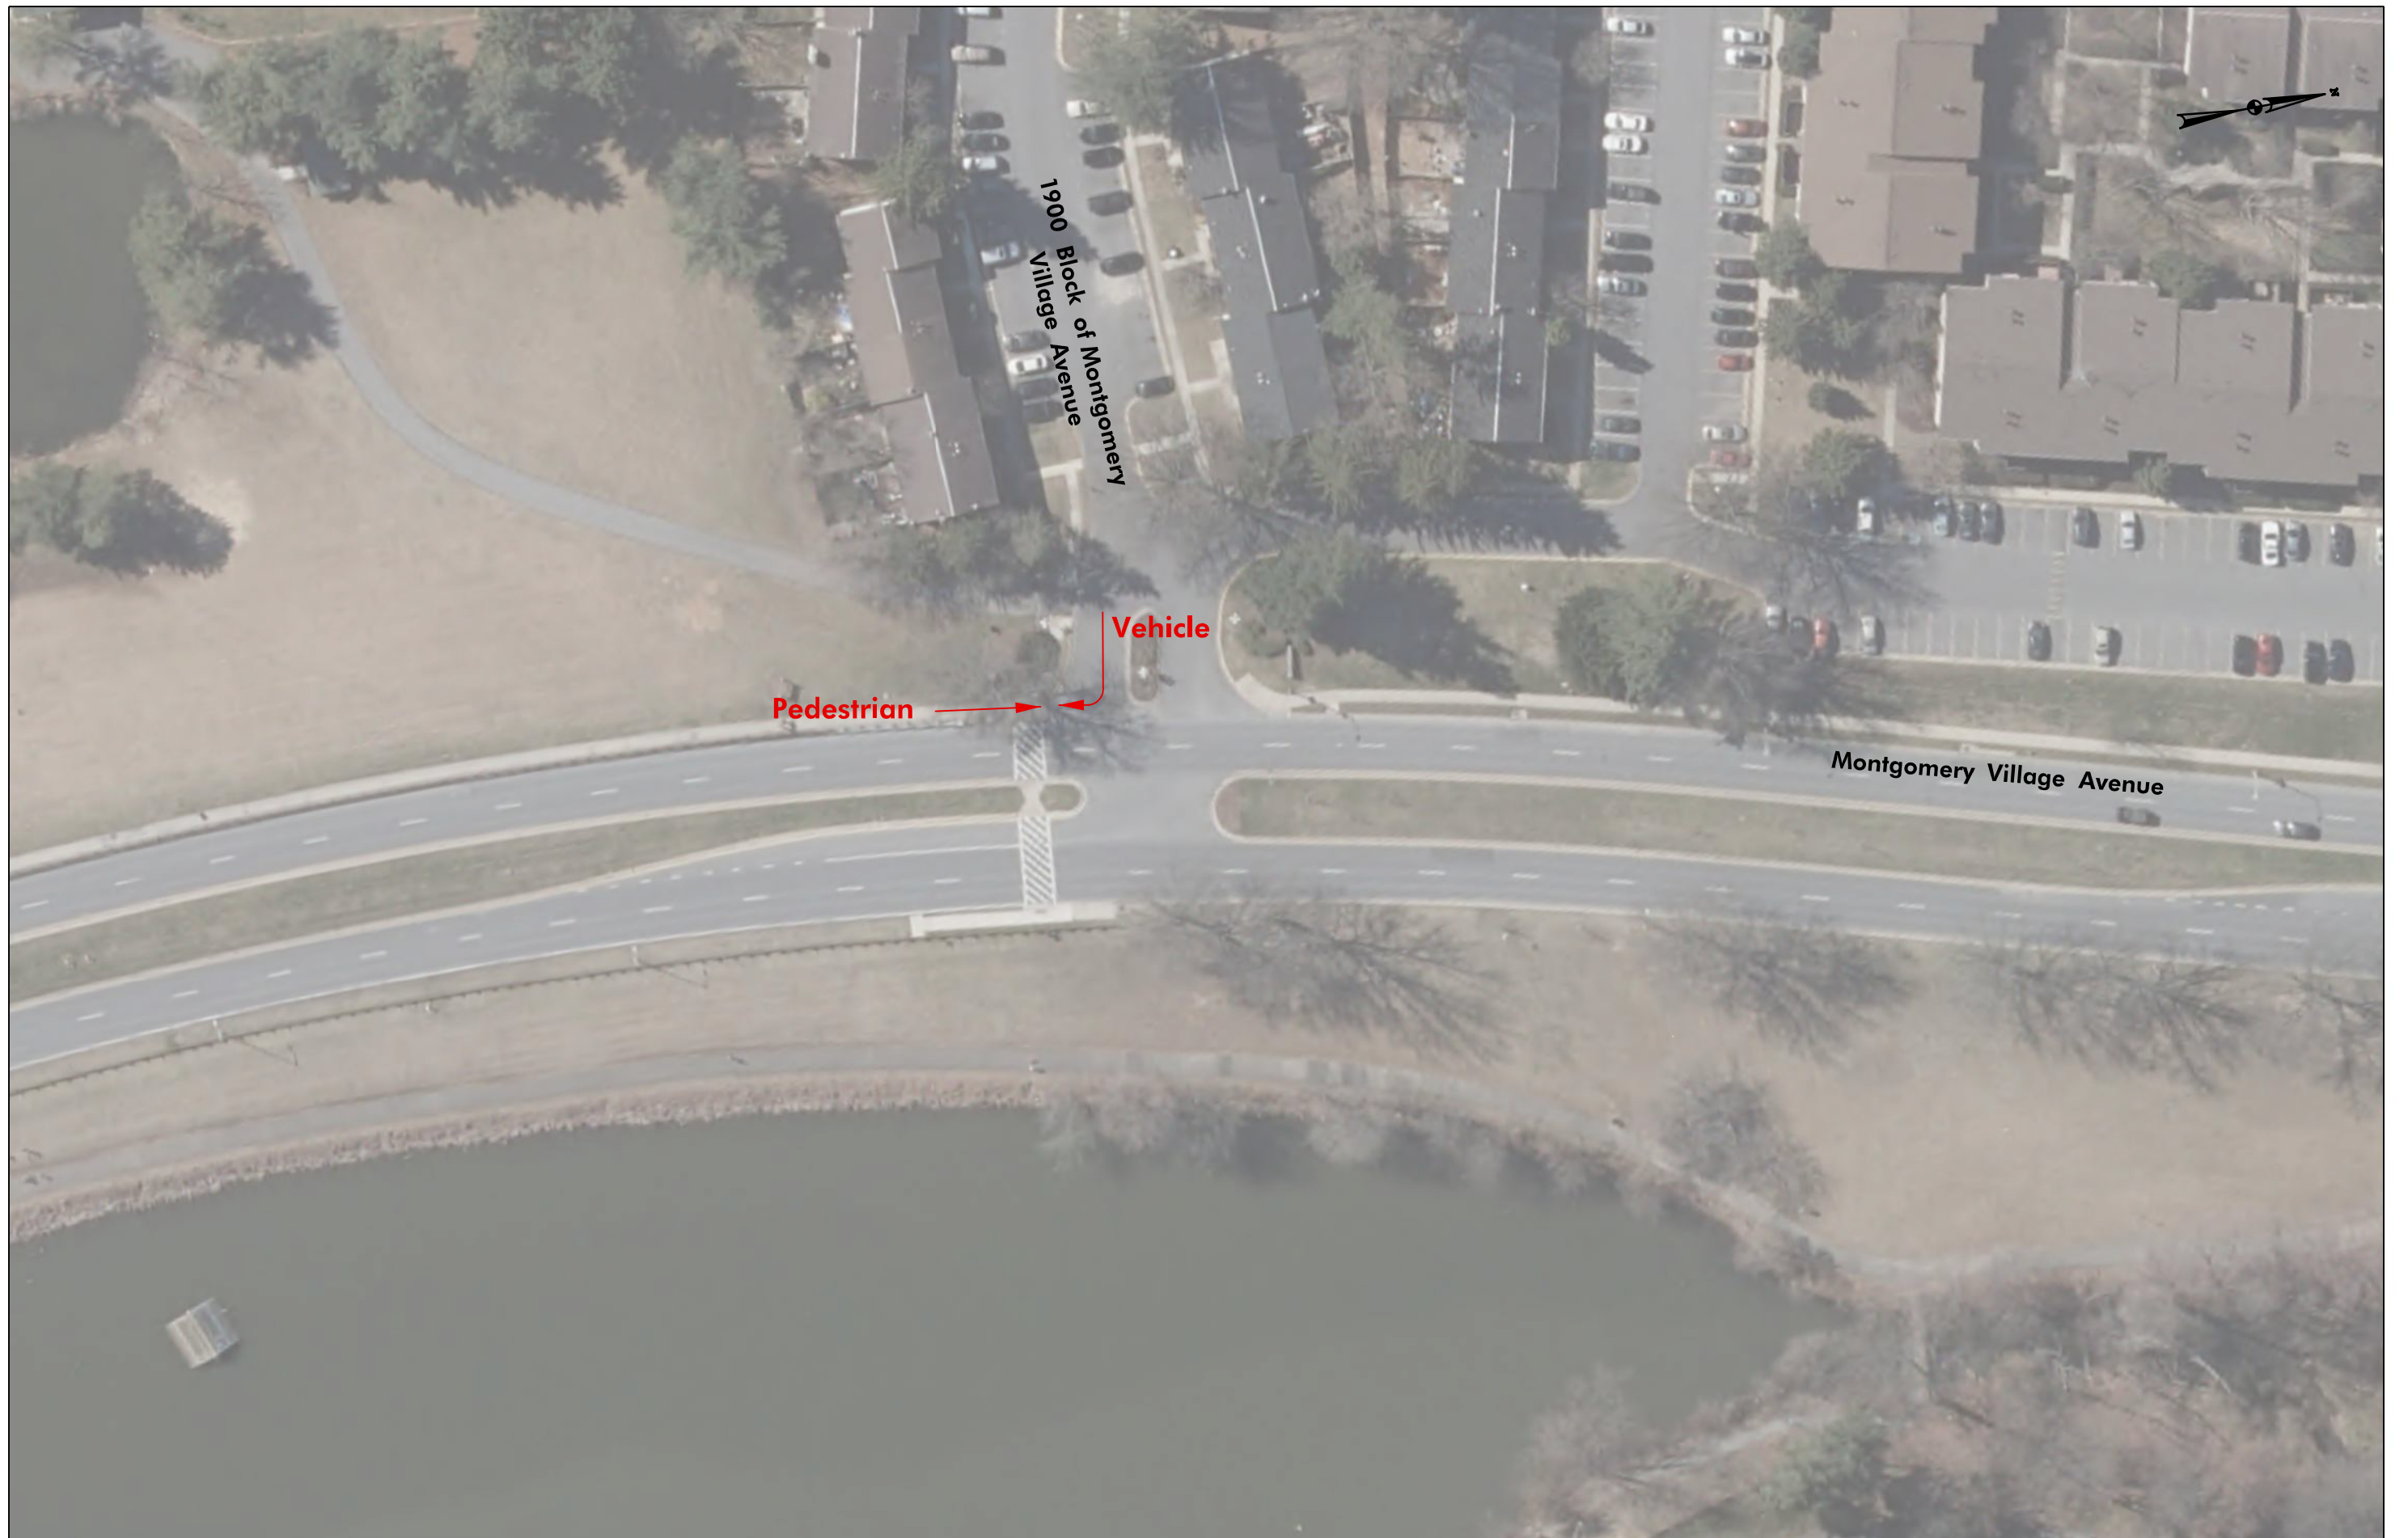
Figure 2 – Crash Diagram

Figure 2 illustrates the crash location and direction of pedestrian and vehicle travel.

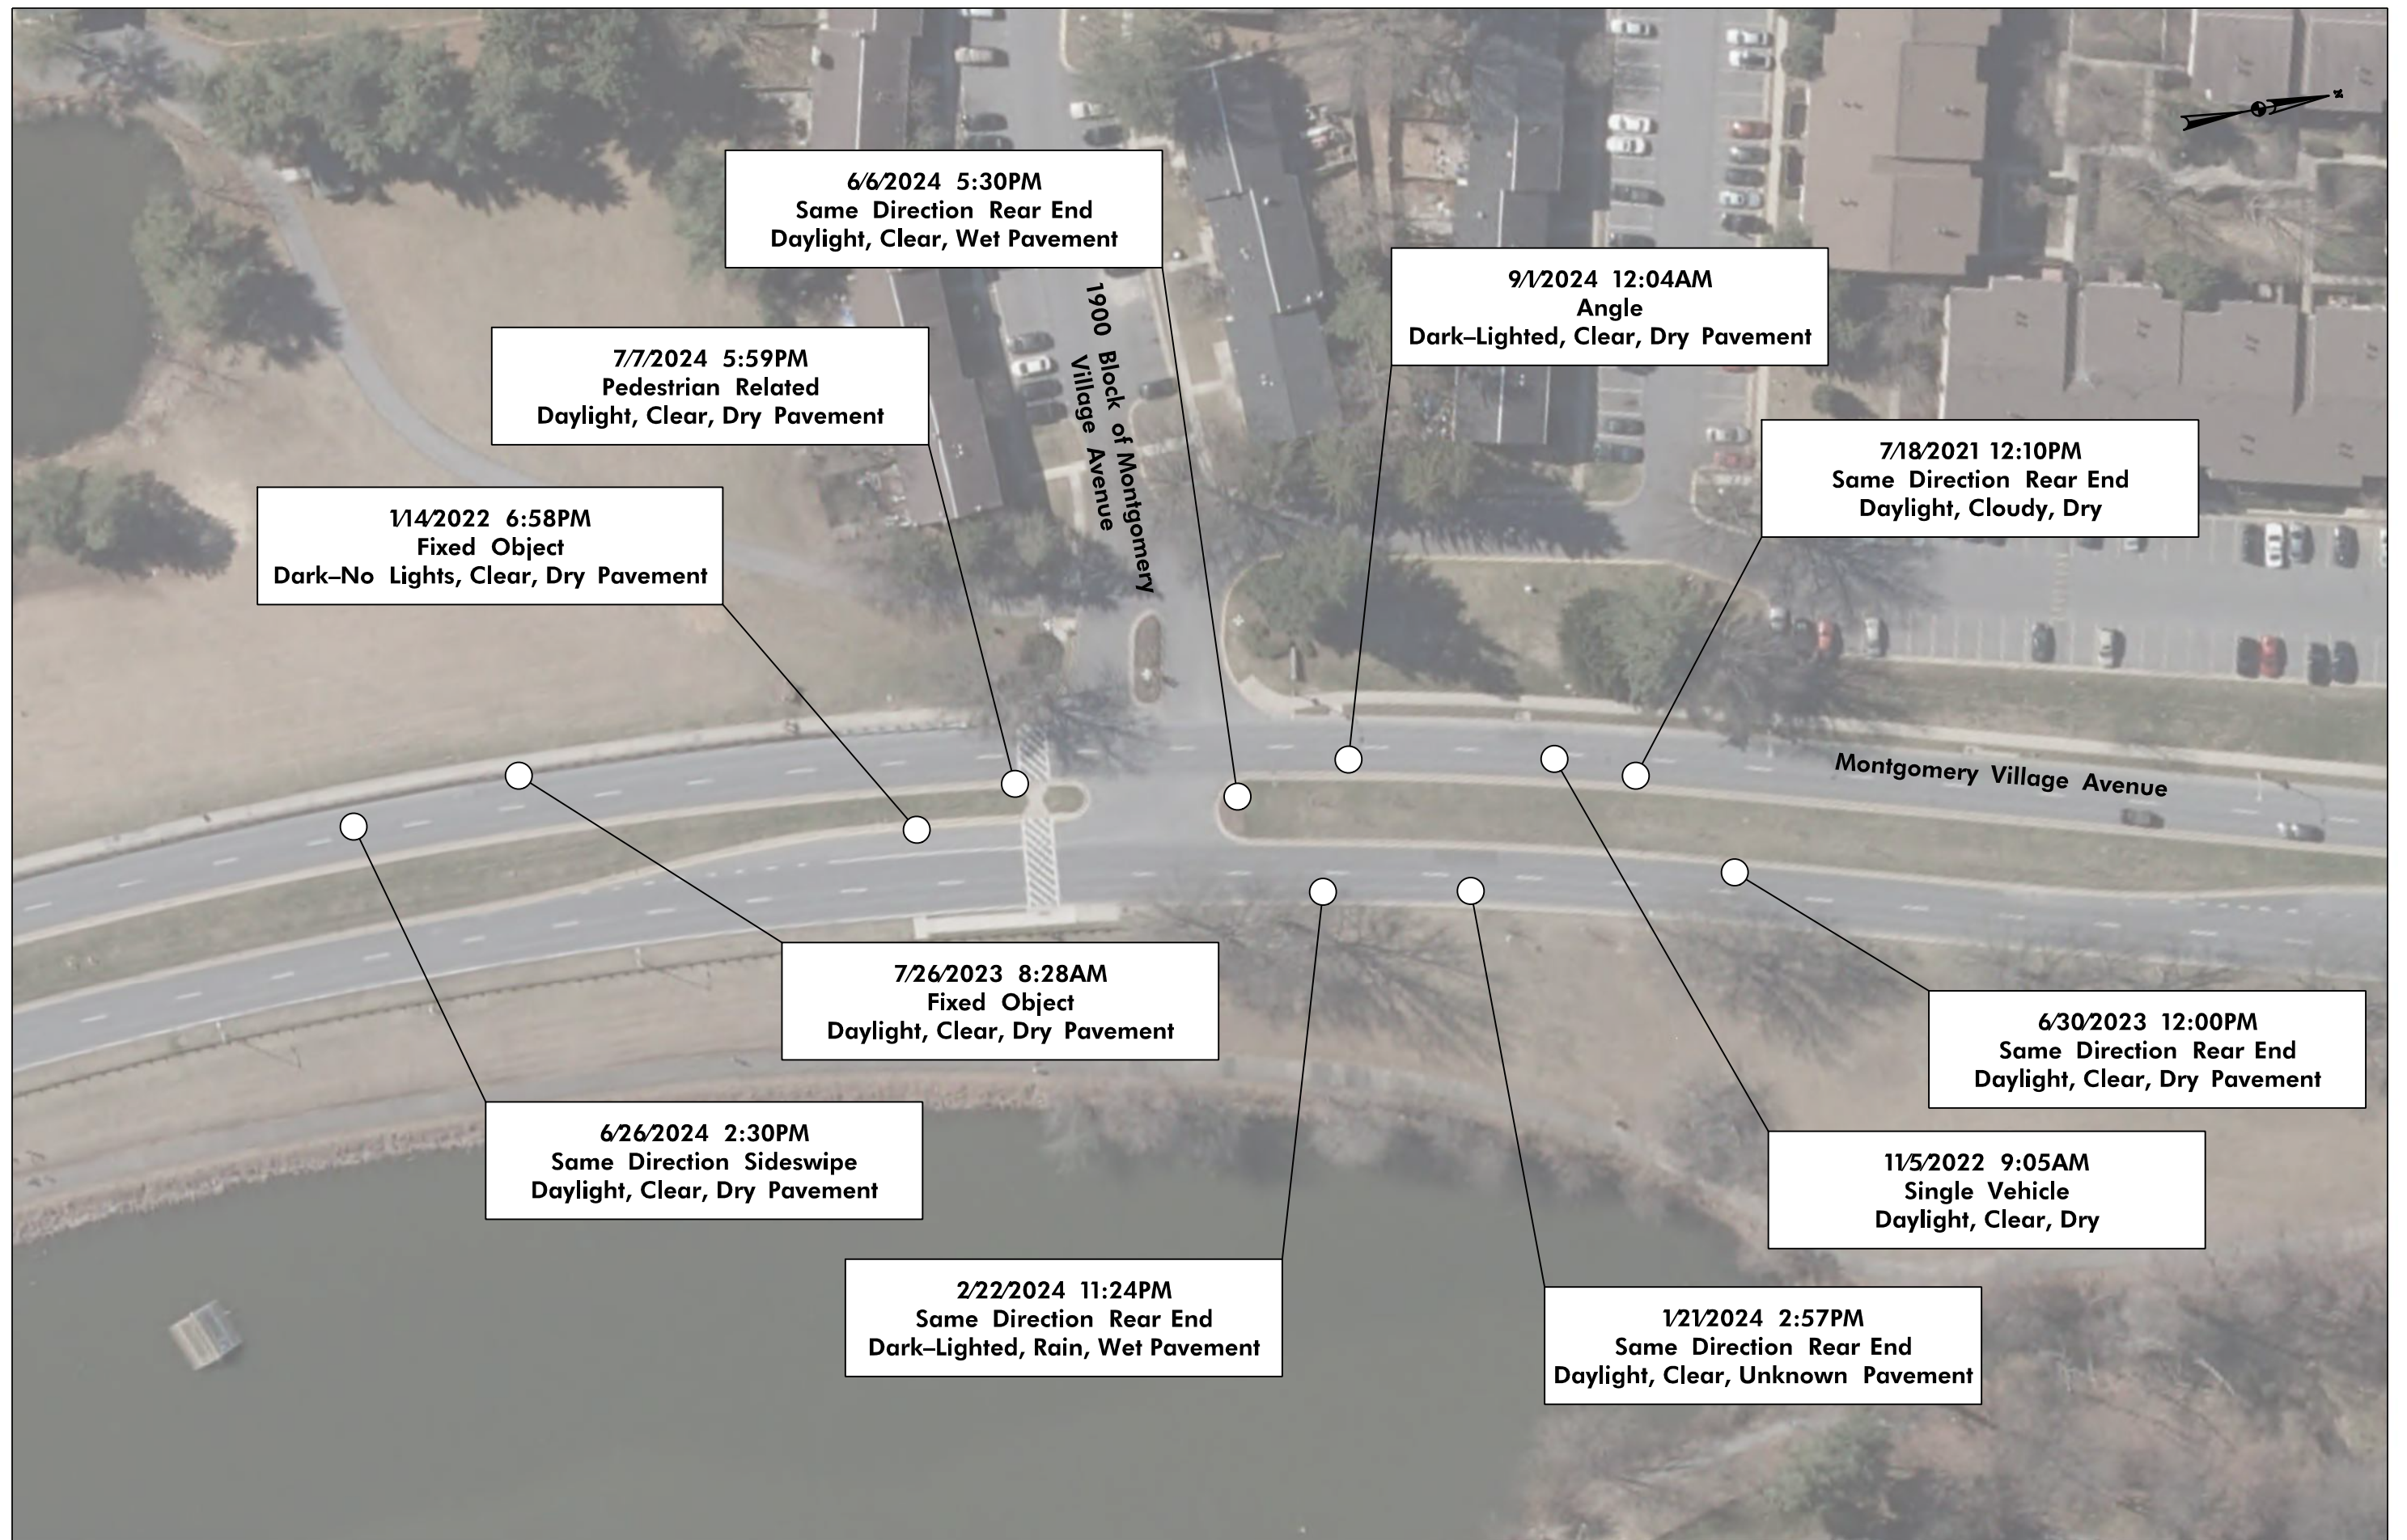
Figure 3 – Crash History (2020–2024)

- Total Crashes (Last 5 Years): 11
- Pedestrian/Bicycle Involved: 1
- Student-Involved Crashes: 0
- Crashes During School Hours: 1
- Recurrent Patterns (Time/Type): 5 Rear End crashes
