SCHOOL-RELATED CRASH INFRASTRUCTURE REVIEW

MONTGOMERY COUNTY DEPARTMENT OF TRANSPORTATION (MCDOT)

- **Location:** Sligo Avenue at Grove Street
- **Crash Date:** February 5, 2025
- **Crash Time:** Approximately 3:30 PM
- **School Name:** East Silver Spring Elementary School & Takoma Park Middle School
- **School Walkshed Boundary:** Inside
- **Local Case No:** 250005339
- **Review Date:** January 29, 2026

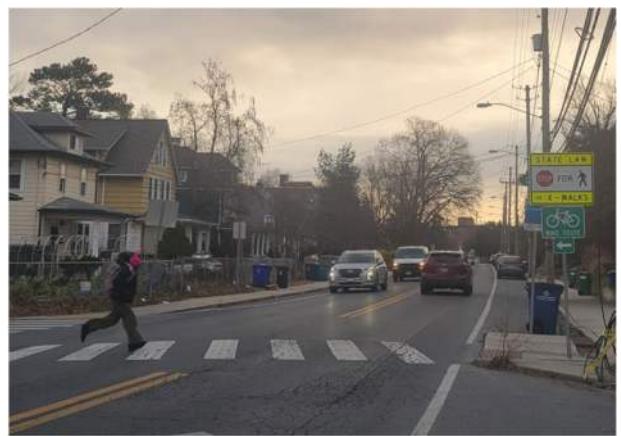
School child runs across marked crosswalk

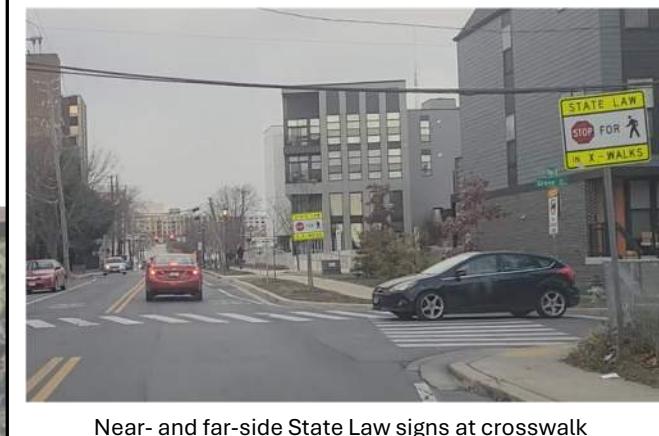
Near- and far-side State Law signs at crosswalk

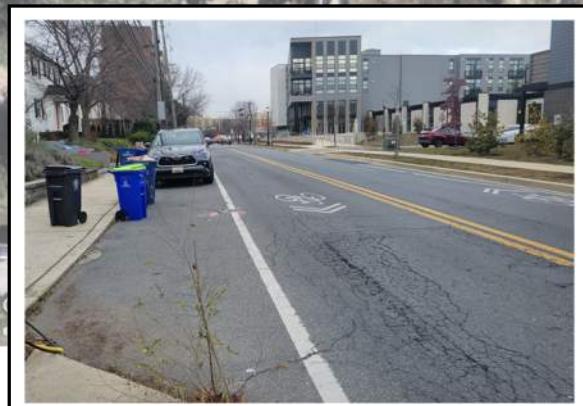
On-street parking is available along the south side of Sligo Avenue. Pedestrian sight distance is adequate at the crosswalk ramp.

Ped Sight Distance from southwest corner looking left; on-street parking on south side of Sligo Ave

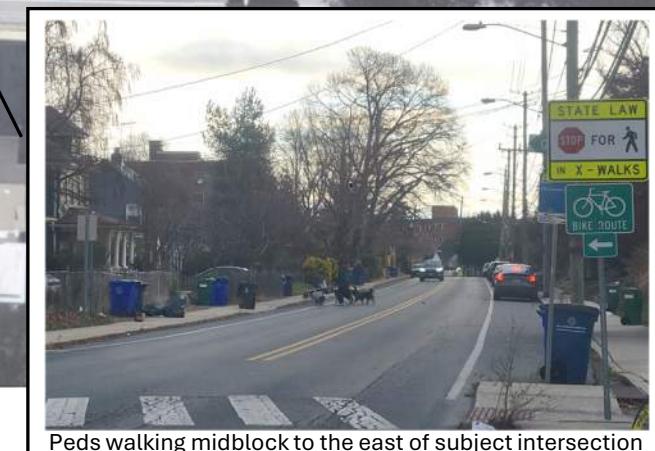
Peds walking midblock to the east of subject intersection

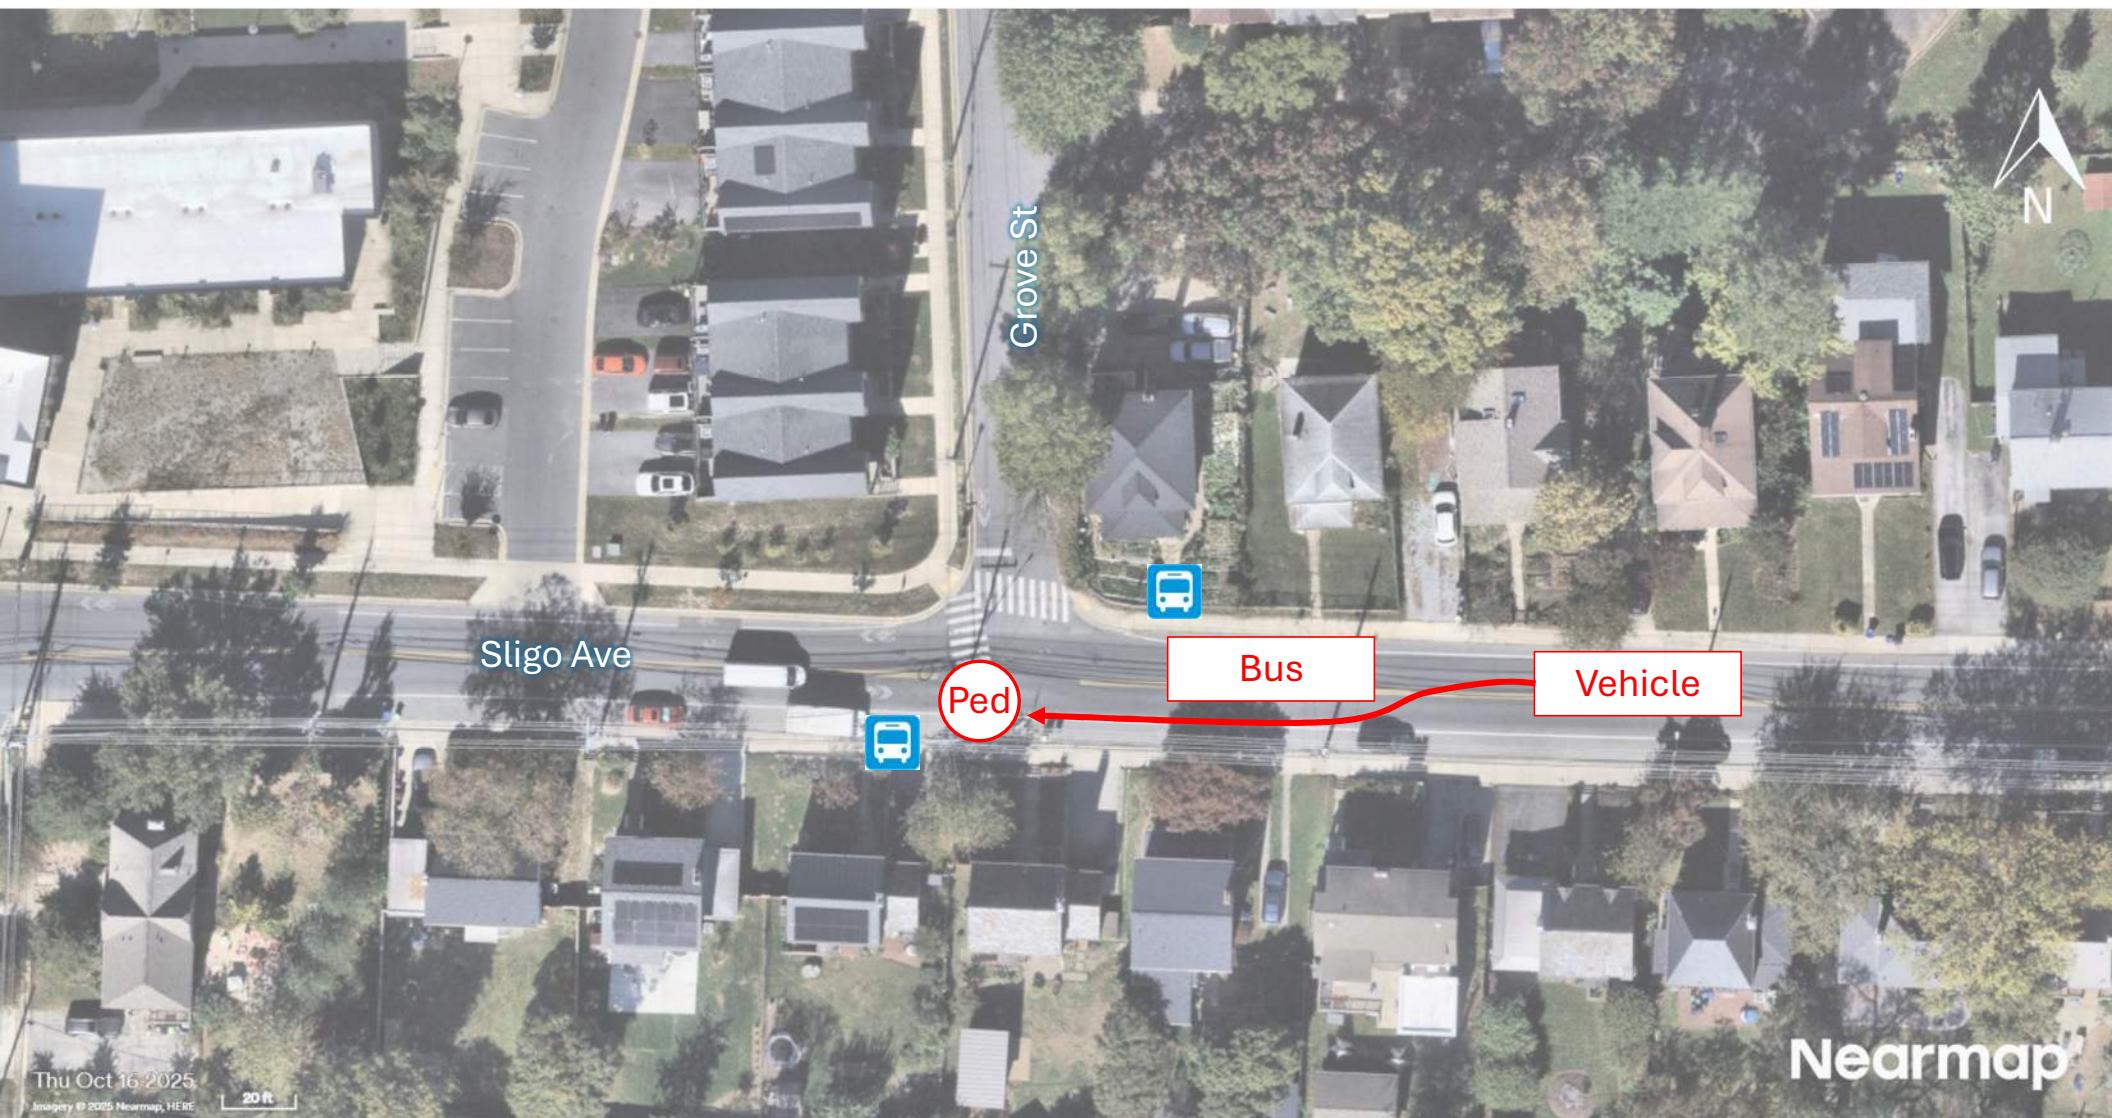
Figure 2 – Crash Diagram

On Wednesday, February 5, 2025, a pedestrian was traveling south along the marked crossing of Sligo Ave on the west leg of the intersection with Grove Street when the pedestrian was struck by a motorist traveling in the wrong lane to bypass a stopped transit bus. The pedestrian suffered a possible injury and was transported to the hospital. The weather was clear, and the roadway was dry. Figure 2 illustrates the crash location and the direction of pedestrian and vehicle travel.

There were no obvious infrastructure deficiencies that contributed to this crash. The crash occurred due to driver failure to exercise due care approaching an uncontrolled pedestrian crossing and passing a transit vehicle.

- Maintenance:** Replace the existing crosswalk with angled continental crosswalk markings to be parallel with the vehicular approach for the west leg of the subject intersection.
- Engineering:** Install centerline hardening along the Sligo Avenue approaches to the Grove Street intersection. This treatment will discourage the crossing of the centerline and visually narrow the travel way. Exposure of vulnerable road users will be reduced by reinforcing the requirement to not cross the centerline.

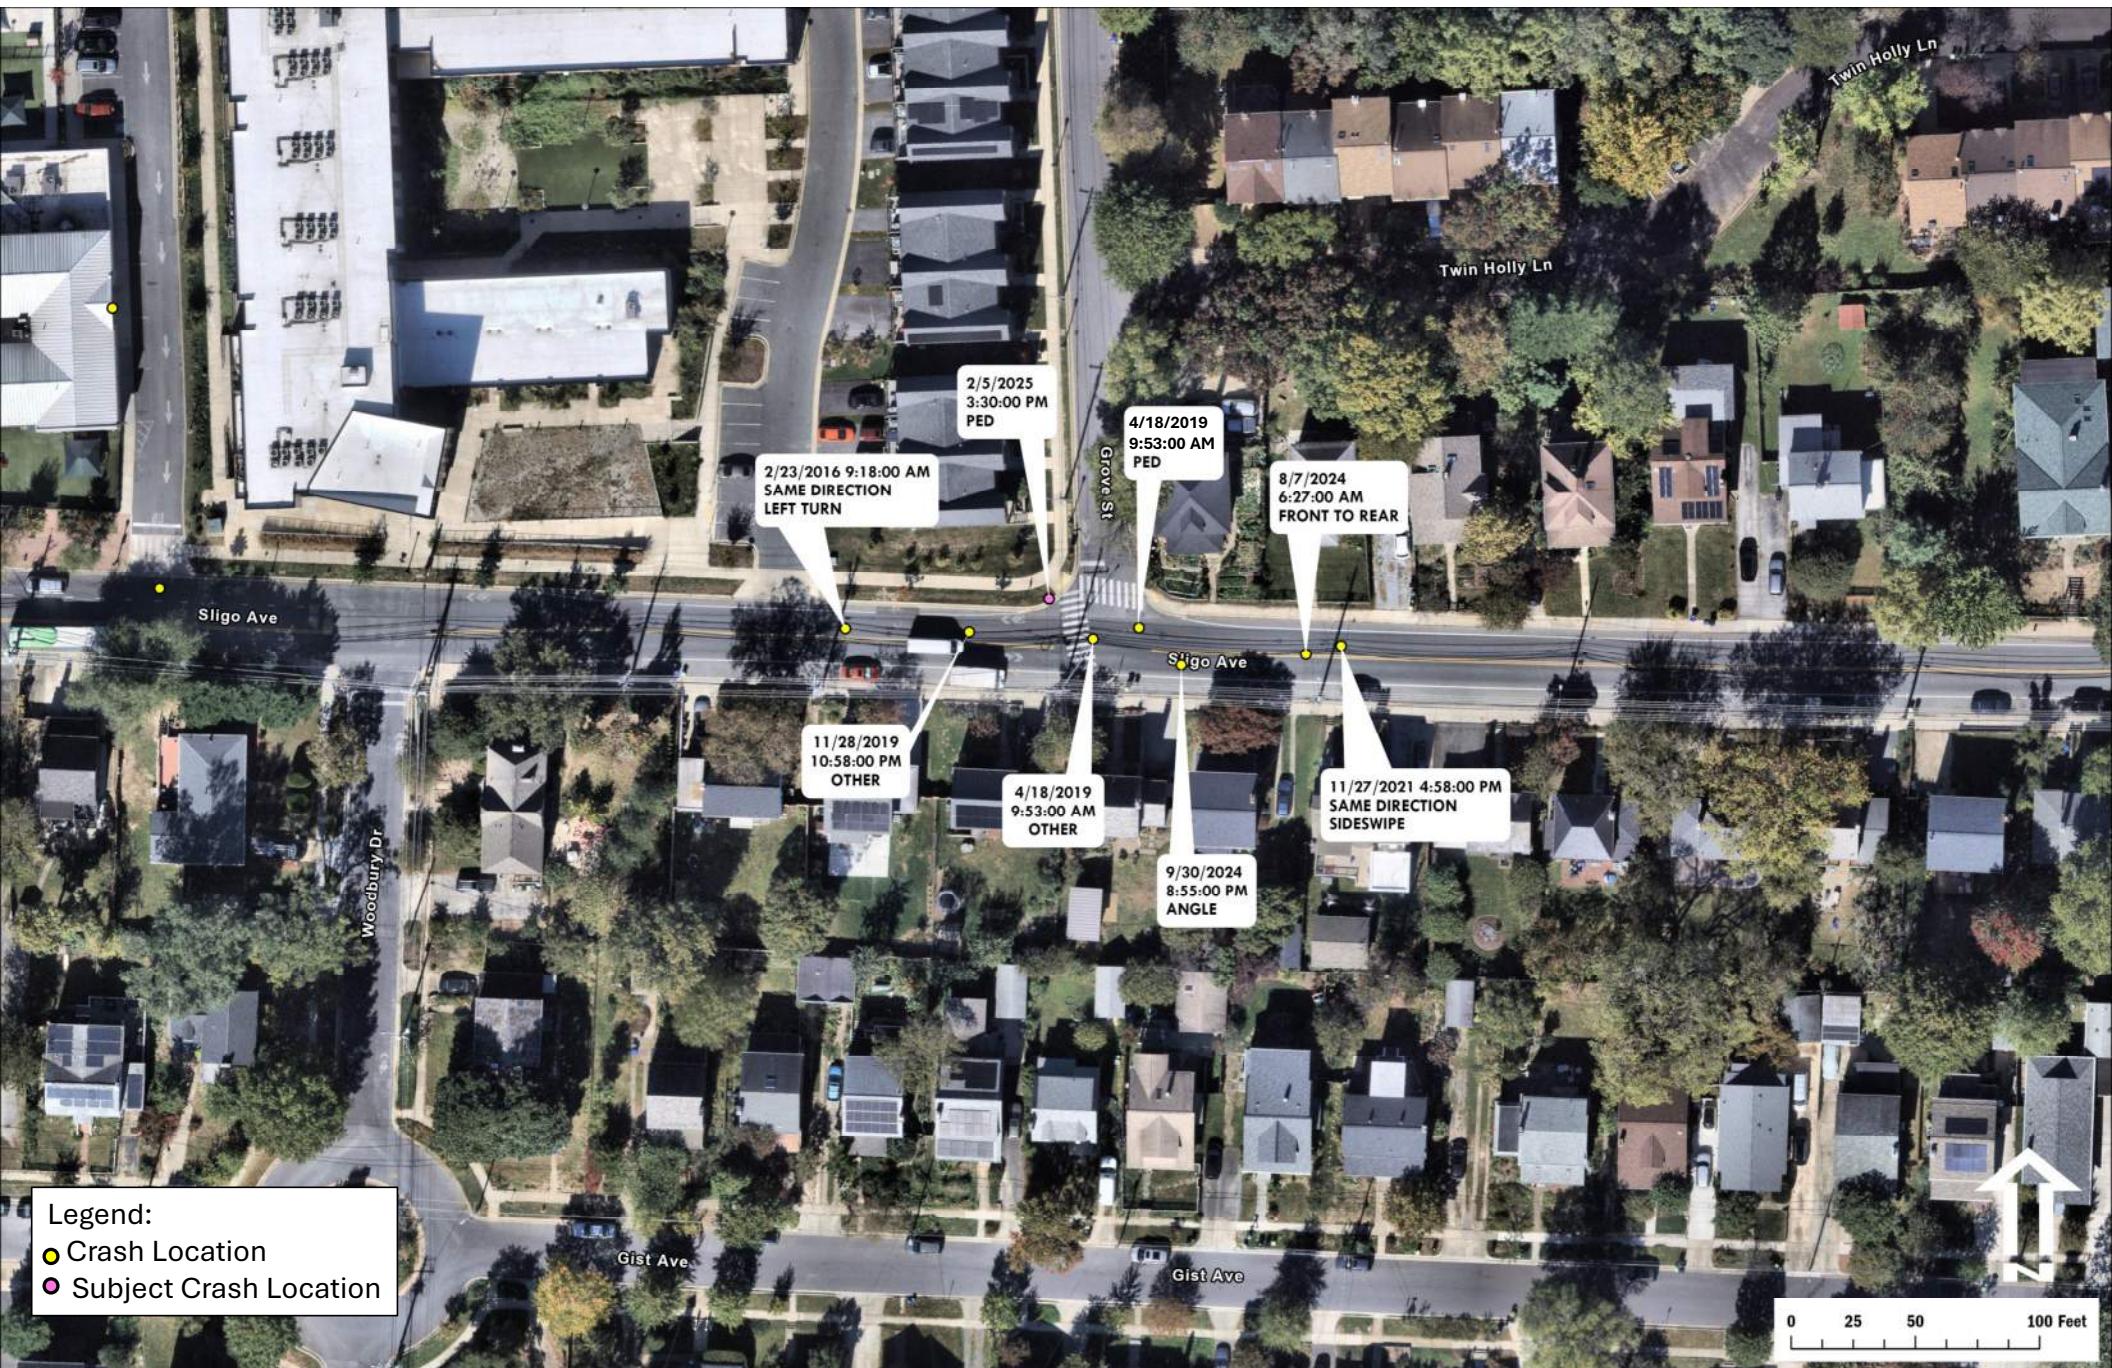
Figure 3 – Crash History (2019-2025)

- **Total Crashes (Last 10 Years):** A total of eight (8) crashes occurred at or near the subject crash location between January 1, 2016 and November 30, 2025.

- **Pedestrian/Bicycle Involved:** There were two (2) pedestrian crashes within the past 10 years; one in April 2019 at approximately 9:53 AM, and the subject crash in February 2025 at approximately 3:30 PM.
- **Student-Involved Crashes:** The only known student-involved crash included the subject crash.
- **Crashes During School Hours:** Of the eight (8) crashes, four (4) crashes occurred within school hours or within one hour of the school bell (7:15 AM to 4:50 PM) and within the school calendar year.
- **Recurrent Patterns (Time/Type):** There is no recurrent pattern of crashes. There have been two (2) angle collisions, one (1) sideswipe, one (1) rear end, one (1) left-turn, two (2) pedestrian, and one (1) “other” collision. Of the eight (8) crashes, three (3) involved a parked vehicle. Two (2) of the crashes occurred along a wet surface, and three (3) occurred in the dark or dusk.
