## FATAL CRASH REVIEW

**Location:** University Boulevard East at Langley Drive  
**Accident Date/Time:** Saturday, September 5, 2020 at approximately 10:37 PM  
**Local Case No.:** 200034859  
**Police District:** District 4  
**Review Date:** Thursday, September 10, 2020

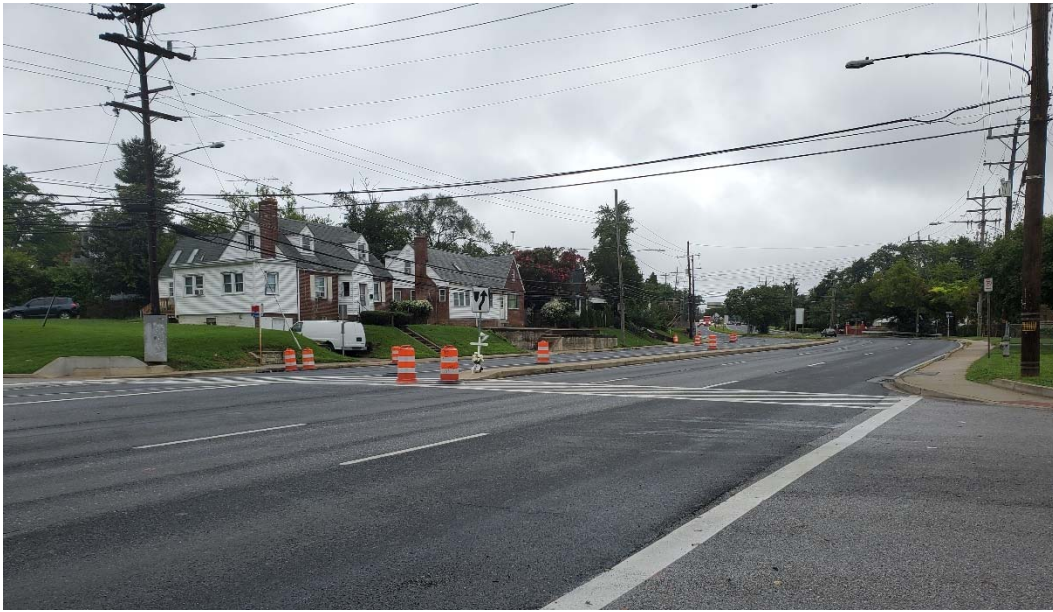
Picture 1: The crosswalk on University Blvd, looking westbound

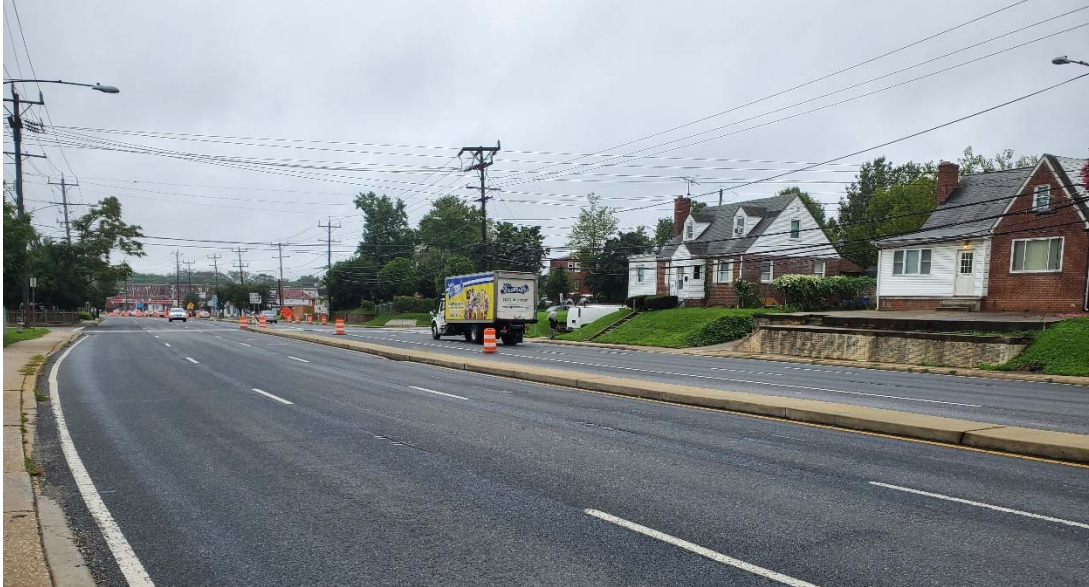
Picture 2: Looking towards intersection from the westbound departure

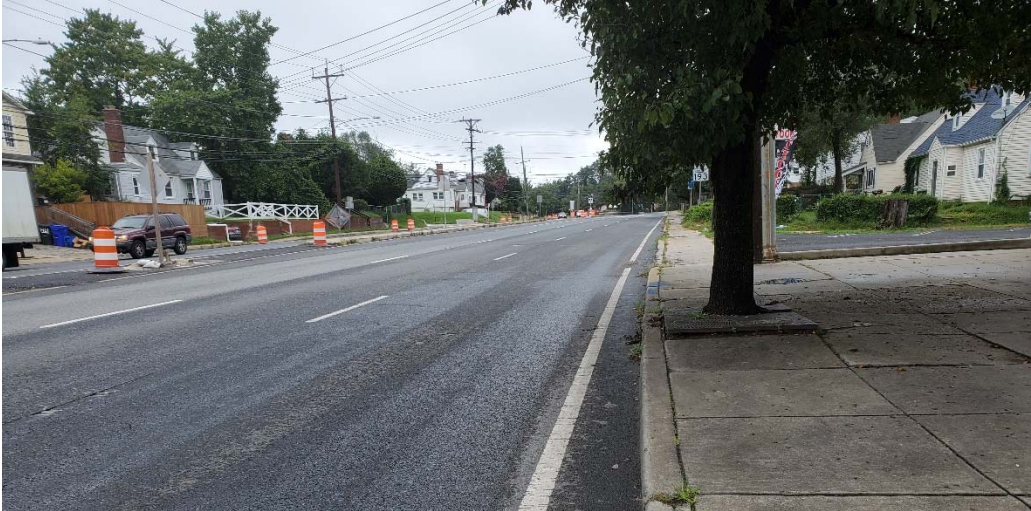
Picture 3: Looking along the westbound lanes from near the intersection with Piney Branch Road

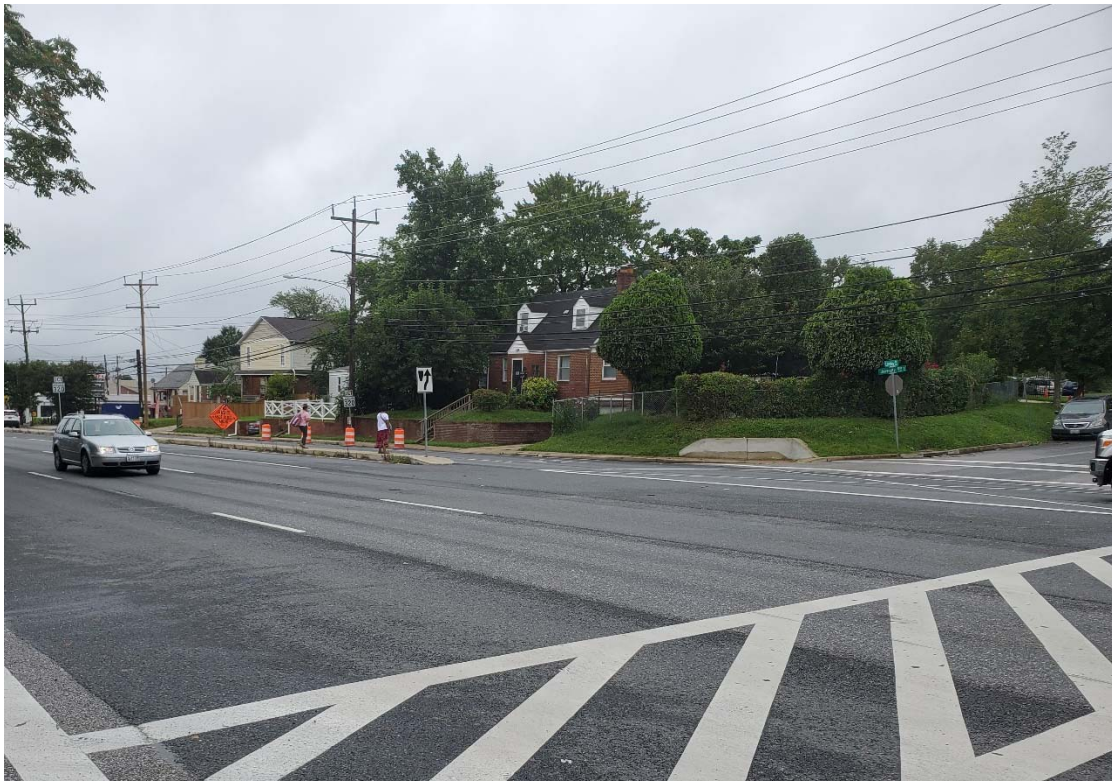
Picture 4: Pedestrians crossing western leg of intersection

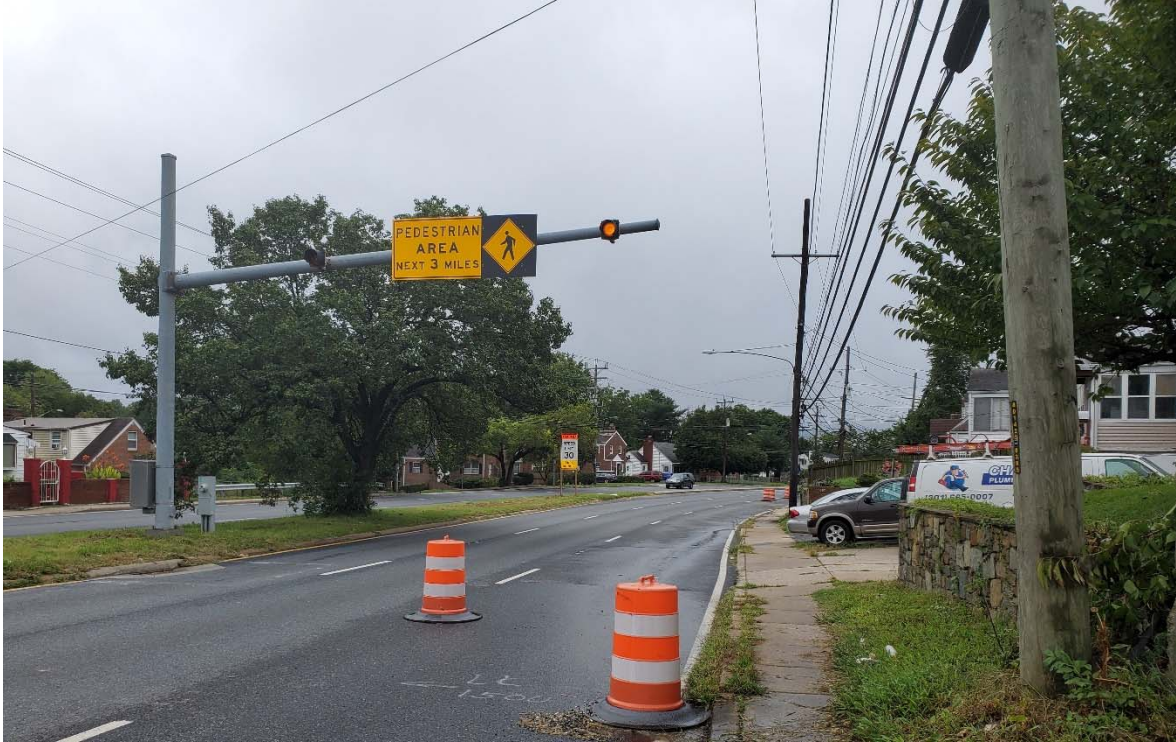
- **Signage:** Existing signing was found to be good condition, visible, and placed properly. Of significant note is the absence of pedestrian warning signing both at and in advance of the crosswalk spanning University Boulevard East. Also of note, is the presence of an overhead sign approximately 500 feet west of the intersection on the eastbound lanes. The sign legend shows as “Pedestrian Area Next 3 Miles” next to an image of a pedestrian warning sign (W11-2) with

flashing beacons. (Picture 5) An investigation did not find a similar sign in the westbound direction.

Picture 5: "Pedestrian Area Next 3 Miles" overhead sign with flashing beacons west of intersection over eastbound lanes. Looking in the direction of the intersection.

2. Install pedestrian warning signs. The crosswalk across University Boulevard operates, effectively, as a mid-block crossing. Advance warning signs are typically installed ahead of the mid-block crossings to alert drivers to the unexpected condition. Though right-of-way is narrow and existing signs complicate sign spacing, it appears that warning can be installed in both directions around the intersection. As this portion of University Boulevard is relatively low speed using median/in-street pedestrian crossing signs may improve visibility at the crossing, in conjunction with standard advance warning signing.
