## FATAL CRASH REVIEW

**Location:** Norbeck Road (MD 28) and Llewellyn Manor Way  
**Crash Date/Time:** Friday, October 23, 2020 at approximately 8:20 PM  
**Local Case No.:** 200041917  
**Police District:** District 4  
**Review Date:** Monday, November 2, 2020

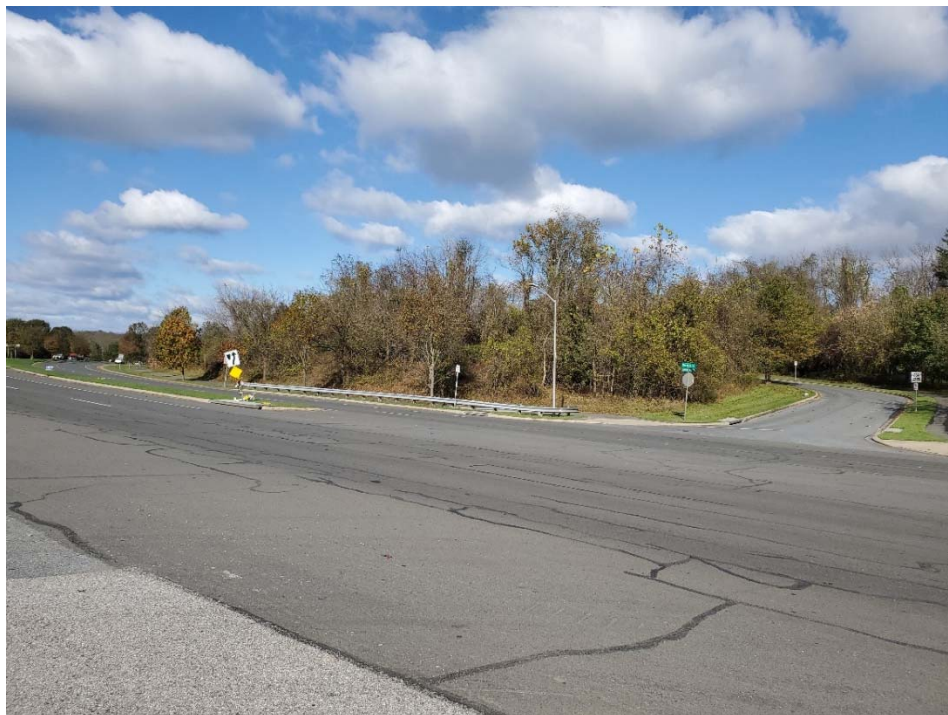
- **Road Geometry:** The intersection is located on a tangent portion of Norbeck Road. Immediately to the east of the intersection, Norbeck Road curves to the (east or west?). The stopping sight distance was determined to be 650 feet on all approaches, meeting MdMUTCD requirements.
- **Pavement markings:** Pavement markings were found to be in good condition and visible.
- **Signing:** Existing signing was found to be good condition, visible, and placed properly.
- **Pedestrian Facilities:** An 8' bituminous shared use path is located on the north side of Norbeck Road. Pedestrian ramps with no marked crosswalk span the Llewellyn Manor Way approach and these ramps were found to be non-compliant with current ADA requirements.

Picture 1: Looking towards the northwestern quadrant of the Llewellyn Manor Way approach from the southeastern quadrant.

- On the Llewellyn Manor Way approach upgrade the existing pedestrian ramps to current ADA requirements.
