## FATAL CRASH REVIEW

**Location:** MD 355 (Rockville Pike) at Grosvenor Lane  
**Accident Date/Time:** Friday, November 20, 2020 at approximately 5:16 AM  
**Local Case No:** 200045803  
**Police District:** District 2, Bethesda  
**Review Date:** Wednesday, November 25, 2020  
**Review By:** Vincent Ho

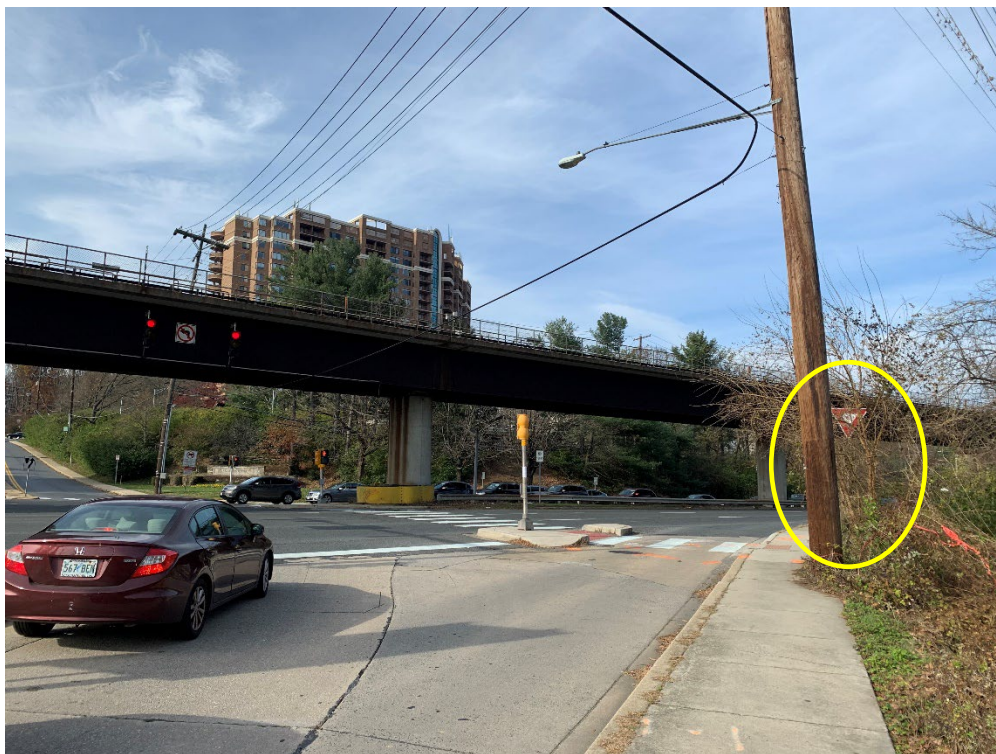
- **Signage:**
  - At the east leg, the yield sign for the slip lane is currently being obstructed by foliage and a utility pole and looks to be undersized (see picture 4). The yield sign should be replaced with a larger 36”x36” sign and relocated such that the sign’s sight distance is not obstructed.

**Picture 4:** Slip lane to NB MD 355. Yield sign is blocked by foliage and utility pole (see yellow highlight).

3. Trim foliage or relocate the yield sign at the northeast corner so that it is not obstructed by the existing foliage and utility pole. (see picture 4).

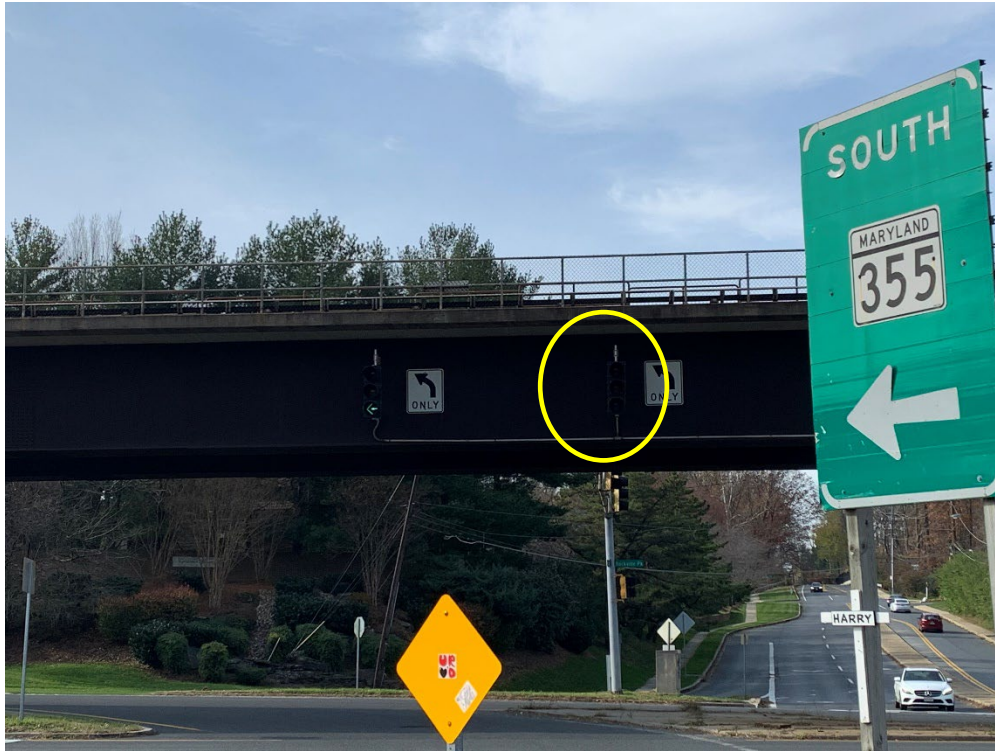
- At the east leg, the “South MD 355, Left” guide sign lacks a complete retroreflective border. Additionally, the lettering and arrows are not flush with the sheet aluminum sign (see picture 5). Consider replacing this sign.

- **Signals:**
  - Multiple signal heads at the east leg of the intersection were observed to be nonfunctioning, possibly burnt out bulbs (see pictures 5 and 6). Fortunately, dual signals provided redundancy and traffic operations was still maintained. The outage was reported immediately by the Area Engineer to the County’s TMC on November 25, 2020 for immediate restoration of the signal heads.

**Picture 5:** Signals facing east leg traffic. The green left turn signal is out (see yellow highlight).

6. Replace the “South MD 355, Left” and the faded “Metro, Next Right” guide signs as indicated in the site observation description section above. (See pictures 5 and 10).
7. Refresh the cracked and fading left turn arrow pavement markings at the west leg of the intersection (see picture 16).
8. Trim back foliage and branches over hanging NB MD 355 prior to the intersection to prevent potential obstruction to the signal’s sight distance (see picture 9).
9. Trim back foliage and branches extending towards the roadway which currently blocks the “Stop Ahead” sign (see picture 16).
10. Provide overhead LED lighting with longer lighting arms at the northeast and northwest corner to better illuminate pedestrians utilizing the crosswalk.
11. Clean debris and repair pavement around the grate inlet at the northwest corner of the intersection (see picture 20).

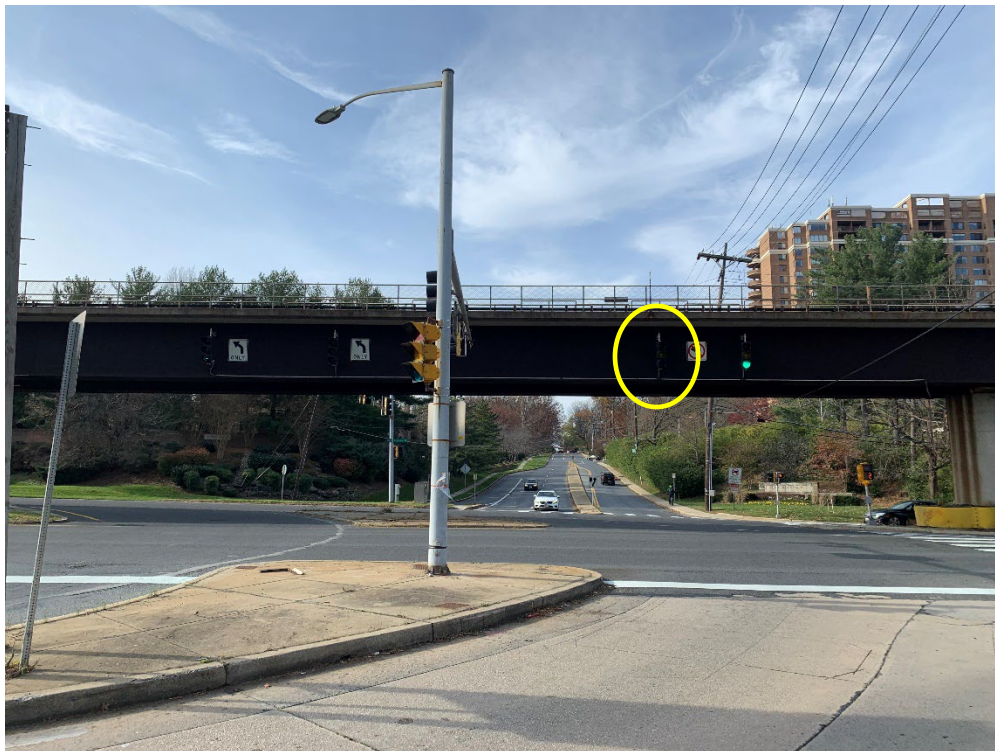
**Picture 6:** Signals facing east leg traffic. Green signal is out for through movement (see yellow highlight).

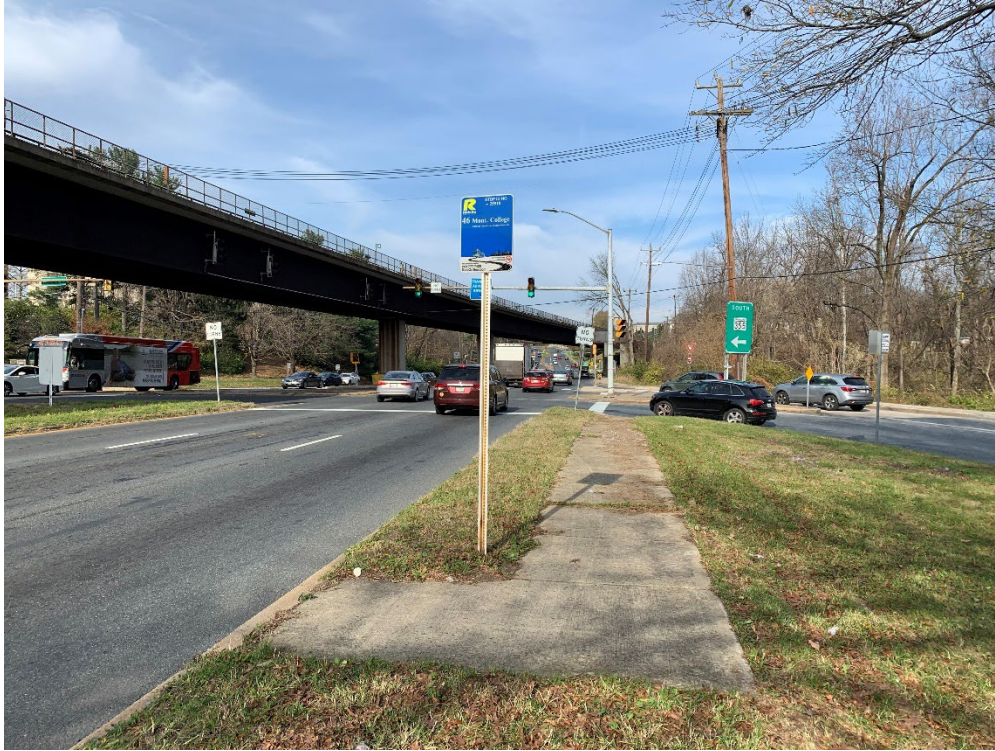
**Picture 7:** Bus stop at southeast corner of the intersection.

5. Relocate the NB MD 355 bus stop at the southeast corner to the northeast corner. Relocating the bus stop to the far side of the intersection will provide better accessibility as there is currently no ADA ramps or clear path to safely get to the existing bus stop location (see pictures 7 and 8).

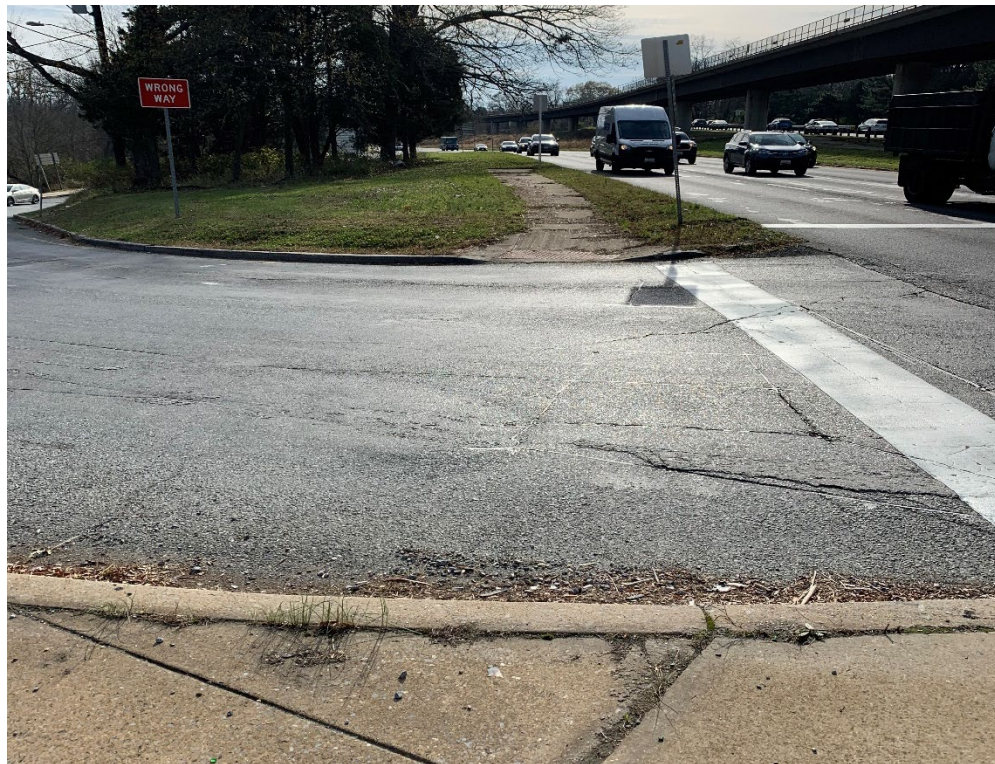
**Picture 8:** No ADA ramp/path across intersection to reach bus stop at SE corner of the intersection.

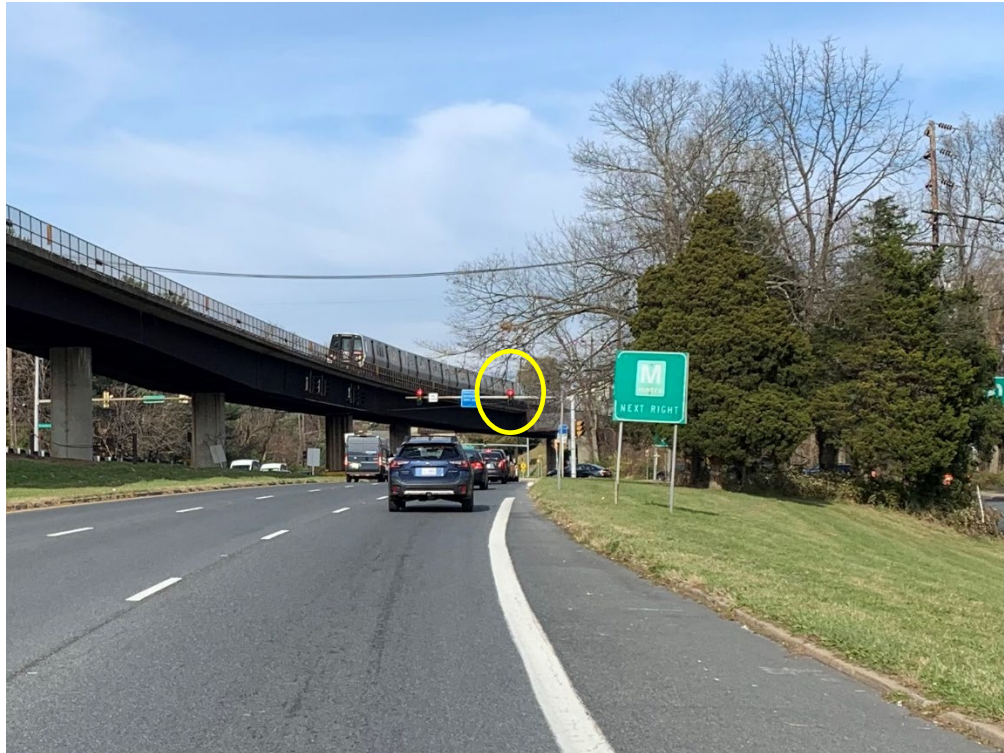
- **Other Hazards:**
  - Overhanging branches with foliage encroaching over NB MD 355 has the potential to obstruct one of the signals for motorists approaching the intersection (see picture 9).
  - Tree branches and foliage extending towards the roadway currently obstructs the “Stop Ahead” sign at the west leg of the intersection. (see picture 16).

**Picture 9:** Northbound MD 355 approaching intersection. Foliage and branches have potential to block signal (see yellow highlight).

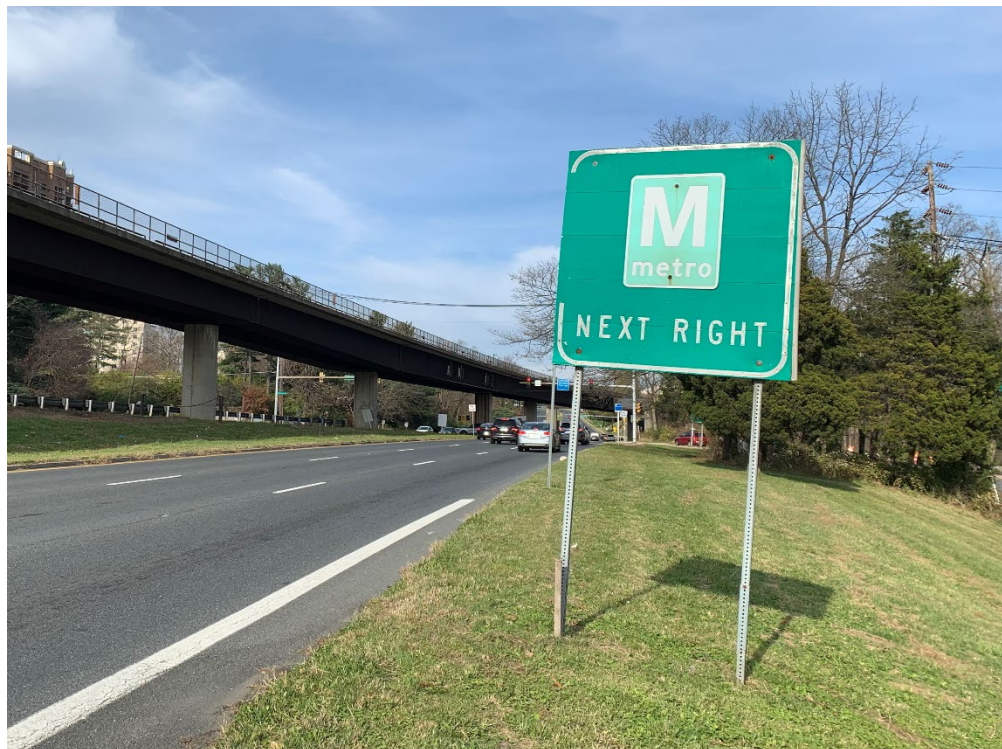
- Along the NB MD 355 approach to the intersection, the “Metro, Next Right” sign lacks a complete retroreflective border and is faded (see picture 10). Consider replacing this sign.

**Picture 10:** Faded “Metro, Next Right” sign with incomplete retroreflective border.

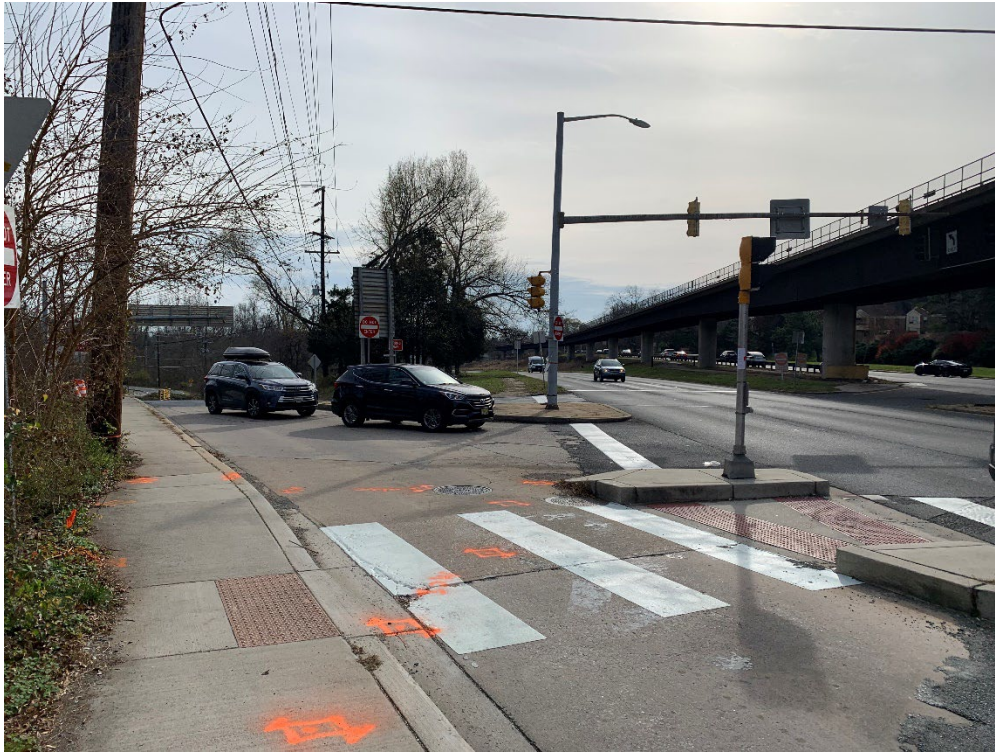
- **Road Geometry:** The east leg of the intersection contains a yield-controlled slip lane with a very short storage length. The slip lane does not provide much benefit when access to the slip lane is blocked when multiple cars are queued in the WB through lane (see picture 11 in appendix).
- **Pavement Markings:** Pavement markings were generally found to be in fair condition and visible. Crosswalks were recently upgraded to high visibility, continental style crosswalks. However, the four left turn arrow pavement markings at the west leg of the intersection are cracked and beginning to fade (see picture 16).

**Picture 11:** Crosswalk within slip lane at the NE corner of intersection.

1. At the northeast corner, consideration should be made to eliminate the yield-controlled slip lane to enhance pedestrian safety.

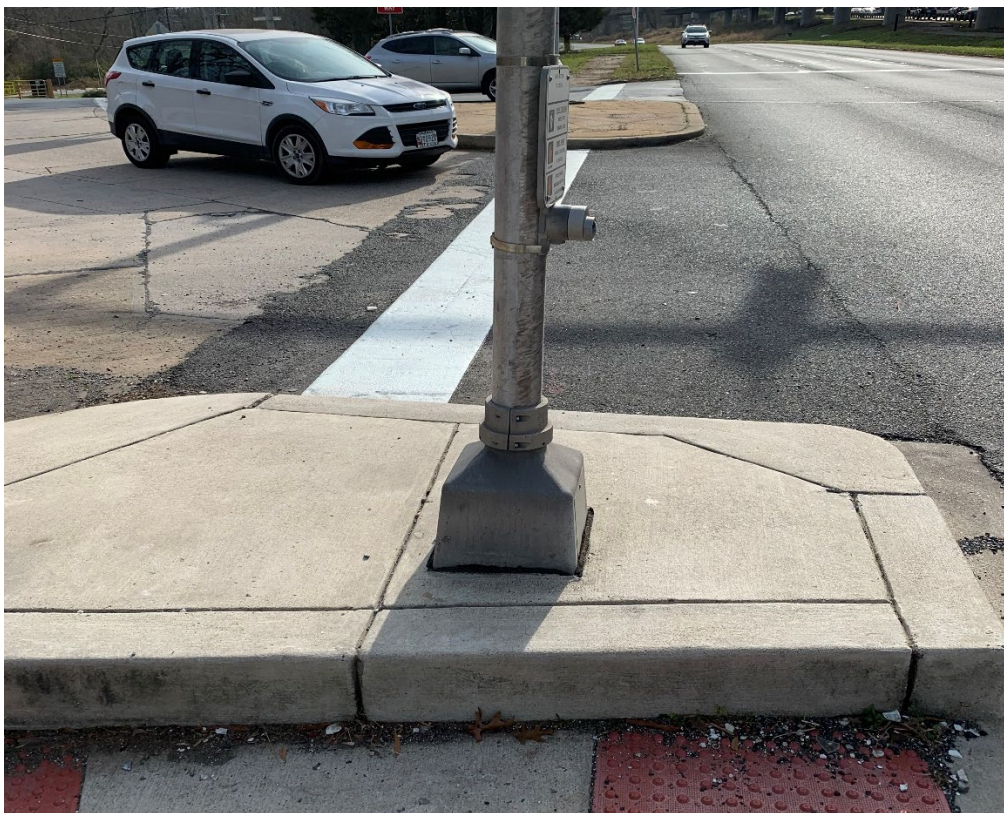
- At the northeast corner, the push button located on the pedestrian signal pedestal is incorrectly facing the road (see picture 12). It should be reoriented perpendicular to the road so that it is facing the user and a pedestrian does not have to reach around to activate the signal.

**Picture 12:** Push button at NE corner of intersection faces the road.

2. At the northeast corner, reorient the pedestrian push button to directly face the user as it is currently facing the roadway (see picture 12). Additionally, consideration should be made to upgrade all pedestrian signals and pushbuttons to the latest APS/CPS standards.

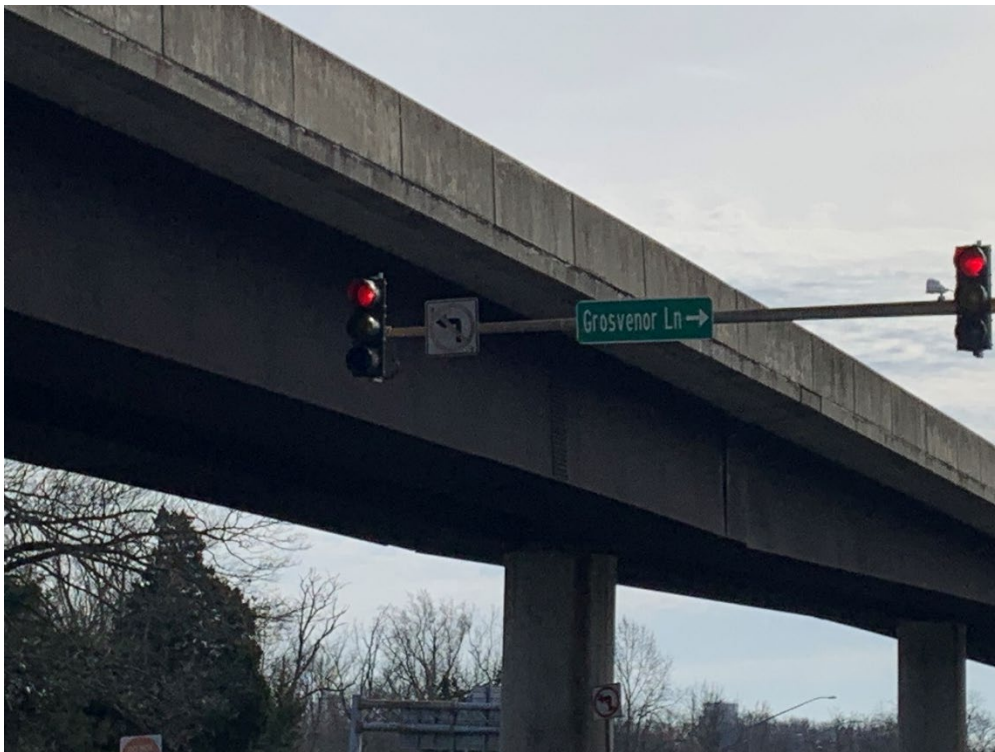
- At the southbound approach of the north leg, the “No Left Turn” sign mounted on the mast arm is extremely faded and should be replaced (see picture 14).

**Picture 14:** Faded “No Left Turn” sign on signal mast arm.

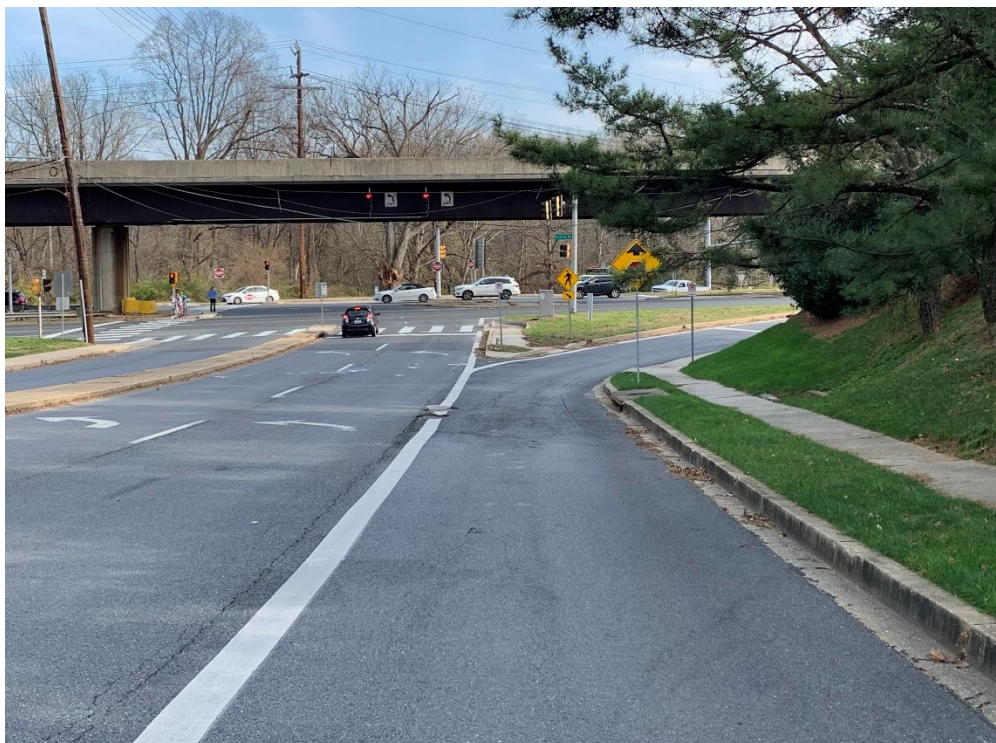
**Picture 16:** Tree branches blocks “Stop Ahead” sign. Cracked and fading left turn arrow pavement markings along west leg approach.

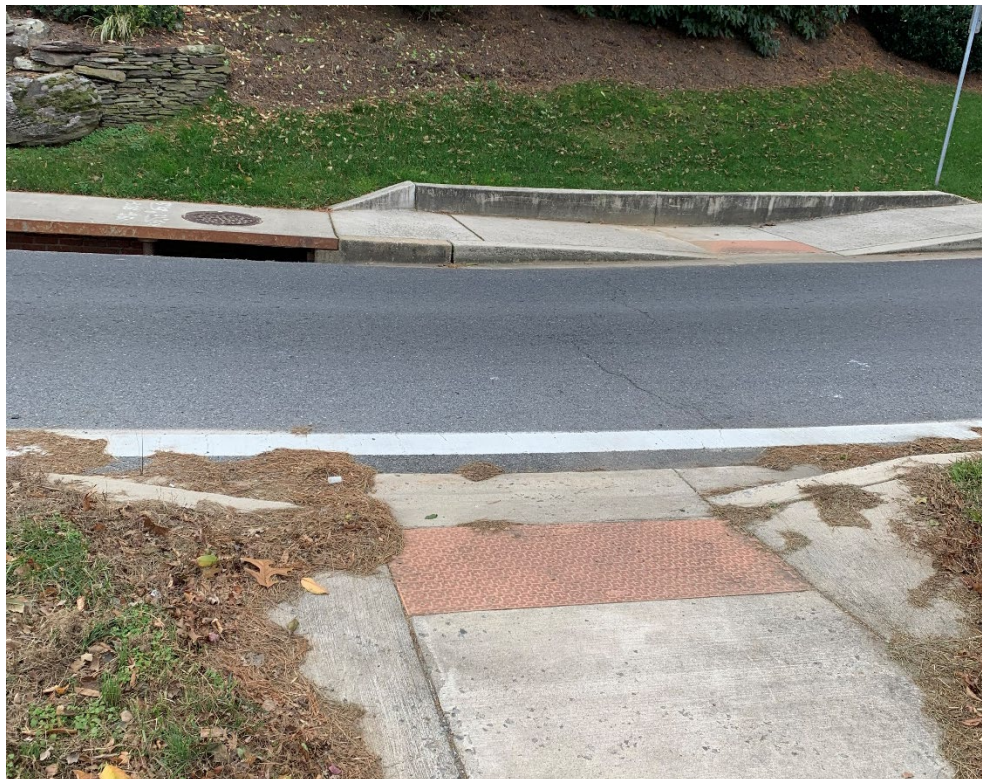
- **Pedestrian facilities:** Sidewalks along MD 355 generally terminate at Grosvenor Lane and do not extend south past this intersection.
  - A bus stop along NB MD 355 exists at the southeast corner of the intersection with a short sidewalk path to the bus pad, however, there is no proper ADA path/ramps to reach this corner of the intersection. It is recommended that this bus stop be relocated to the far side of the intersection at the northeast corner of the intersection where it would be more accessible. (See pictures 7 and 8).
  - At the west leg, the unmarked crossing across the slip lane is a skewed crossing where the two corresponding ramps do not align. This is a hazard for pedestrians unable to identify the skewed crossing and follow the natural direction of the ramp (see picture 18).

**Picture 18:** Unaligned ramps with screwed crosswalk at west leg slip lane.

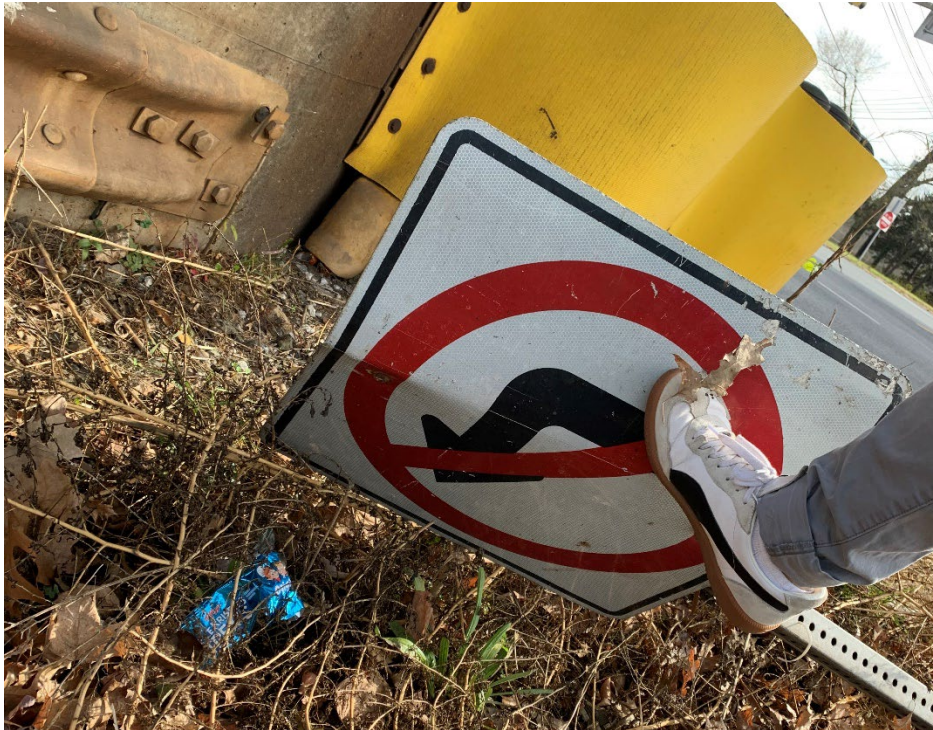
- A “No Left Turn” sign located at the median of the north leg has been knocked-over and damaged (see picture 19). This sign should be replaced and reinstalled.

**Picture 19:** “No Left Turn” sign knocked-over and damaged at north leg median.

4. Replace the knocked-over and damaged “No Left Turn” sign located in the median of the north leg (see picture 19).

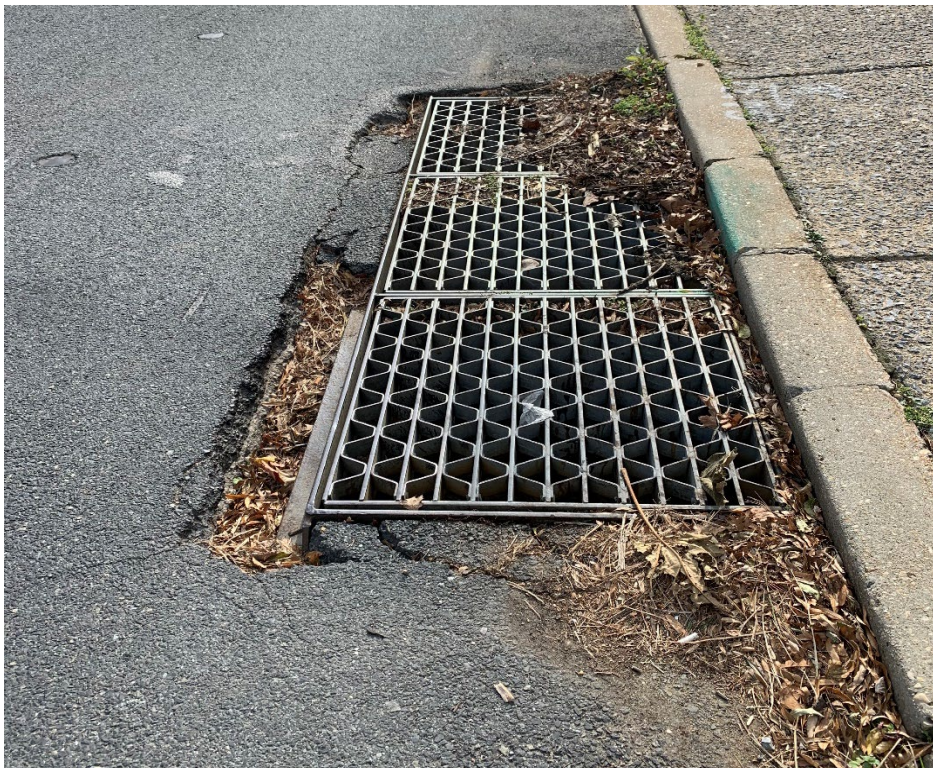
- **Drainage:** Curb and grate inlets are present along the southbound side of MD 355. Typical debris and sediment build-up and pavement deterioration around the grate inlet located at the northwest corner was noted (see picture 20).

**Picture 20:** Debris, sediment build-up, and deteriorating pavement around grate inlet at the NW corner.
