Final  
Report of  
Inspection

Project Management  
Deficiencies in Constructing  
the Paul S. Sarbanes  
Silver Spring Transit Center

Report # OIG-14-007

April 15, 2014

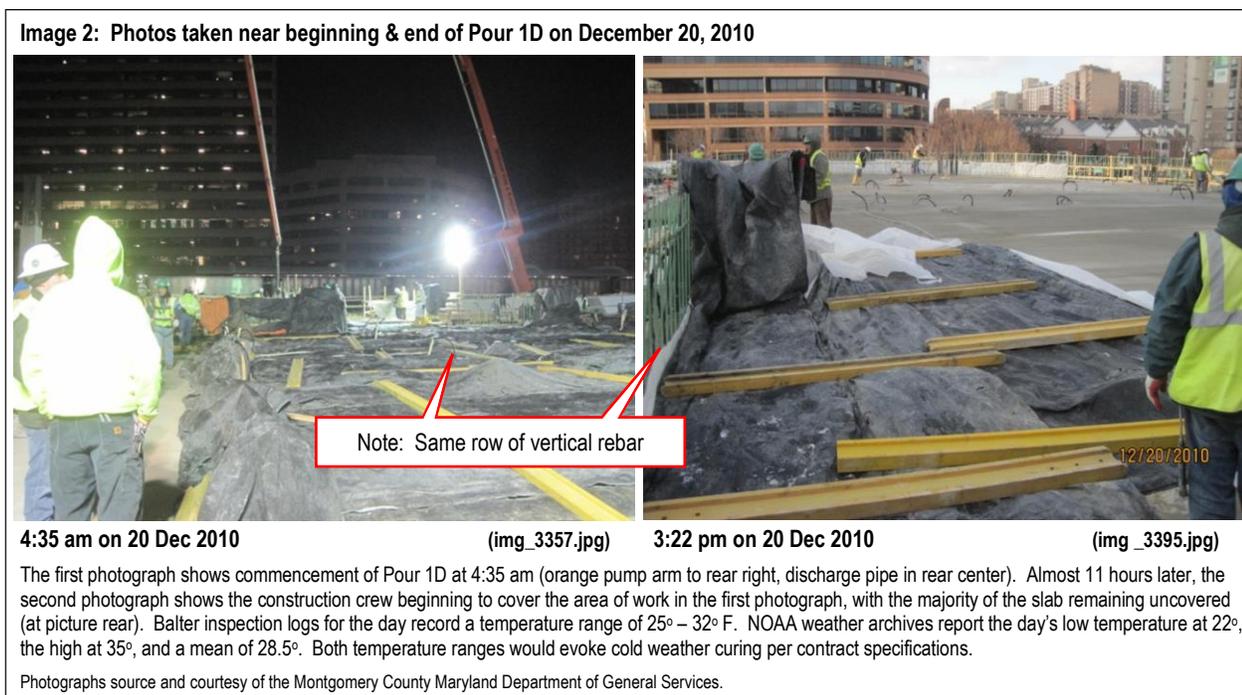
The unhydrated cementitious material was attributed by KCE to delayed placement and/or early removal of thermal protection during cold weather.<sup>39</sup> We reviewed photographic evidence from pour 1D on December 20, 2010, when temperatures required cold weather curing measures, that supports this conclusion. In the photographs in Image 2, below, 11 hours elapse<sup>40</sup> from the beginning to the end of the pour when requisite protective covers were placed. NOAA records reflect a mean temperature of 31° F for the day of this pour, and temperatures ranging between 26° and 41° F over the ensuing 7 days. The mid-afternoon photograph from the end of the pour

depicts workers who were beginning to place the moisture-retaining plastic sheeting and blankets on the area where the pour had initiated in the early morning image. Industry standards indicate that covering “should follow closely the finishing of concrete.”<sup>41</sup>

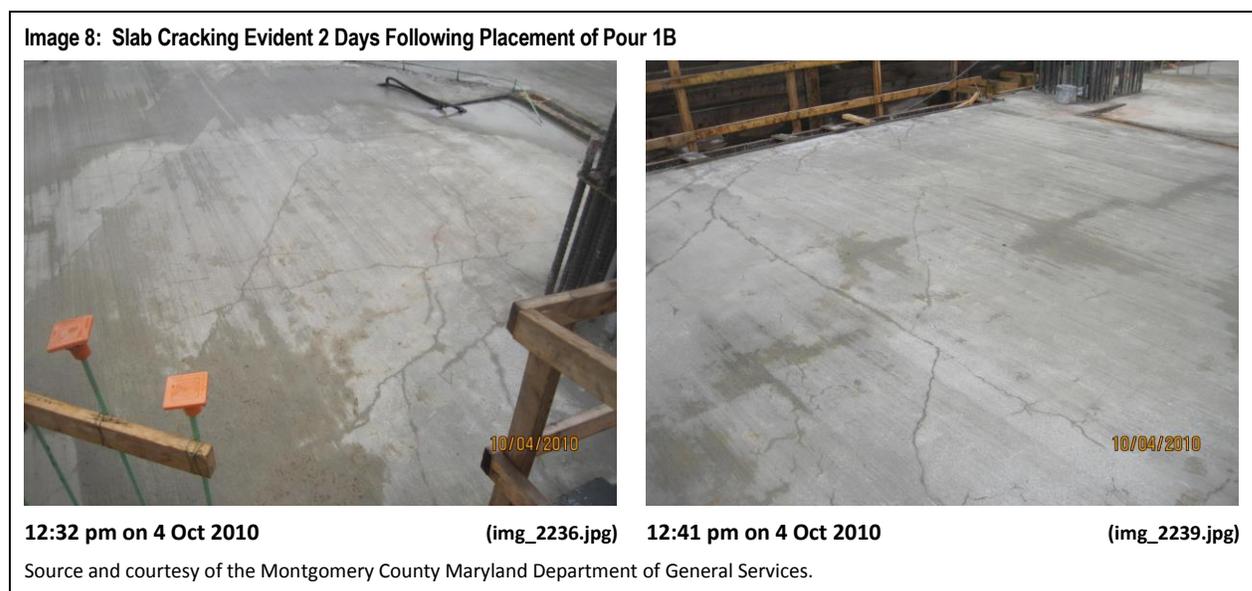
The appearance of cracking had been documented early in the process of constructing the 330 and 350 levels. The first three level 330 slabs (1A, 1B, and 1C) were poured between September 13, and October 18, 2010. Problems related to concrete cracks became evident within 24 hours after placement (see image 8). Three ducts became exposed to view through the surface of Pour 1A shortly after being grouted.<sup>89</sup> Significant cracks were observed in pours 1B and 1C prior to the post-tensioned tendon stressing operations. In a September 20, 2010 meeting to review Pour 1A - the first pour of these levels – shrinkage cracks were discussed, noting that the Structural Engineer of Record (SEOR) would visit the site to inspect.
