2021 BIENNIAL BRIDGE INSPECTION REPORT
September 13, 2021

BRIDGE NO. M-0229001
BRIGHTON DAM ROAD
OVER
BRIGHTON DAM & TRIADELPHIA RESERVOIR
Prepared by

Roadway	BRIGHTON DAM ROAD
Bridge Orientation	East-West
Crossing	BRIGHTON DAM & TRIADELPHIA RESERVOIR
Crossing Orientation	North-South
Inspection Date	9/13/2021
Inspected By	Whitman, Requardt, and Associates, LLP
Spans	15
Type	Prestressed concrete solid slab beams
Structure Organization	The numbering convention for reporting purposes is from the south and the west.
Deck	N/A
Railing	Rectangular concrete parapet
Abutments	Concrete buttresses
Wing Walls	Concrete cantilever
Piers	Concrete buttresses (Odd Buttresses 3-29)
Overall Length	601'-6"
Clear Roadway	28'-0"
No. of Lanes	2
Out-to-Out Width	36'-4"
Year Built	1944
Year Reconstructed	1999 - superstructure and top 4' of buttresses were reconstructed
Approach Section	28'-0"
Shoulders	No
Alignment	Moderate curve from the north on both approaches.
Profile	Moderate downgrade to the bridge on the west approach. Steep downgrade to the bridge on the east approach.
Guardrail	W-Beam

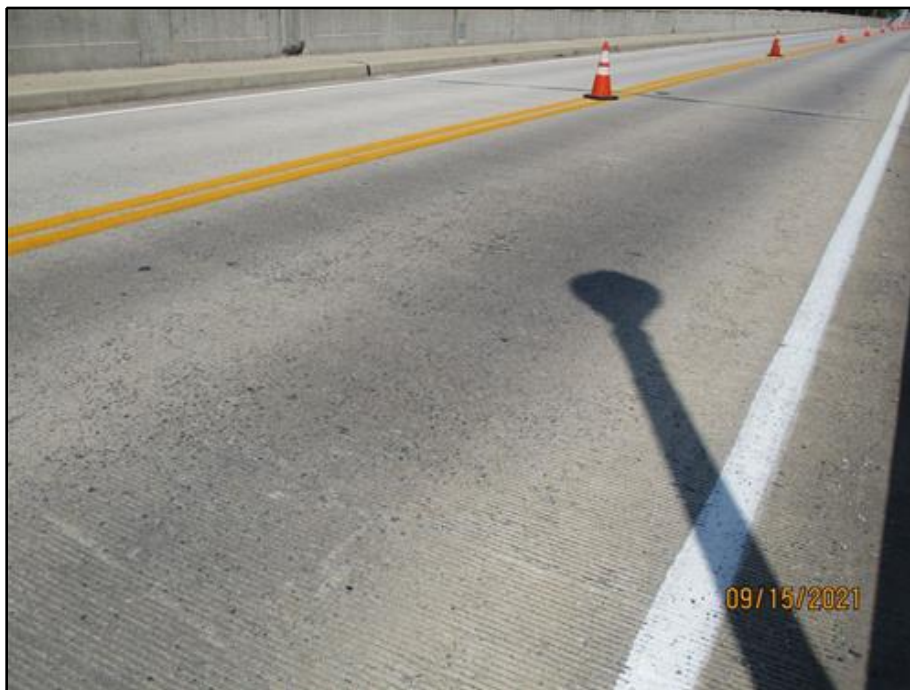
7. Typical wearing surface (Span 1, looking northeast shown)

58.1 – The concrete integral wearing surface is in good condition (see Photo 7). The top face of the beams are not visible for inspection due to the presence of the concrete overlay. The wearing surface of the overlay exhibits deteriorated lane striping throughout, minor scaling throughout, and moderate scaling near the ends of the structure

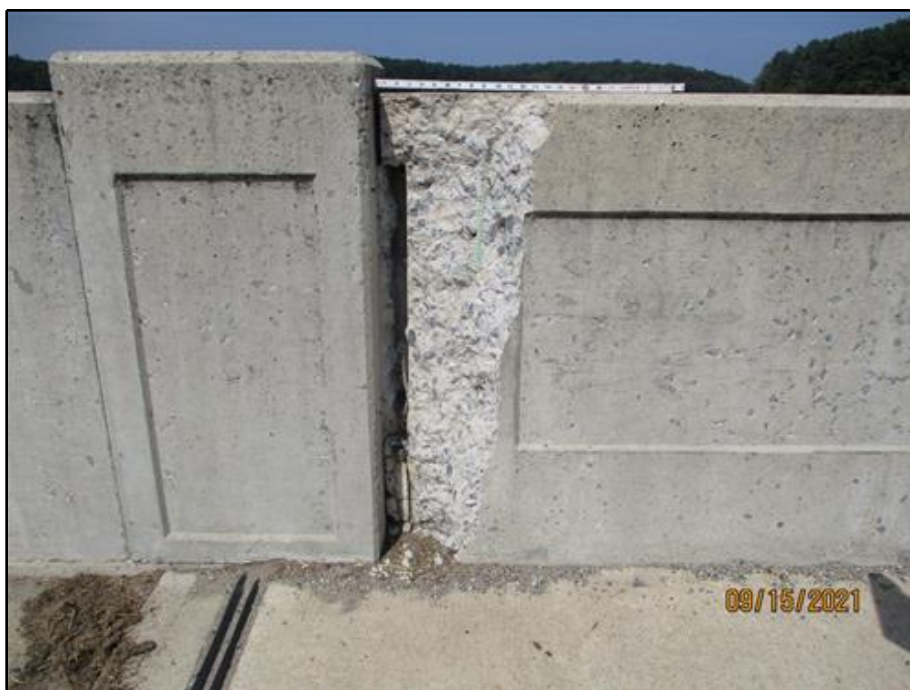
8. Spall with exposed steel reinforcing on the south face of the north parapet at
the west abutment

- There are vertical hairline cracks up to full-height throughout the south face.
- Above the west abutment, there is a full-height x 1'-2" wide x 4" deep spall with exposed corroded reinforcement (see Photo 8).

3. Repair the damage to the traffic barrier end treatment on the southwest approach.	2	1 L.S.	\$2800/Ea.	\$2800
4. Repair the spalled and delaminated areas on the parapets.	3	1 L.S.	\$20000/L.S.	\$20000

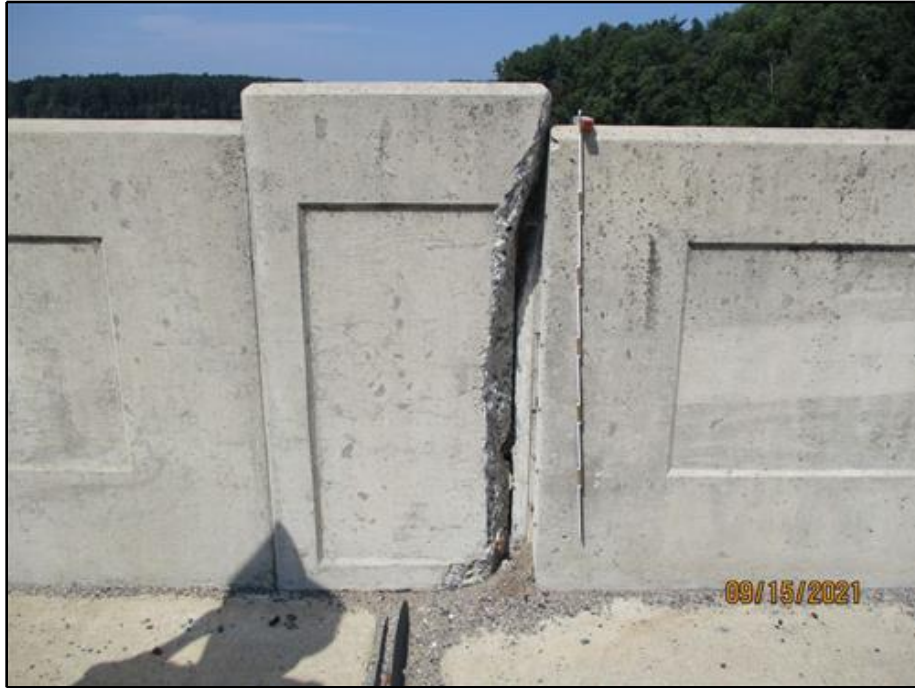
9. Spall on the south face of the north parapet above Buttress 23

- Above Buttress 20, there is a 3" high x 8" wide x 1/2" deep corner spall in the top of the post.
- Above Buttress 23, there is a full-height x 5 1/2" wide x 7" deep spall (see Photo 9).

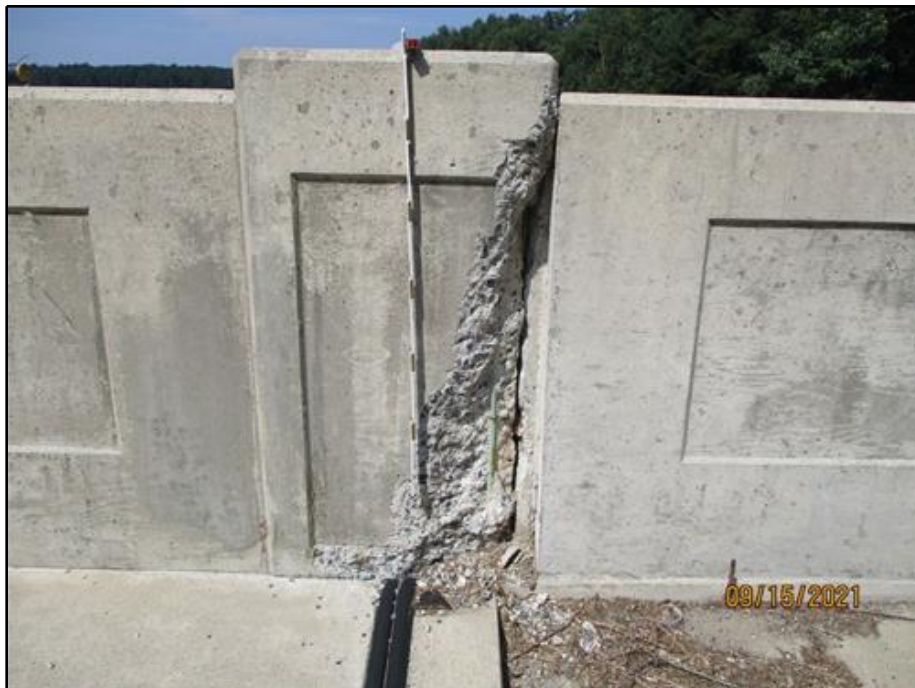
10. Spall in the south face of the north parapet above the east abutment

- Above Buttress 27, there is an up to 1'-4" high x 9" wide x 2" deep spall at the bottom of the parapet.
- Above the east abutment, there is an up to 2'-4" high x 1'-8" wide x 2" deep spall with efflorescence (see Photo 10).

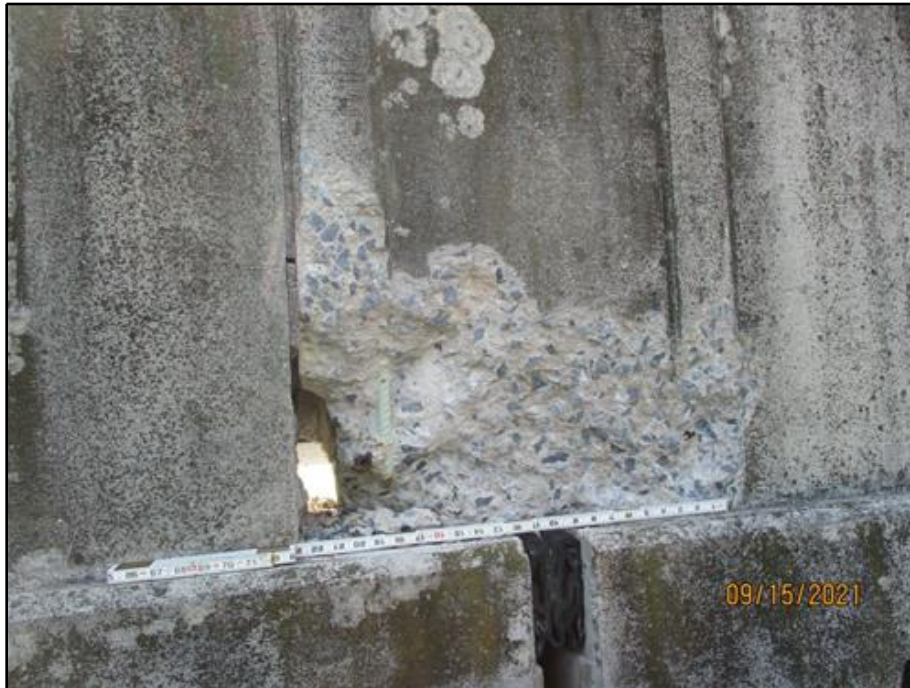
11. Full depth spall with exposed epoxy coated steel reinforcing in the exterior face of the north parapet above Buttress 3

- Above Buttress 3, there is a 1'-6" high x 2'-0" wide x full depth spall with exposed epoxy coated steel reinforcing and efflorescence at the base (see Photo 11).

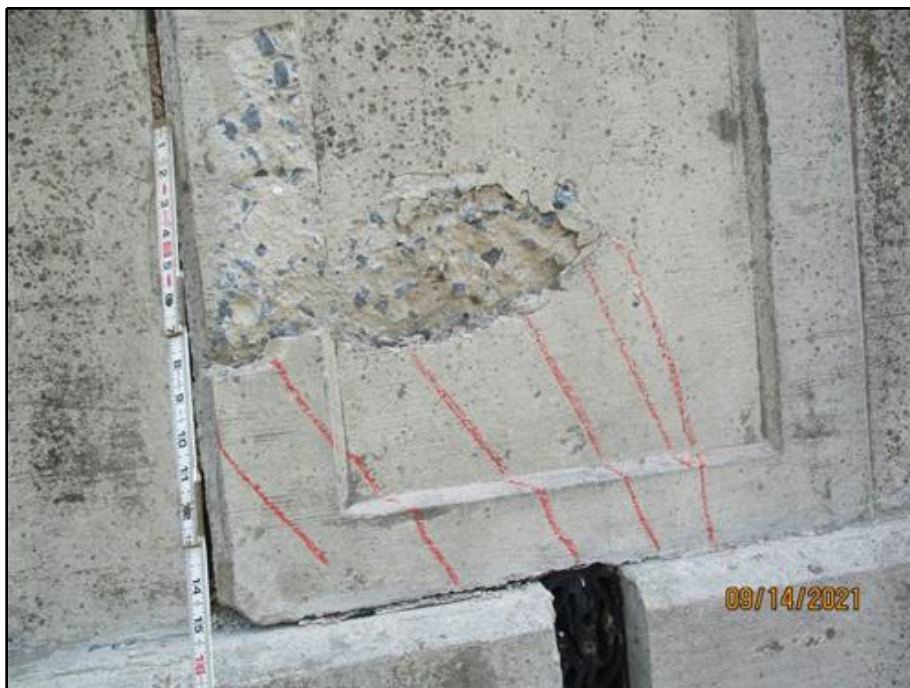
12. Delaminated area on the north face of the base of the exterior face of the north parapet above Buttress 11

- Above Buttress 7, there is a 1'-5" high x 1'-9" wide x 5" deep spall.
- Above Buttress 11, there is a 1'-3" high x 1'-0" wide delaminated area with a 7" high x 1'-0" wide adjacent spall at the base (see Photo 12).

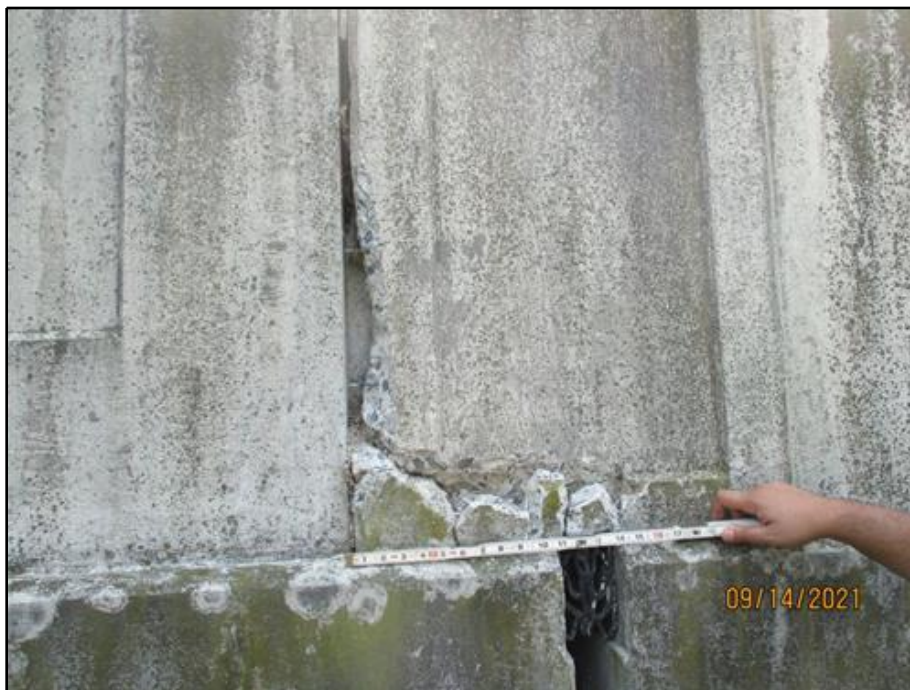
13. Spalling in the north face at the base of the north parapet over Butress 27

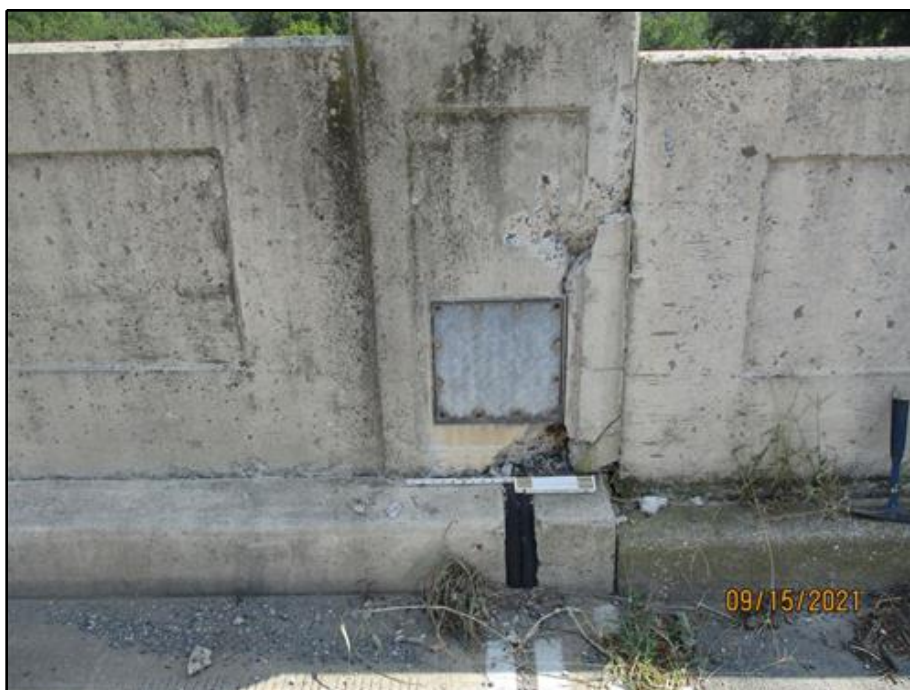
**14. Imminent spall in the north face of the south parapet at the west abutment
joint**

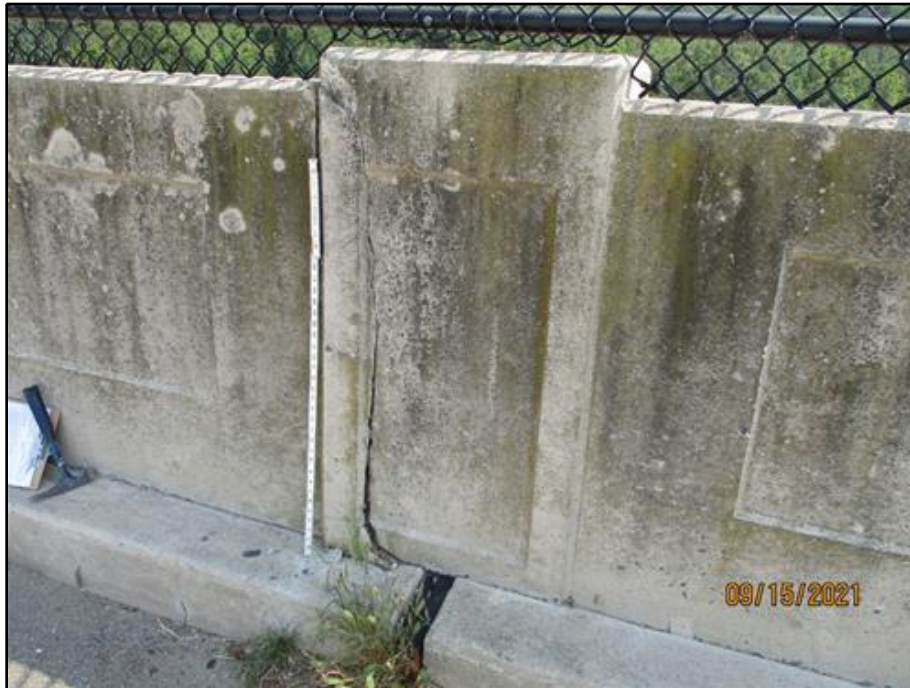
**15. Cracking and imminent spall in the north face of the south parapet over
Buttrass 11**

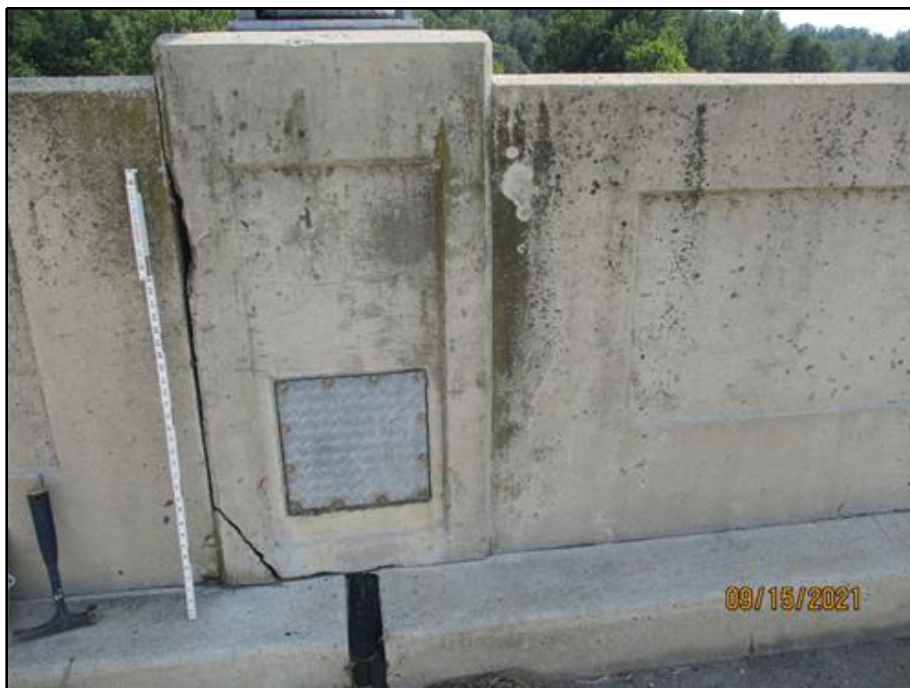
**16. Imminent spall in the north face at the base of the south parapet above
Buttrass 19**

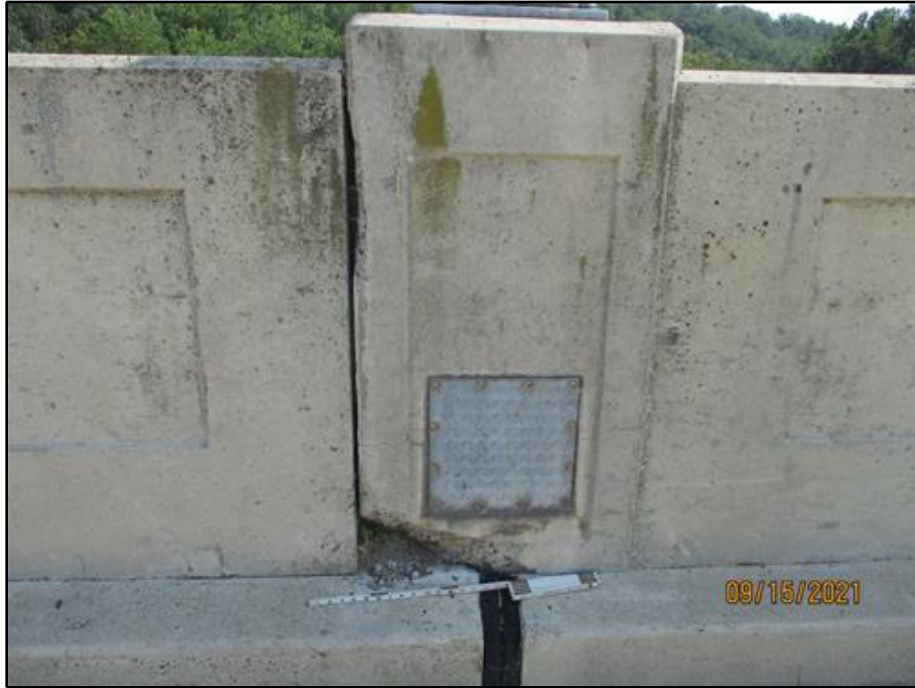
17. Spall in the north face at the base of the south parapet above Buttress 29

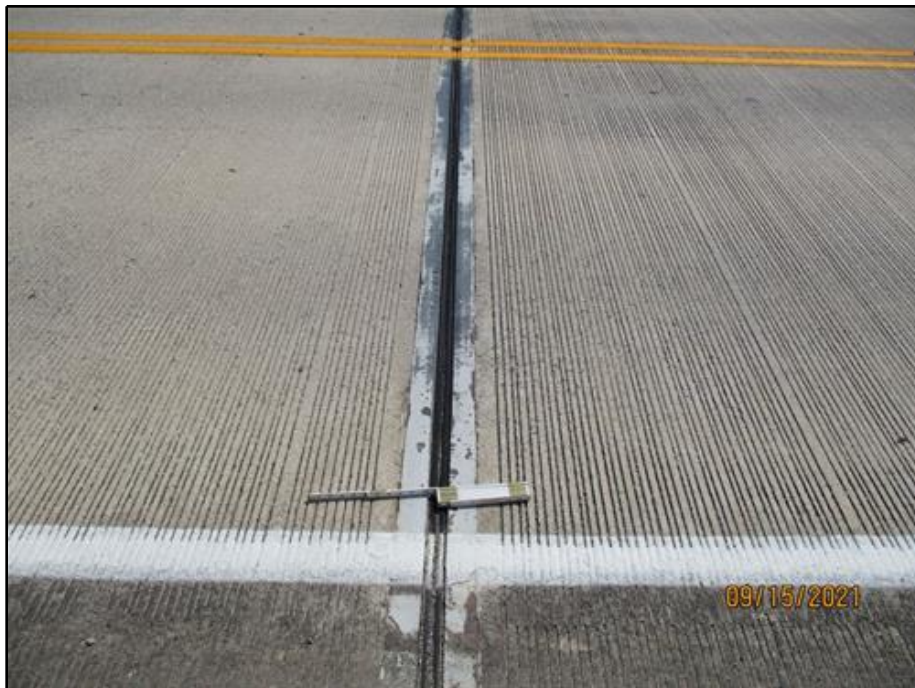
18. Typical compression joint seal condition (Joint 17, looking south shown)

58.9 – The compression joint seals are in satisfactory condition (see Photo 18).

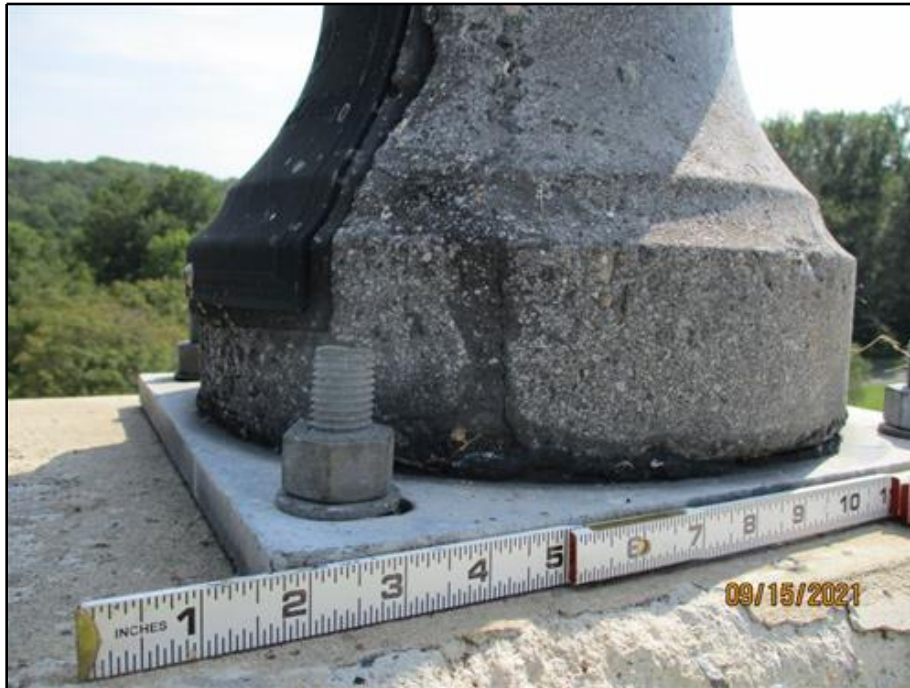
19. Typical crack in the lamp post base (lamp post on the south parapet above Buttress 7 shown)

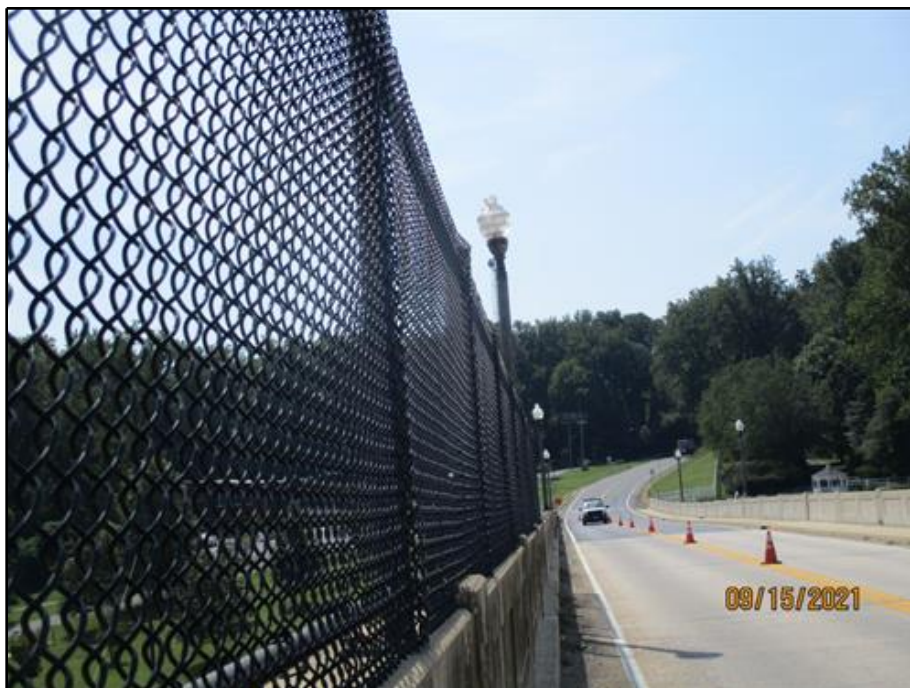
The light poles are in satisfactory condition. The previously noted missing light fixtures on the south parapet at the east and west abutments have been replaced. Two (2) light fixtures are damaged and leaning to the east at Buttresses 13 and 19.

20. Light fixture leaning east relative to the post (lamp post on south parapet above Buttress 7 shown)

9. Seal cracks in the bottom and exterior faces of the prestressed beams	2	60 L.F.	\$50/L.F.	\$3000
10. Repair the light fixtures on the light poles above Buttresses 13 and 19.	2	1 L.S.	\$1500/L.S.	\$1500

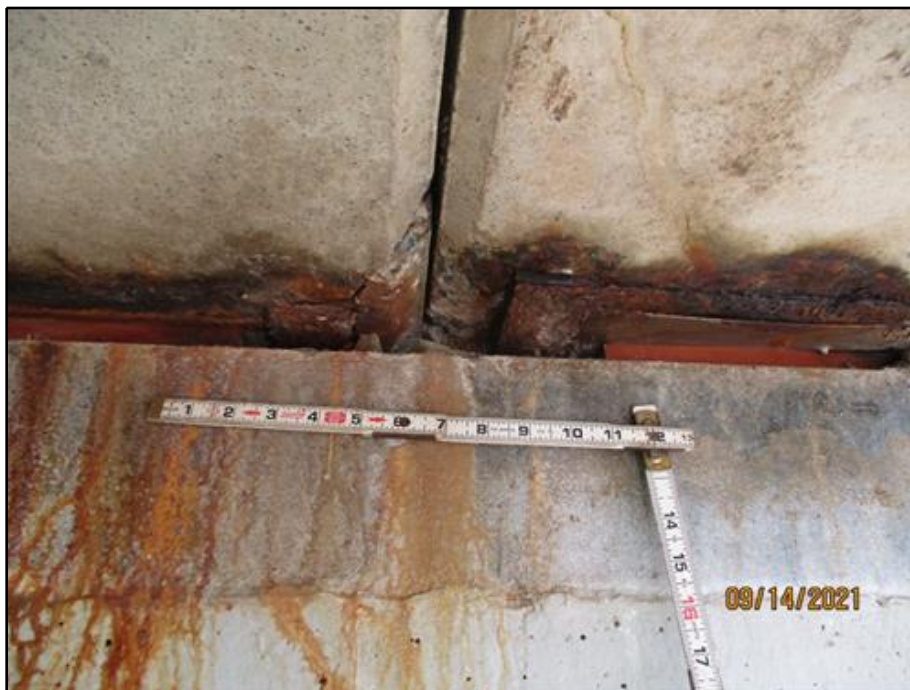
The bearings are in satisfactory condition. There are minor gaps along the edges of several beams and typically the bearing plates have moderate corrosion.

21. Typical exposed and corroded bearing plates (Beams 1 and 2 in Span 13 at Buttress 27 shown)

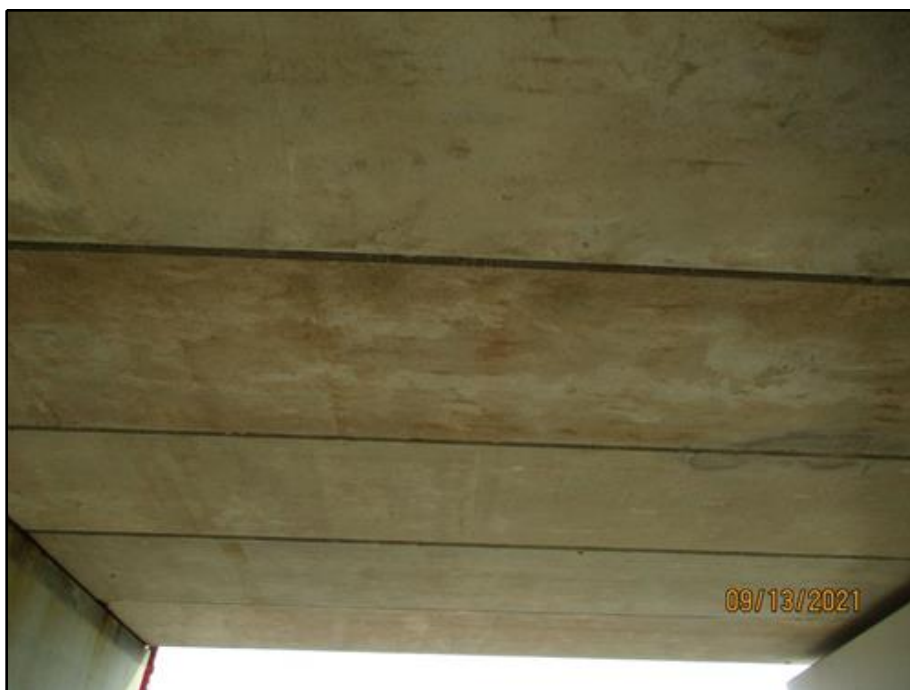
22. Typical underside of the superstructure (Span 7 between Buttresses 13 and 14 shown)

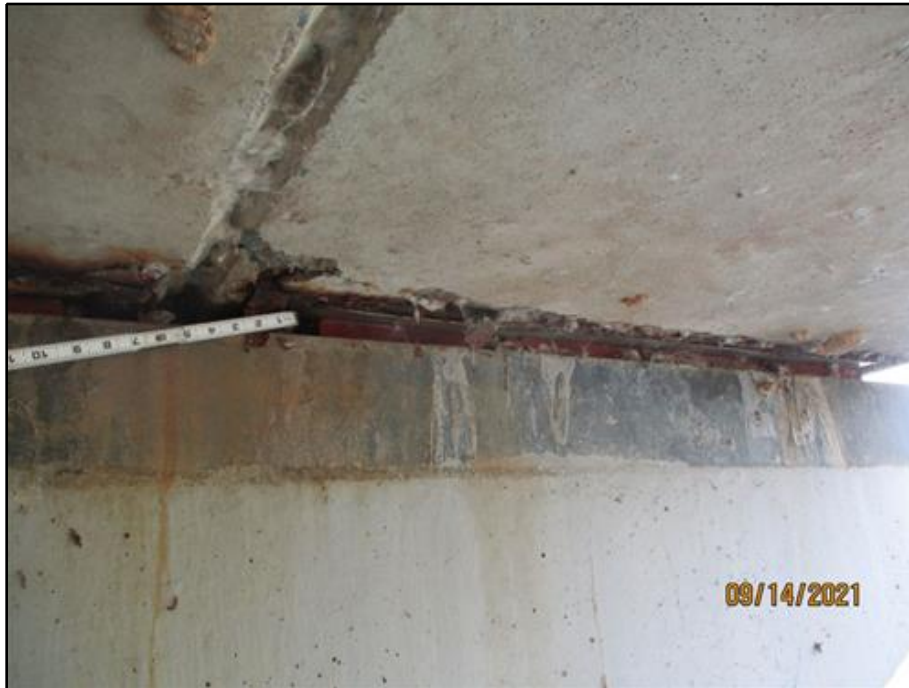
23. Typical delamination at beam corners near bearings (Beam 9 in Span 14 at Buttress 27 shown)

5. Seal the 1/16" wide cracks in the parapets.	3	30 L.F.	\$50/L.F.	\$1500
6. Patch the spalls and delaminated areas in the prestressed concrete beams.	3	1 L.S.	\$10000/L.S.	\$10000

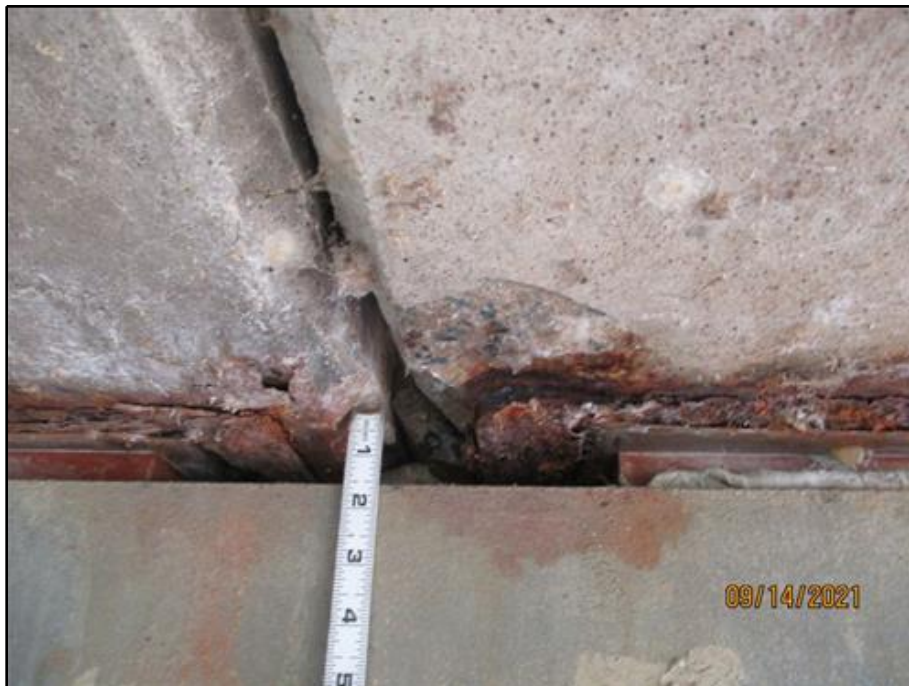
24. Spall with exposed bearing plate at the west end of Beam 2 in Span 6 at Buttress 13

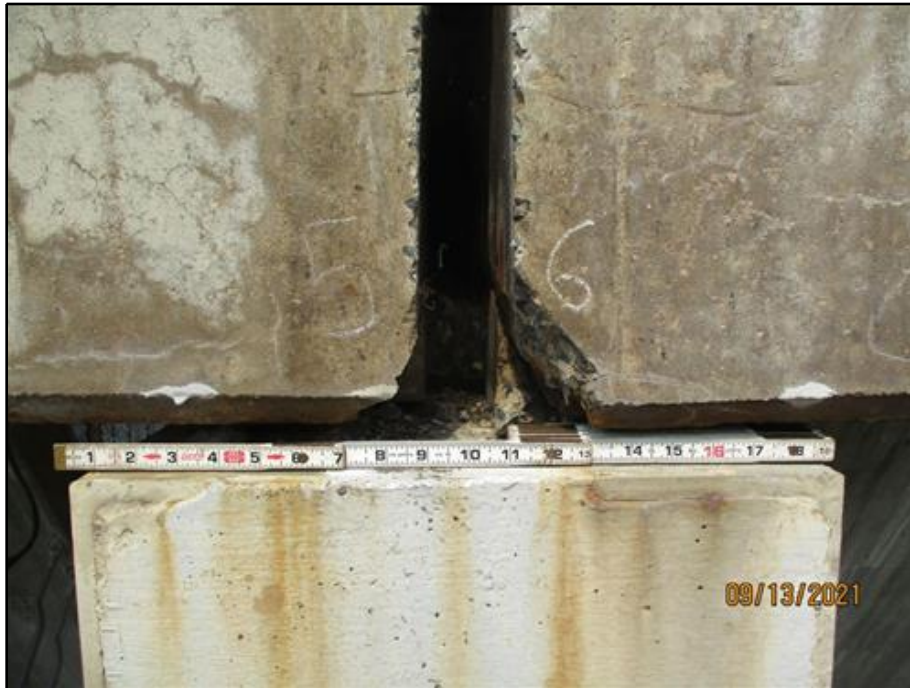
25. Full width spall on Beam 1 at the east end of Span 5 and west end of Span 6 at Buttress 11

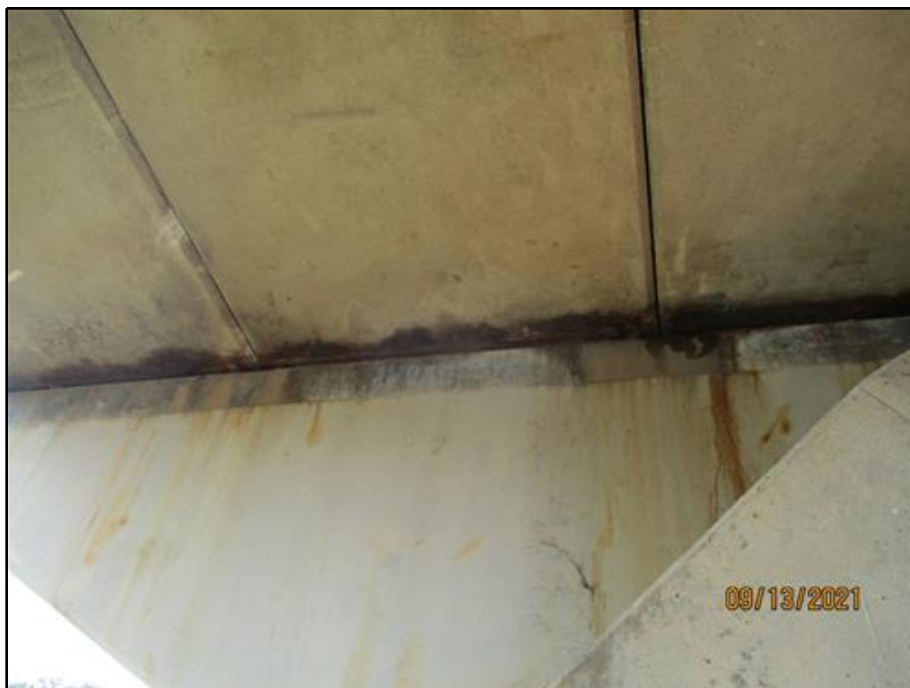
26. Typical active water leakage between beams (Beams 2 and 3 at west face of Buttress 3)

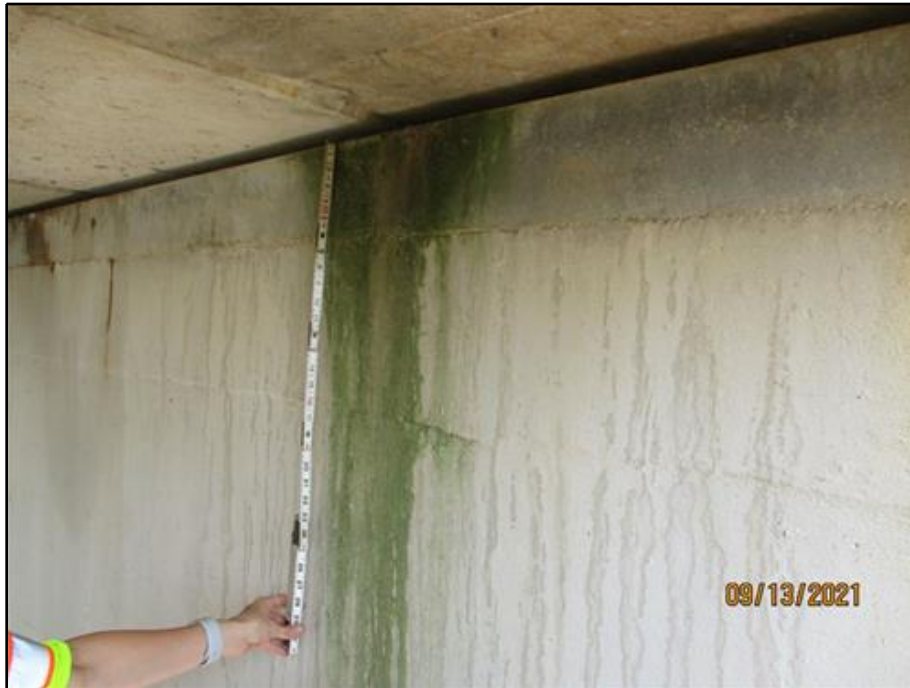
27. Typical active water leakage between beams (Beams 1 and 2 at west face of Buttress 13 shown)

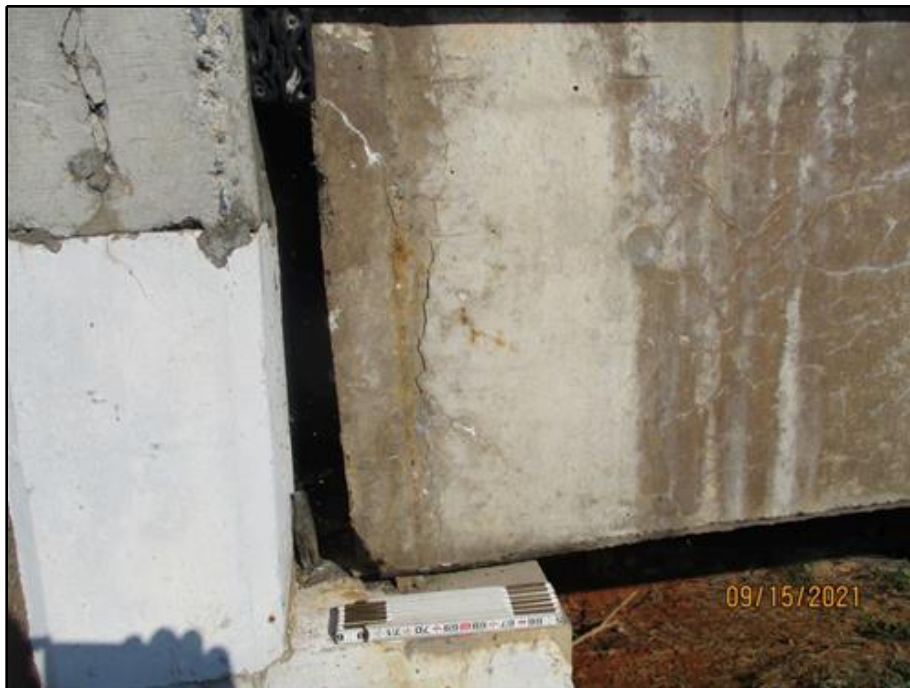
28. Vertical crack in the south face of Beam 1 at the west abutment

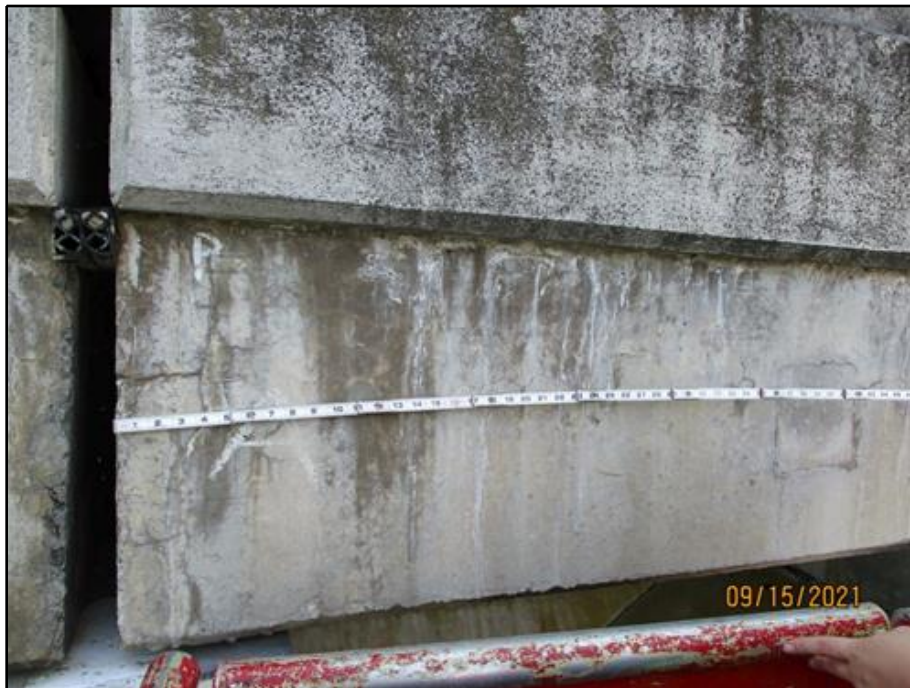
29. Horizontal crack in the north face of Beam 9 above Buttress 3 in Span 1

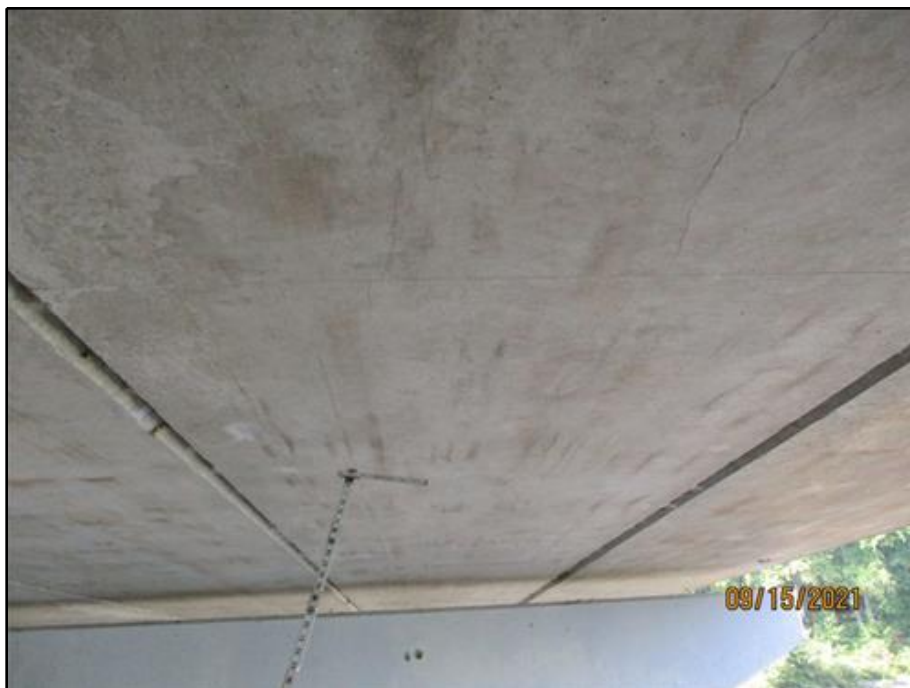
30. Two (2) longitudinal cracks in the bottom end of Beam 8 in Span 2

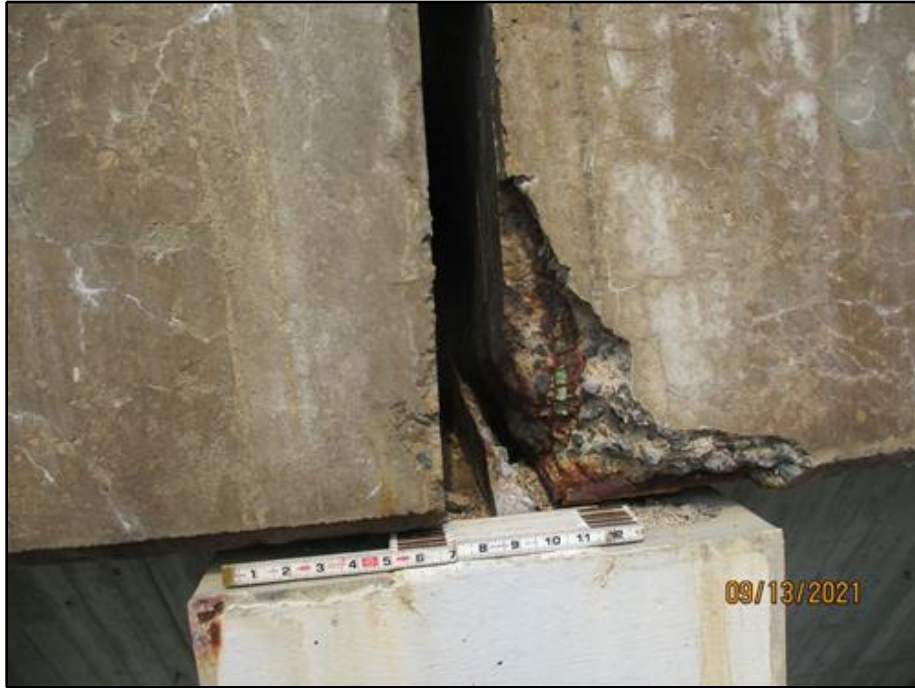
31. Full width spall on the west face of Beam 1 at the west end of Span 4 at
Buttress 7

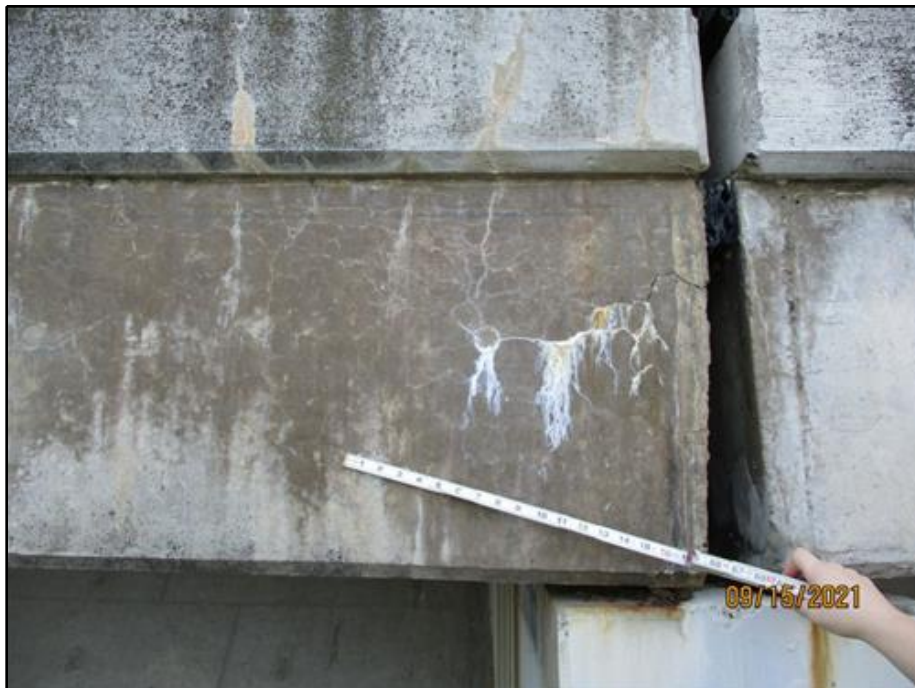
32. Map cracking with efflorescence in the north face of Beam 9 in Span 4 at
Buttress 7

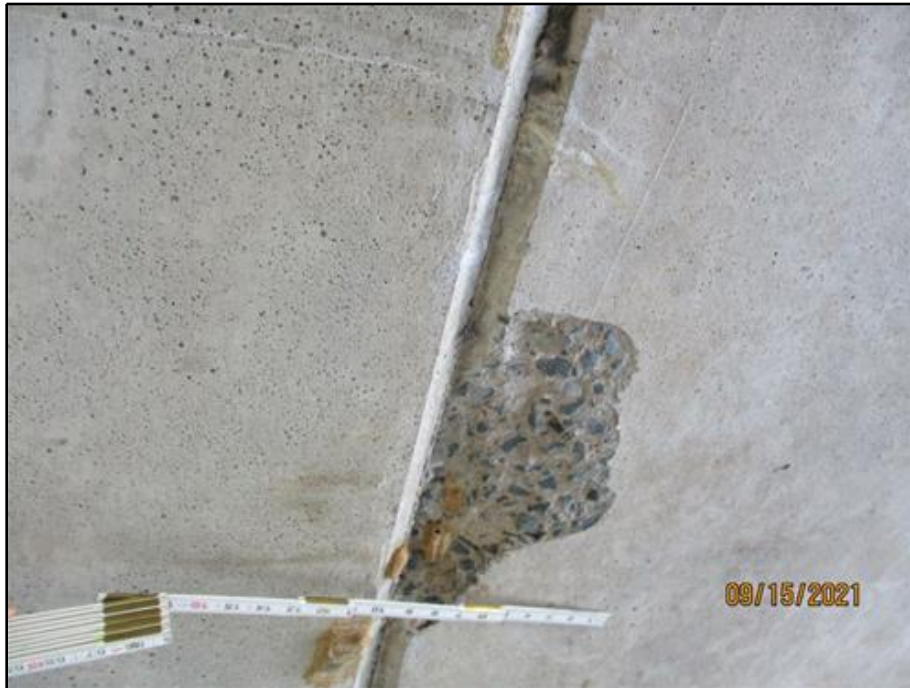
33. Spall on the bottom face of Beam 8 adjacent to Beam 9 in Span 5 near Buttress 9

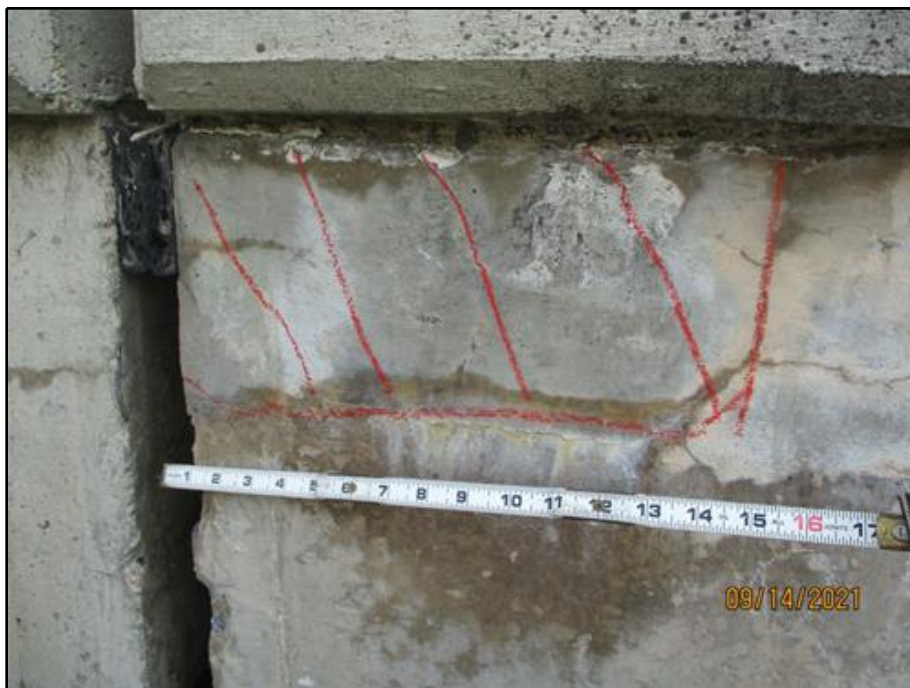
34. Delaminated patch on the north face of Beam 9 at Buttress 11 in Span 5

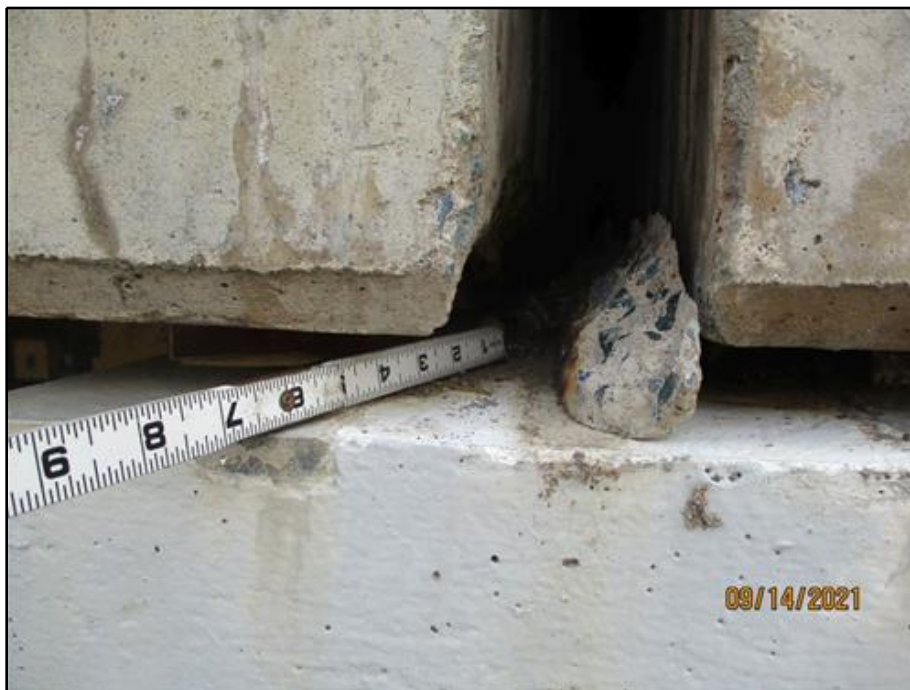
35. Corner spall on the west end of Beam 9 in Span 6 at Buttress 11

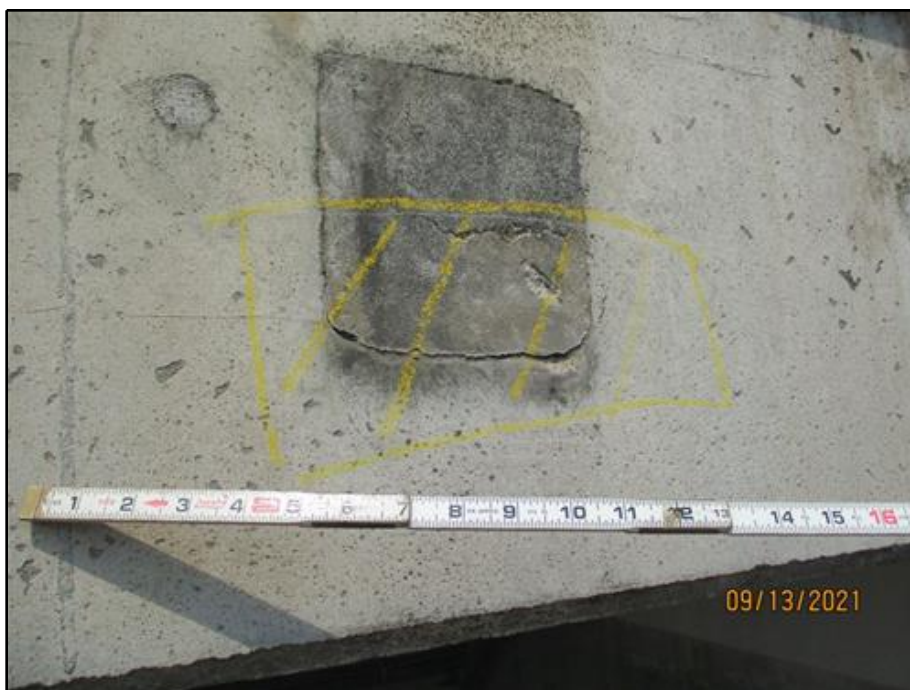
36. Delaminated tie rod grout pocket on the south face of Beam 1 at Tie Rod 3
in Span 7

14. Repair the delaminated and spalled areas in the east and west faces of the buttresses.	3	1 L.S.	\$7500/L.S.	\$7500
15. Repair the delaminated tie rod pocket on the south face of Beam 1 in Span 7	3	1 C.F.	\$500/C.F.	\$500
16. Repair the delaminated and spalled areas on the approach parapets.	3	1 L.S.	\$4000/L.S.	\$4000
Total:				\$ 71700

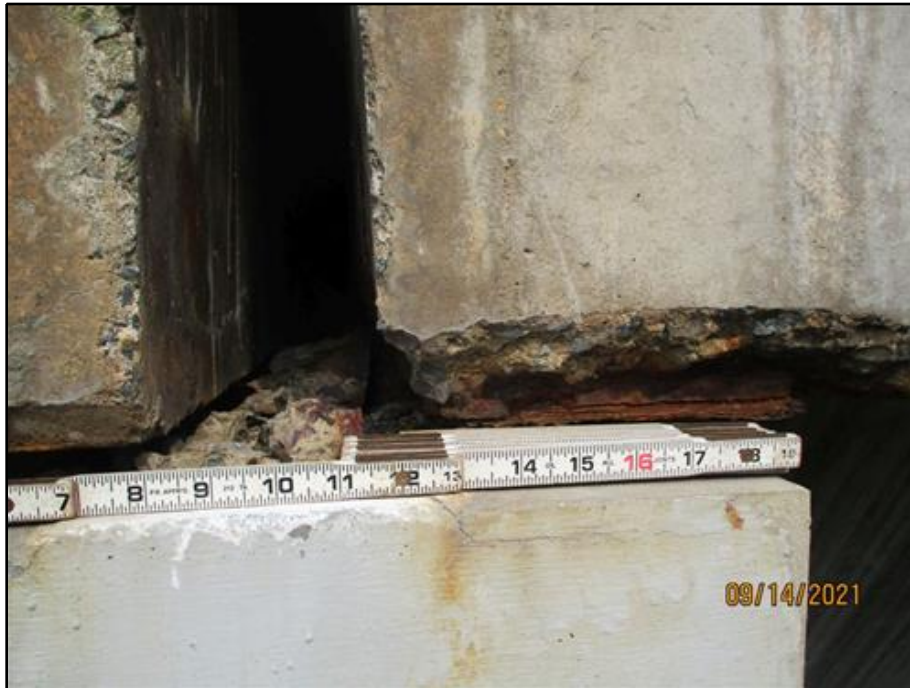
37. Corner spall on the west end of Beam 1 in Span 14 at Buttress 27

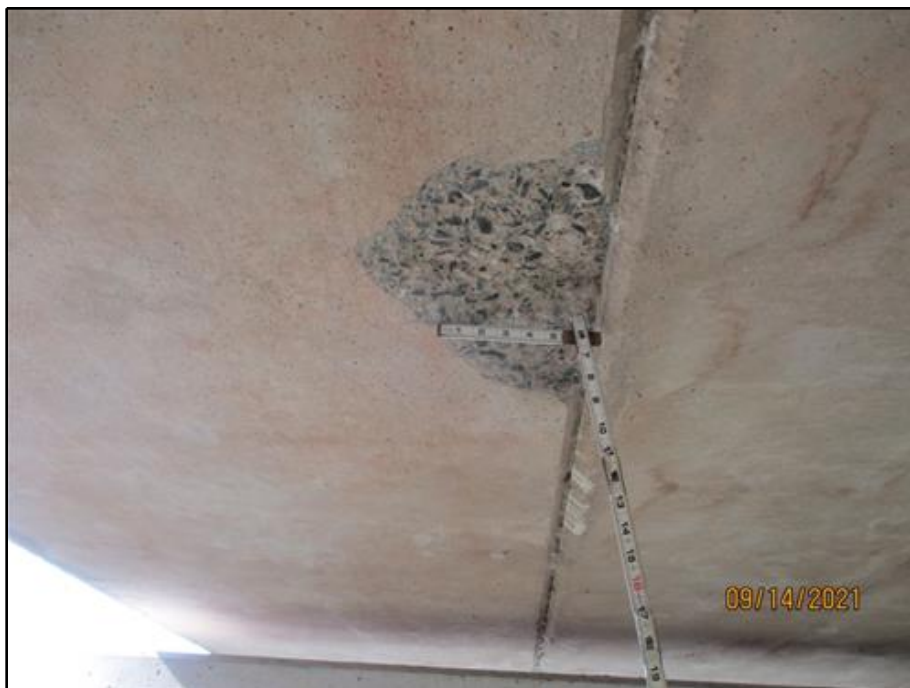
38. Spall in Beam 1 at Joint 1 in Span 14, four feet (4 ft.) east of Buttress 28

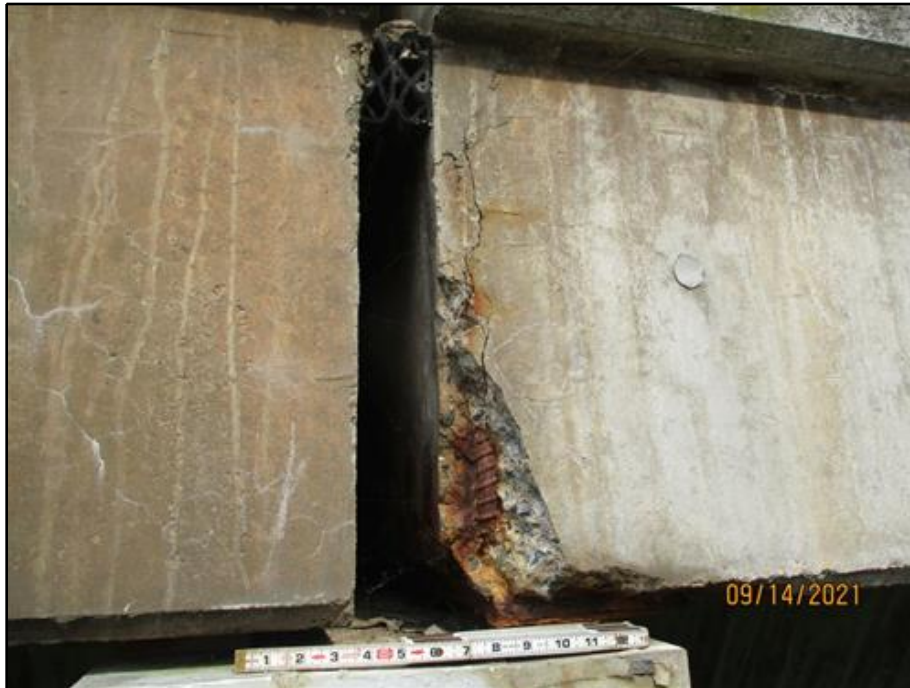
39. Corner spall on the southwest corner of Beam 1 in Span 15 at Buttress 29

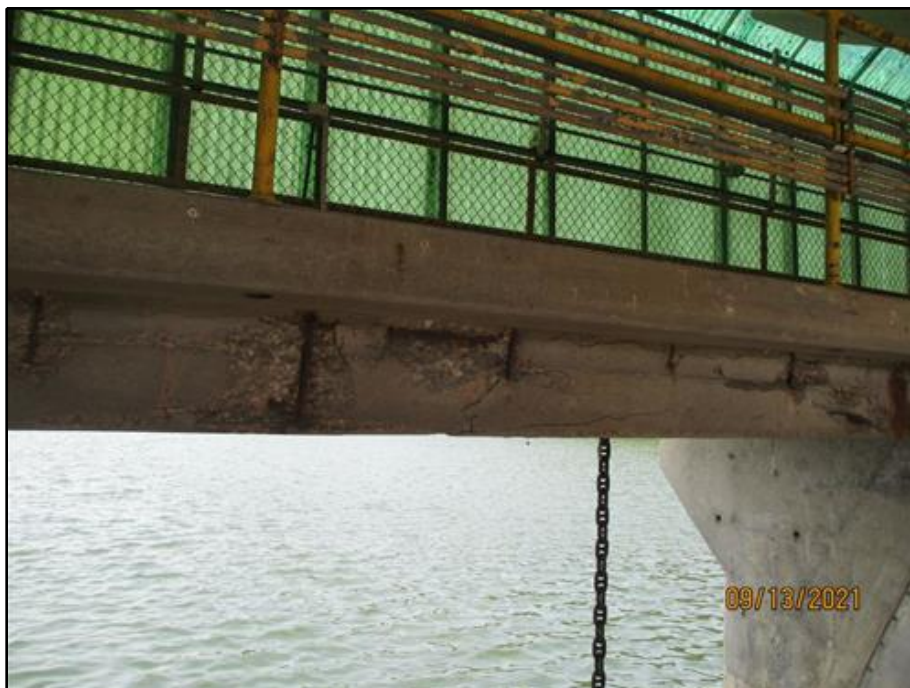
40. Typical spalling, cracks, and delamination at mid-span on the south stem of the flood gate walkway (walkway between Buttresses 19 and 20 shown)

13. Repair the spalls, delaminations, and cracks in the walkway support beams in Spans 6 through 12.	3	1 L.S.	\$15000/L.S.	\$15000
