2021 BIENNIAL BRIDGE INSPECTION REPORT
September 13, 2021

BRIDGE NO. M-0229001
BRIGHTON DAM ROAD
OVER
BRIGHTON DAM & TRIADELPHIA RESERVOIR
Prepared by

Roadway	BRIGHTON DAM ROAD
Bridge Orientation	East-West
Crossing	BRIGHTON DAM & TRIADELPHIA RESERVOIR
Crossing Orientation	North-South
Inspection Date	9/13/2021
Inspected By	Whitman, Requardt, and Associates, LLP
Spans	15
Type	Prestressed concrete solid slab beams
Structure Organization	The numbering convention for reporting purposes is from the south and the west.
Deck	N/A
Railing	Rectangular concrete parapet
Abutments	Concrete buttresses
Wing Walls	Concrete cantilever
Piers	Concrete buttresses (Odd Buttresses 3-29)
Overall Length	601'-6"
Clear Roadway	28'-0"
No. of Lanes	2
Out-to-Out Width	36'-4"
Year Built	1944
Year Reconstructed	1999 - superstructure and top 4' of buttresses were reconstructed
Approach Section	28'-0"
Shoulders	No
Alignment	Moderate curve from the north on both approaches.
Profile	Moderate downgrade to the bridge on the west approach. Steep downgrade to the bridge on the east approach.
Guardrail	W-Beam

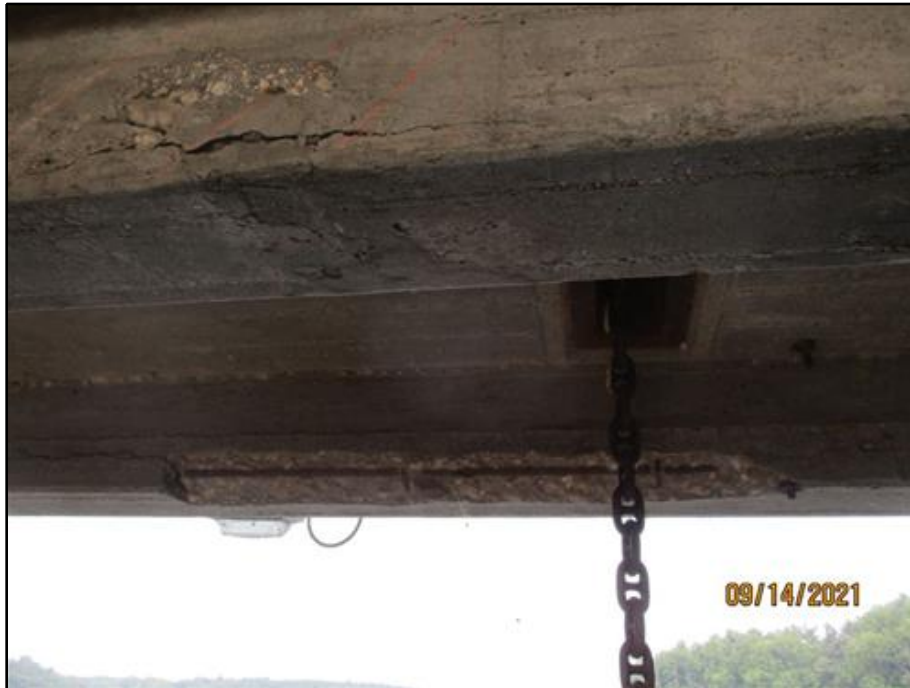
41. Spall with exposed , corroded steel stirrups and abandoned conduit in the south corner of the north stem of the walkway support between Buttresses 24 and 25

13. Repair the spalls, delaminations, and cracks in the walkway support beams in Spans 6 through 12.	3	1 L.S.	\$15000/L.S.	\$15000

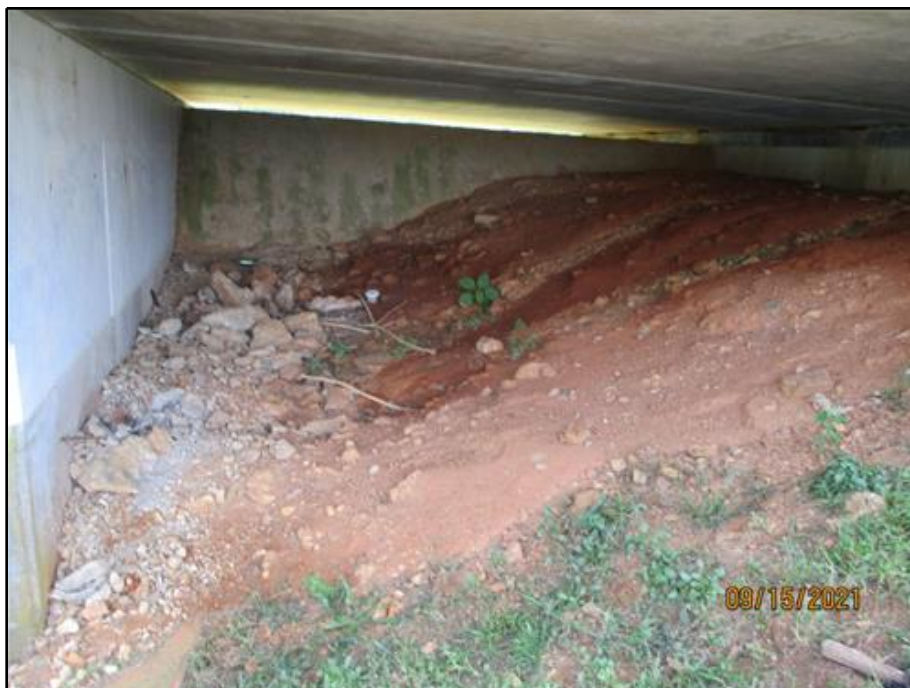
42. Loose soil and rocks in front of the north end of the west abutment

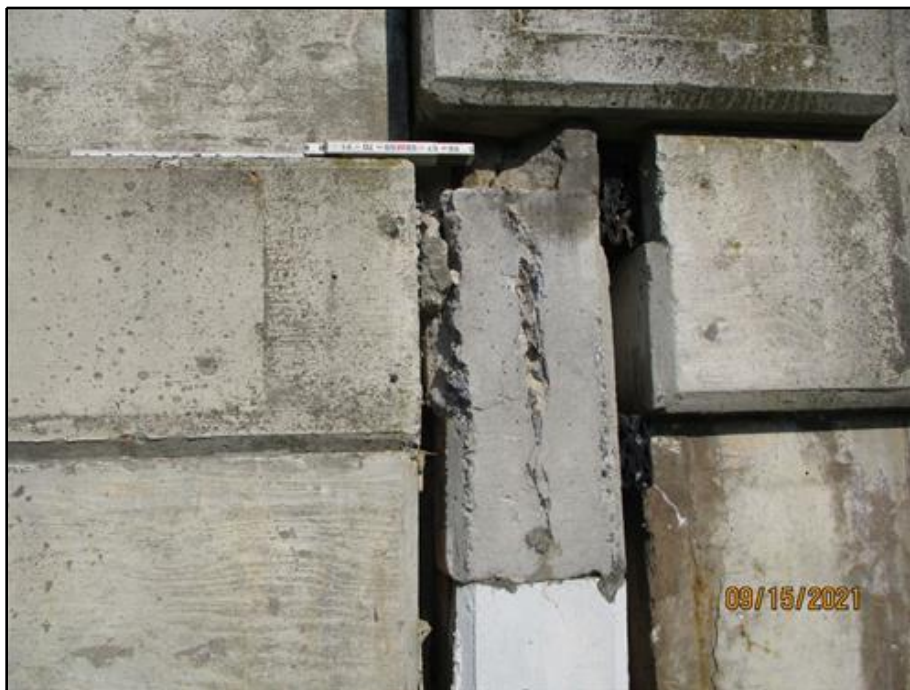
43. Delaminated area and spalls in the south face of the west abutment
backwall

7. Repair the spalls in the wing walls and abutment backwalls.	3	1 L.S.	\$1000/L.S.	\$1000
8. Replace the missing anchor bolt nut on the light pole in the northwest approach.	3	1 L.S.	\$500/L.S.	\$500

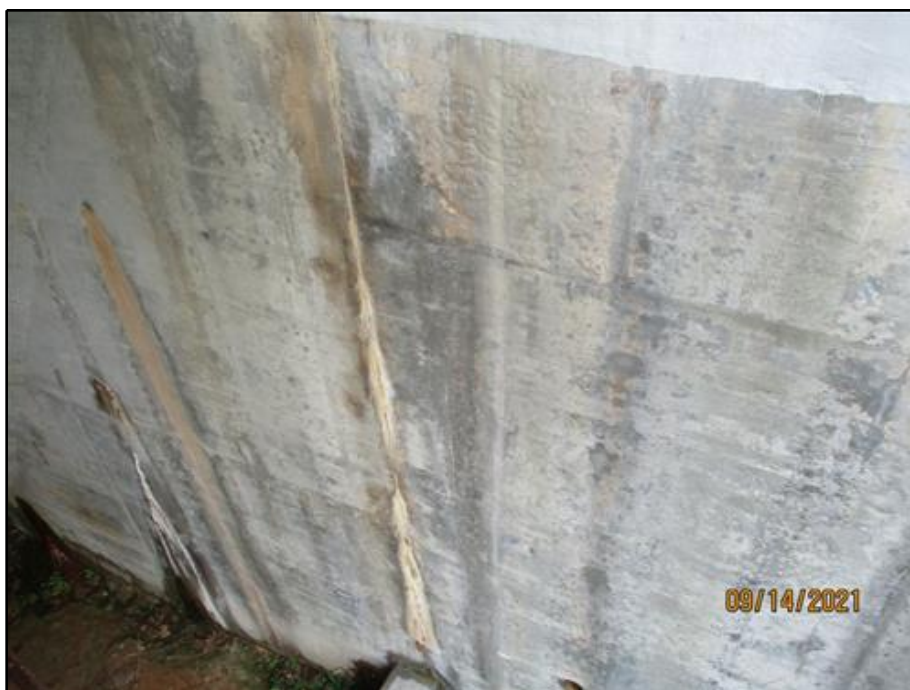
44. Full height crack with efflorescence in the east abutment

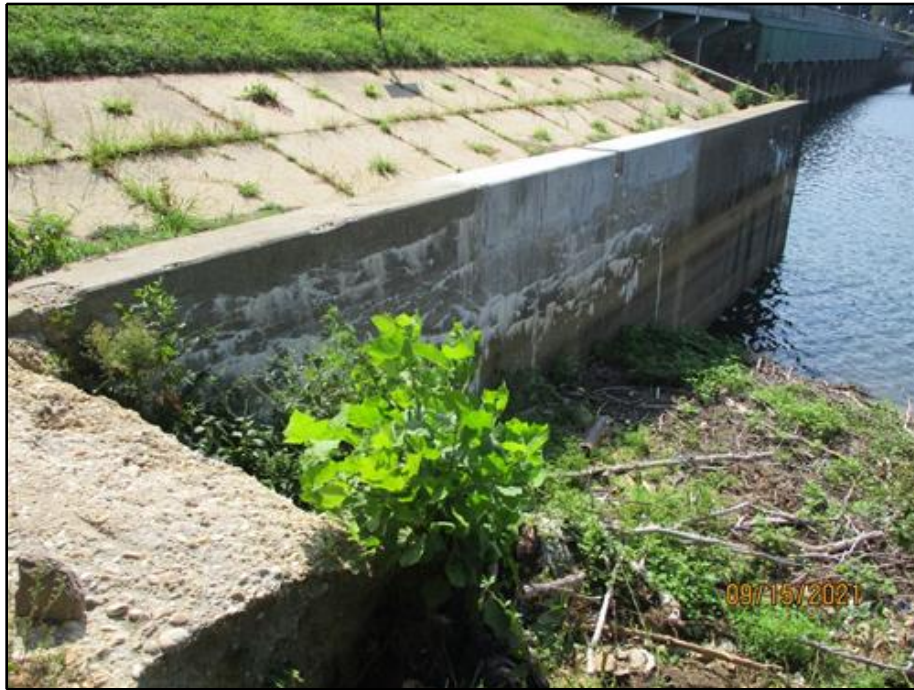
45. Map cracking and efflorescence on the northeast retaining wall. Note the vegetation growing between concrete slope protection panels above the wing wall

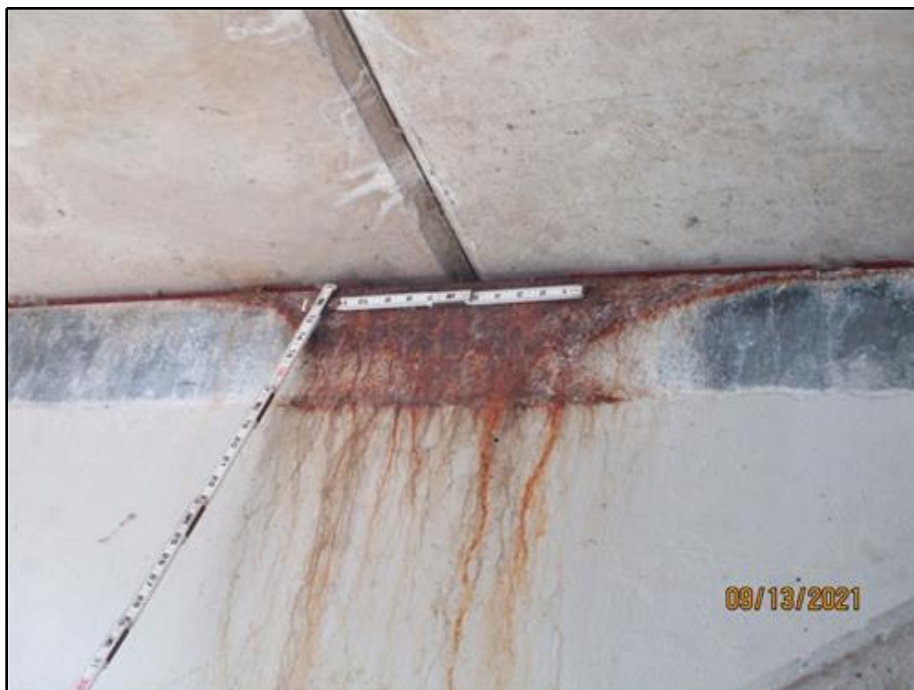
46. Typical moderate corrosion at buttress angles (Buttress 5 between Beams 2 and 3 in Span 3 shown)

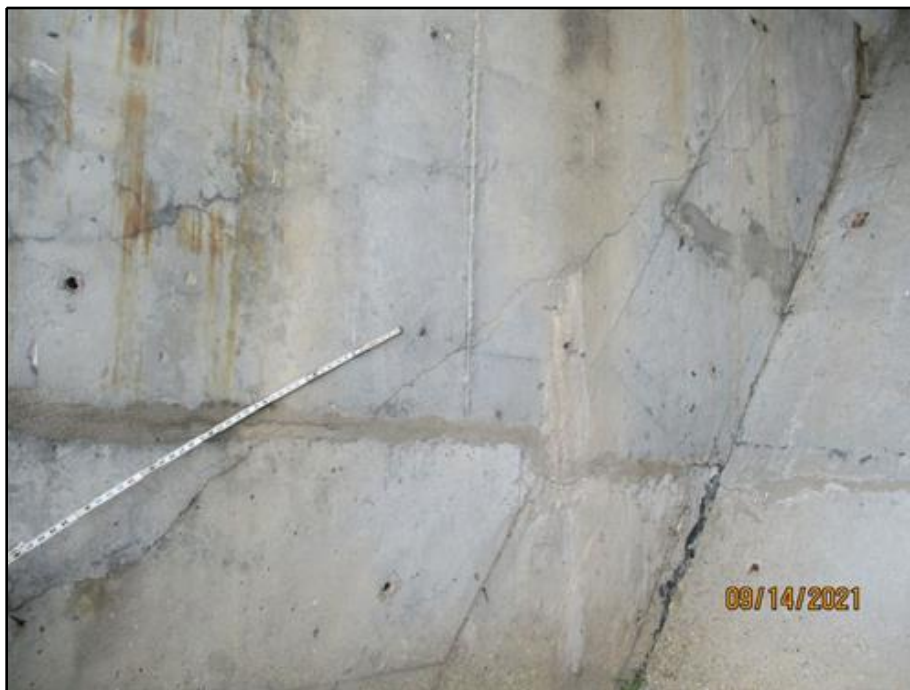
47. Typical diagonal crack in the buttress column along the dam wall (west face of Buttress 27 shown)

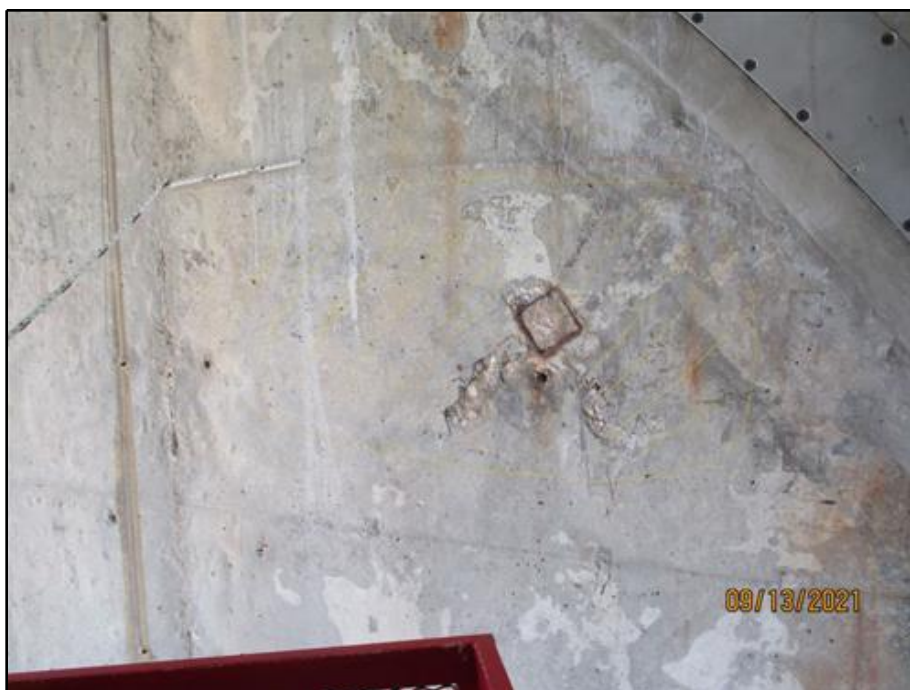
48. Delamination below the flood gate guide (east face of Buttress 15 shown)

14. Repair the delaminated and spalled areas in the east and west faces of the buttresses.	3	1 L.S.	\$7500/L.S.	\$7500
15. Repair the delaminated tie rod pocket on the south face of Beam 1 in Span 7	3	1 C.F.	\$500/C.F.	\$500
16. Repair the delaminated and spalled areas on the approach parapets.	3	1 L.S.	\$4000/L.S.	\$4000
Total:				\$ 71700

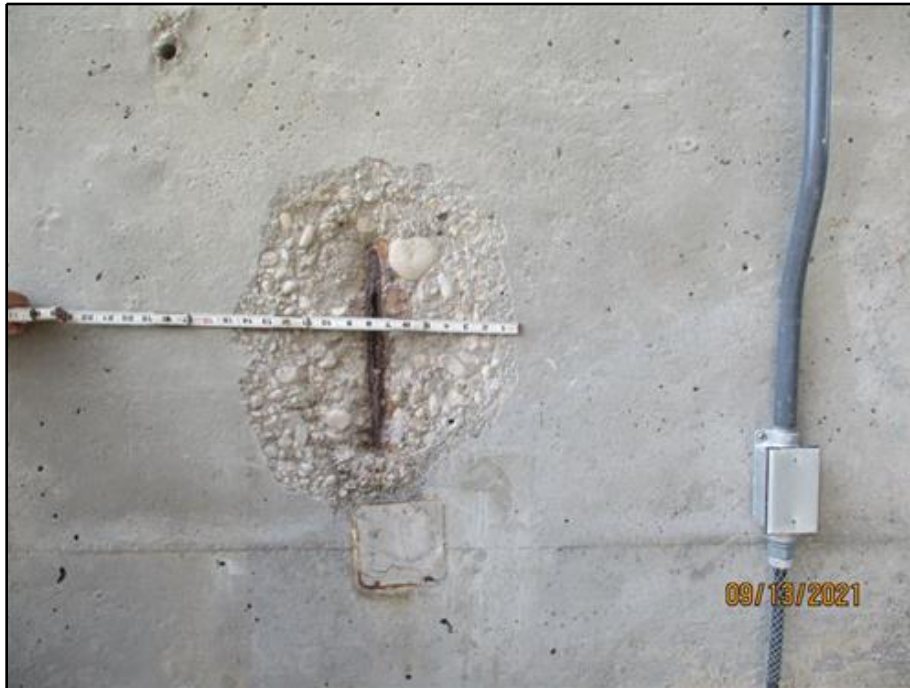
49. Typical spall around corroded electrical junction box and conduit in the buttress column (east face of Buttress 17 located 20' from the top shown)

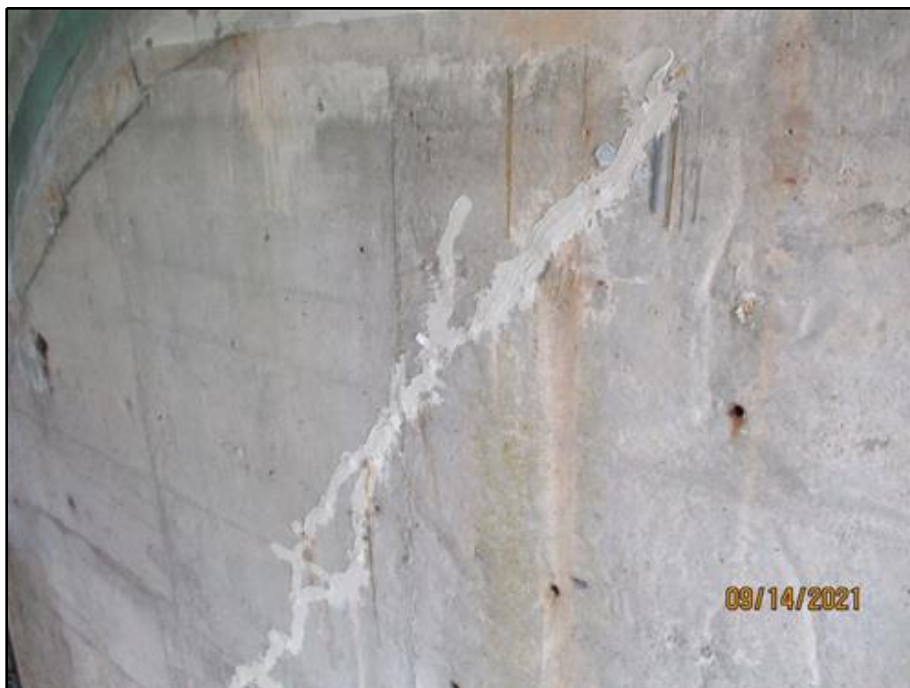
The buttress columns are in good condition. Most of the spalls in the north and south faces have been repaired since the previous inspection. The west and east faces of the buttresses in the dam gate bays have isolated sealed cracks that are equipped with strain gauges.

50. Typical sealed crack with strain gauge (east face of Buttress 25 shown)

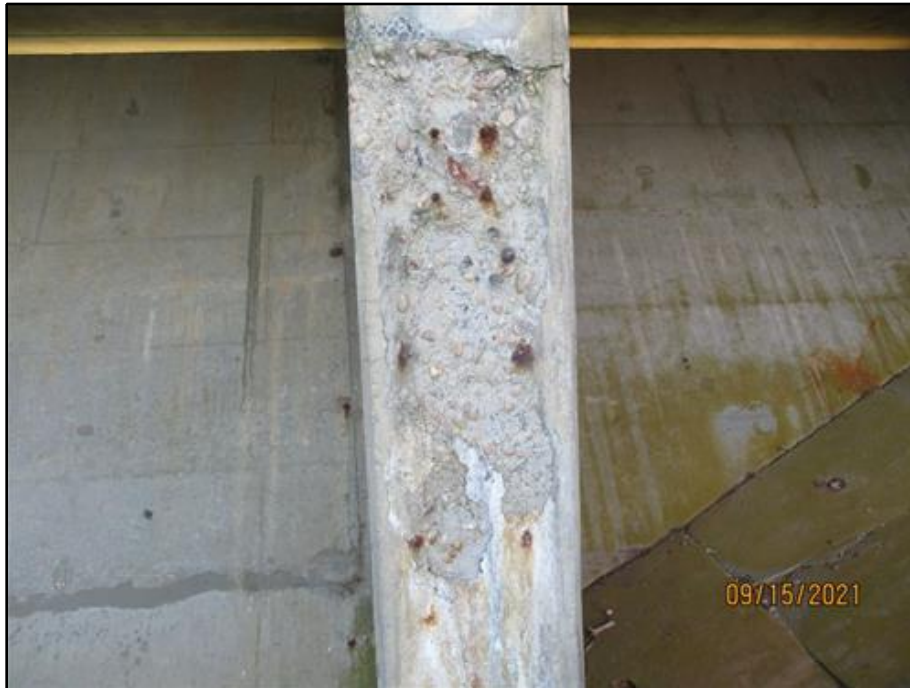
51. Full width spall in the north face of Buttress 3, five feet (5 ft.) below the cap

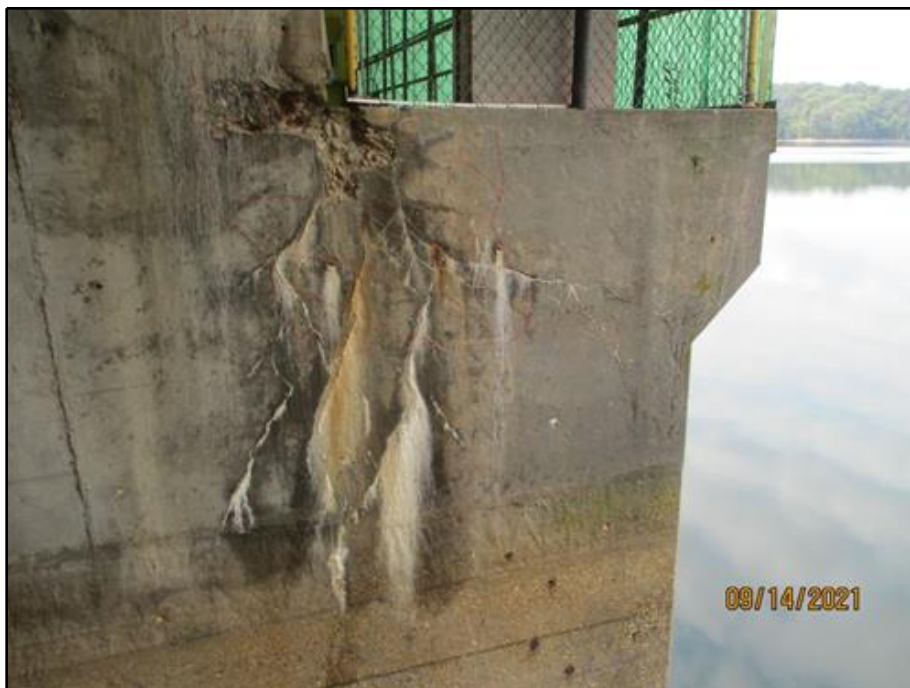
**52. Spall, delaminated area, and cracks with efflorescence on the east face
near the north end of Buttress 25 at the walkway support**

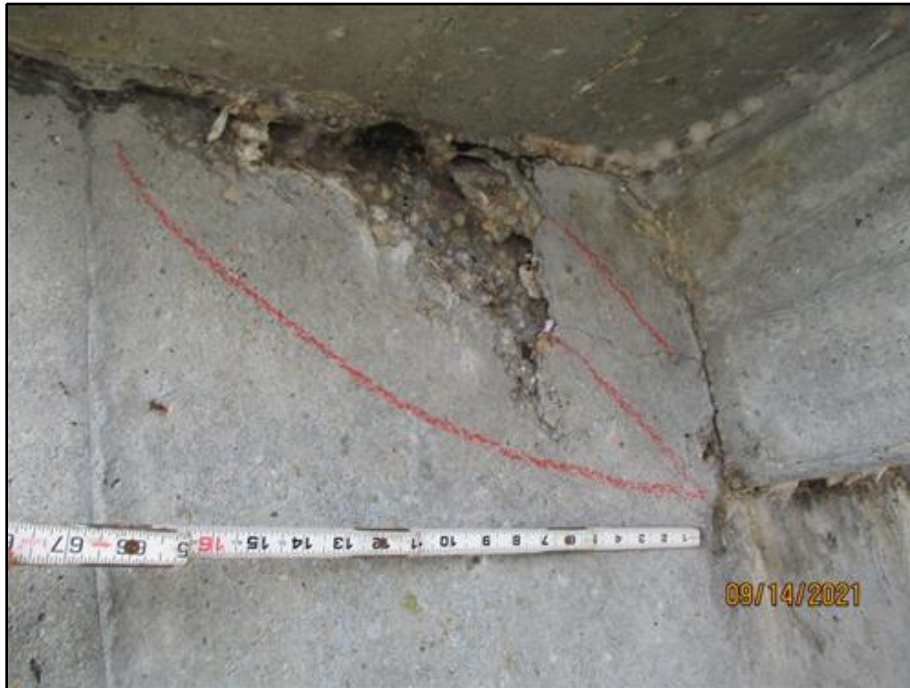
**53. Typical spall and delaminated area under the north flange of the walkway
(west face of Buttress 25 shown)**

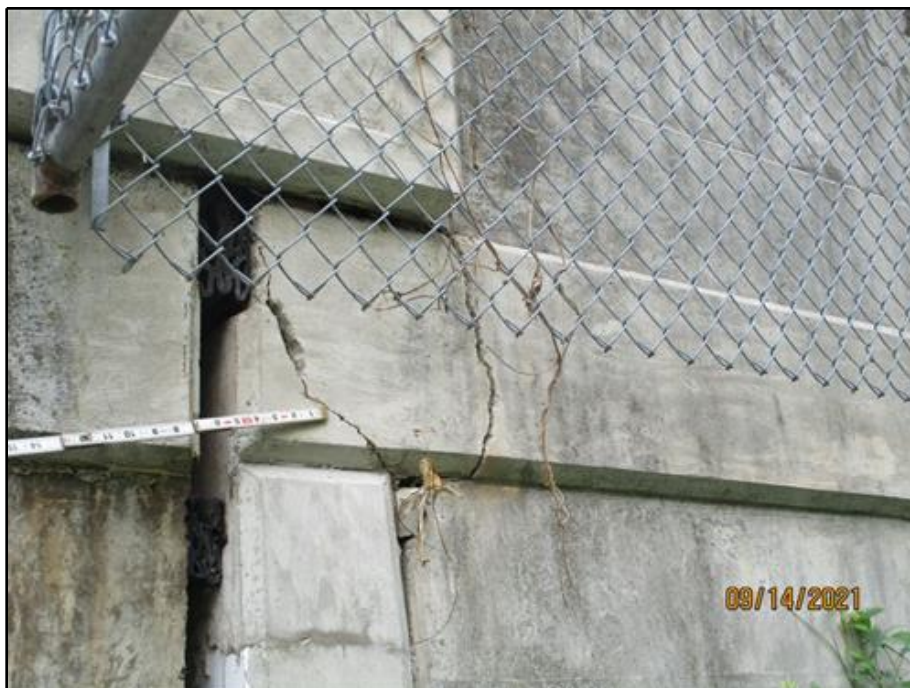
**54. Cracks in the south face of the southeast approach traffic barrier at the east
abutment**

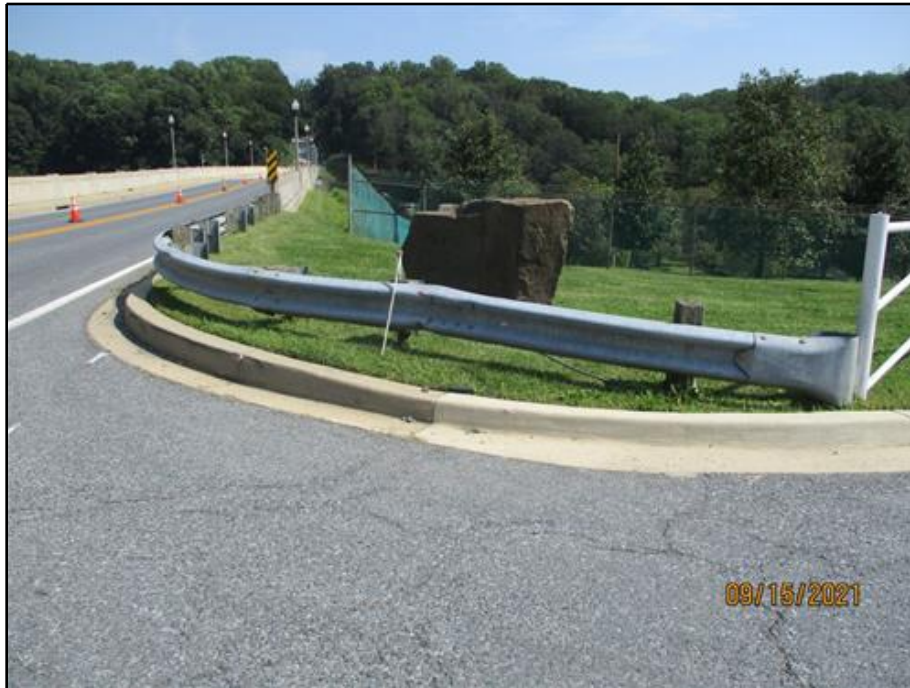
55. Impact damage at the southwest approach traffic barrier end treatment

3. Repair the damage to the traffic barrier end treatment on the southwest approach.	2	1 L.S.	\$2800/Ea.	\$2800
4. Repair the spalled and delaminated areas on the parapets.	3	1 L.S.	\$20000/L.S.	\$20000

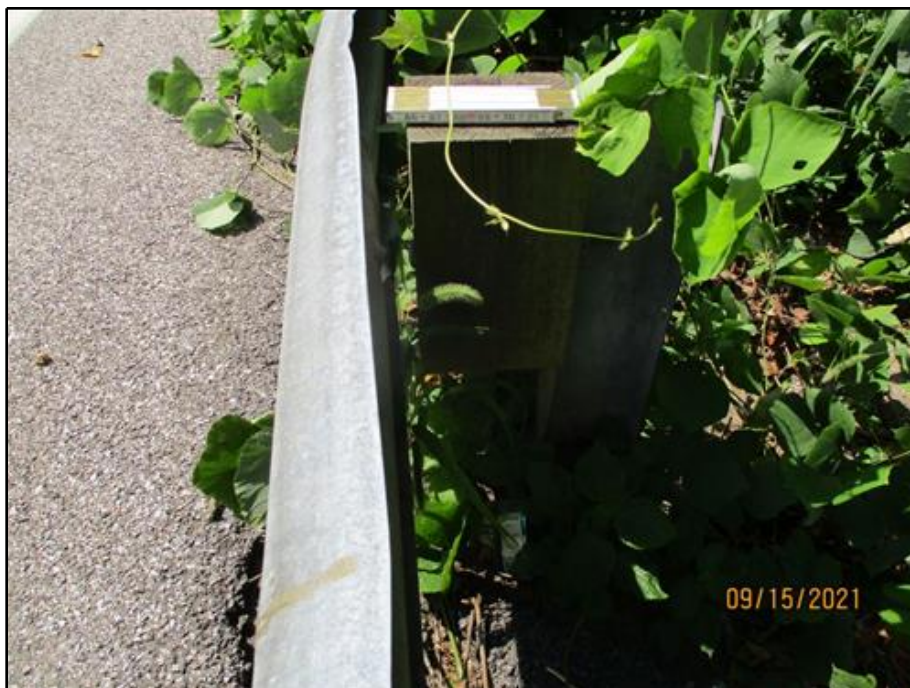
56. Post 17 is detached from the northeast approach traffic barrier

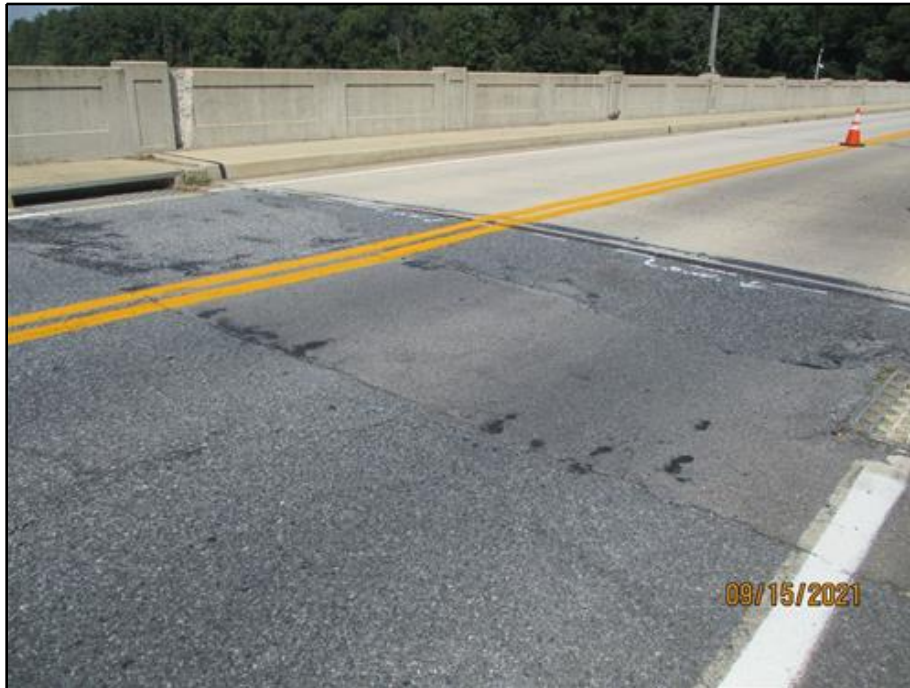
The approach roadways are in satisfactory condition with areas of settlement at the transitions. There is moderate settlement of the northwest and northeast approach sidewalks and minor impact damage to the southwest approach traffic barrier.

57. Full width patch at the west approach transition with settlement at the transition joint

DESCRIPTION	PRIORITY	QUANTITY	UNIT COST	TOTAL COST
1. Repave the transition on the west and east roadway approaches.	3	45 S.Y.	\$50/S.Y.	\$2250
2. Repair the settled sidewalk on the northwest and northeast approach.	3	1 L.S.	\$1500/L.S.	\$1500

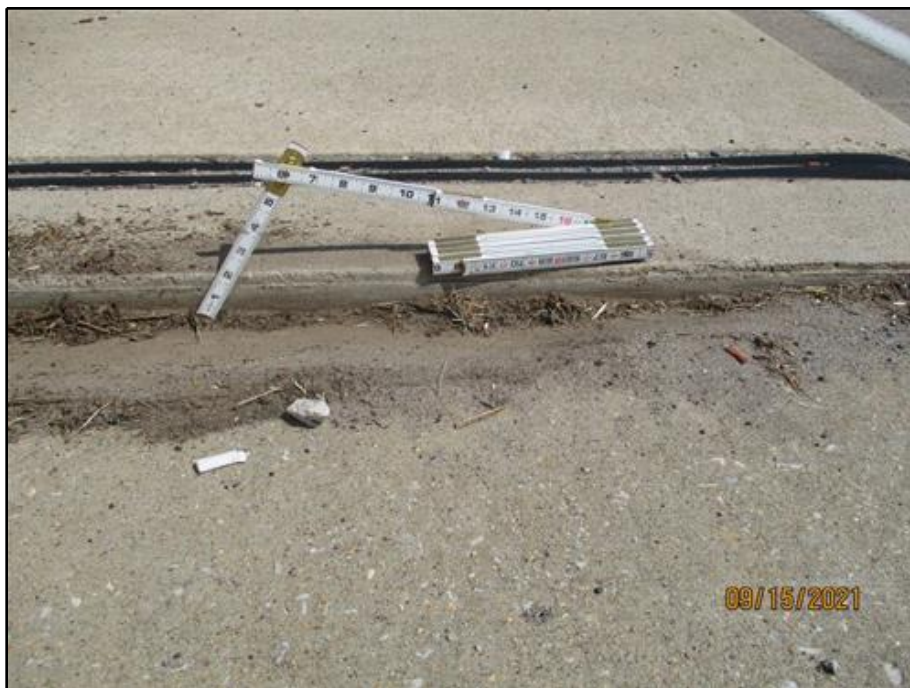
58. Typical settlement of the sidewalk at the approach transitions (northwest approach sidewalk transition shown)
