Montgomery County
Department of Transportation
Division of Transportation Engineering

2023 BIENNIAL BRIDGE INSPECTION REPORT
July 26, 2023

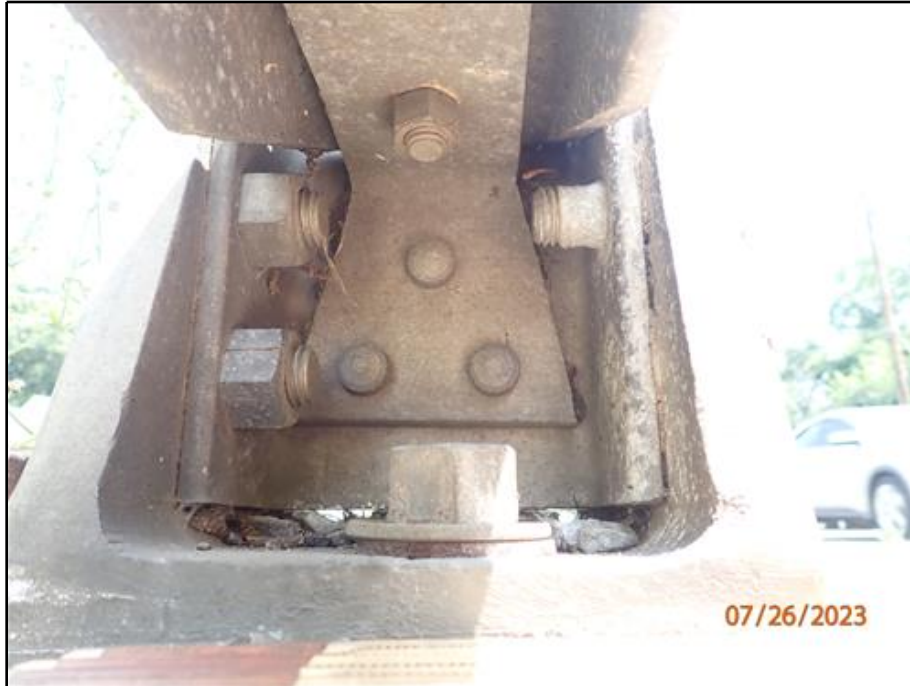
9. Sheared bolt, cracked and missing nut at Post 5 of the north railing (looking east)

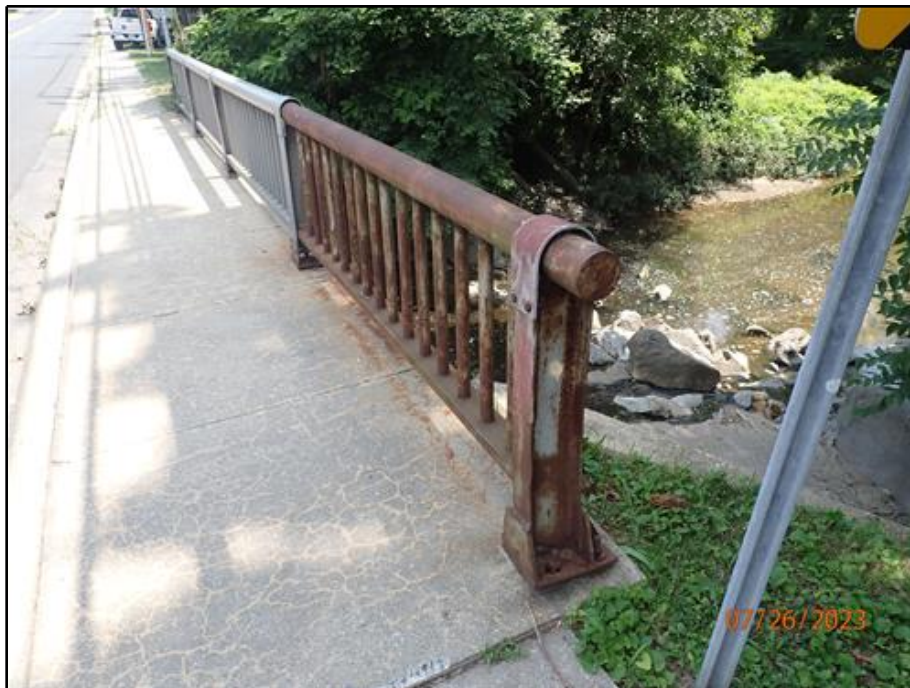
10. Moderate corrosion at the west section of the south railing (looking east)

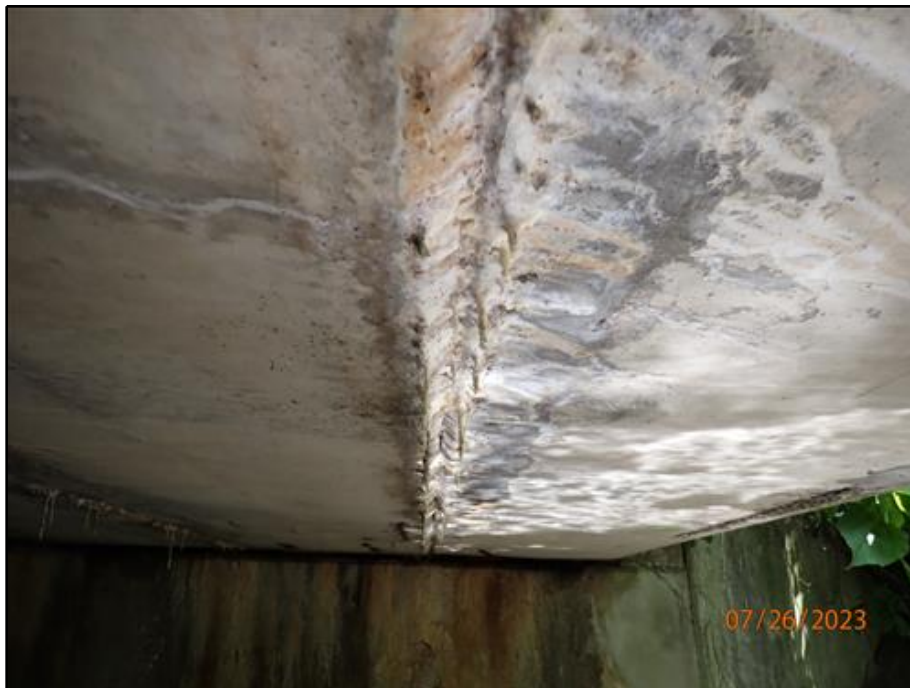
12. Water leakage and efflorescence between Beams 1 and 2 (looking east)

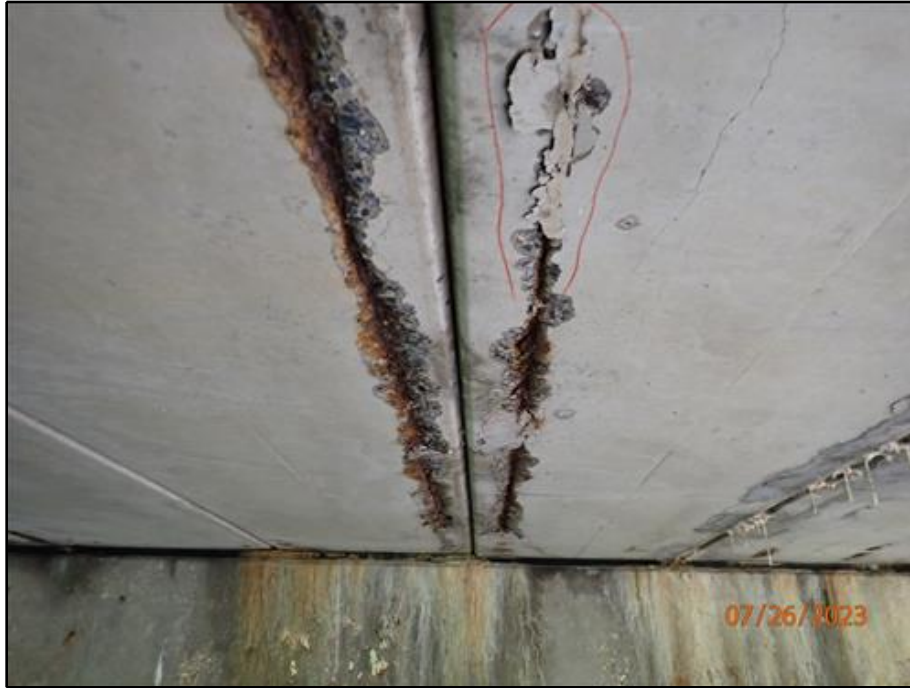
13. Spall with exposed reinforcement along Beams 3 and 4 near the east abutment (looking east)

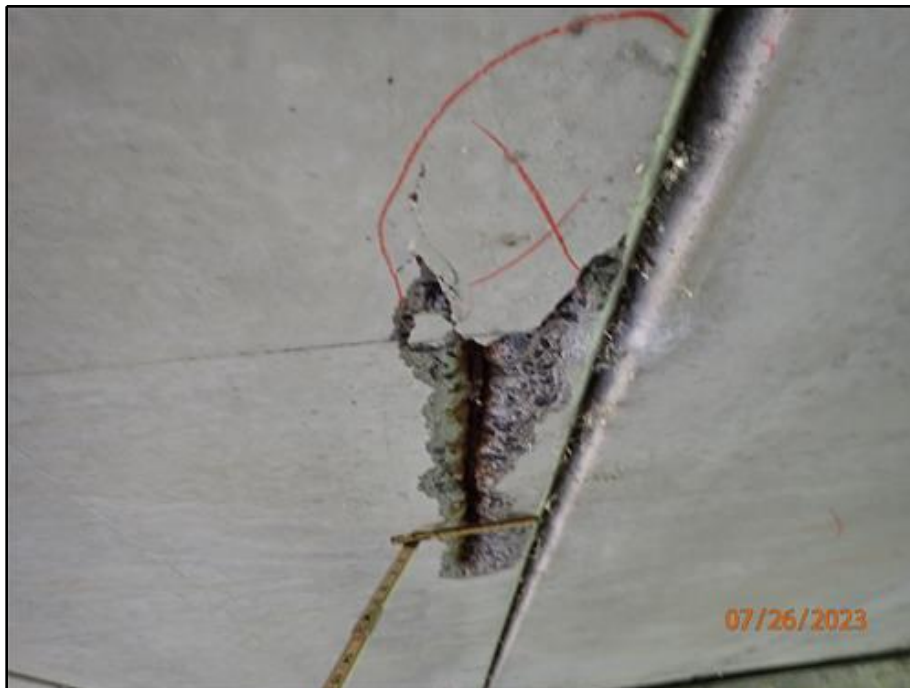
14. Spall with exposed reinforcement along the north edge of Beam 5 near the west abutment (looking west)

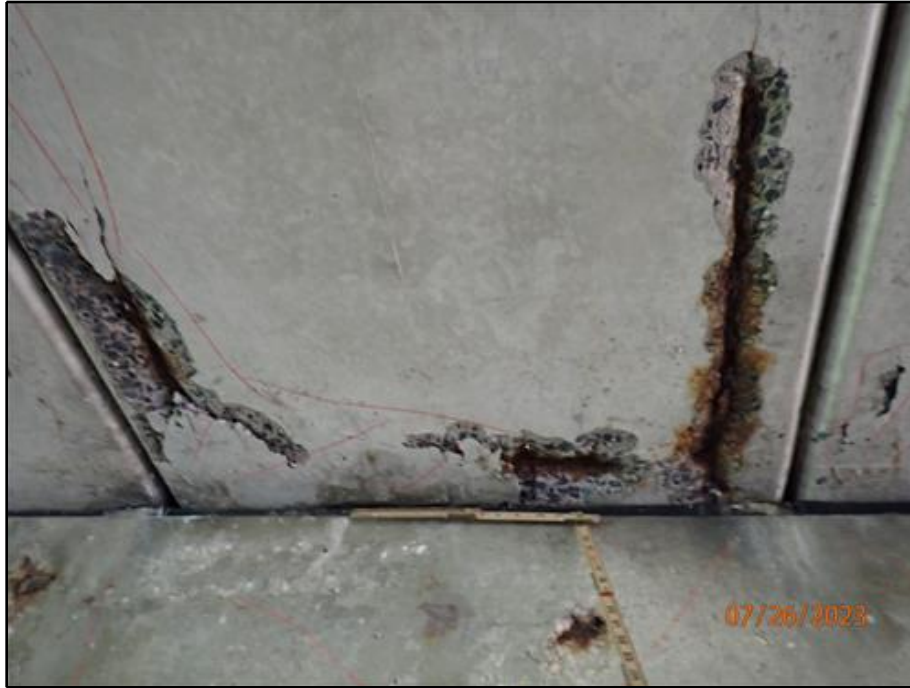
15. Delamination and spalling with exposed corroded reinforcement at the end of Beam 6 near the east abutment (looking east)

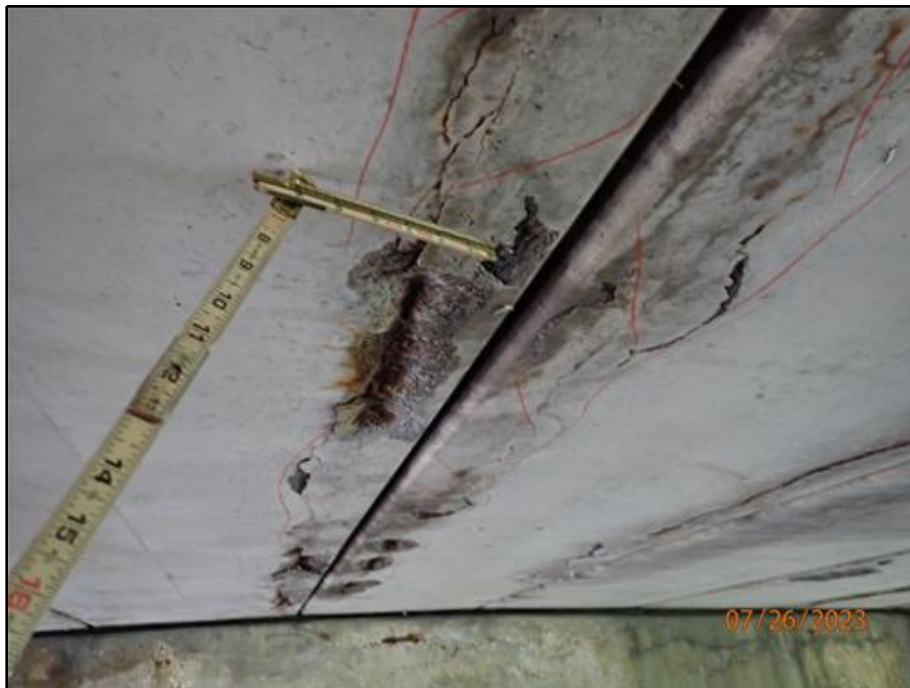
16. Spalls with exposed reinforcement at Beams 7 and 8 near mid-span (looking east)

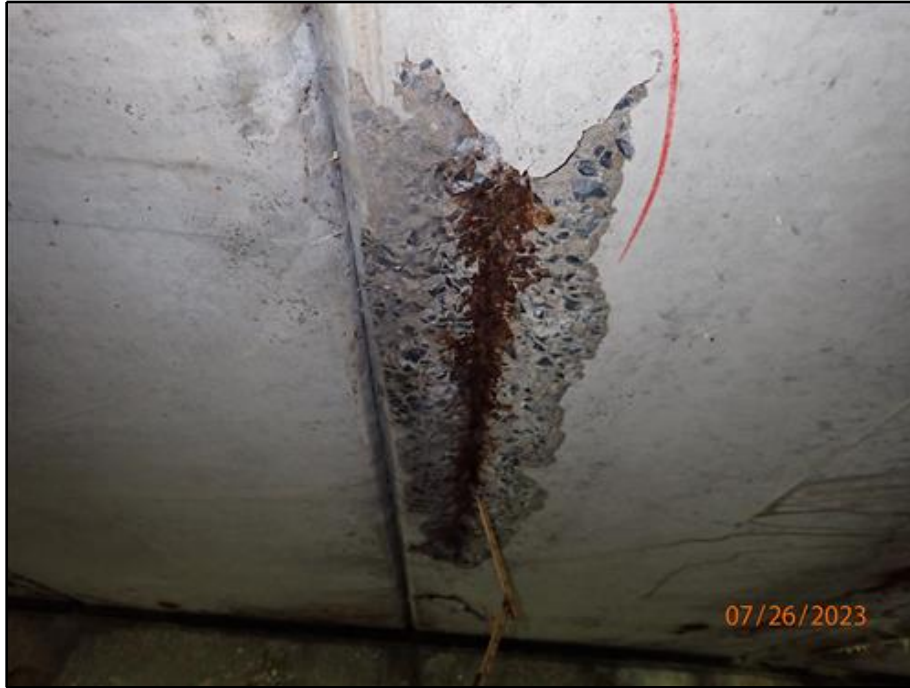
17. Spall/delamination with exposed reinforcement at Beam 9 starting at the east abutment (looking east)

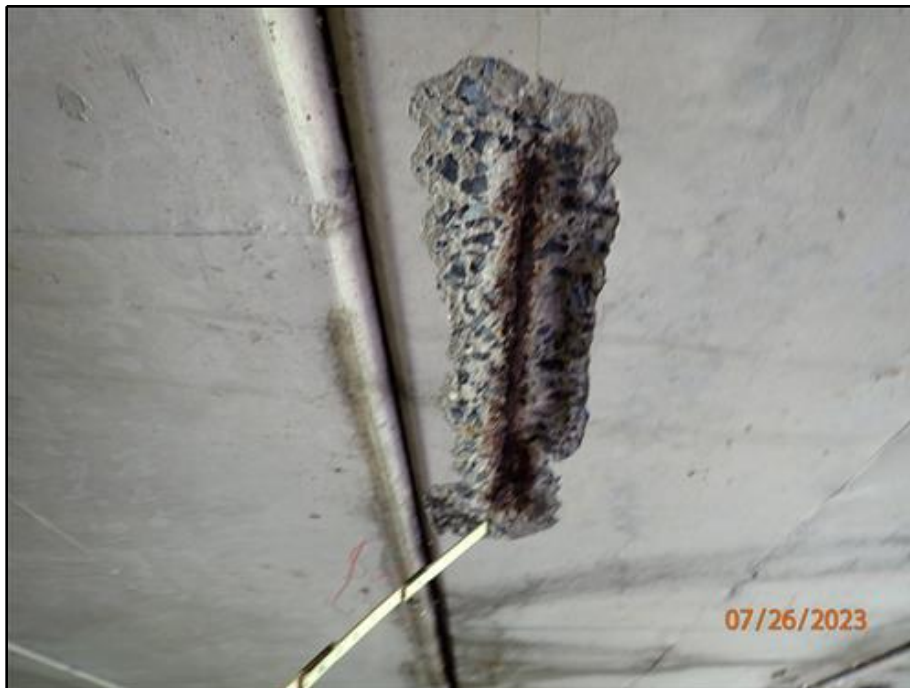
18. Spall with exposed reinforcement along the south edge of Beam 13 near midspan (looking west)

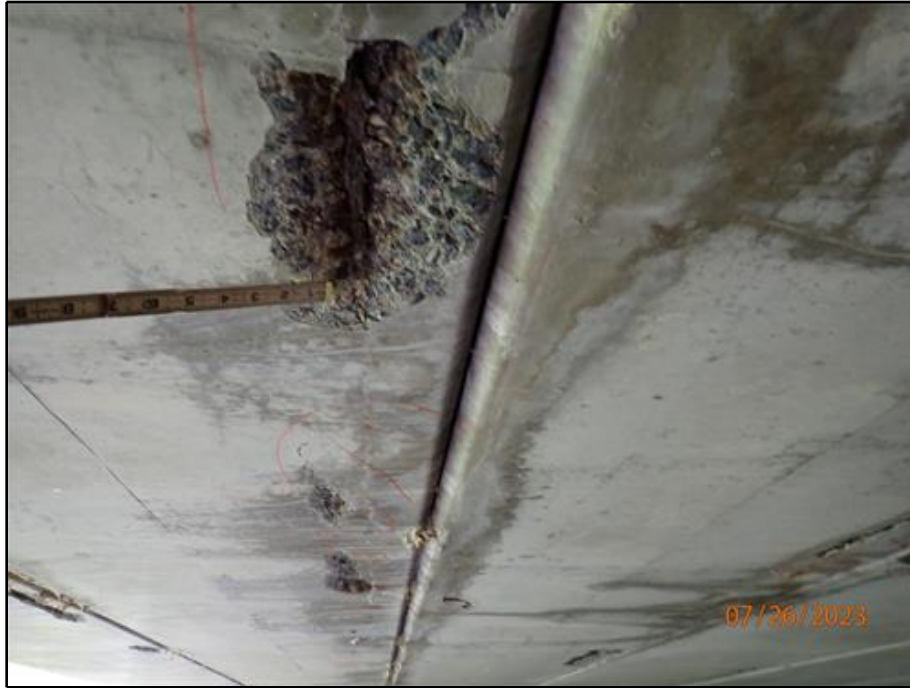
19. Spalls with exposed reinforcement along the south edge of Beam 14 near midspan (looking east)

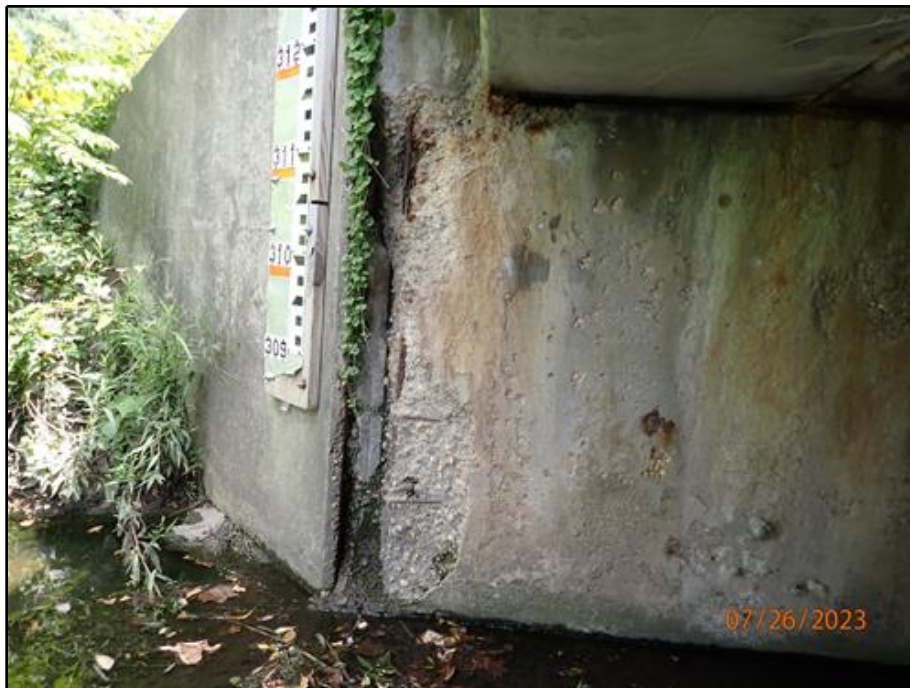
20. Spall with exposed reinforcement in the east abutment at the interface with the northeast wing wall (looking east)

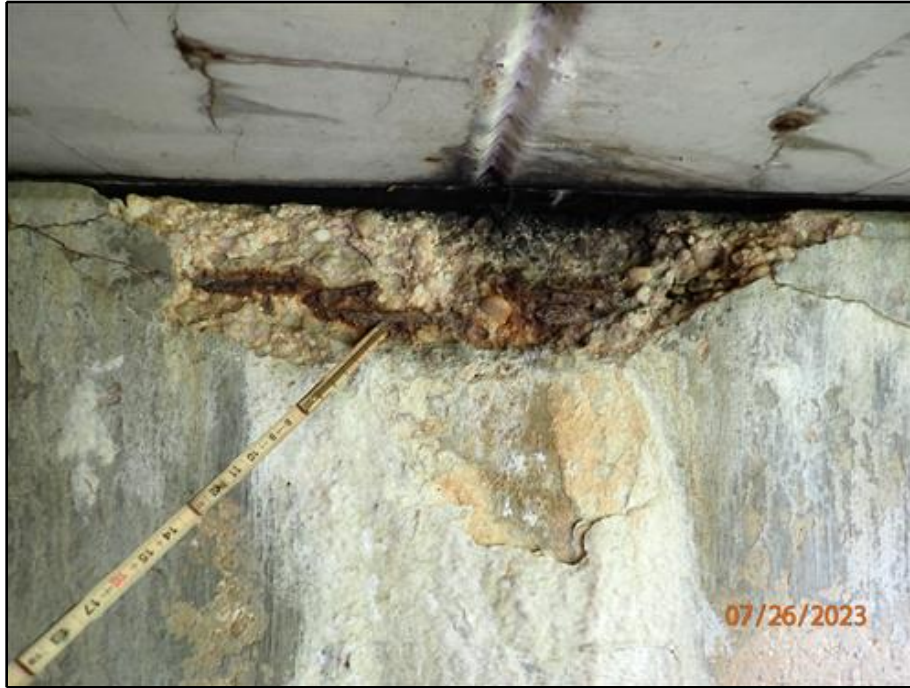
21. Spall with exposed and corroded reinforcement in the west abutment below Beams 14 and 15 (looking west)

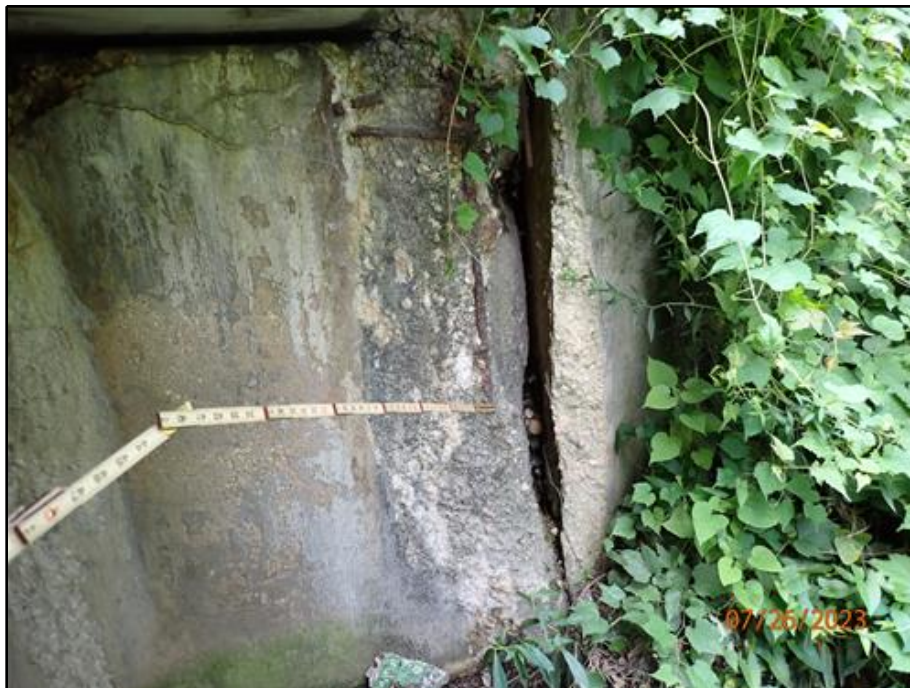
22. Spall with exposed reinforcement and fill infiltration in the west abutment at the interface with the northwest wing wall (looking west)

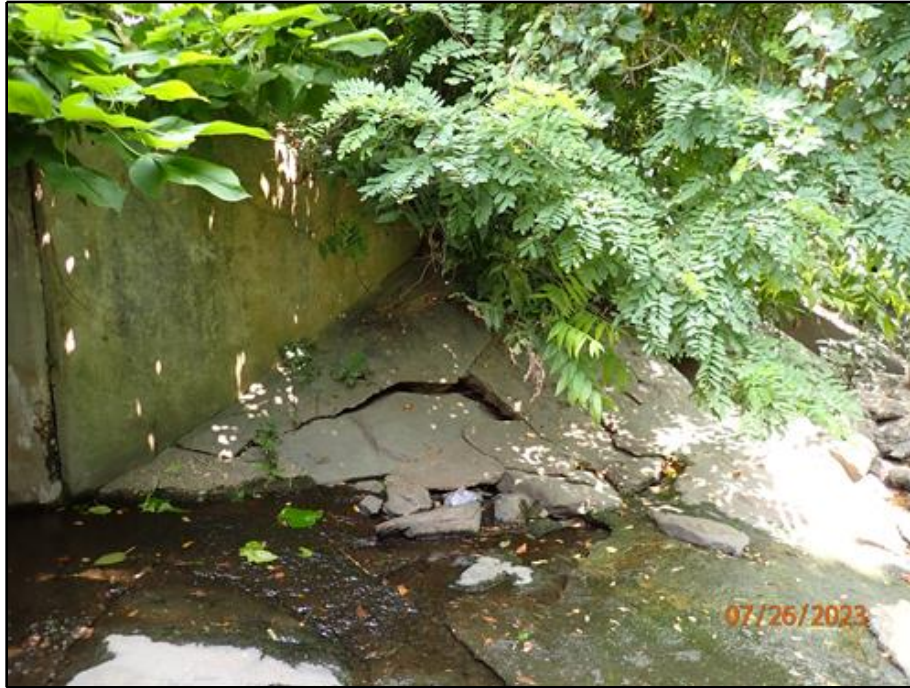
23. Fractured channel protection along the southeast embankment (looking east)

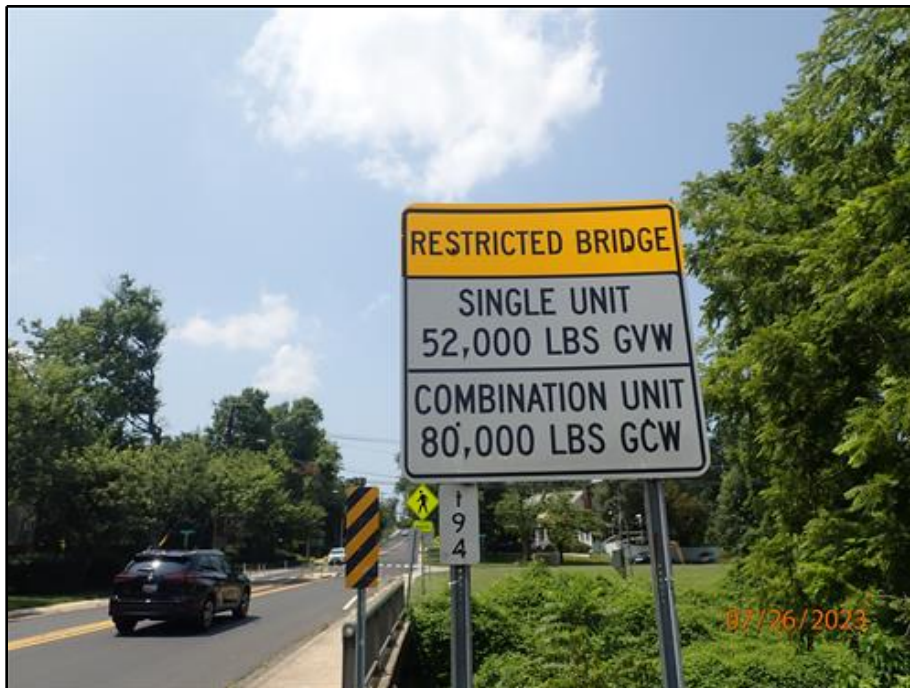
24. Load posting sign at the east approach (looking west)
