# Morningwood Drive Safety Analysis

July 2021

This study conducts a traffic safety analysis for this corridor to determine existing safety conditions, potential safety impacts that the proposed North High Street connection would need to address, and strategies for addressing safety challenges moving forward.

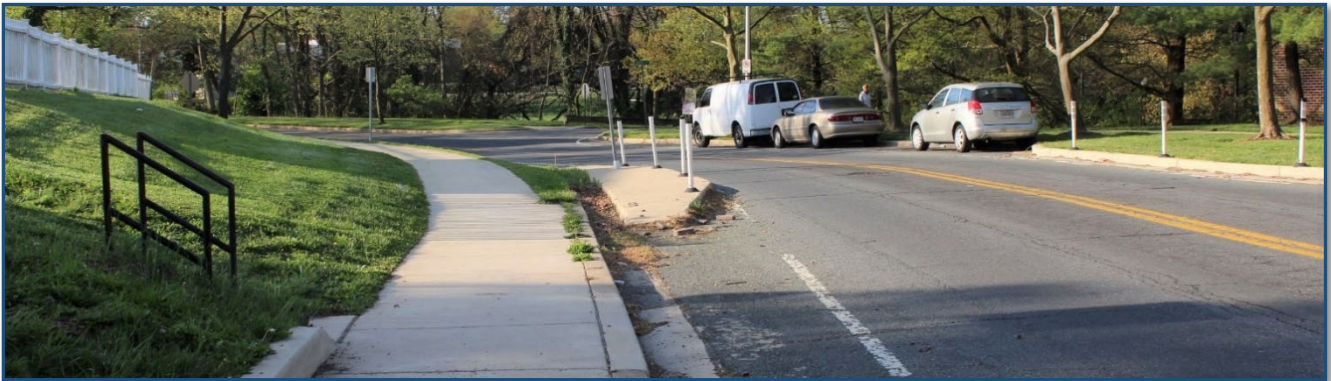
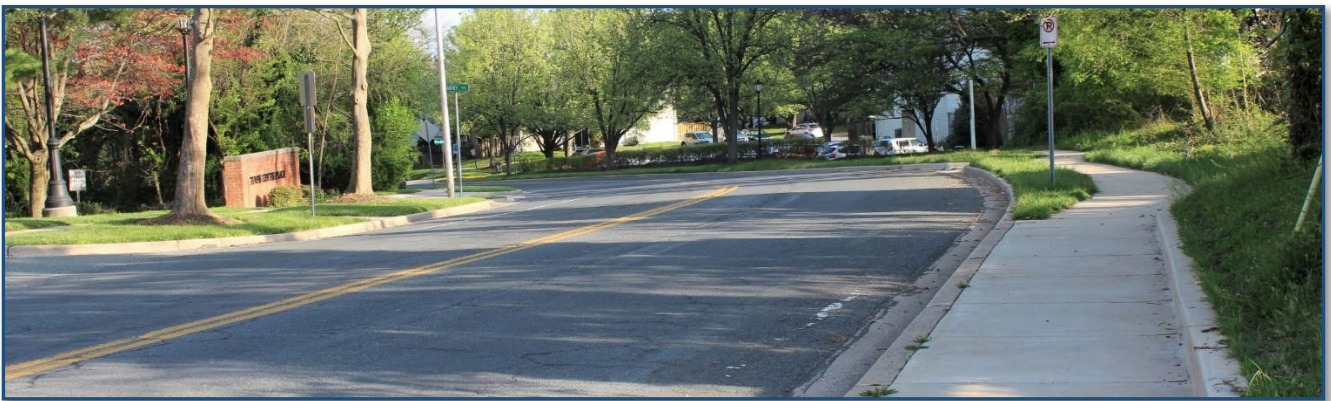
**Figure 2-4: Morningwood Drive Visibility from Proposed N. High Street Approach**

Figure 2-4 shows Morningwood Drive looking left and right from the proposed North High Street approach. From the figures and aerial photo, the visible sight distance is less than 250 feet to both the left and right directions with the horizontal curves. Sight distances are discussed in more detail in Section 5 of this report.

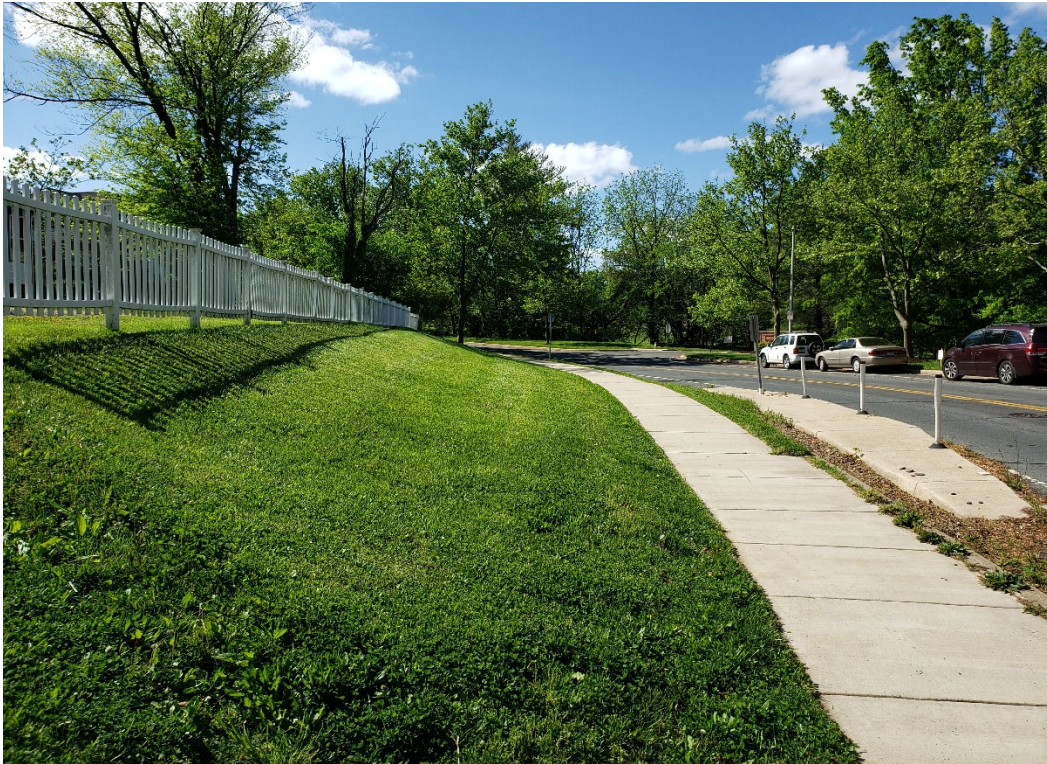
**Figure 5-2: Looking Left at Proposed North High Street Connection**

Figure 5-1 shows sight triangles from an imaginary car looking from the proposed connection of North High Street to Morningwood Drive. Looking left from North High Street, the required minimum sight line potentially cuts into the hillside and white picket fence (see Figure 5-2), establishing a sight distance of about 250 feet. Looking right from North High Street, the needed sight line could cut through a wooded area and fence (see Figure 5-3), establishing a sight distance of about 250 feet. Additionally, before the end of the sightline is the start of the parking lane allowed along southbound Morningwood Drive, creating another visual obstruction.

In order to achieve the required intersection sight distance for the proposed connection of North High Street to Morningwood Drive, extensive grading and Right-of-Way impacts may be required. Existing utilities would also need to be investigated for potential impacts in this area. Potential solutions to avoiding these impacts would be to implement a right-in/right-out configuration or an all-way stop condition at the proposed North High Street connection. The right-in/right-out configuration would eliminate the intersection sight distance requirement for left turning vehicles. The intersection sight distance requirement for right turning vehicles would still need to be achieved. The all-way stop condition would eliminate all intersection sight distance requirements because the turning vehicles would be protected by the stop condition of all vehicles. A Synchro analysis of this intersection with an all-way Stop shows that it would operate at a LOS A in the AM and PM peaks (Appendix 5).

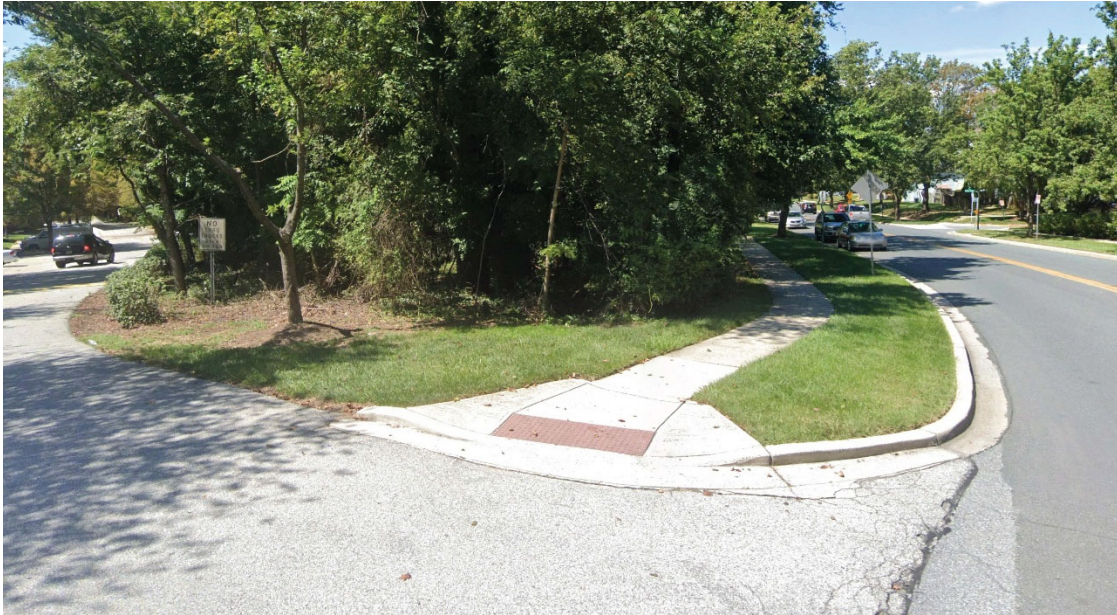
**Figure 5-5: Looking Left at Bantry Way (North)**

The only existing intersections that have obstructions to required intersection sight distances are right and left turns from Bantry Way (north) and both left and right turns from Softwood Terrace. At Bantry Way (north), right and left turn sight distance is obstructed by a wooded area and parked cars along Morningwood Drive (see Figure 5-5). At Softwood Terrace, right turn sight distance is obstructed by trees and parked cars in the adjacent parking lot (see Figure 5-6) and left turn sight distance is obstructed by trees and parked cars along Morningwood Drive (see Figure 5-7). Trimming of vegetation and limits on street parking would enhance sight distance at these locations.

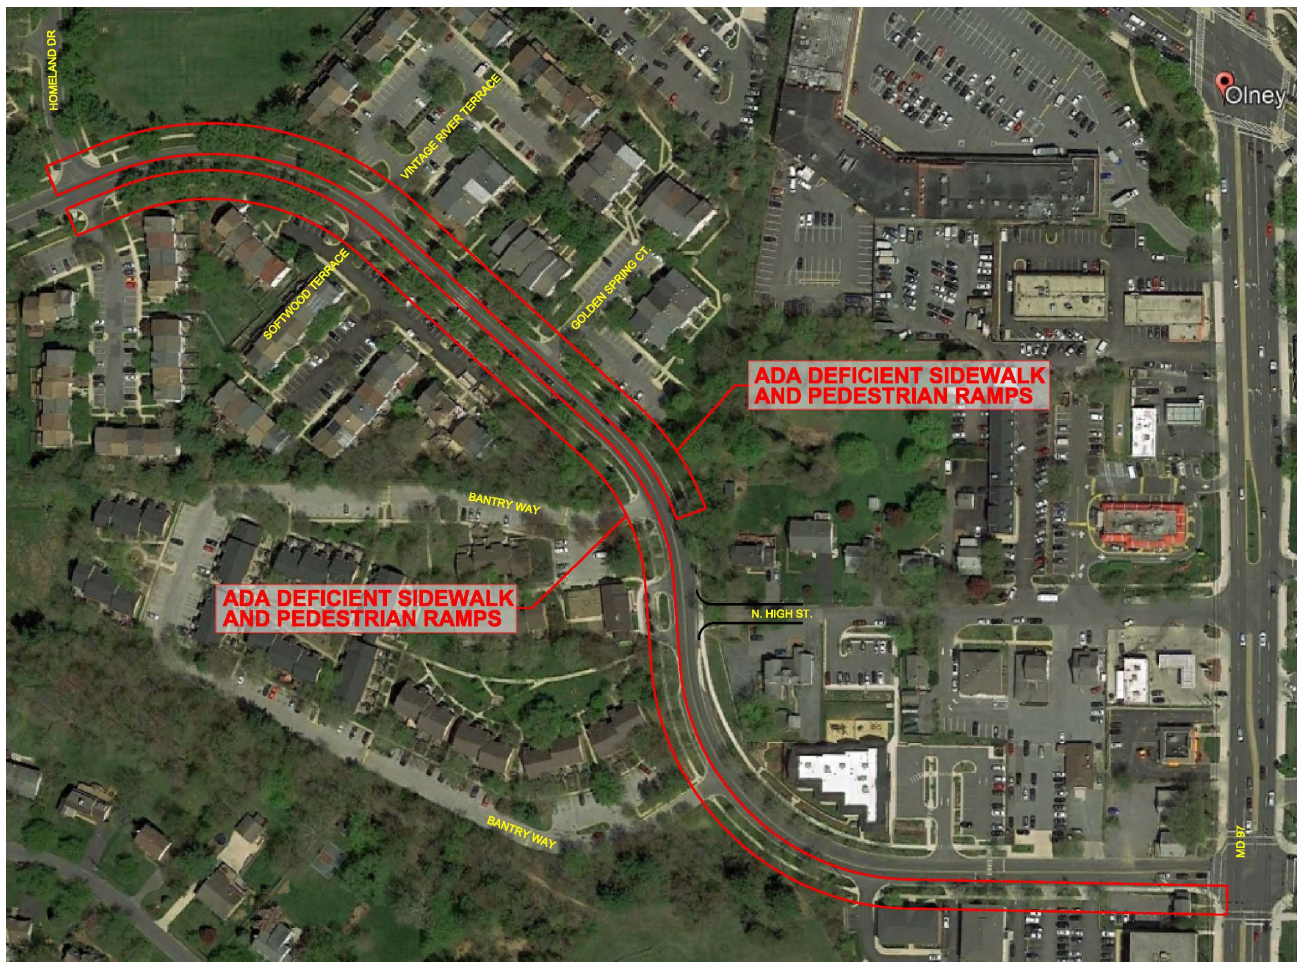
Figure 6-1: ADA Deficient Sidewalks

Sidewalks are provided along both sides of the Morningwood Drive study section. For the west/south side of the roadway, the sidewalk is provided along the entire corridor from Homeland Drive to MD 97, while for the east/north side, the sidewalk does not reach MD 97, ending after the Goddard School parking lot. The entire length of sidewalk on the west/south side of the study corridor and the sidewalk on the east/north side of the study corridor from Homeland Drive to the proposed N. High Street connection is four feet wide, thus not conforming to the ADA requirement of a minimum sidewalk width of five feet or the draft Complete Streets design guide recommendation of six feet for a sidewalk and 8 feet for a sidepath. The sidewalk on the east/north side of the study corridor is five feet wide from just north of the proposed N. High Street connection to the end of the sidewalk after the Goddard School parking lot (see Figure 6-1), again not meeting the Complete Streets guidance. ADA pedestrian ramps are provided at each intersection and across the driveways along the entire Morningwood Drive corridor. Any pedestrian ramp along the sidewalk areas that are four feet wide do not meet ADA requirements. All the sidewalk and pedestrian ramps along the west/south side of Morningwood Drive and the portion that is four feet wide along the east/north side of Morningwood drive would need to be reconstructed to be six feet wide in order to be ADA and Complete Streets compliant.

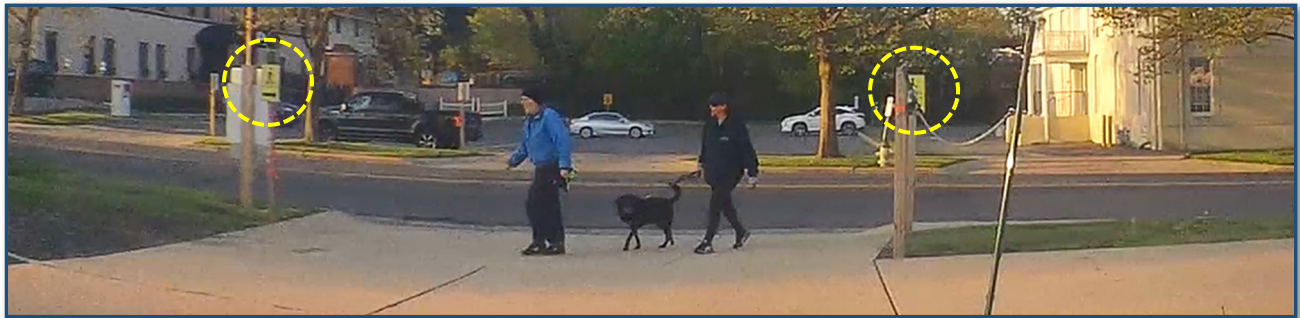
**Figure 6-2: End of Sidewalk on the Morningwood Drive north side and Pedestrian Crossing Signs**

Figure 6-2 shows that pedestrians with a dog were walking through the parking lot at the end of the sidewalk near the Chang Hai Restaurant. Non-standard pedestrian crossing signs are placed at the parking lot access, as shown in the circles of the figure. The opposite driveways also have the same pedestrian crossing signs posted.

- Extend the sidewalk adjacent to the Chinese Restaurant along the north side of the Morningwood Drive toward MD 97, if feasible, to complete this pedestrian connection. This may require redevelopment of the adjacent property on the corner of MD 97/Morningwood Drive in order to have room to do so to provide the recommended 6 feet plus space for Maintenance and Street Buffers.

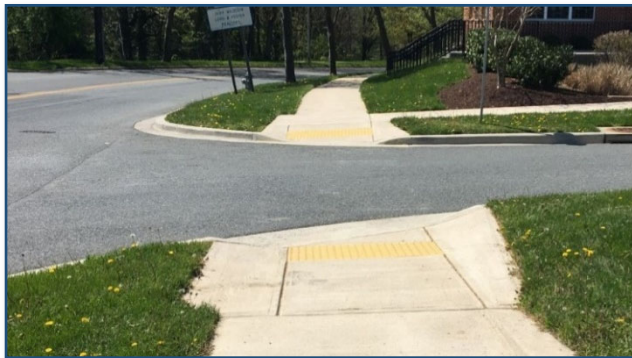
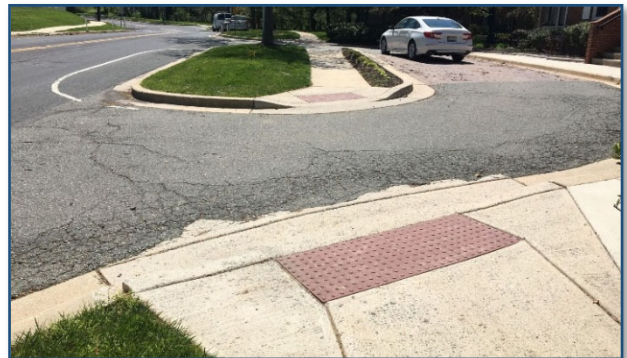
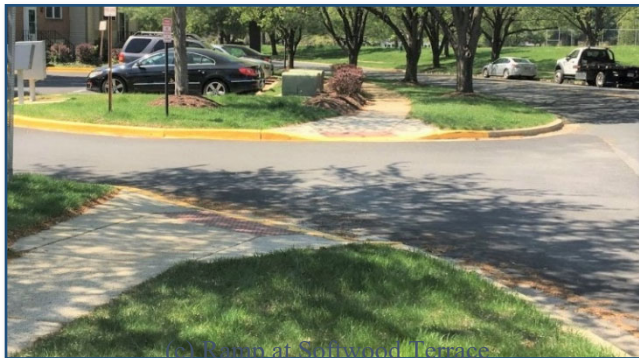
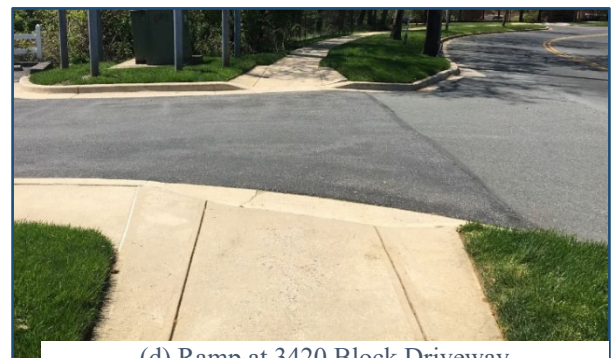
**Figure 6-3: Pedestrian ADA Ramps across Driveways along Morningwood Drive**

The ADA pedestrian ramps are provided across the driveways along the Morningwood Drive corridor, as shown in Figure 6-3. It appeared that the pedestrian ramp across the 3420 Block driveway of Morningwood Drive does not conform to the ADA standard as it is without a detectable warning surface (Figure 6-1(d)).

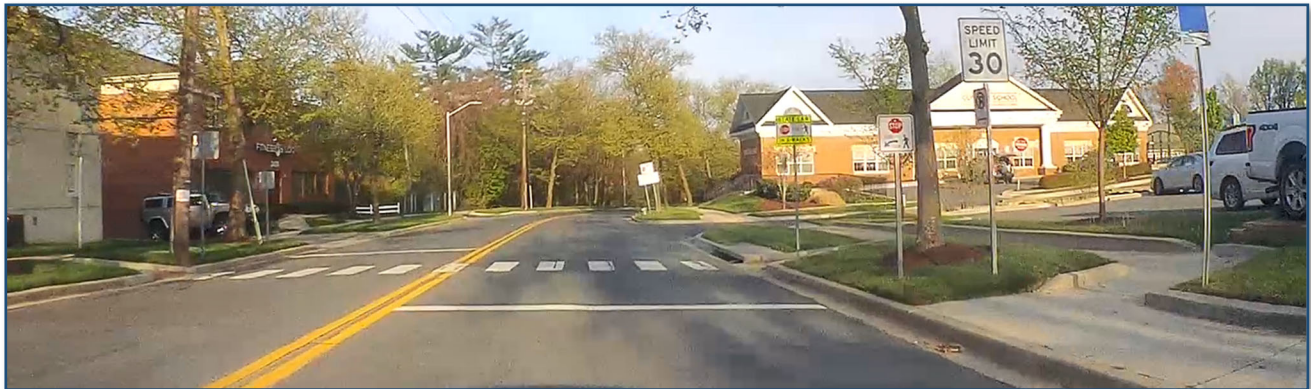
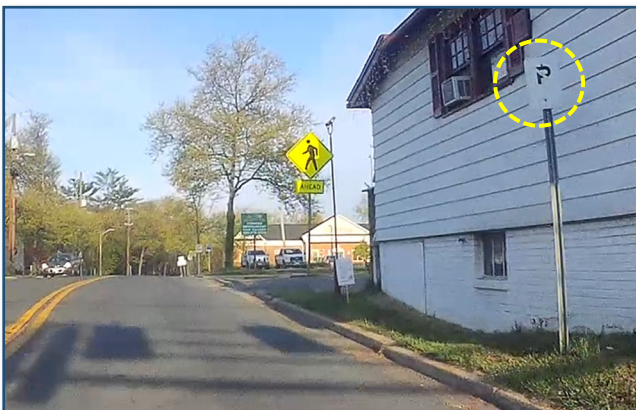
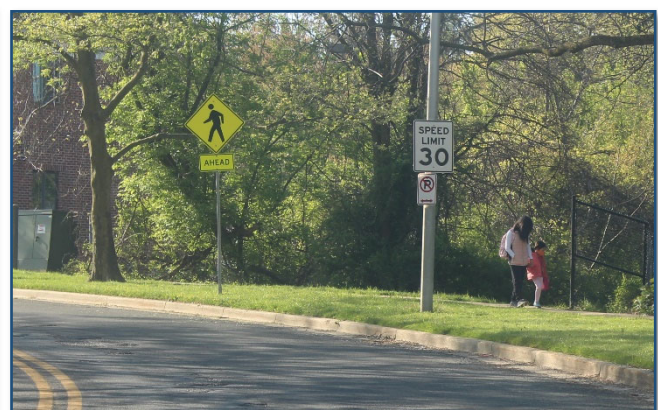
**Figure 7-1: Traffic Signs in advance of Crosswalk**

30 mph speed limit signs are posted in advance of the crosswalk at the Goddard School parking lot in both directions. The westbound traffic speed on the corridor can be controlled with this speed sign over the corridor after entering Morningwood Drive from MD 97 (See Figure 7-1(a)). However, for the eastbound traffic, no speed limit sign is posted, except for the advisory speed plaques at speed humps, along the Morningwood Drive corridor from Cashell Road to the sign near the school (Figure 7-1(c)). For Cashell Road, the speed limit signs of 35 mph are posted in both directions. The No Parking sign on the westbound receiving lane of the MD 97/Morningwood Drive intersection is faded and needs to be replaced or fixed (Figure 7-1(b)).

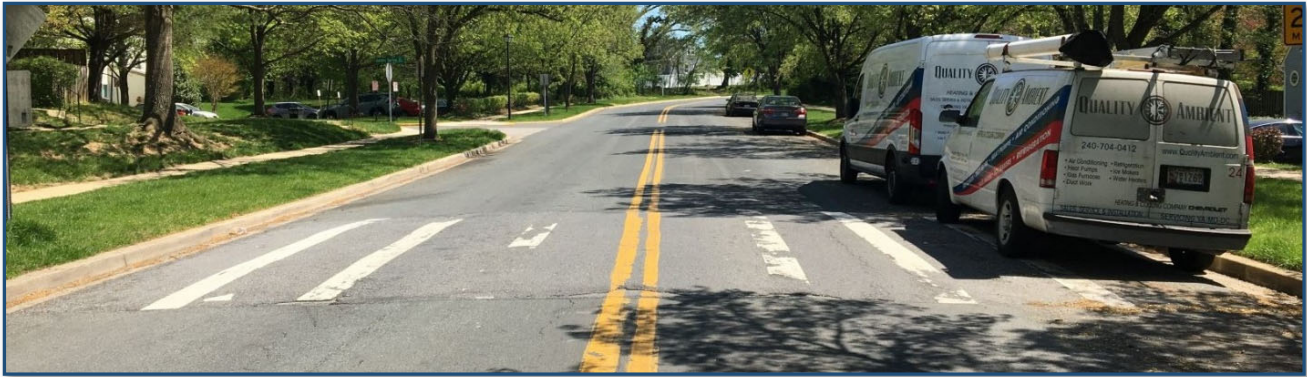
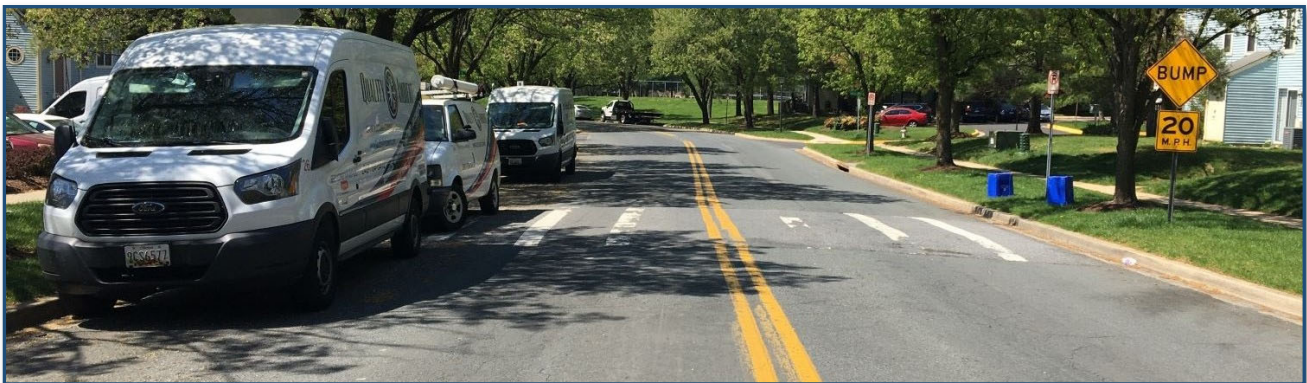
Figure 7-2: Speed Hump and Parked Vehicles on Morningwood Drive

One speed hump on Morningwood Drive is provided between Vintage River Terrace and Golden Spring Court. In conjunction with the hump, Bump and 20 mph-advisory speed plaque signs are provided. As shown in Figure 7-2, the speed hump marking is faded and is not installed per MUTCD standards (MUTCD 3B.25 and 3B.26). A few commercial vans were seen parked on the street near the speed hump all day. It is possible that parked vehicles block the speed bump signs.

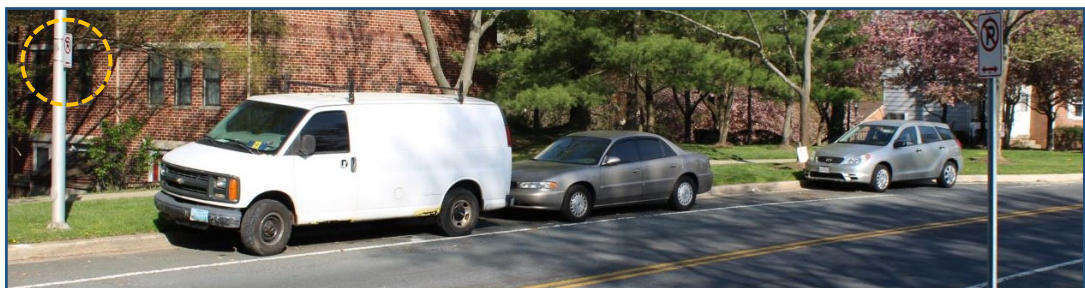
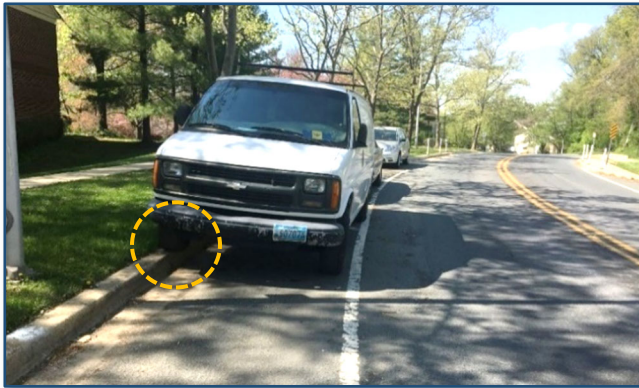
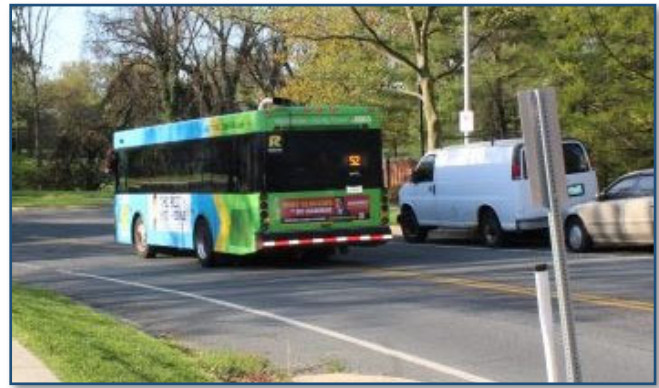
Figure 7-3: Parked Vehicles on SB Shoulder near Bantry Way (South)

Figure 7-3(a) shows vehicles that parked on the southbound shoulder between the apartment office driveway and Bantry Way (south). Those three vehicles on the shoulder were parked for the full time of the site review. Although this parking is not illegal, the parking on the narrow shoulder induces potential safety issues at this curve segment, such as sight distance for pedestrian traffic and causing some traffic to go over the roadway center line to pass. Figure 7-3(b) shows that the right-side wheels of the van is on the curb for the vehicle to be able to stay outside of the lane edge line. Figure 7-3(c) demonstrates that a Ride On Bus is crossing the centerline, probably due to the presence of adjacent parked vehicles.

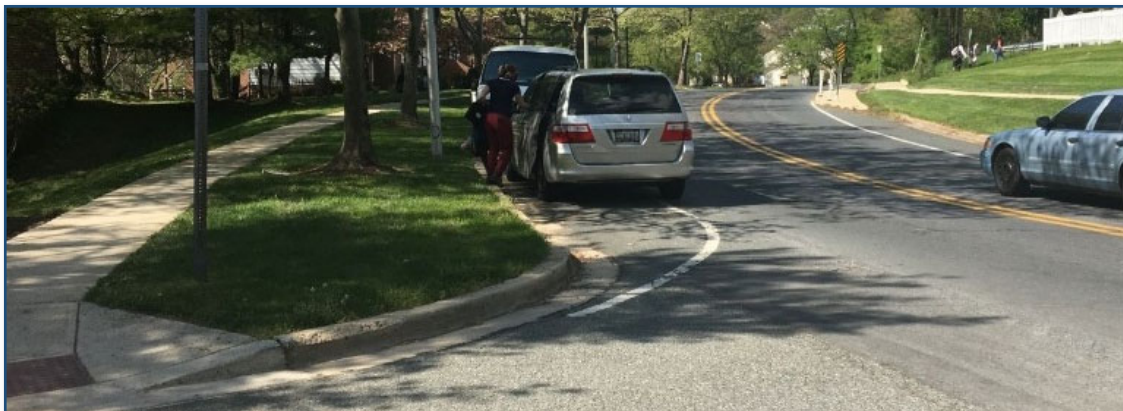
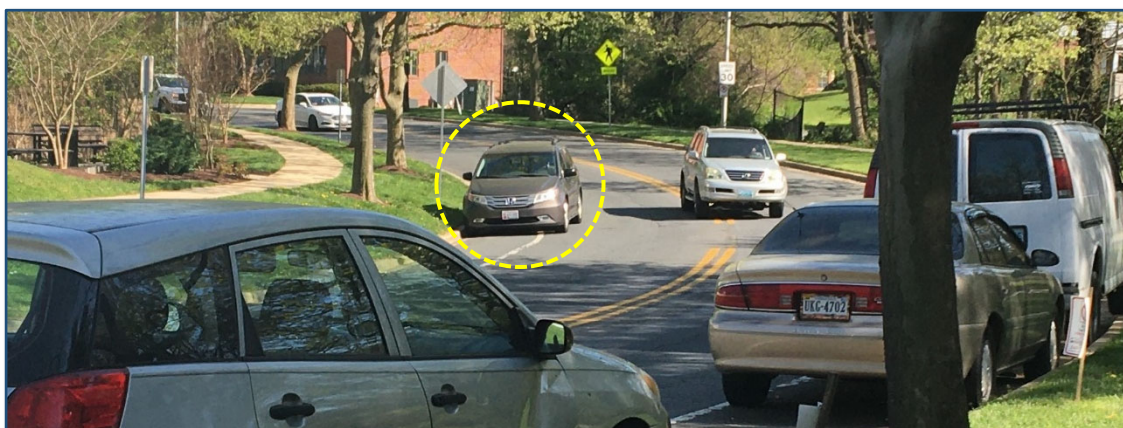
**Figure 7-4: Illegal Parking/Standing near Bantry Way (south)**

Also, parked vehicles affect the left sight distance from Bantry Way (south). Figure 7-4(a) shows a minivan was standing/parking on the shoulder in the reverse direction to pick an elementary student from the school trail in the afternoon. This vehicle was standing/parking beyond the parking area available from the No Parking sign in the circle drawn in Figure 7-3(a).

Figure 7-4(b) shows a vehicle crossing the centerline on the curve section due to the standing minivan on the northbound shoulder in the afternoon. It appeared that the minivan driver was stopping the vehicle on the shoulder in order to throw trash away into the trash can in the adjacent resting space with benches.

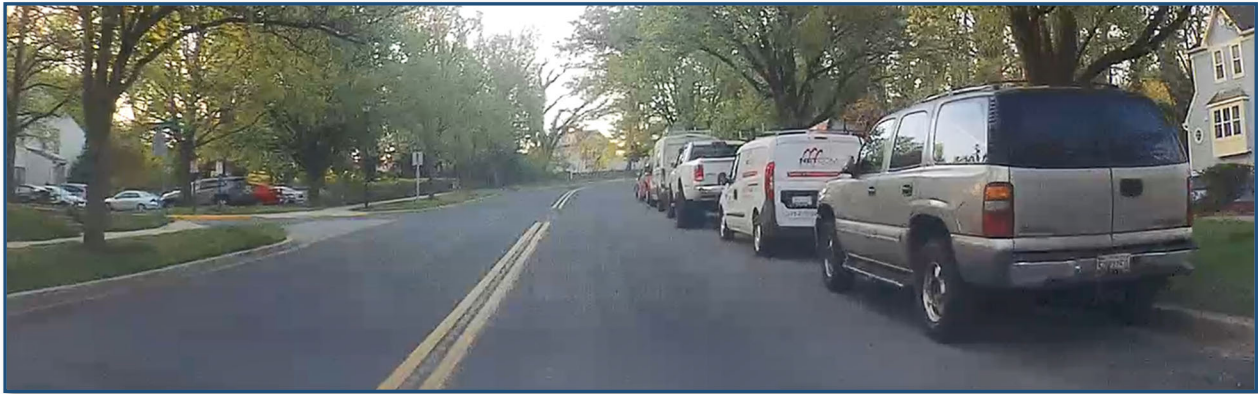
**Figure 7-5: Parked Vehicles on the EB Morningwood Drive**

On-street parking is available on the straight segment of eastbound Morningwood Drive between Softwood Terrace and Bantry Way (north), and some part of the westbound Morningwood Drive between Vintage River Terrace and Homeland Drive (Figure 7-7). “No Parking” signs regulate the street parking locations. There are no marked bicycle facilities along the roadway or sidepaths.

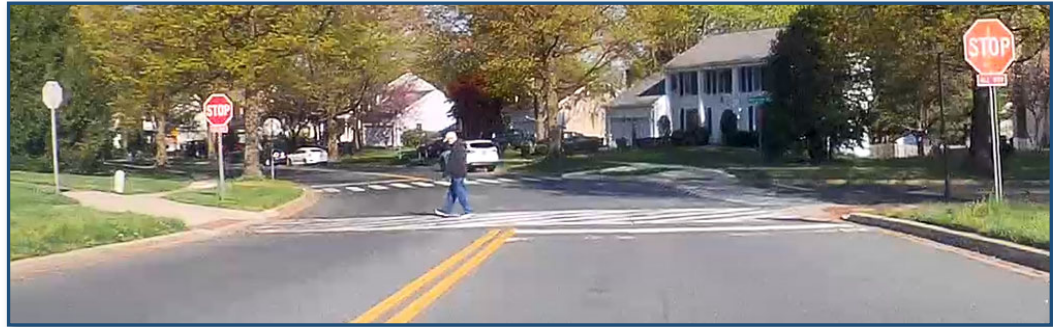
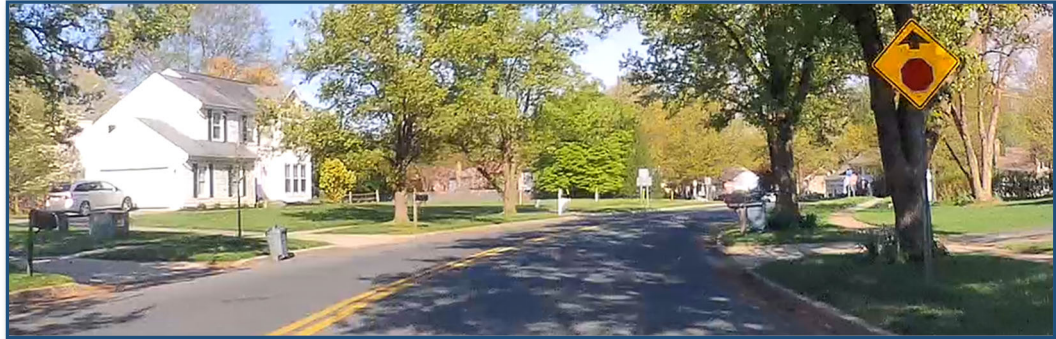
**Figure 7-6: All-Way Stop Control at Morningwood Drive/Headwaters Drive Intersection**

In the 2020 virtual public meeting, one resident commented about the All-Way Stop at the Morningwood Drive/Headwaters Drive intersection noting that many people do not come to a full stop at that intersection, treating the Stop signs as suggestions. In the field observations, the operation of All-Way Stop at Headwaters Drive appeared with the standard signage and pavement markings, including advanced warning signs on Morningwood Drive. However, it should be noted the observations of drivers was limited to single day.
