Montgomery County
Department of Transportation
Division of Transportation Engineering

2019 BRIDGE INSPECTION REPORT
December 27, 2019

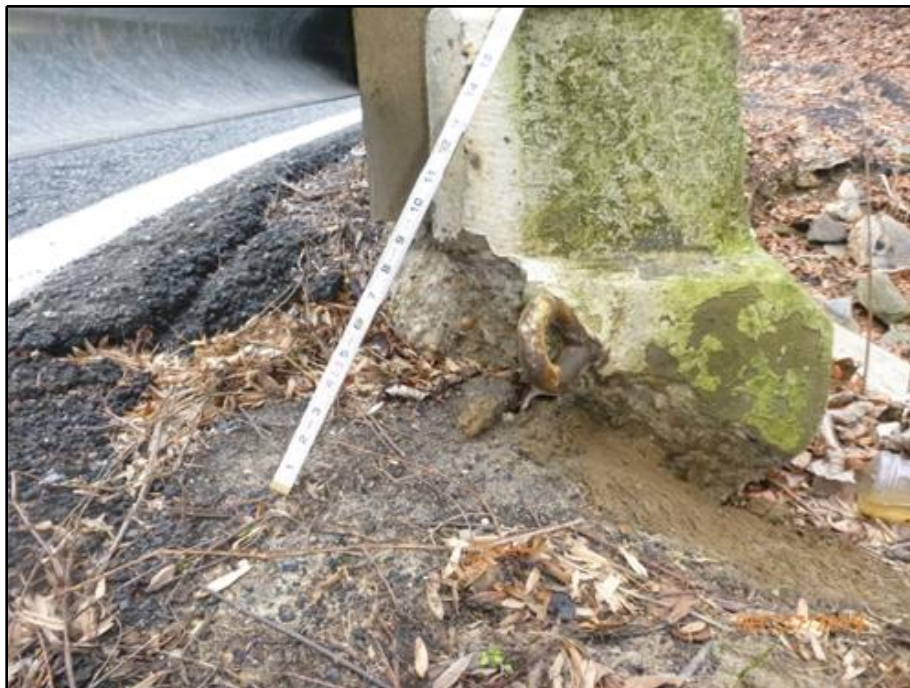
16. Spall at the base of the north end post on the West Bridge Railing

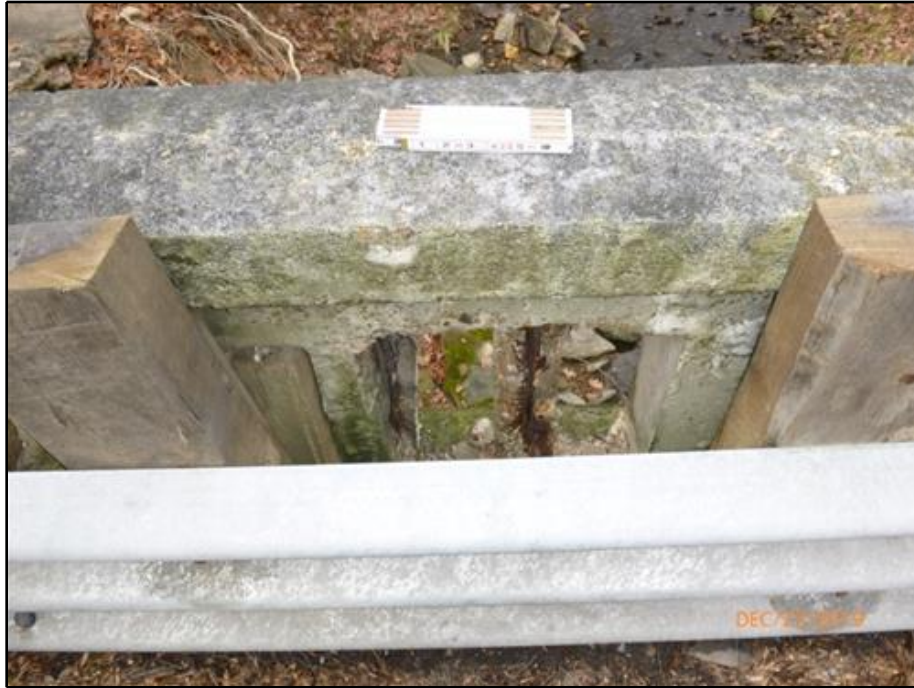
17. Balusters 10 and 11 of the West Bridge Railing are spalled with exposed reinforcement

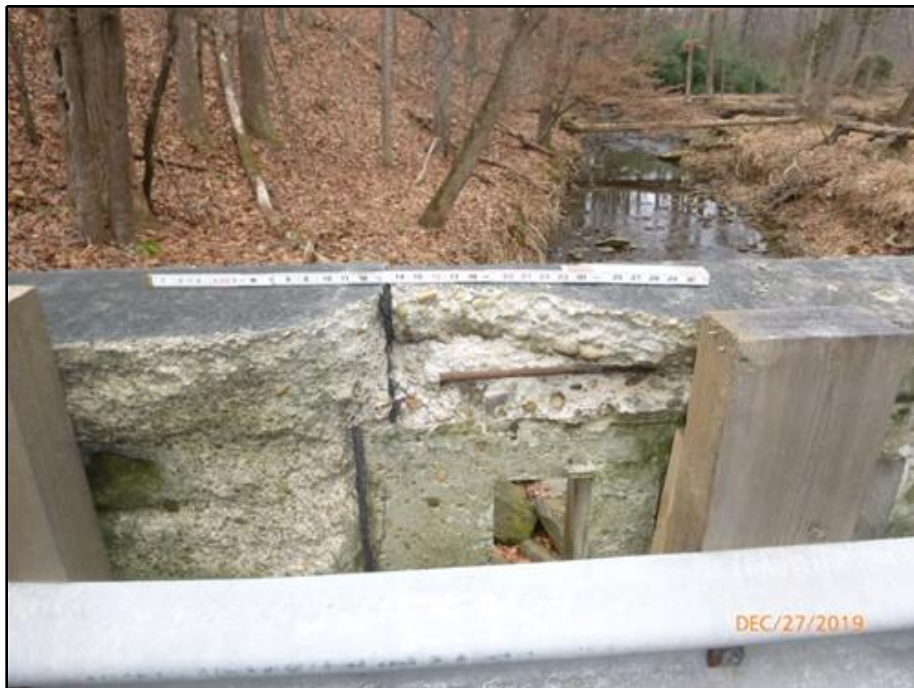
18. Spall with exposed reinforcement in the top face of the West Bridge Railing at the south end

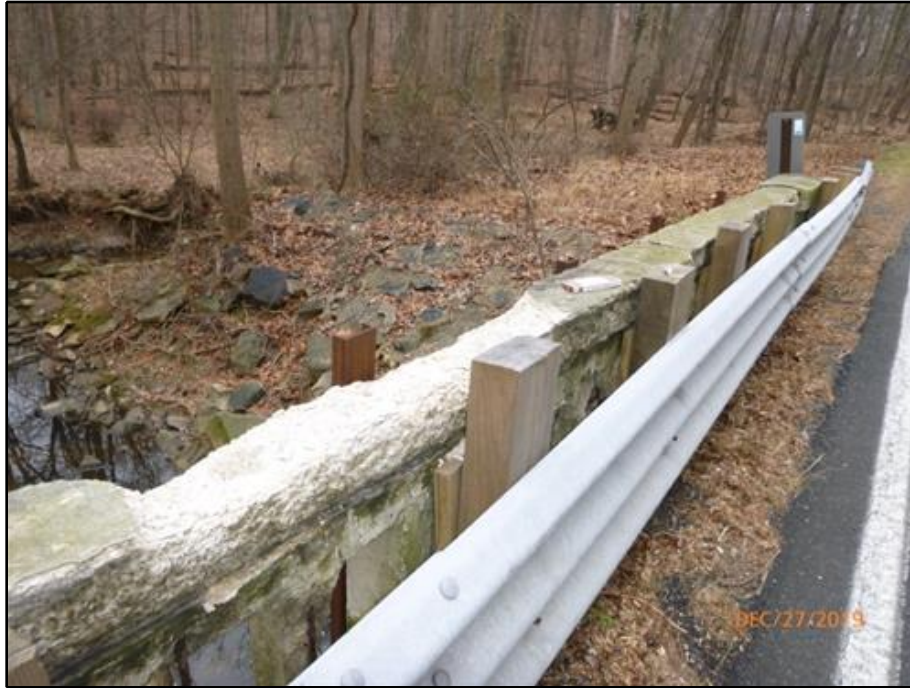
19. Spalls in the top face of the East Bridge Railing

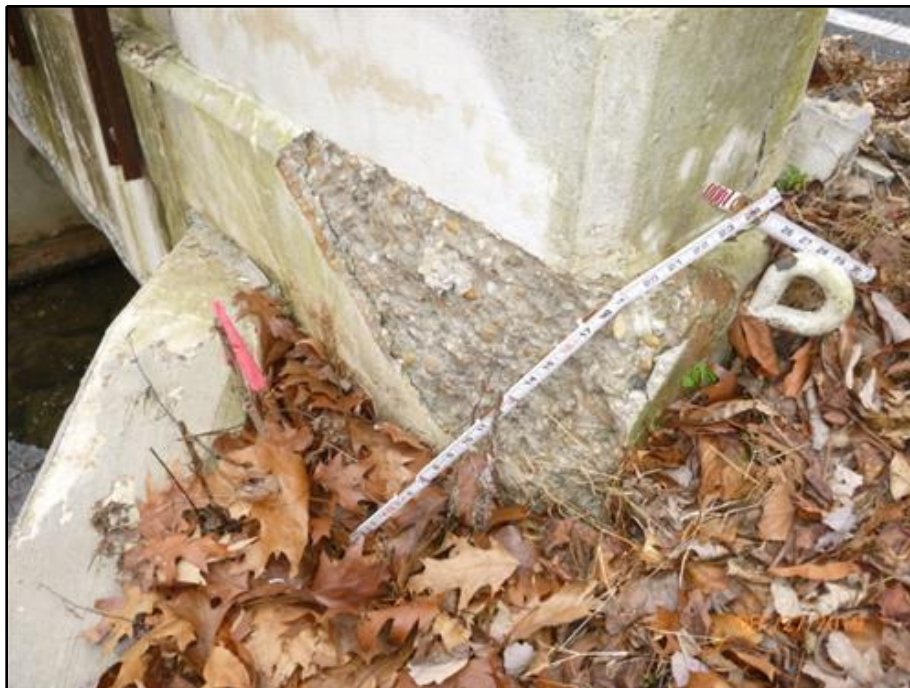
20. Spall in the base of the east face of the north end post on the East Bridge Railing

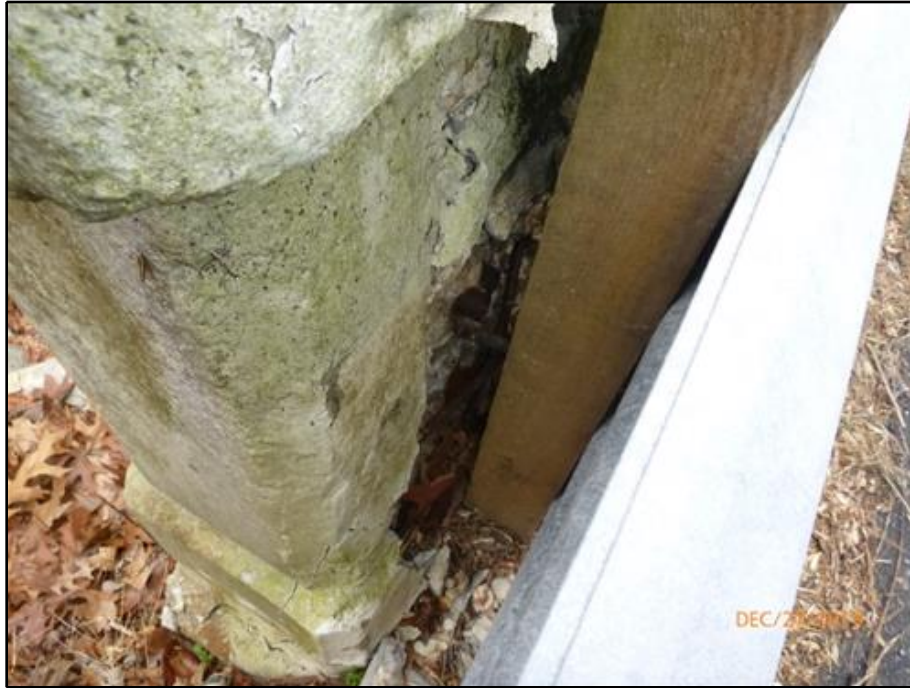
21. Spall with exposed reinforcement in the base of the west face of the East Bridge Railing, at the first traffic barrier post from the north end

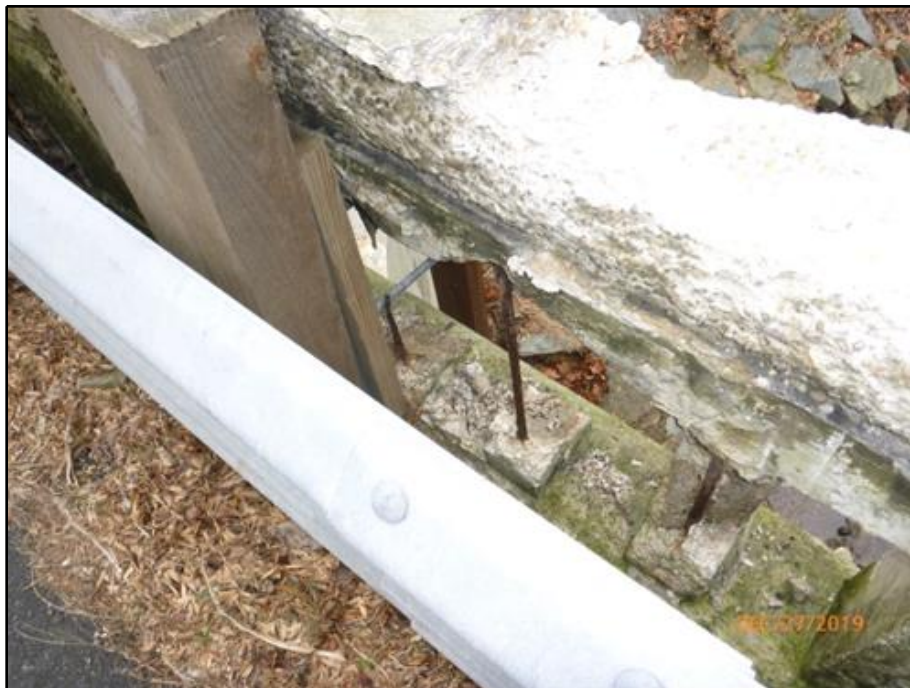
22. Balusters 1 and 2 of the East Bridge Railing are missing

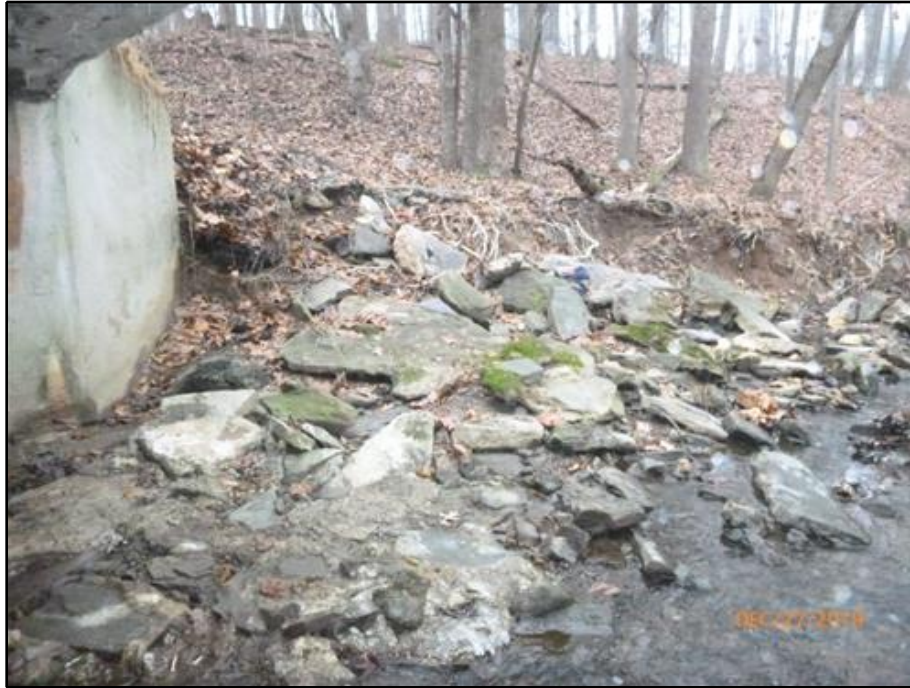
25. Southwest Slope Protection has failed due to erosion and riprap has fallen into the channel and mostly washed away

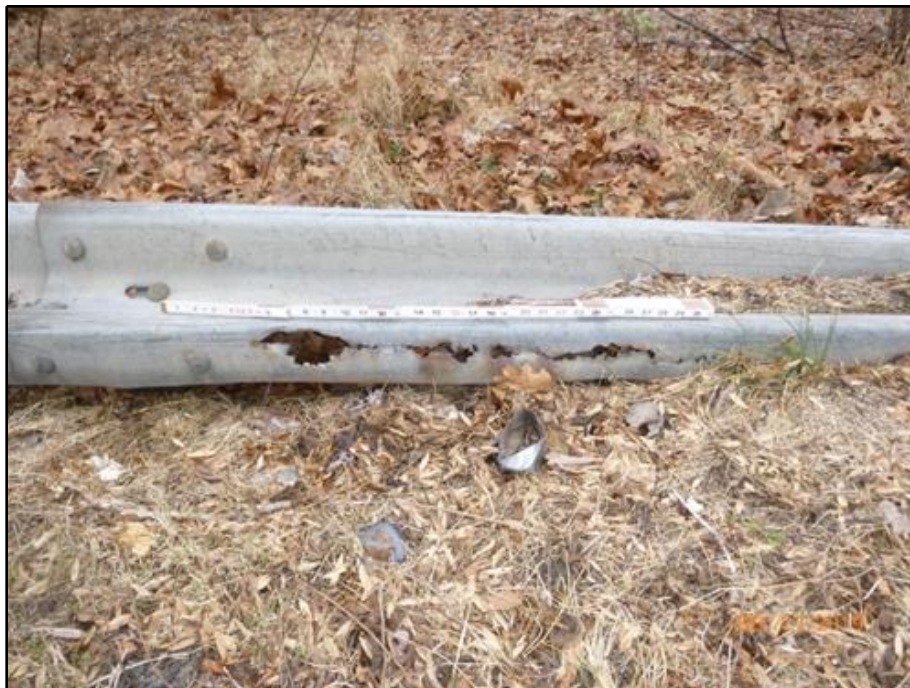
26. Section loss on the Northwest Approach Traffic Barrier between the 1st and 2nd posts from the north end

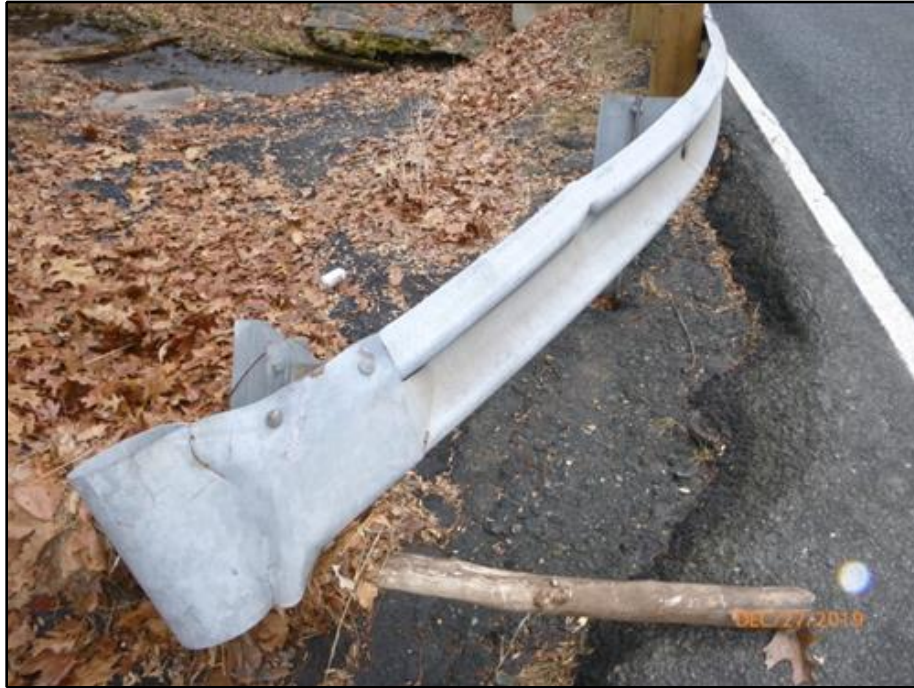
27. Impact damage to the Southwest Approach Traffic Barrier End Treatment

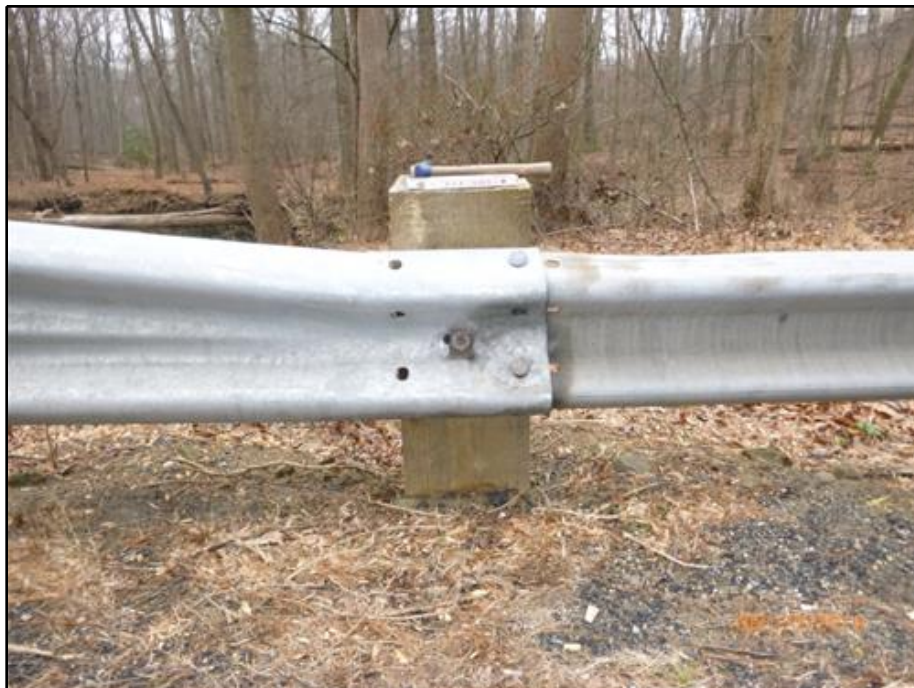
28. Missing W-beam splice bolts and the W-beam splice is lapped incorrectly at the 2nd post from the bridge for the Southeast Approach Traffic Barrier

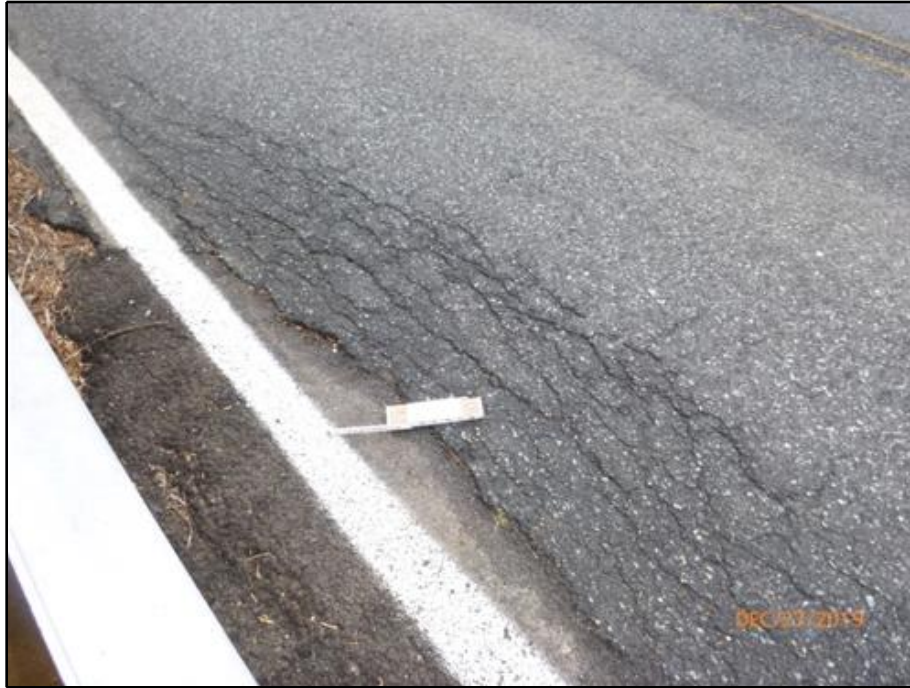
31. Map cracking at the Northwest Approach, 3' north of the bridge rail

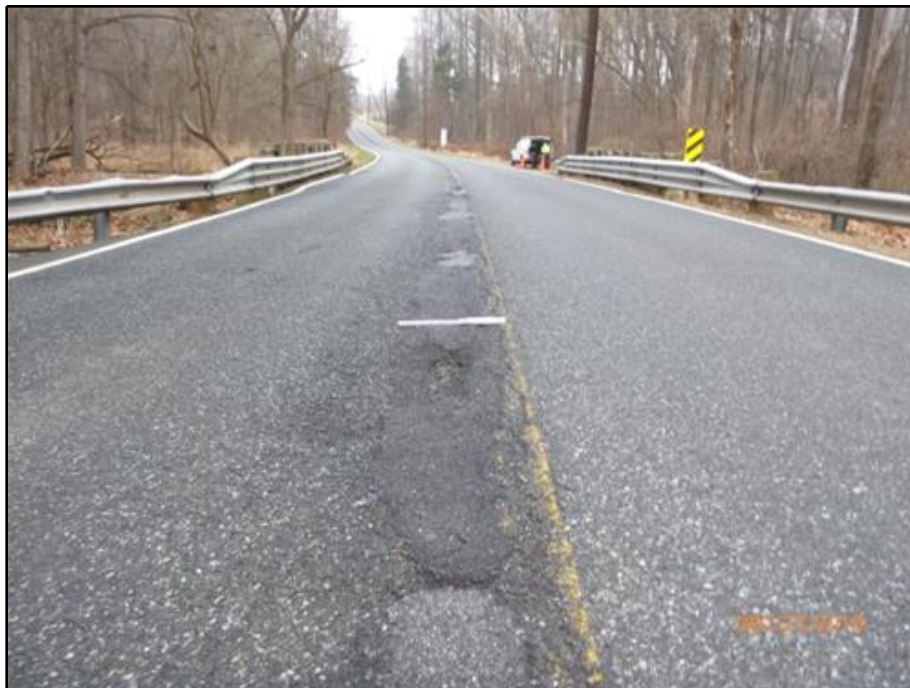
32. Potholes within the patch along the centerline of the South Approach
