# **Glen Echo Heights**

## **Roadway and Drainage Study**

MONTGOMERY COUNTY, MARYLAND

**August 2007**

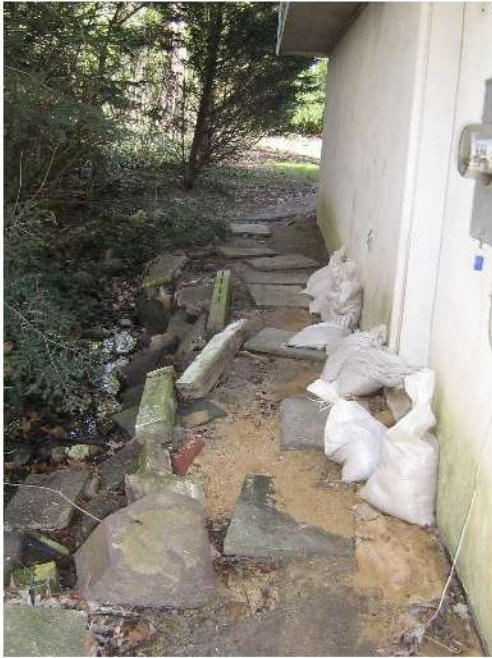
**Photo 1 – Drainage Ditch at 5409  
Wehawken Road**

This drainage improvement consists of two problem areas. The first area is located at 5328 Wapakoneta Road. The issue at this location is the ponding of storm runoff in front of the asphalt flume located in the front yard of this property. In large rain events, the ponding water could create a driving hazard. Also, storm runoff from the opposite side of Wapakoneta Road is crossing the surface of the roadway, creating a safety concern for drivers. The second problem area is at 5409 Wehawken Road. The issue at this location is the surface runoff of water from Wapakoneta Road through the property at 5328 Wapakoneta. This water is carried in an asphalt swale to the backyard of 5332 Wapakoneta. The swale then ends in a dirt channel onto 5409 Wehawken Road and continues down very close to the house at 5409 Wehawken. Further downstream, the undersized and blocked 18" pipe under Wehawken Road

contributes to an undesirable ponding situation in the front yard of 5409 Wehawken Road. Additionally, the surface watercourse adjacent to 5409 Wehawken Road is within a few feet of the building, and has caused flooding and water damage to the structure (see **Plan A**).

While conducting the field investigation during a nominal rain event (approximately 1 – 2 inches of rain within a 24 hour period), ponding was observed in front of the property at 5328 Wapakoneta Road. Subsequent analysis of the area revealed two factors contributing to the drainage issue at this location. The first contributing factor is the lack of storm drainage structures on this segment of Wapakoneta Road. This segment of Wapakoneta Road begins at the intersection with Walhonding Road and ends at the intersection with Namakagan Road; approximately 950 ft of roadway without one storm drain structure. The second factor causing this drainage issue is the natural topography of the area in which the property at 5328 Wapakoneta is located at the natural low point for this segment of the road.

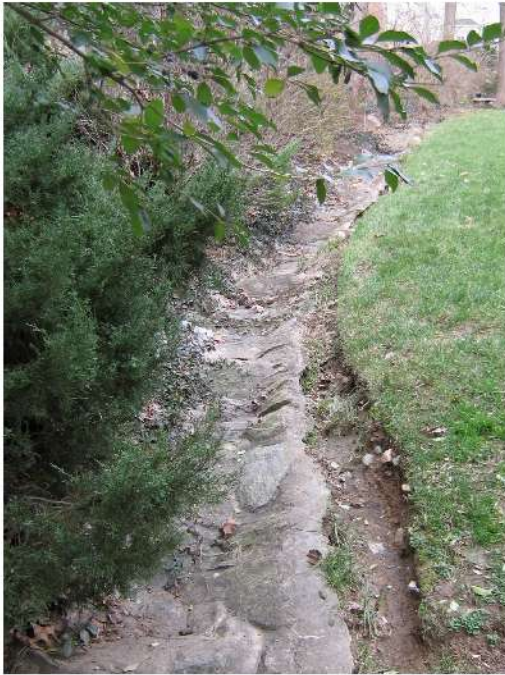
**Photo 2 – Concrete and Stone Ditch at  
5400 Tuscarawas Road**

A closed drainage system that was planned by MCDPWT but never implemented would have connected Waneta and Tuscarawas Roads. Due to homeowner opposition at the time, the improvements were limited to a cross culvert at Waneta Road. Runoff discharges into the backyard of 6114 Walhonding Road and drains to the low point of the backyard of 5417 Waneta Road. The storm runoff flows into a small yard inlet and is carried by 6" plastic pipe to the back property line of 5417 Waneta Road where it is discharged into a surface ditch. This concrete and stone ditch carries the runoff to an inlet adjacent to 5400 Tuscarawas Road. The outfall behind 5421 Waneta Road is silted in and the ditch at the rear of 5400 and 5402 Tuscarawas Roads shows signs of erosion. In addition, the yard inlet and outlet pipe are not adequately sized for the volume of water that reaches the area.

The recommendations for this area may be dependent upon the coordination with the multiple residents affected by this drainage improvement. The minimum remediation would include the reconstruction of the two open channels. Additional work could include extending the closed system from Tuscarawas Road to Waneta Road. All work on this drainage improvement would require Right-of-Way or easement from the affected properties. For plan view, refer Plans B-1 and B-2.

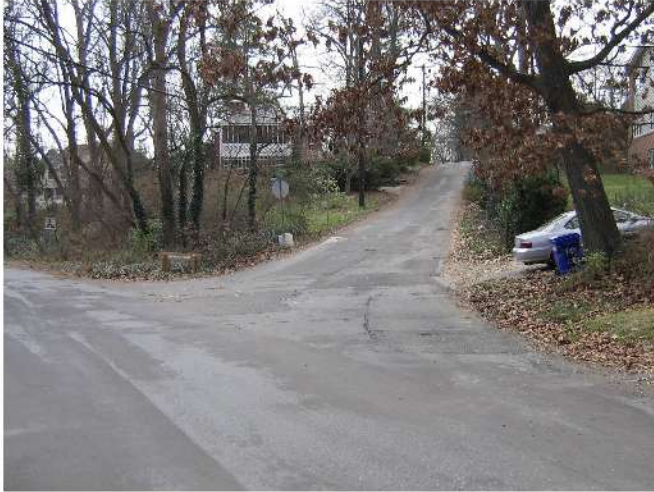
**Photo 3 – Intersection of Walhonding and Scioto Roads**

The drainage issue at the intersection of Walhonding Road and Scioto Road is ponding at the intersection. Scioto Road approaches Walhonding Road on a steep downgrade, while Walhonding is relatively flat through the intersection area. Runoff flows from north to south across the intersection, to an inlet on the southwest corner. The areas of ponding water at the intersection freeze in the winter, making it difficult to travel on Scioto Road. The northwest corner of the intersection also serves as a school

We recommend the following measures to improve drainage at this intersection:

3. Resurface Scioto and the intersection area of Scioto and Walhonding Roads to provide a more defined crown to the road that would better confine the runoff to the roadsides where it can be collected in the inlets more efficiently.
4. Perform work recommended in Drainage Improvement D

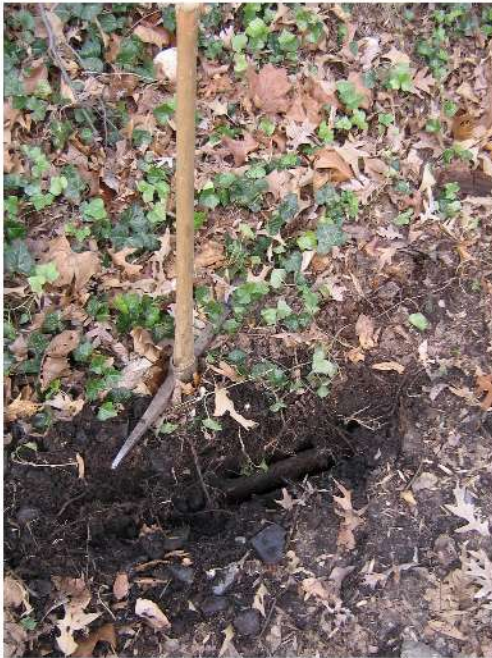
The grate inlets near each of these properties was found to be buried underneath several inches of topsoil, with the exception of the inlet at 6241 Walhonding Road, which the survey crew could not locate.

**Photo 4- Covered Inlet along Walhonding Road**

During the field investigation, several grate inlets were discovered buried under several inches of topsoil. As mentioned previously in the report, Glen Echo Heights is located in an area of rolling topography with many elevation changes. Specifically, the area where these three inlets are located, the western side of Walhonding Road, has a very steep hillside. Due to the steep hillside, soil has eroded from the slopes and collected on the grate inlets.

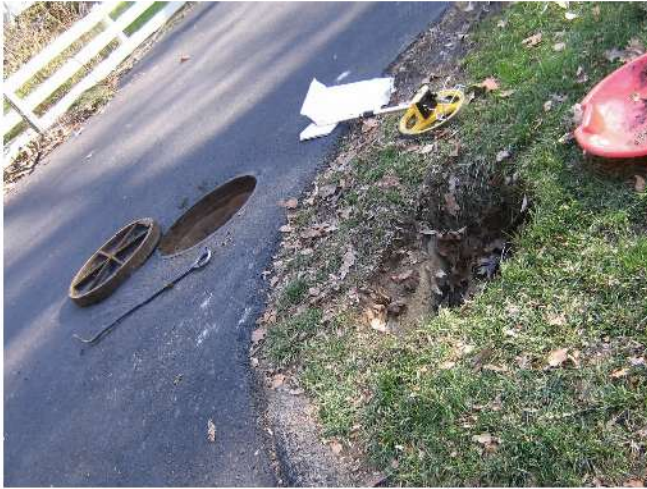
**Photo 5 – Converted Inlet at 5317 Tuscarawas**

In the front yard of 5317 Tuscarawas Road, the existing manhole, previously converted from a curb on grade (COG) type inlet, has experienced a wall failure and is contributing to a sinkhole adjacent to the roadway (see **Photo 5**). Due to the sinkhole, ponding occurs during storm events which appears to have increased the size of the sinkhole.

1. Remove the existing manhole and replace it with a COG inlet located approximately 17 feet east of the existing manhole along the existing curb. In addition to improving the drainage at this location, the amount of water flowing along the edge of Tuscarawas Road would be reduced significantly, which was contributing to drainage issues at 5311 Tuscarawas Road (**see Plan G**)
2. Construct a grate inlet between 5317 and 5319 Tuscarawas Road to capture surface runoff.

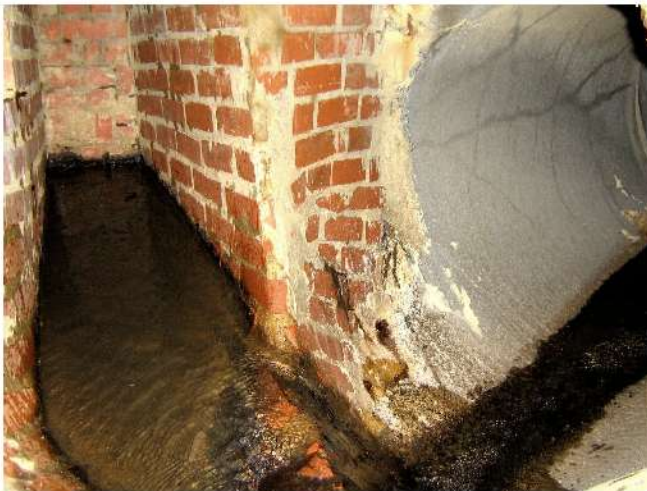
**Photo 6 – Inside Converted Inlet**

There are two main factors contributing to the drainage problem at 5317 Tuscarawas Road. The first factor is that the inlet was not properly converted into a manhole. Upon an inspection of inside the manhole, it was discovered that the original structure was a COG type inlet because the trough section of the inlet was left intact when it was converted into a manhole (see **Photo 6**). In addition to the trough portion being left intact, the inlet also seems configured to direct the storm runoff into the trough section instead of the 42" RCP that connects this drainage

structure to the rest of the SD system on Tuscarawas Road. The second factor is that the pipe or under-drain structure located at the end of the trough is allowing the storm runoff to pond in the trough section of the inlet. It is likely that there is a leak in the trough of the inlet causing the sinkhole that is located at the end of the trough section of the inlet. This sinkhole has been repaired multiple times, and the same issue has returned.

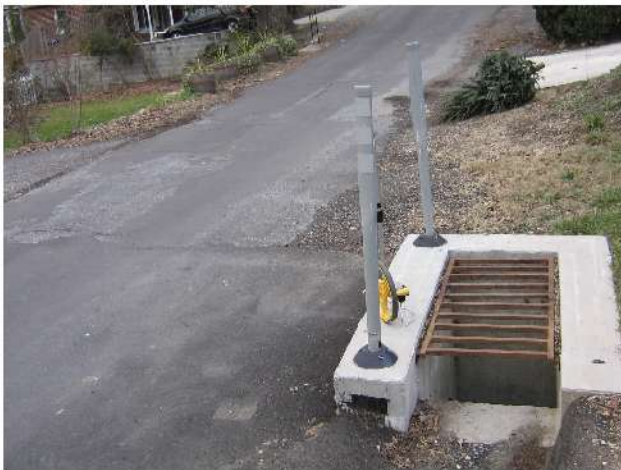
**Photo 7 – Type J Inlet at 5301 Iroquois Rd**

The main contributing factor for this drainage issue is the storm water runoff collected from Iroquois and Namakagan Roads outfalls into the backyard of 5319 Tuscarawas Road. The runoff enters a grate inlet located near the intersection of Iroquois and Namakagan Roads, which captures the runoff from Namakagan Road. It is then carried across the road and drains into a ditch located in the backyard of 5302 Iroquois Road. The ditch flows across the backyard of 5302 Iroquois Road and outfalls onto the southwest corner of 5304 Iroquois Road where it

then flows into the backyard of 5319 Tuscarawas. The second factor is the storm drainage installed by the resident to convey the overland flow entering their property from 5304 Iroquois Road was not adequately sized for the volume of runoff. During the field investigation, the survey team found a 12x18 inch residential yard inlet connected to a six-inch High Density Polyethylene (HDPE) pipe which drains the storm runoff (approximately 4.2 acres) from the backyard of 5319 Tuscarawas Road onto Tuscarawas Road. The survey team also found the backyard of 5319 Tuscarawas Road to be saturated from the excess water.

We recommend the installation of a closed drainage system from the upstream side of Iroquois Road to connect to the existing closed drainage system on Tuscarawas Road. This work also includes constructing inlets between 5300 and 5302 Iroquois Road to reduce surface runoff entering the backyard of 5319 Tuscarawas Road. This work will require Right-of-Way or easement and may impact existing water and gas facilities on Iroquois Road. For more detailed information, refer to Plan F. This drainage improvement would require the construction of Drainage Improvement E.

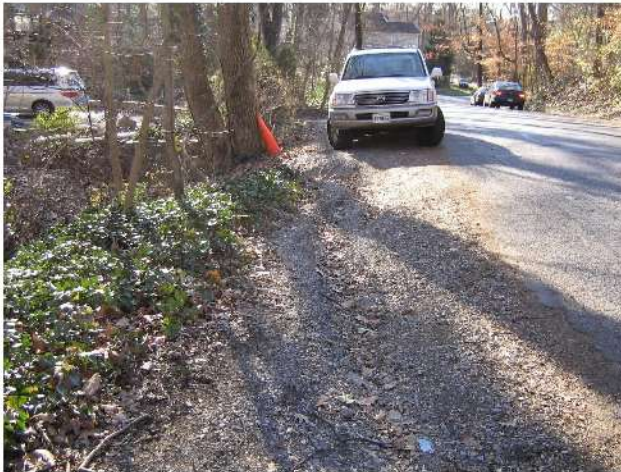
The storm runoff from Tuscarawas Road has eroded a ditch along the southern edge of the roadway between 5311 and 5309 Tuscarawas Road. The eroded ditch drains into an ephemeral stream across the front of the properties of 5315 through 5303 Tuscarawas Road. The location of the outfall where the eroded ditch is draining is next to two large

**Photo 8 – Eroded Ditch on Tuscarawas Road**

trees whose roots are being undermined by the storm runoff. Also, based on conversation with property owners, the driveways at 5311 and 5309 Tuscarawas Road have experienced excessive runoff from the roadway.

1. Tuscarawas Road should be resurfaced in order to redefine the roadway crown, which has been reduced due to roadway patching.
2. The deteriorated and undercut outfall at 5307 Tuscarawas Road should be repaired by removing the remaining portions of the concrete apron and placing riprap to stabilize the outfall. This work should be performed as a first order of work to minimize any additional deterioration of the existing stone retaining wall

located at the outfall, which shows signs of potential settlement (eg. Cracks in wall, etc.)

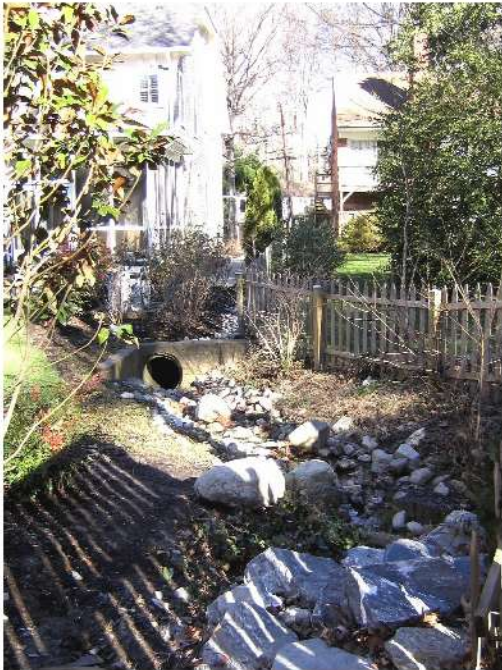
**Photo 9 – Behind 6108 Winnebago Road**

The area between 6108 Winnebago Road and 6111 Madawaska Road has multiple drainage issues. The primary issues are in the area behind 6108 Winnebago Road and 6115 Madawaska Road, where there is an outfall of an existing storm drain system. Roadway runoff drains down the driveway of 6115 Madawaska Road, which is located in a sump area, contributing to the drainage problem. The drainage area to the upstream of the 24" pipe at 6108 Winnebago Road is approximately 15.4 acres, of which 3.8 acres drains down the driveway at 6115 Madawaska Road. The total estimated runoff at the existing headwall behind 6108 Winnebago Road is approximately 35 cfs during the 25 year storm event.

1. Construct a closed storm drain system along Madawaska Road that includes improvements at the intersections with Wehawken and Wapakoneta Roads. In addition, the existing inlet in front of 6111 Madawaska Road should be cleaned.
2. Construct inlets at the sump of the roadway at 6115 Madawaska Road and outfall into the existing riprap channel at the rear of the residence.
3. Although the current homeowner has not noted any problems with flooding, consideration should be made to increase the size of the storm drain system that connects the area draining to the backyard of 6108 Winnebago Road to the existing storm drain system along Winnebago Road. Based on preliminary drainage analysis, the storm drain would need to be increased from a 24" CMP to a 27" RCP to handle the flow from a 25 year storm.

Item 1 will not require additional Right-of-Way, but Items 2 and 3 would require easements or Right-of-Way from multiple property owners. All 3 Items would possibly impact existing water and gas facilities on Madawaska, Wehawken, and Wapakoneta Roads. For plan views of the recommended items, refer to Plans H and M.

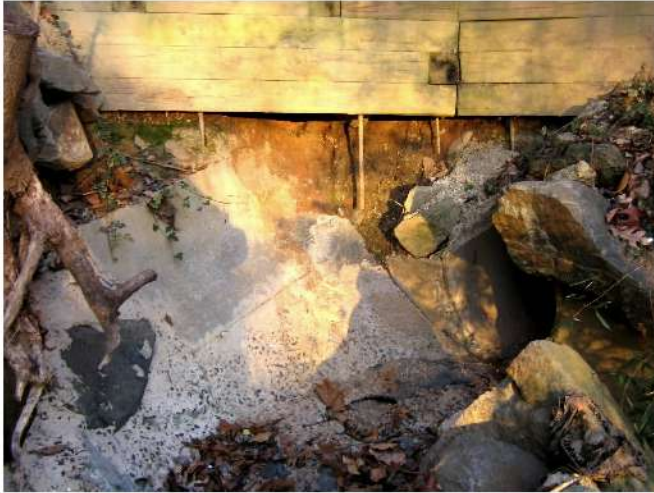
The drainage issue is located at the outfall pipe (24" RCP) along the side of 5202 Wyoming Road, that has a drainage area of 8.74 acre. The flow is undermining the outfall including the subgrade supporting a wooden retaining wall that in turn supports a wooden deck located between 5102 & 5202 Wyoming Road. In addition, the outfall is flooding the driveway of 7011 MacArthur Boulevard, located downstream of the outfall.

**Photo 10 – Outfall Area at 5202 Wyoming Road**

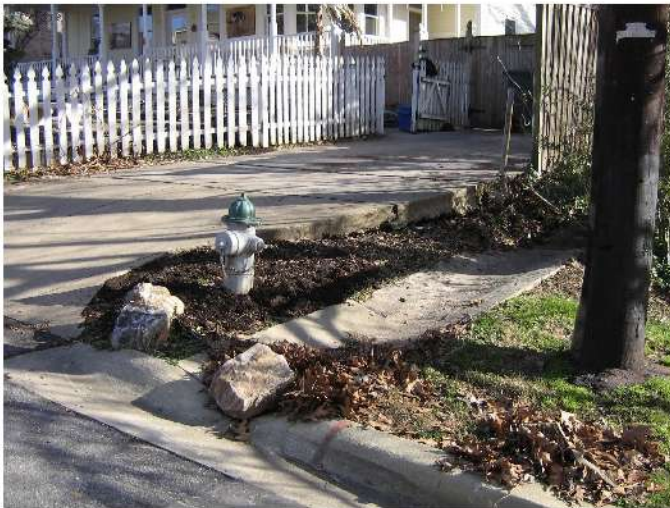
**Photo 11 – Concrete Swale at 5123 Waukesha**

The drainage issue at 5110 Wehawken Road and 5123 Waukesha Road consists primarily of excessive overland flow running through these two properties. The runoff from the storm drain system is first collected by a 5' COG in front of 5109 Wehawken Road, then outfalls across the roadway onto the side of 5108 Wehawken Road; where it drains into the backyard of 5110 Wehawken Road. The runoff drains into a concrete swale that flows along the southern property line of 5123 Waukesha Road. The runoff is

causing the following types of damage:

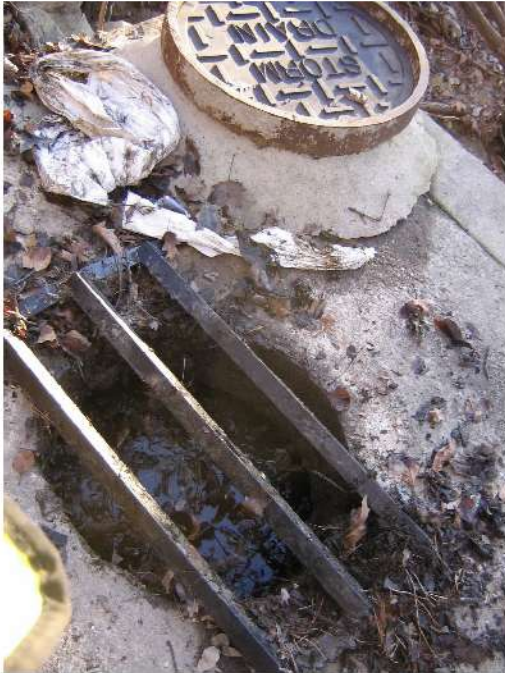
**Photo 12 – Manhole Located Behind  
5104 River Hill Road**

opening of the concrete structure. For the last field located manhole of the existing SD system, we recommend further investigation by the appropriate agency to discover where the pipes clogged and/or failed and determine the necessary repairs. In addition, the manhole frame and cover needs to be bolted onto the concrete structure. This structure is located on Maryland-National Capital Park and Planning Commission property. For plan view information, refer to Plan K.

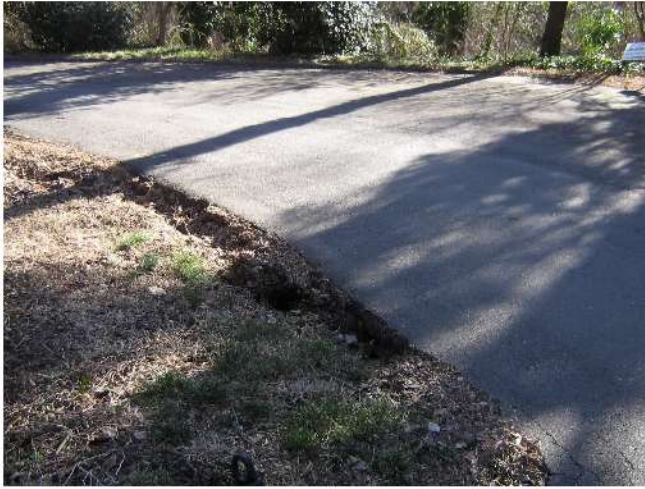
**Photo 13 – Soil Erosion Along Edge of Alexander Road**

Alexander Road is experiencing erosion problems along the edge of the existing roadway at various locations, from the end of the cul-de-sac for a distance approximately 450 ft. The greatest amount of erosion was found at the inside of the two tight turns on Alexander Road.

Item 2 will require easement from 6691 MacArthur Boulevard. All other items are located within existing Right-of-Way. For plan view, refer to Plan L.

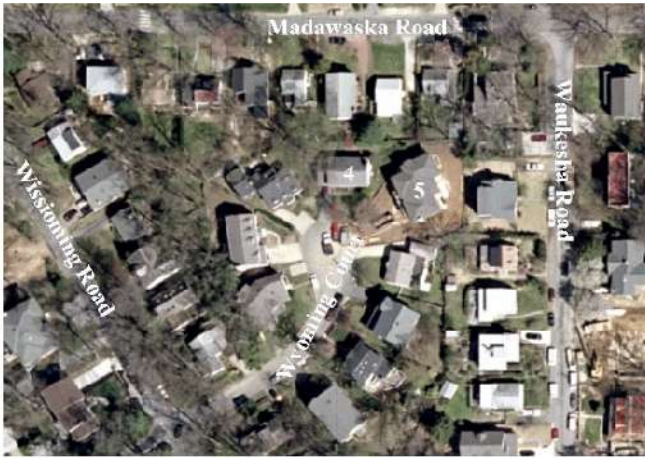
The properties at #4 & #5 Wyoming Court are experiencing flooding in their backyards due to storm runoff draining from the backyards of 5126 Waukesha Road and 6206 Madawaska Road. Both of these properties are located at the sumps of their respective roads and therefore have storm runoff draining off the roads and through their properties.

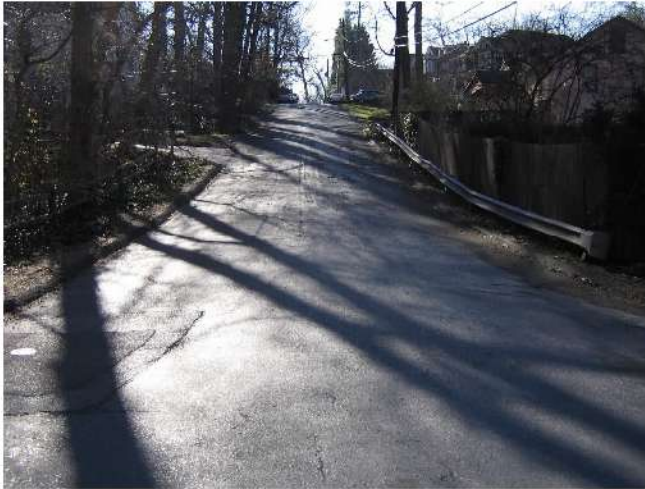
**Photo 15 – Wissioming Road**

The main drainage issue at the intersection of Tuscarawas and Wissioming Roads is the ponding of storm runoff at the southeast corner of the intersection. Another related drainage issue is the need to replace/repair the existing 33" CMP cross culvert at Wissioming Road located near the intersection. The bottom of the culvert near the upstream end of the pipe has rusted out, leaving a  $\pm 2"$  gap between the top of the culvert and the bottom of the end treatment, which has caused settlement along the edge of Wissioming Road.

Easement will be required for discharge from the new inlets, and may be required for replacement / refurbishment of the existing cross-culvert. Additionally, this work may impact existing water facilities on Wissioming Road. For plan view, refer to Plans O – P.

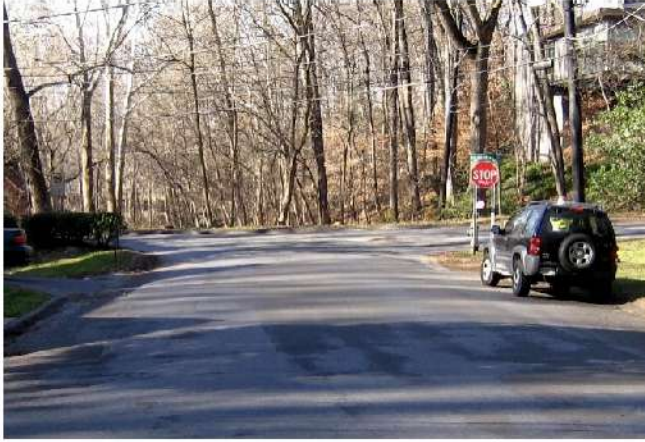
**Photo 16 – Intersection of Walhonding and Tuscarawas**

The main drainage issue at the intersection of Walhonding and Tuscarawas Roads is the ponding of storm runoff at the Northeast corner of the intersection. The storm runoff collects at the corner of the intersection before crossing Tuscarawas Road. The storm runoff then continues to flow downstream along the southern edge of Tuscarawas Road and crosses Walhonding Road; entering one of two COG inlets on the western side of the road.
