Electric car fire in an underground garage. Courtesy of Fire and Rescue Department of the Capital City of Prague. Computer translated from Czech language Nov 2023

## Electric car fire in an underground garage

Incident Date: 4. 5. 2023 @ 23:56

Location: Praha 2, Bělehradská 299/132. Czech Republic

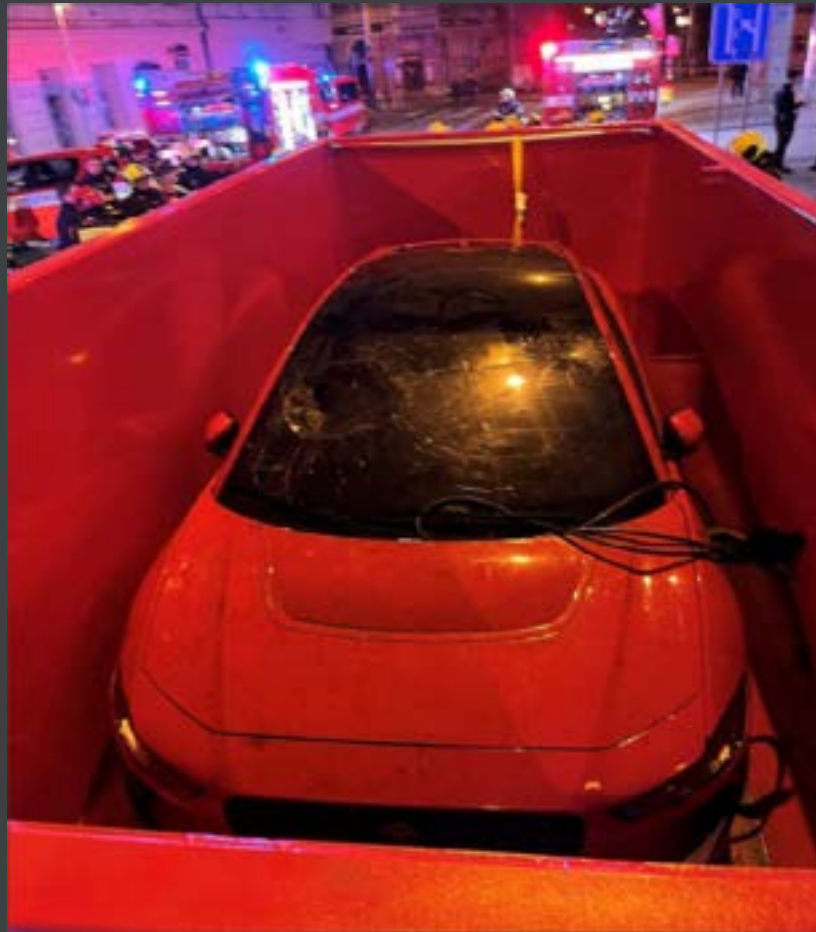
Position of the EV in the container (KHE) before transport – secured the vehicle against movement.

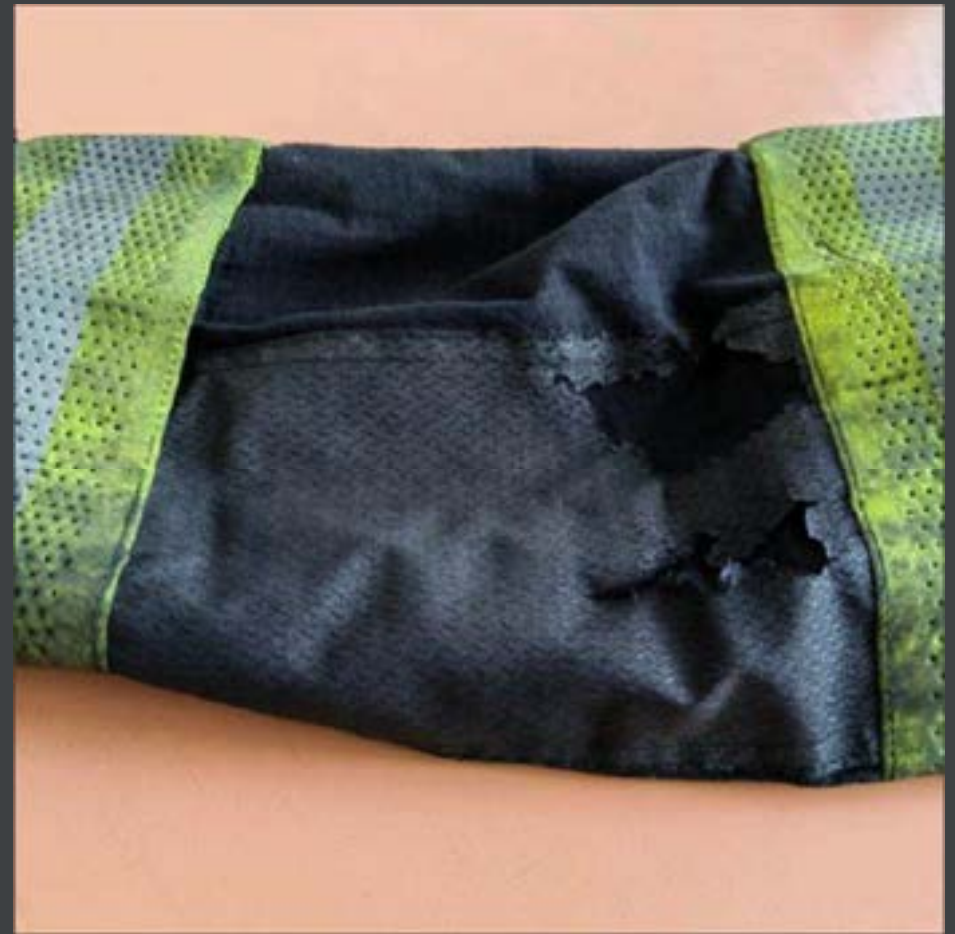
- the COBRA fire extinguisher does not provide sufficient protection for the operator – it is necessary to have a water jet to cover firefighters from the start of COBRA deployment in the immediate proximity.
- Damaged protective suit of member who used COBRA.

- ensuring sufficient protection of firefighters working with Cobra (cooling),
- equipping the units with hoods against the penetration of aerosols of harmful substances,
- the possibility of decontamination by undressing the member at the scene of the intervention a prevention of secondary contamination,
- decontamination of emergency footwear,
- detailed washing and decontamination of the emergency helmet,
- the wheels of handling carts must be made of durable materials acids and bases,

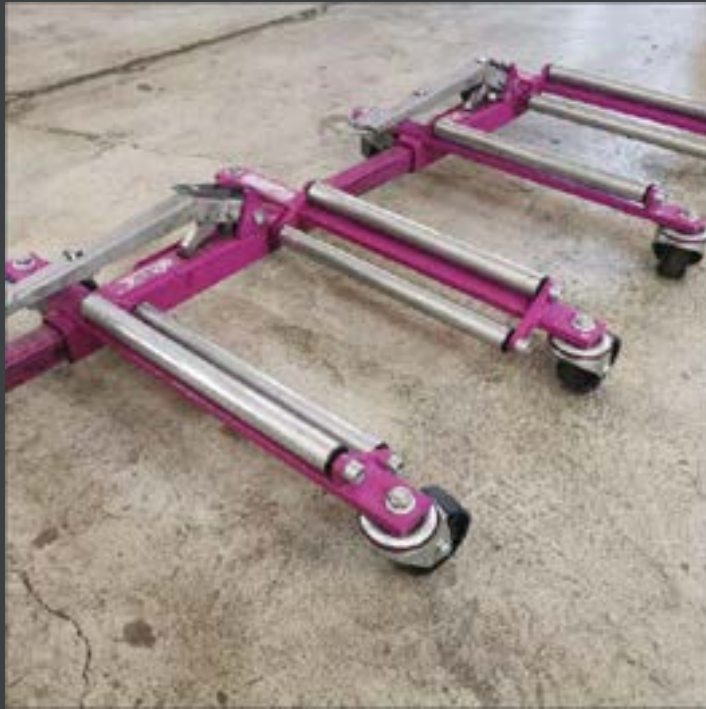
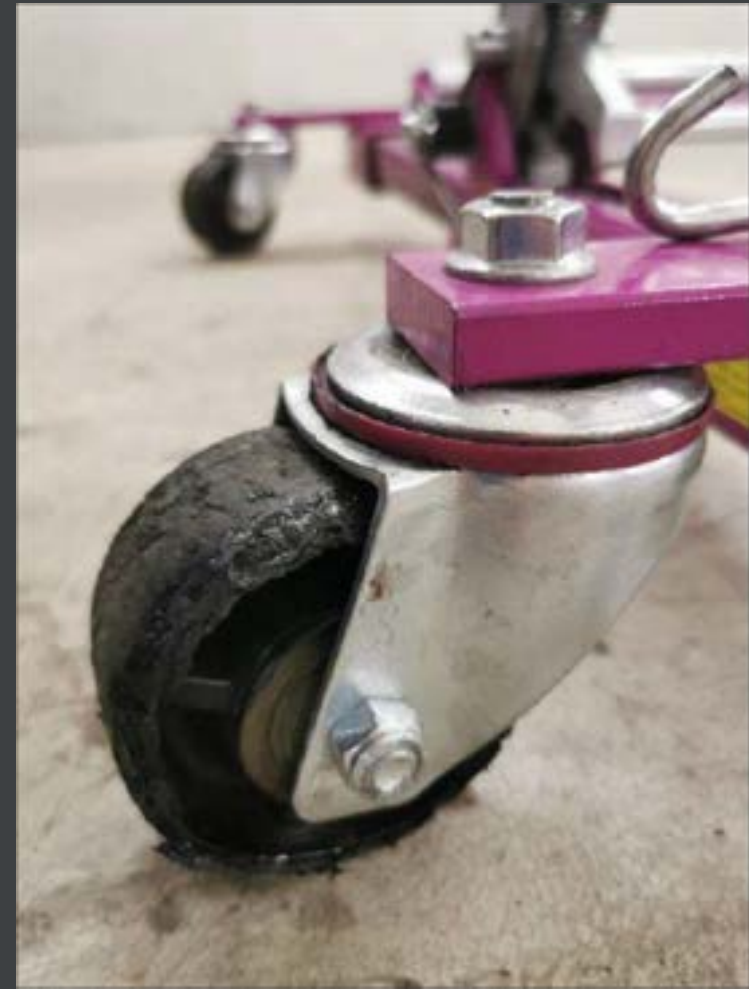
- insufficient load capacity of the carts, one cart has a load capacity of 510 kg and is useful vehicle weight 2266 kg,
- etching of the wheels on the auxiliary chassis,

- the Cobra high-pressure cutting device can be placed on the chassis of a pick-up truck with the option driving into underground garages,
  - increase the number of KHE in the territory of Hl. city of Prague, minimum condition 3 pcs.,
  - equip the KHE construction with anchor points in the rear part to ensure transport EV,
  - different design of handling carts under EV wheels, focus on load capacity, width and manoeuvrability, the ideal option is not to exceed the floor plan of the vehicle and possibility of filming all wheels + locking,
  - equipped with approach ramps for overcoming height differences,
  - equipped with crossing plates for overcoming unevenness and holes,
- the wheels of handling carts must be made of durable materials acids and bases,

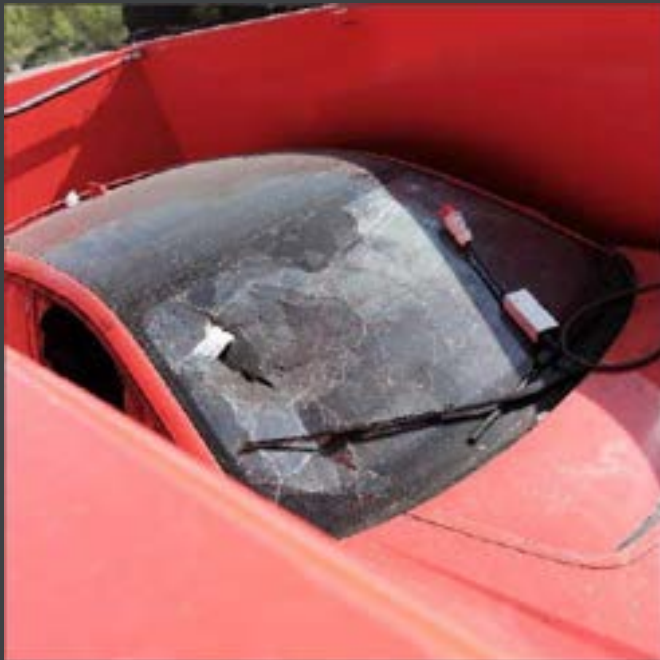
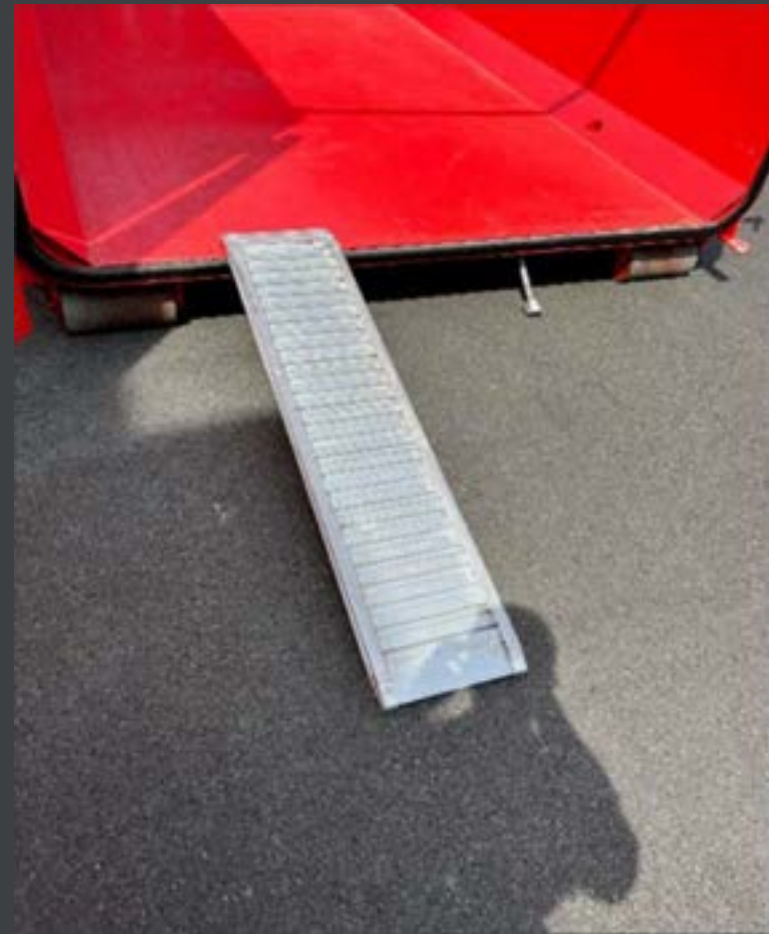
- inappropriate access ramps to the electrical container (KHE), ribbing and insufficient attachment of ramps,
- absence of anchoring eyes for anchoring the transported OA inside on the back side container,
