Montgomery County Fire and Rescue Service

POST INCIDENT ANALYSIS

Three Alarm Garden Apartment Fire 9300 Piney Branch Road Silver Spring, Maryland

Incident Date: August 27th 2013

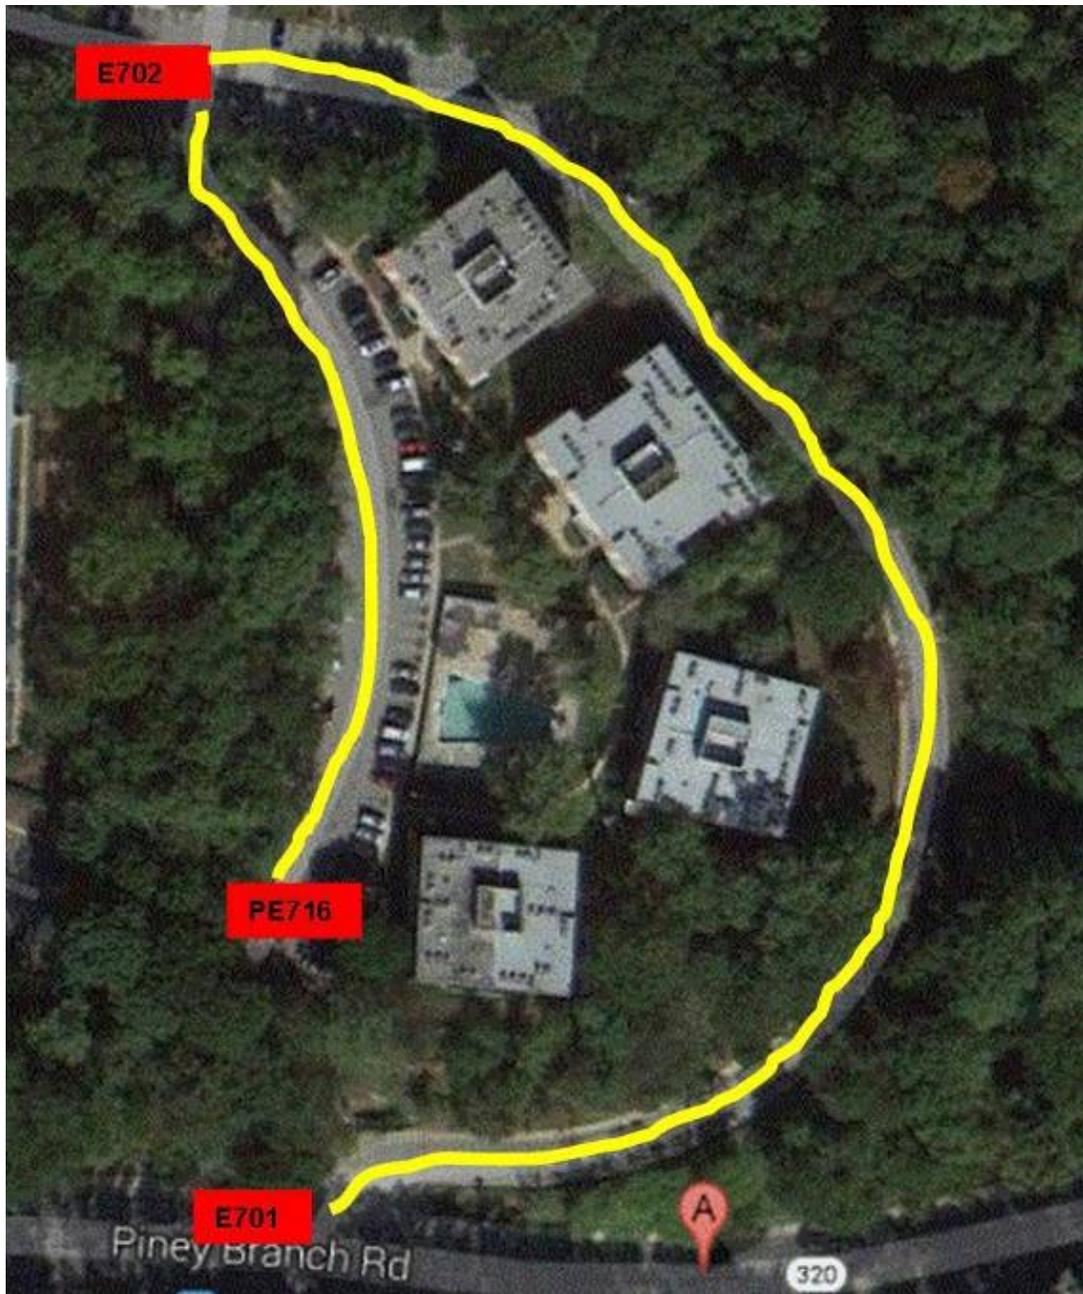
Initial water supply

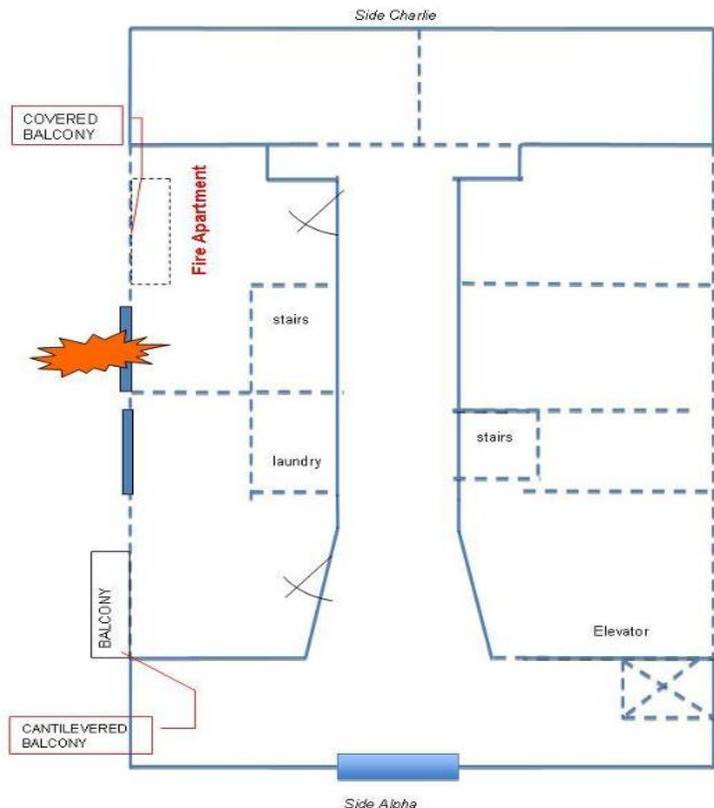
A vertical void for plumbing, extending the entire height of the structure, was likely the most rapid path of vertical fire travel inside the structure.

Approximation not to scale

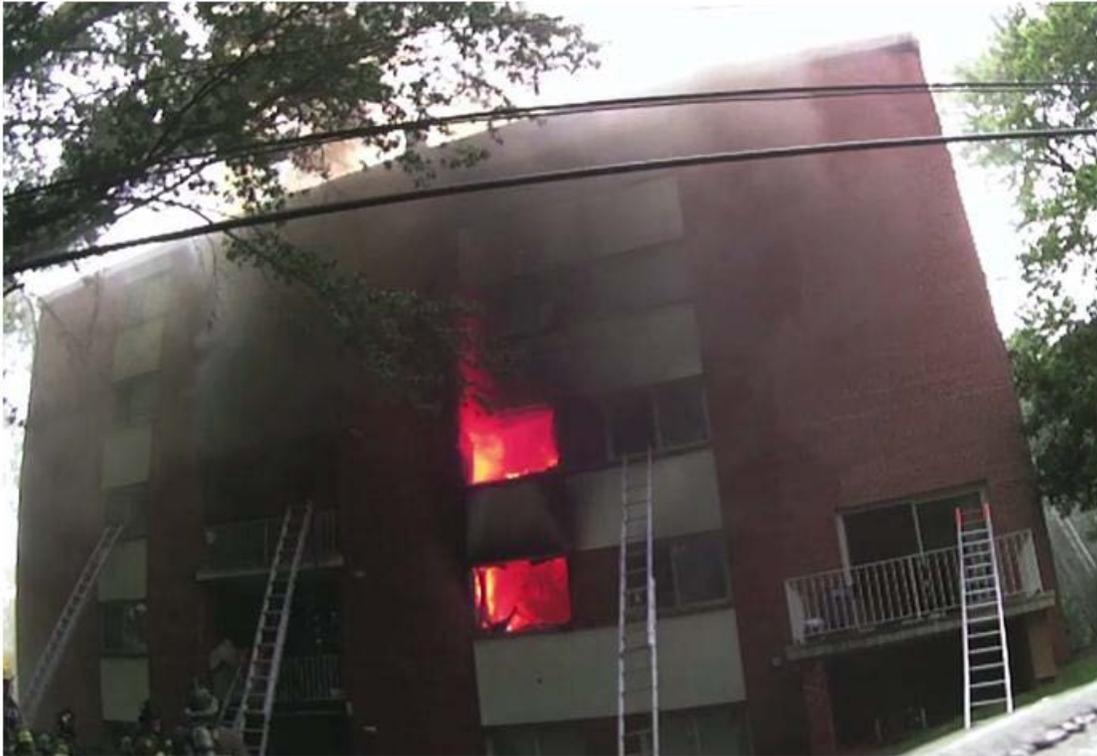
View from Side Bravo shortly before exterior knock

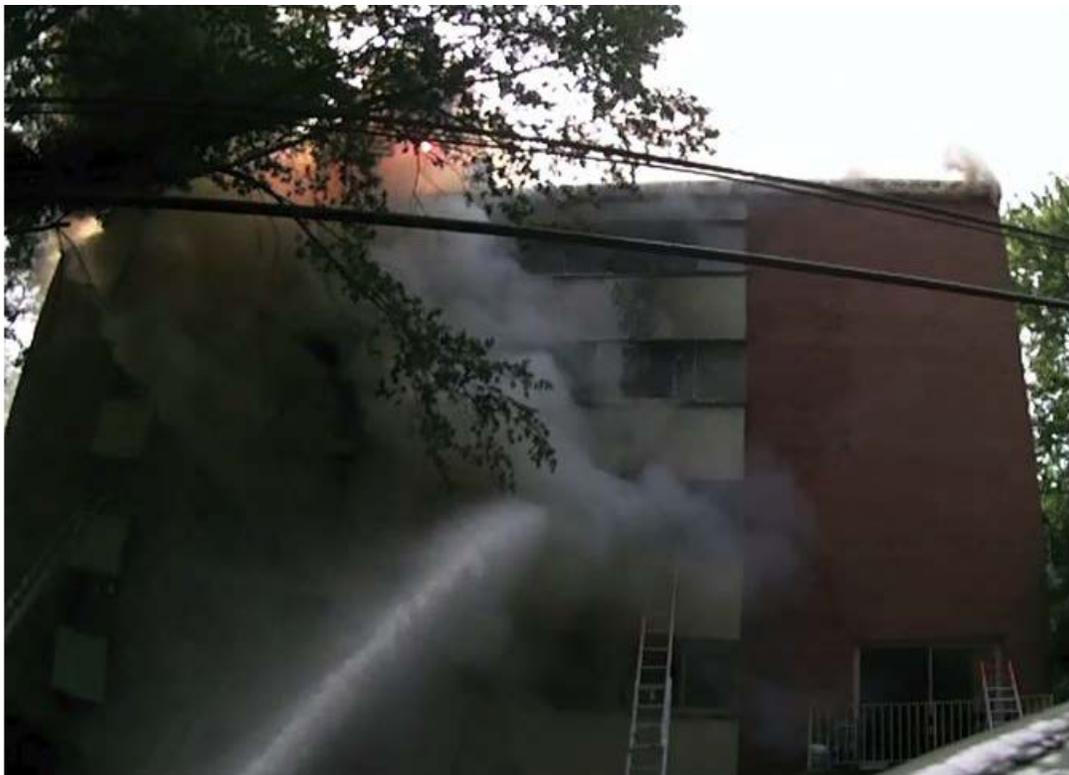
The BlitzFire and handline quickly knocked down the fire in apartments on all three floors. This tactic was successful in rendering the building safe for a continued interior operation and it certainly changed the dynamic and direction of the event.

View from Side Bravo during exterior knock

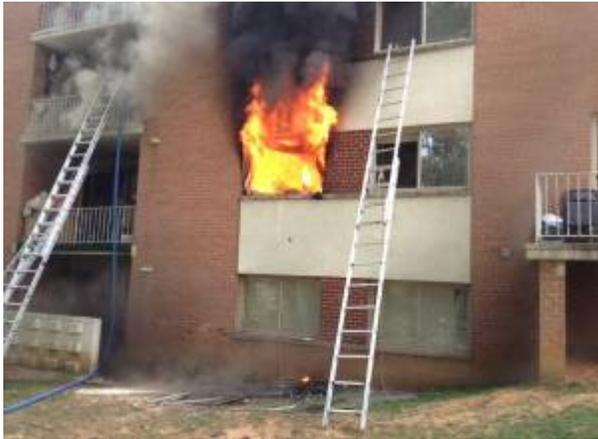
Views from Side Bravo before fire extended to the floor above.

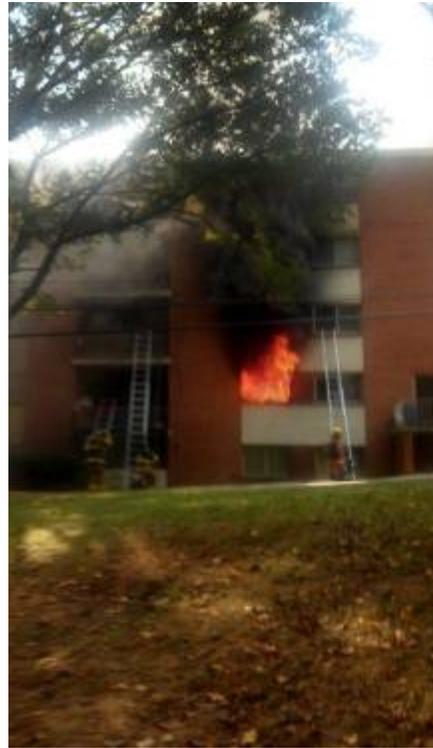
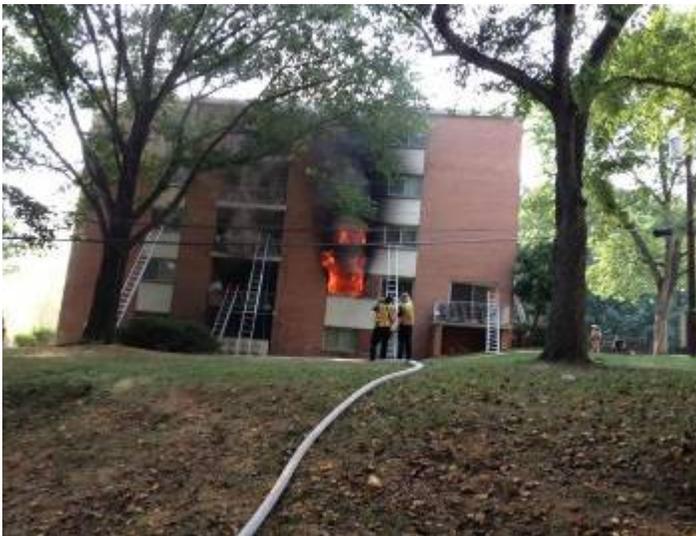
On the second floor, windows were vented without a hand line in place. The crew responsible for doing so was never identified. Paramedic Engine 701 advised that the floor in the apartment directly above the fire was spongy and that fire was extending into the second floor via an exterior window.

Fire extending to second floor

Venting windows without a hose line in place is inviting fire to overtake your position. Without a hose line, fire can rapidly extend to the other areas in the fire building such as the apartment above. Coordinated and controlled ventilation is key.

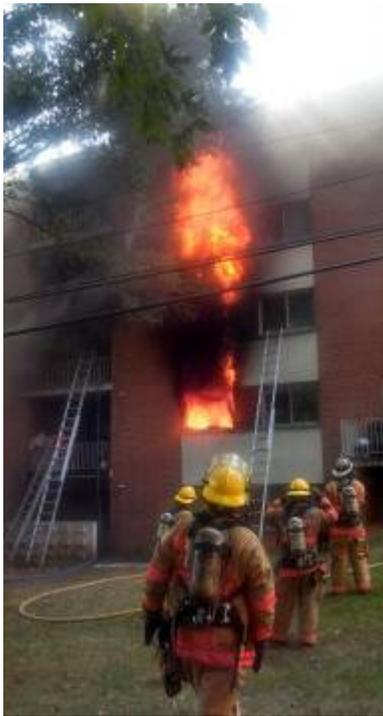
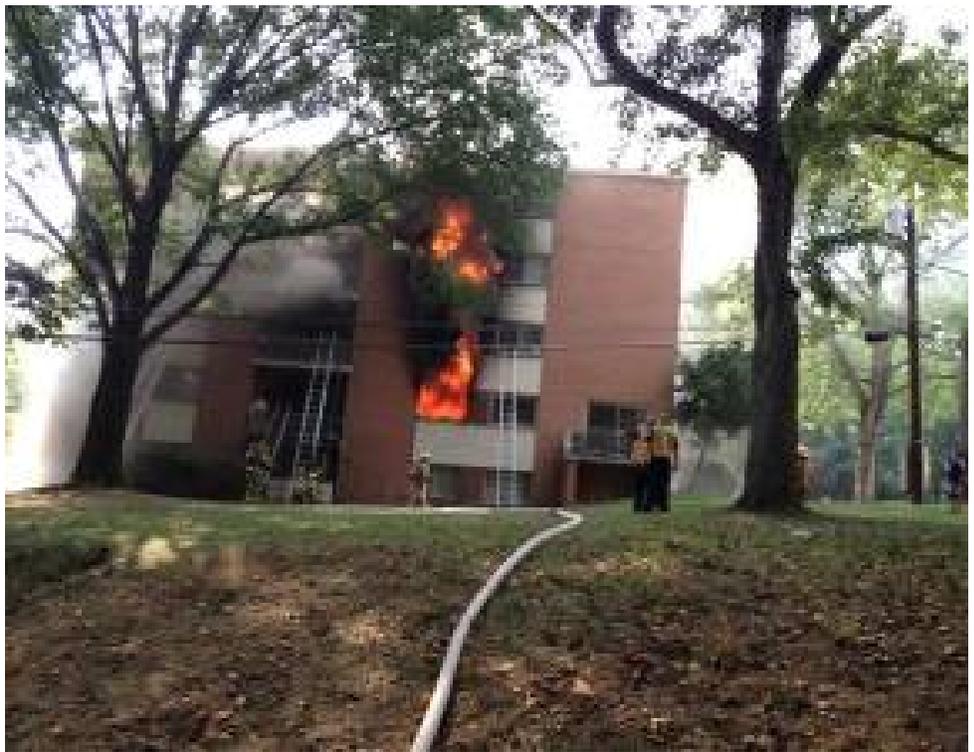
Fire extending to the third floor just before the BlitzFire was used

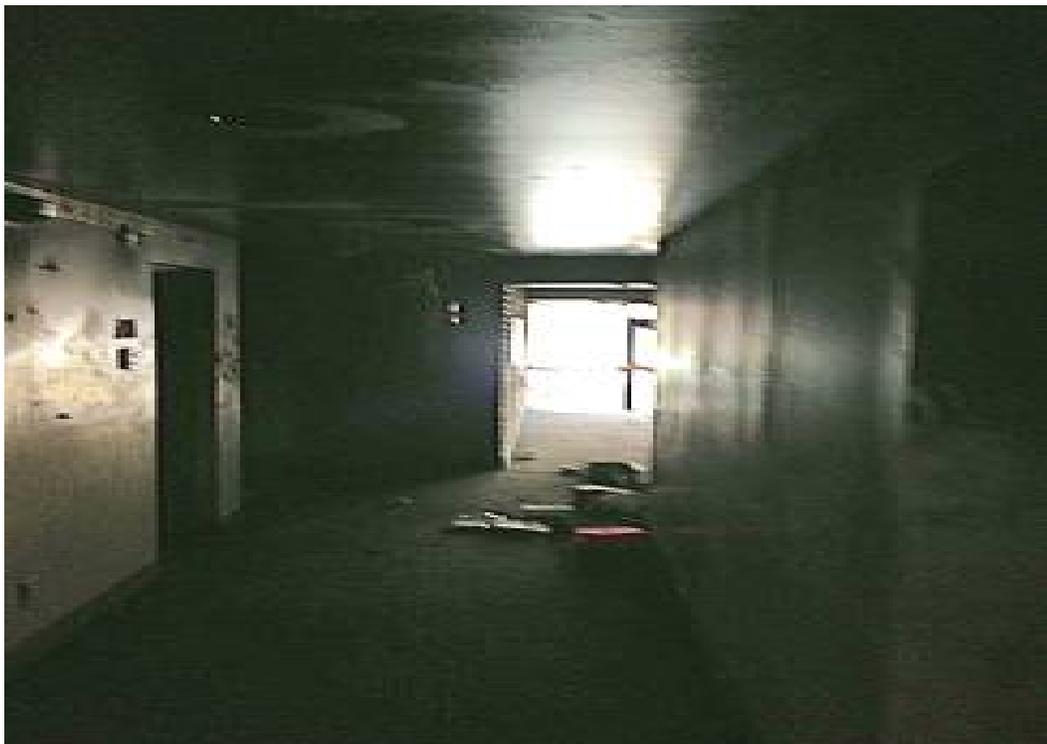
From the exterior, it appears that the fire apartment would be accessed via the first interior door on the left past the lobby; however, it was actually the fourth door on the left. The building contains several void spaces.

View from the fire apartment main entry door to the exterior entrance

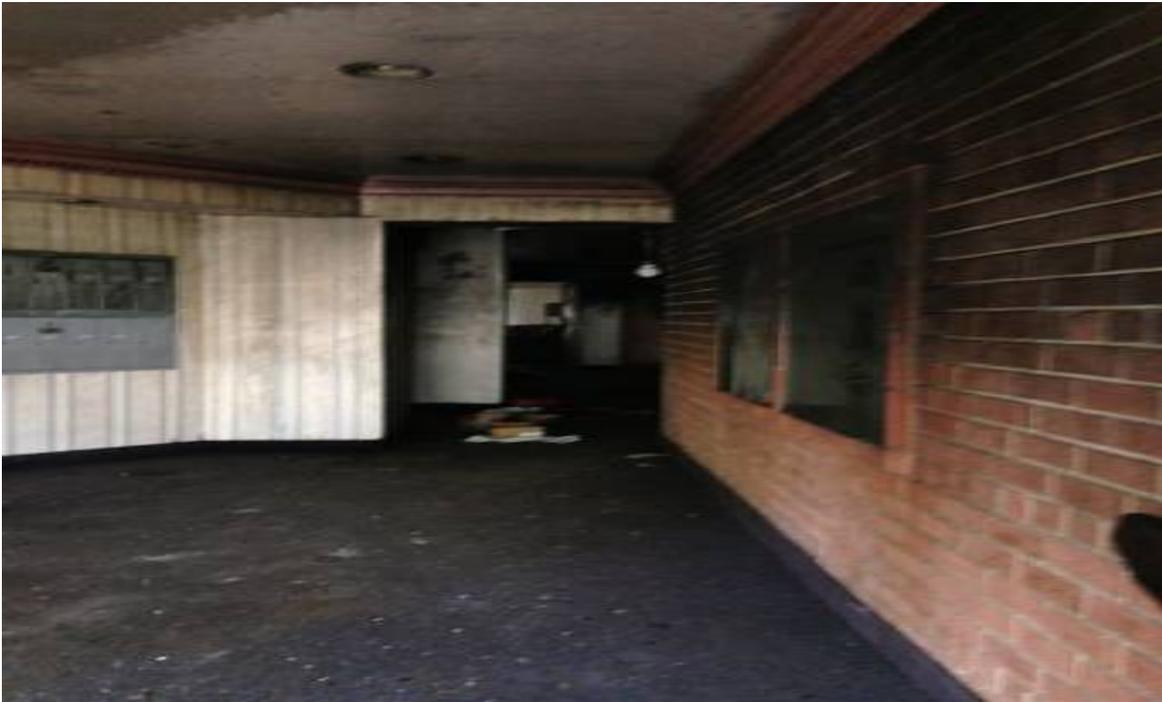
View from Side Alpha entrance to the fire apartment, approximately 45 feet.
