MONTGOMERY COUNTY FIRE AND RESCUE SERVICE POST INCIDENT ANALYSIS

Townhouse Fire
19027 Colfield Court
December 13, 2014
Box Area 8-3
Captain Patrick Stanton

19027 Coltfeld Court

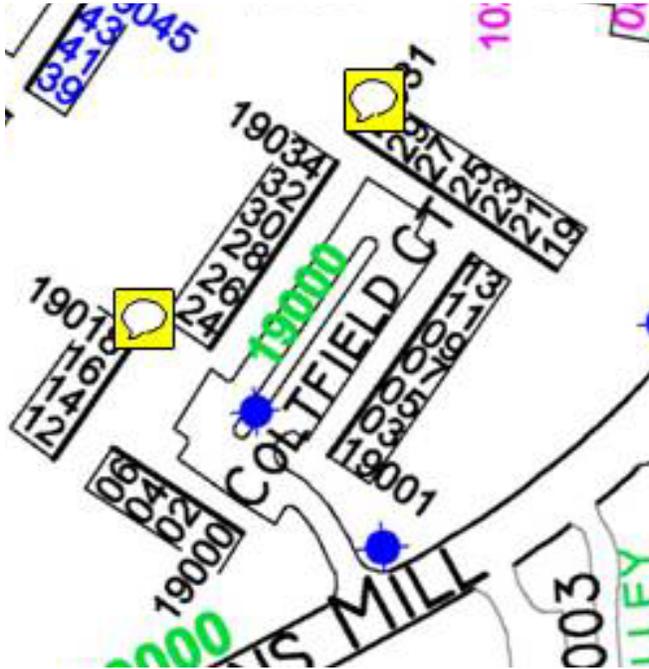
The “Box Map” of the development and court was adequate for access and identification of the addresses for the designation of locations. The attached diagrams of the development will show:

1. Box Map 08-018 showing the development showing the water supply point for the first engine, the locations of the Command Post, and 1st engine and truck placement.
2. Zoom of the Box Map to show the units involved and the labeling of structures as understood by the Incident Commander.
3. Google earth screenshot of the neighborhood showing limited access to

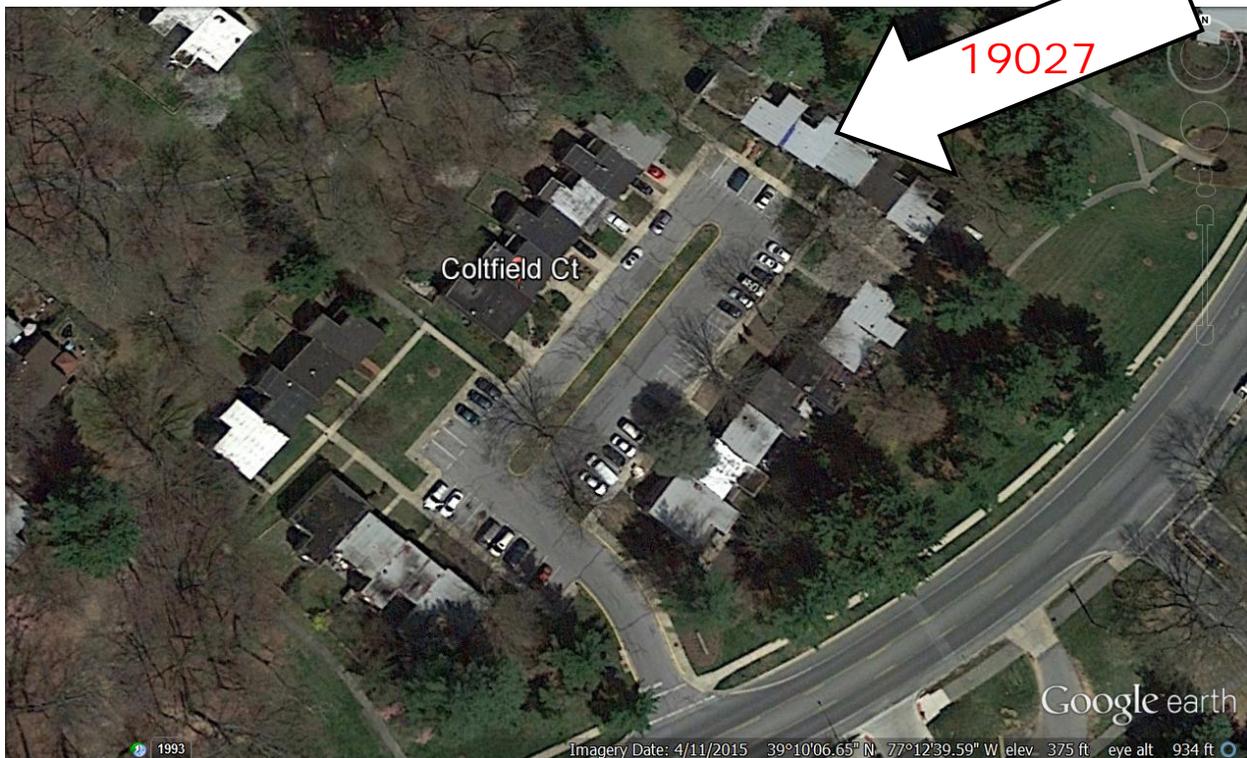
Side Charlie of the dispatched address as well as the access to the development from Watkins Mill Road.

Had the incident escalated and elevated water streams been needed, then positioning another aerial in the court would have been difficult, as well as supplying multiple master streams would have involved hand jacking several hundred feet of hose from Watkins Mill Road hydrants.
