Montgomery County Fire and Rescue Service

Post Incident Analysis

Fatal Plane Crash
19733 Drop Forge Lane
Gaithersburg, MD

Incident Date: December 8th, 2014
Incident # 14-0140425
Submitted by Chief Scott Goldstein

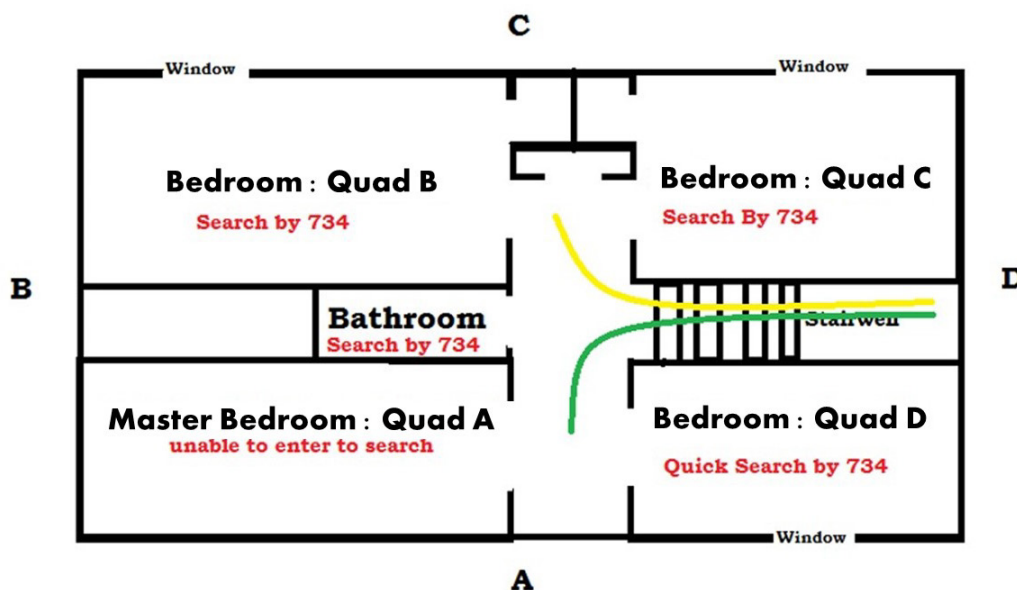
Floorplan of 19733, 2nd Floor – As perceived by crews
Yellow Line: PE734 and Green Line: PE728

At roughly 20 minutes into on-scene operations, Battalion Chief 705 reported a partial collapse on the second floor, which lead Command to direct all units to evacuate 19733.

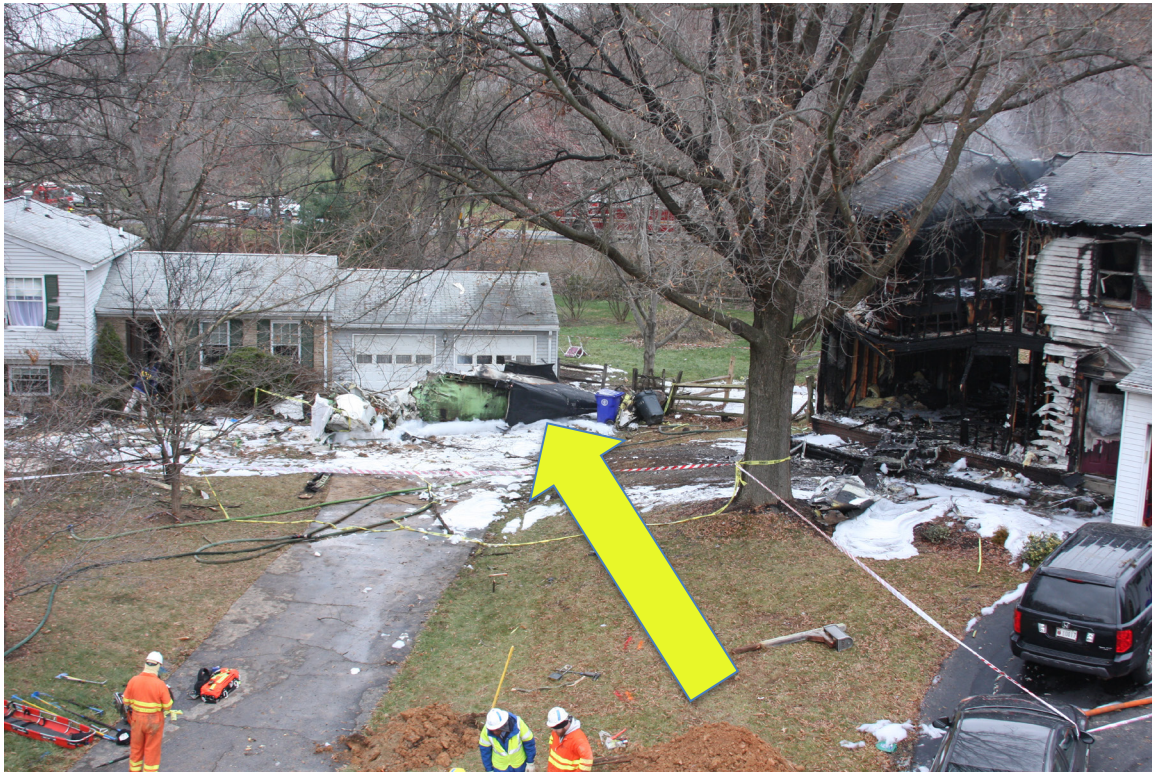
View of fuselage in driveway of 19737

The plane fuselage was sitting in the driveway of Exposure Bravo and presented a moderate fire exposure to the structure. Paramedic Engine 717 was assigned to the fire in the fuselage and to 19737 Drop Forge Lane. As the crew advanced lines to the fuselage and the house, assessments determined that the fuselage fire had not extended to the house.

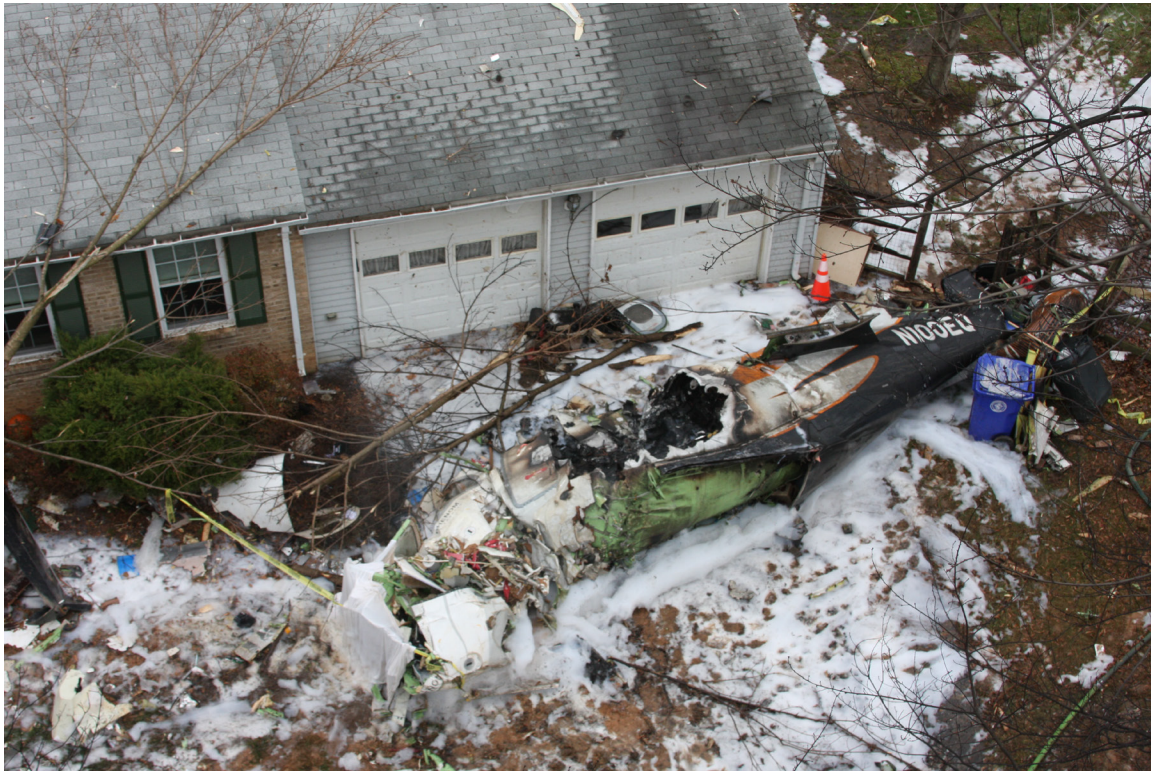
View of plane fuselage and proximity to structure

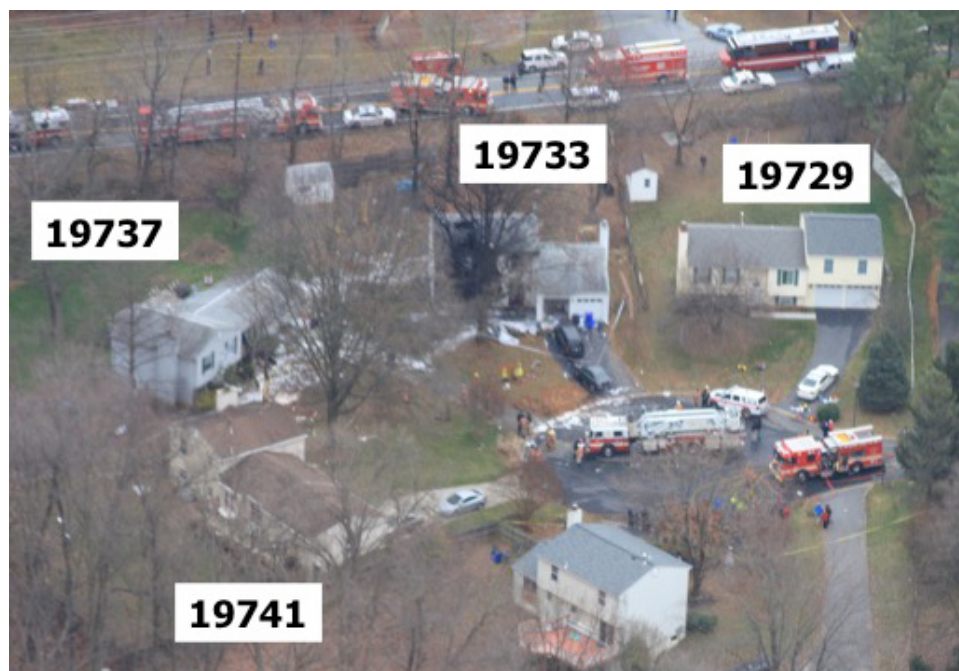
Layout of Drop Forge Lane cul-de-sac

Each of the residences along Drop Forge Lane consisted of lightweight wood frame construction two (2) story houses with basements. The houses average 1,800 square feet and were constructed in the early 1980s.

No fire code or building code issues were noted. As identified earlier, the significant structural damage on Side Alpha of the 19733 lead to a structural compromise that limited fire rescue operations in Quadrant Alpha of the first and second floor.

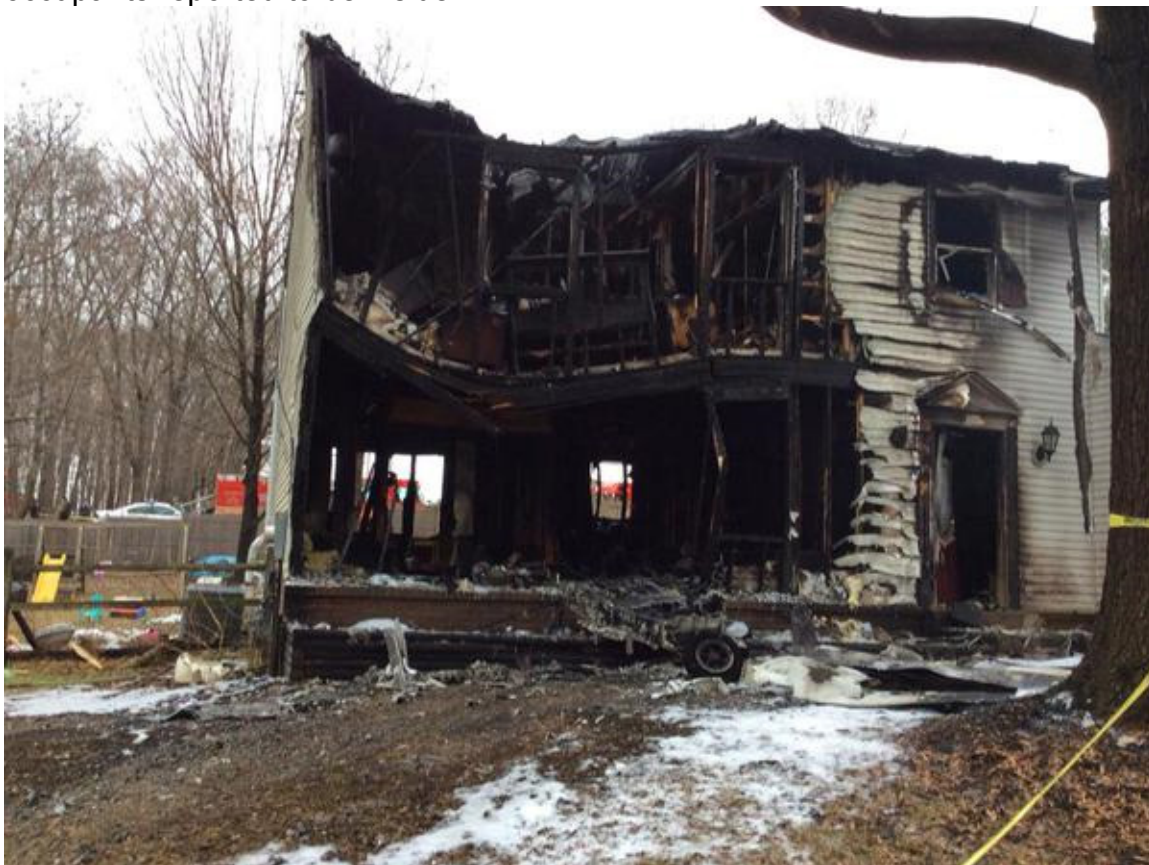
As noted earlier, 19733 sustained structural compromise when elements of the aircraft pierced Side Alpha. This initiated a very intense fire that trapped the occupants on the second floor and attacked the structural integrity in Quadrant Alpha. All units operating in 19733 and those observing the fire condition outside continuously re-assessed the risk/benefit of interior operations. This risk/benefit calculated a large factor of fire fighter risk as crews were searching for three (3) occupants reported to be inside.
