# **SIGNIFICANT INCIDENT INVESTIGATION FINAL REPORT**

**TRUCK 411  
BEACON HILL ROAD  
AUGUST 12, 2014 – 0426 HOURS**

FAIRFAX COUNTY FIRE AND RESCUE DEPARTMENT  
*SIGNIFICANT INCIDENT INVESTIGATION REPORT*

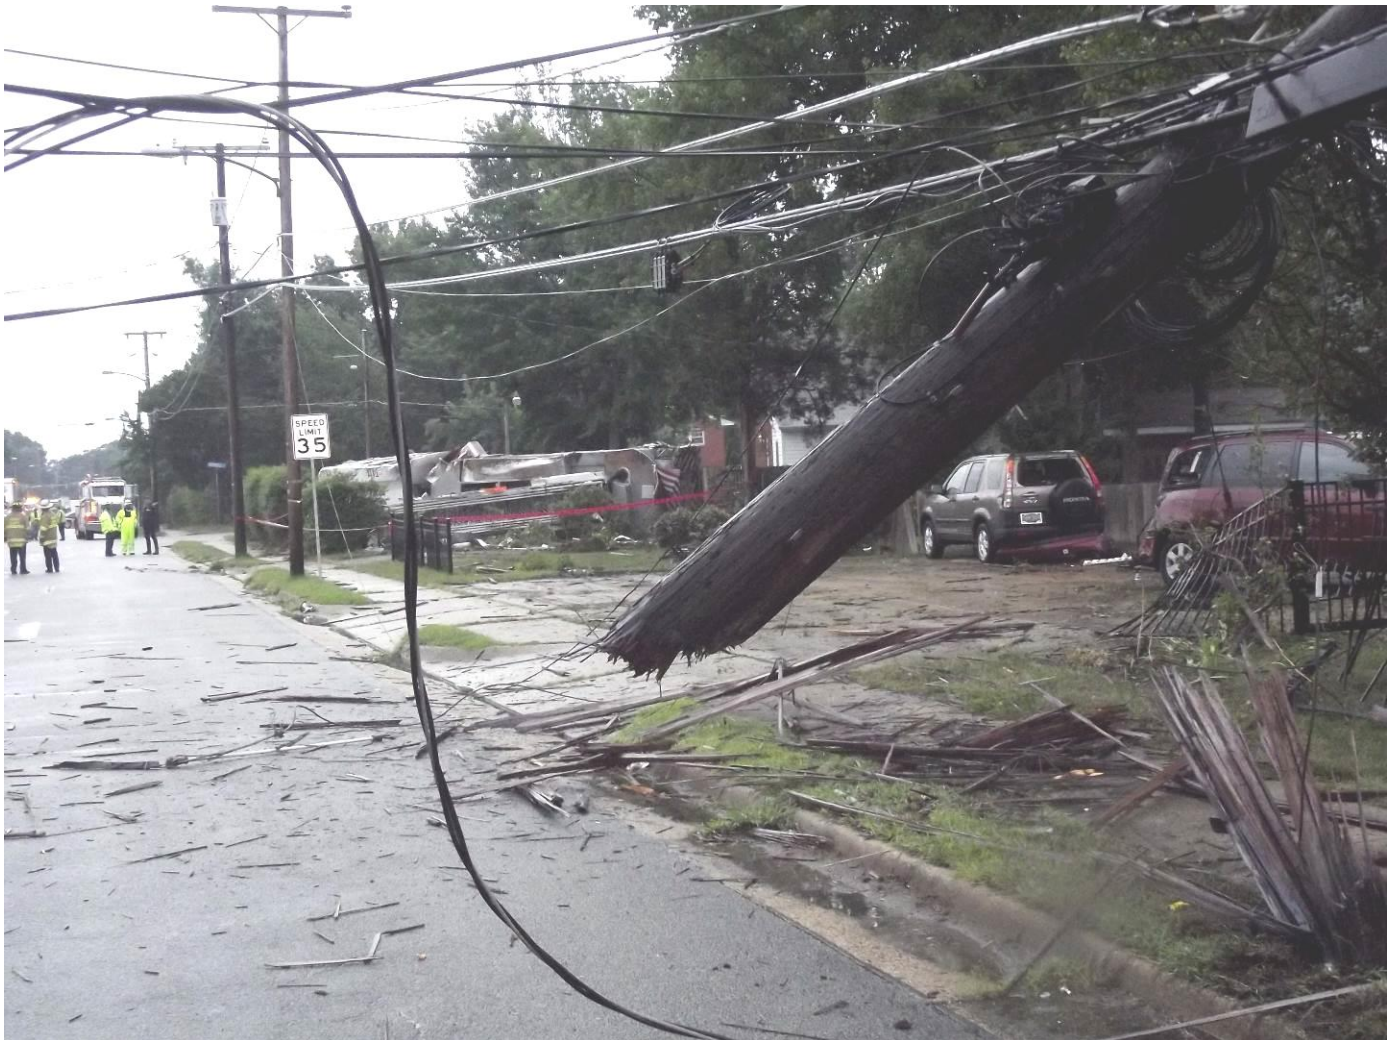
Eastbound Beacon Hill Road at [REDACTED] Smithway Drive

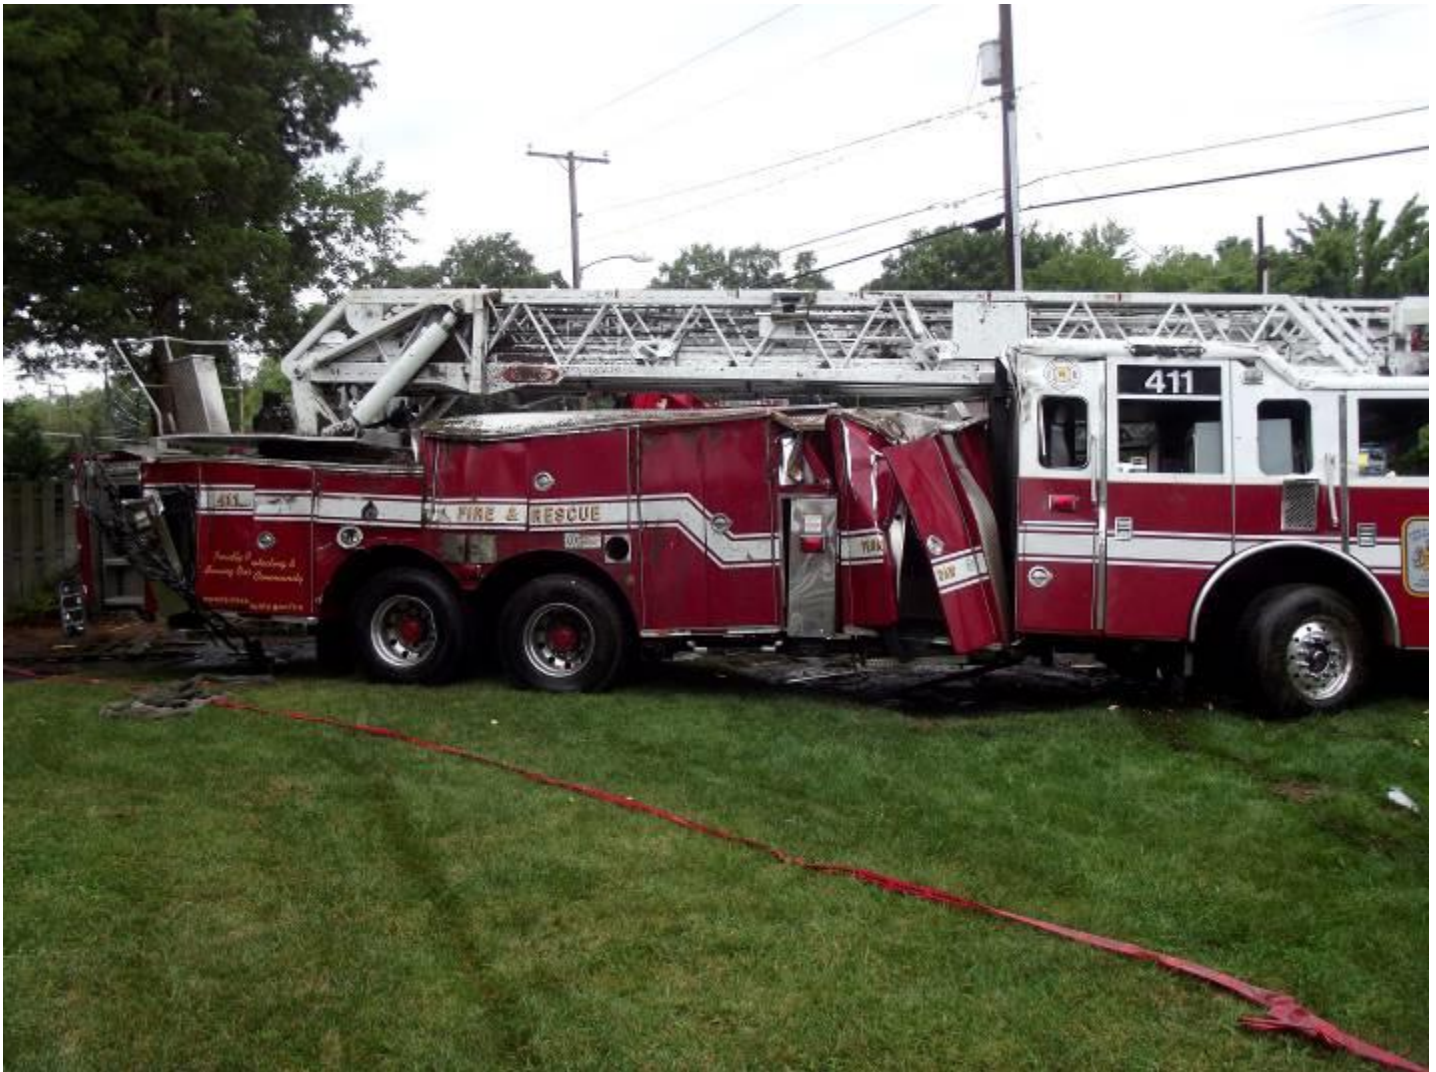
Truck 411 after being up-righted in the side yard of 6800 Derrell Court

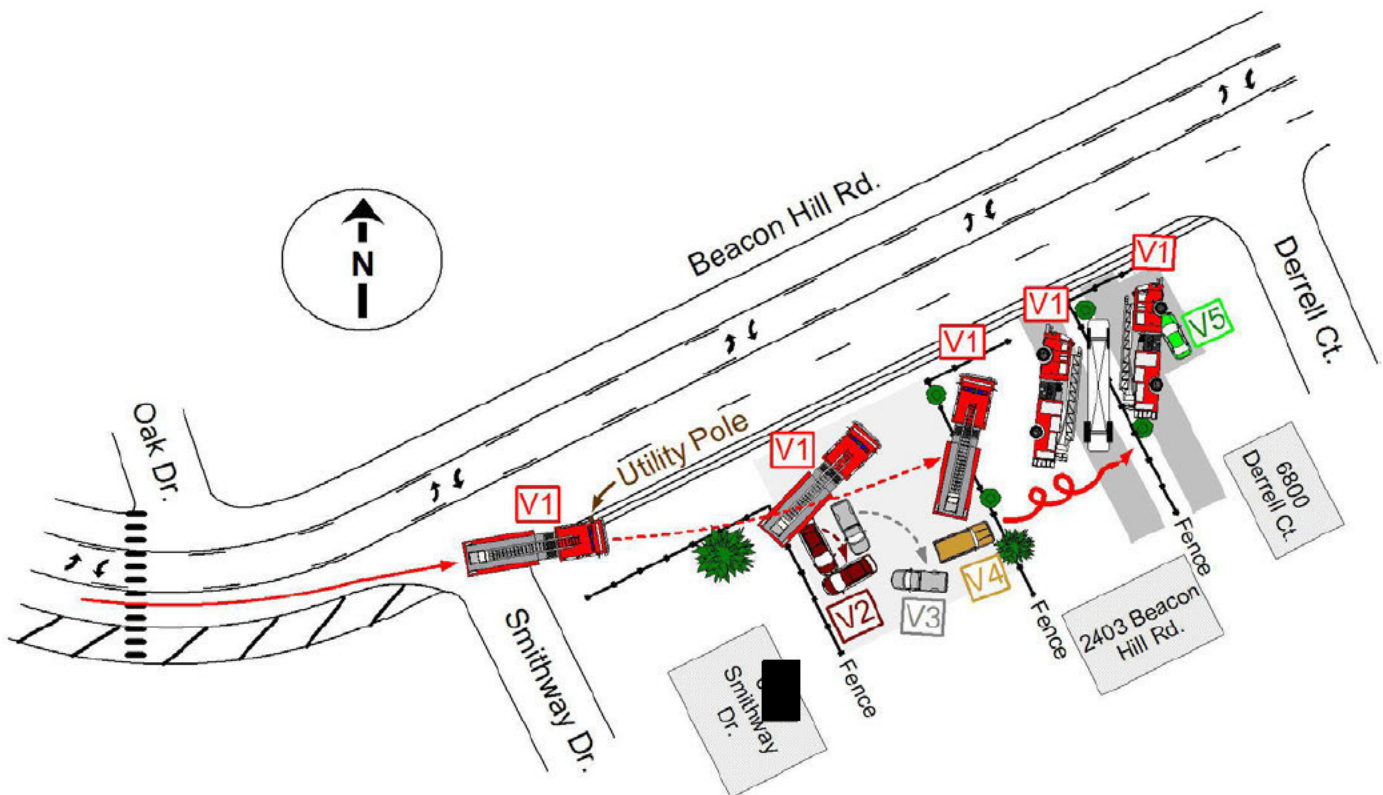
**Scene Graphics**

**Measurements: (Approximates in Feet)**

- 35' – Utility Pole – First Car Struck
- 121' – Utility Pole – Start of Roll
- 150' – Utility Pole – Truck on its top
- 166' – Utility Pole – Vehicle at rest on driver's side

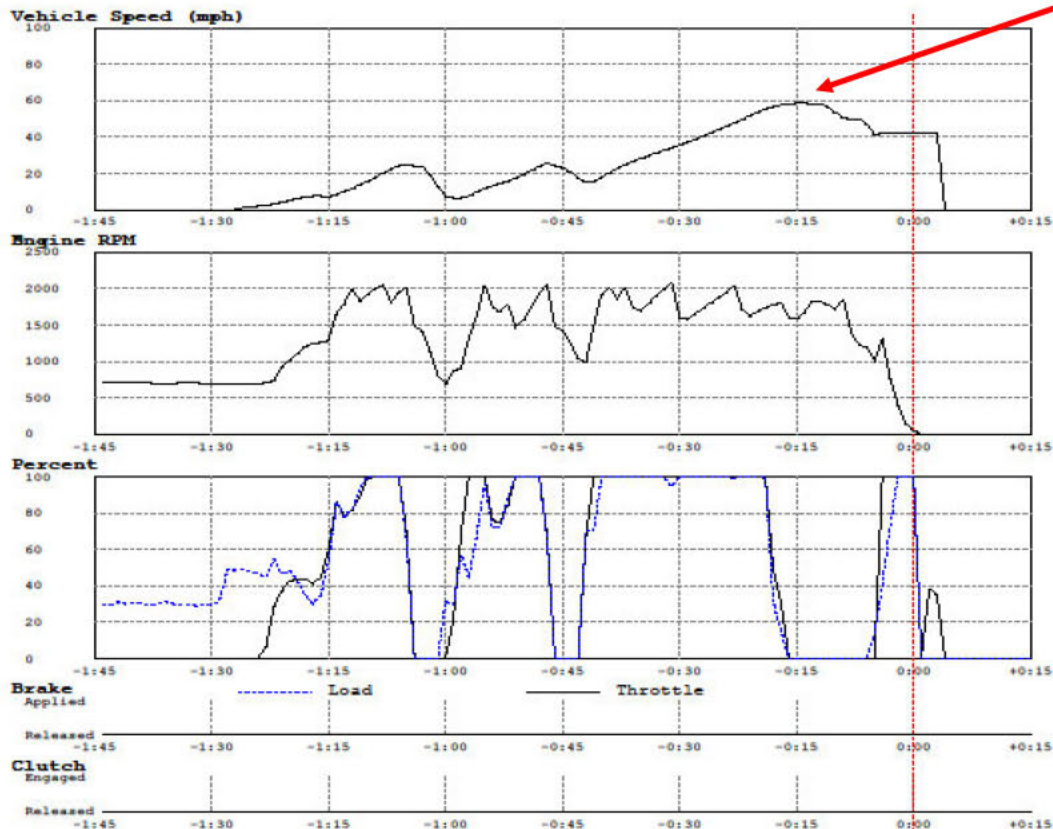
#### DDEC® Reports - Last Stop Record

During the course of the investigation it was determined that Truck 411 reached a speed of 58mph on Beacon Hill Road. This has been validated by the CRU final report and from Pierce Manufacturing through the Detroit Diesel Electronic Controls (DDEC) Report. (See Appendix E).

Vehicle speed documented at 58mph

Red Line indicates vehicle at rest after impact

Unit officers shall ensure that drivers maintain the vehicle speed as directed in Standard Operating Procedures (*S.O.P.*) *01.08.03 Apparatus Response Categories*. All personnel shall re-familiarize themselves with this policy. Drivers shall take into consideration road conditions due to inclement weather, traffic, pavement type, and geometric design in lowering the vehicle's authorized speed.
