Montgomery County Fire and Rescue Service

POST INCIDENT ANALYSIS

**2nd Alarm Commercial Building Fire
1091 Taft Street
Rockville, Maryland**

Incident Date: April 14, 2014

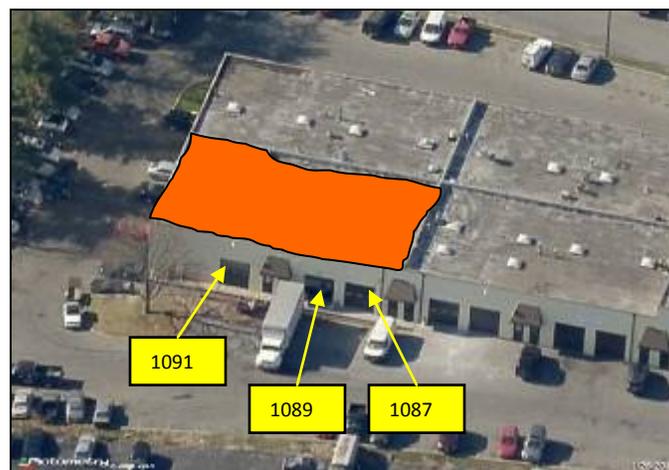
Figure 3: Since the occupancies had addresses on this side of the structure, the side was designated as Side Alpha by Command (Battalion Chief 703). The “orange” area in the photograph represents the area totally destroyed by fire. Roof collapse also occurred in this area.

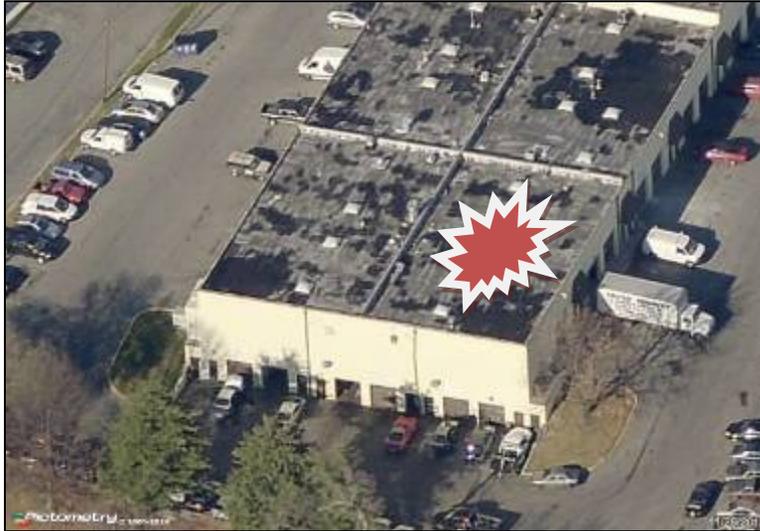
Figure 4: The lower level automobile repair shops are shown in this view of Side Bravo. Note the sky lights on the roof – once the fire broke through the roof, the sky lights on the Side Charlie roof area melted and allowed fire to extend into those occupancies.

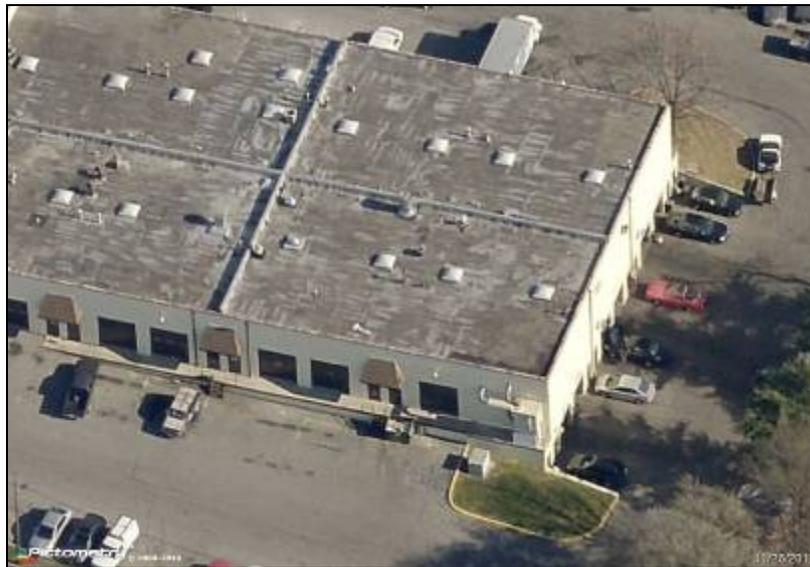
Figure 5: The Side Charlie occupancies had a similar layout to the Side Alpha occupancies and also housed a wood working shop that stored a significant amount of wood working materials. Some fire spread occurred on the Side Charlie roof when flames jumped the firewall from Side Alpha and burned the roof deck surface. When flames melted the skylights, several small “drop down” fires occurred inside the Side Charlie workshops.

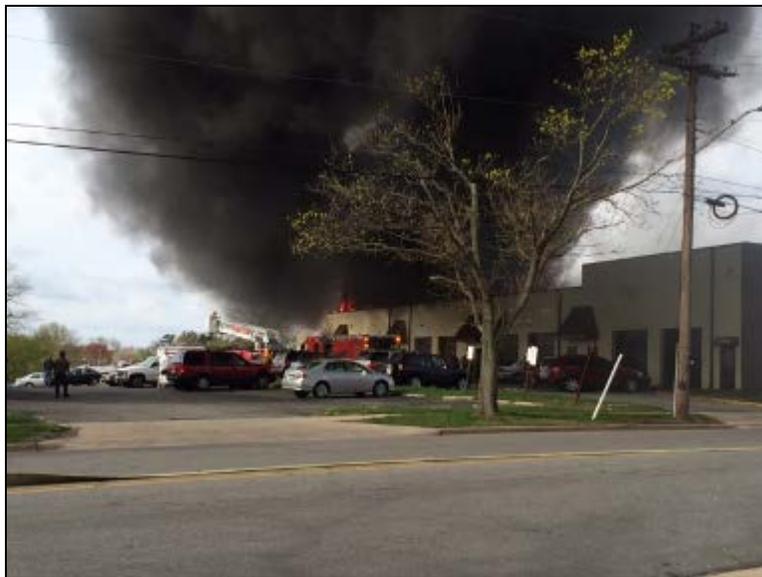
- Initial water supply operations could not support the use of Tower 703's master stream and Engine 703's Blitzfire line. Once Engine 703 was supported by three, 4-inch supply lines, the water supply was sufficient for Side Alpha operations. Note: E703 driver hand jacked 2nd 4" line back to Paramedic Engine 723 and then Paramedic Engine 725 reverse laid from Engine 703 to provide the 3rd line.

Figure 8: Taken by Chief 705 (Heflin), this photo shows the volume of fire present on arrival and the absence of a charged supply line to Engine 703 (the only engine shown here).

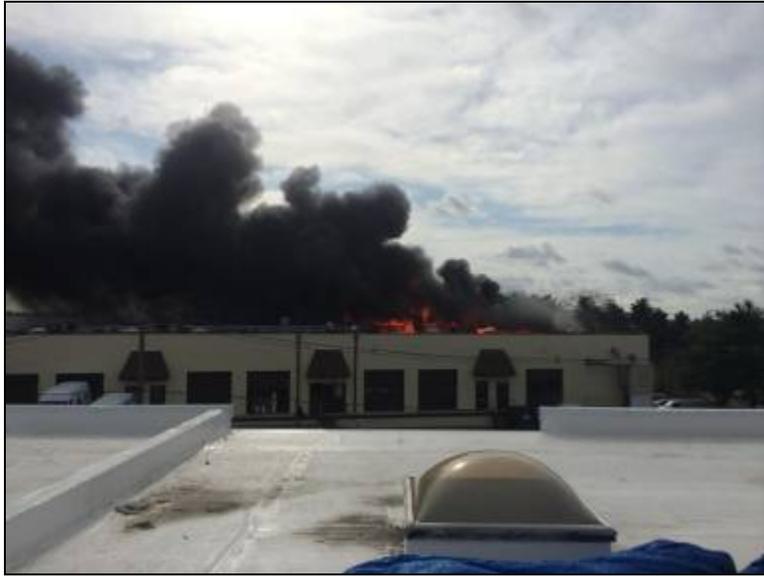
Figure 9: Taken by a worker from a nearby building, this photo shows Side Charlie of the fire building prior to the arrival of 1st Alarm units. Note the fire spread already occurring on the roof deck.

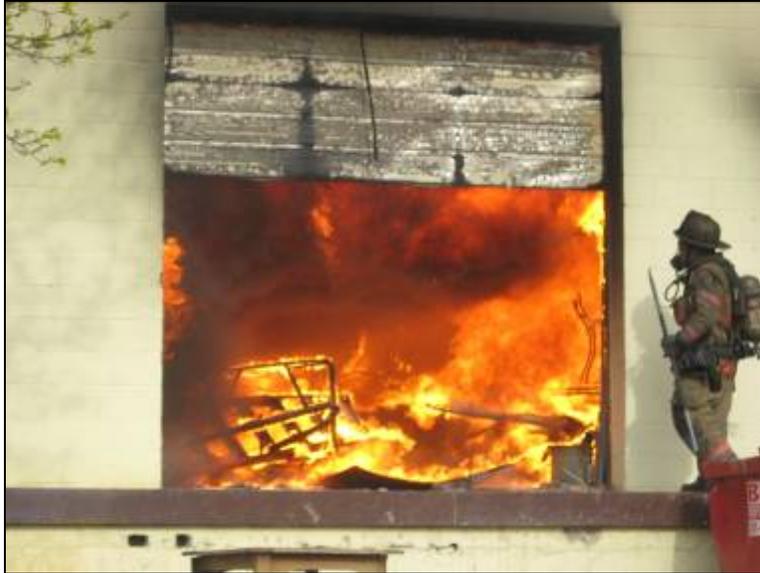
Figure 11: Heavy fire involvement in 1091 Taft Street. (Photo by MCFRS)

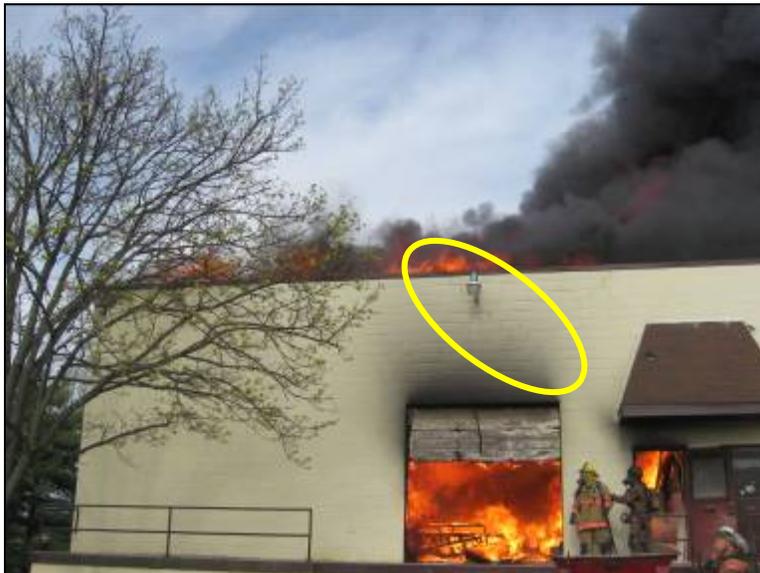
Figure 12: The roof has not yet collapsed, but the roof decking is on fire and the exposed steel bar joists underneath of it are being attacked by flames. Note the crack in the masonry wall now forming – from the light fixture to the bay door frame header. Crews reported “hearing creaking noises.” (Photo by MCFRS)

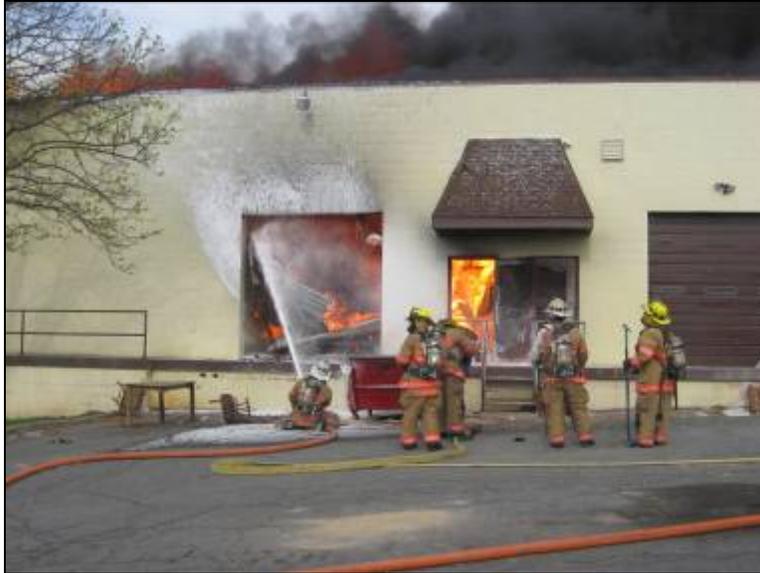
Figure 13: While Aerial Tower 703 prepares for elevated master stream operations, crews deploy a 2-1/2-inch attack line flowing Class A foam solution. Note that the crack in the wall is getting larger. (Photo by MCFRS).

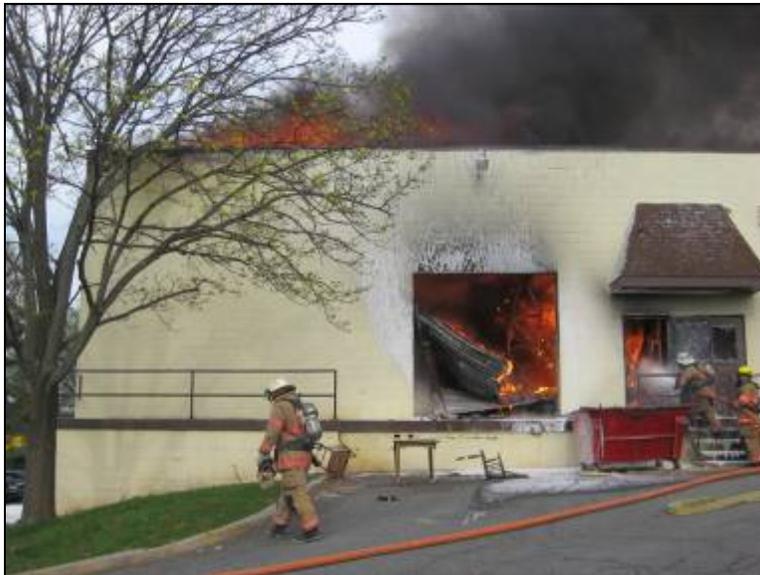
Figure 14: The roof has collapsed – as evidenced by the steel bar joist seen in the bay door opening. Battalion Chief 704 is seen in the foreground assuming the Side A Division Supervisor role. The 2-1/2" attack line is moved to try and cut off the fire spread. (Photo by MCFRS)

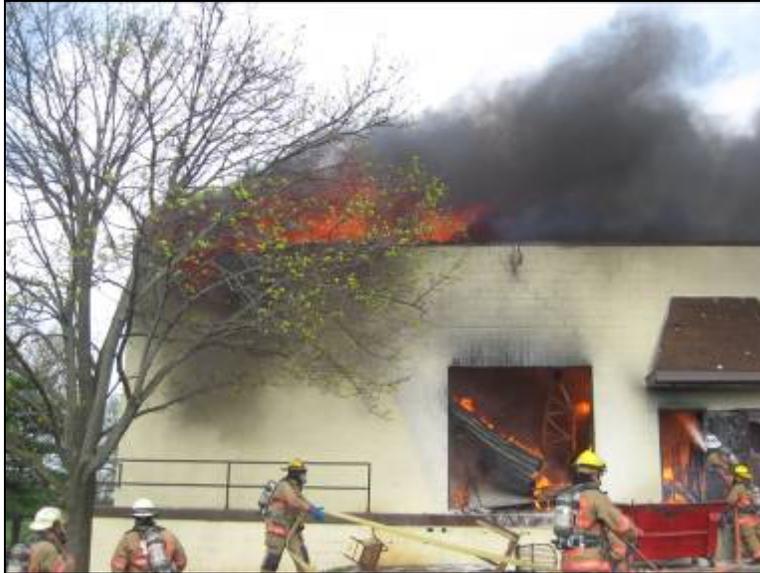
Figure 15: With the roof now collapsed, fire easily escapes vertically. Additional crews are arriving on the scene and Safety 700 now monitors the collapse potential. (Photo by MCFRS)

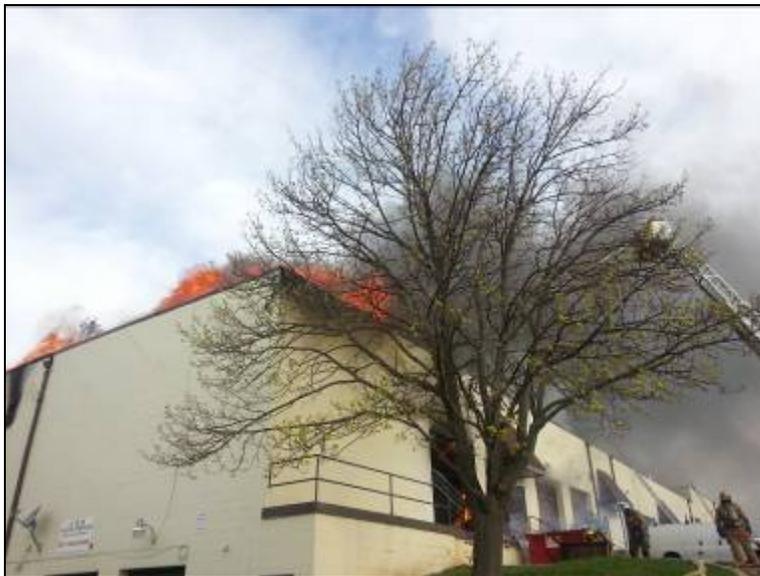
Figure 16: The stability of the Side Alpha/Bravo corner comes into question as additional cracks form in the exterior walls. (Photo by MCFRS)

- Several substantial structural cracks developed in the exterior masonry block walls on Sides Alpha and Bravo of the structure, and Safety 700 was instrumental in notifying the Command Post about the collapse hazard.

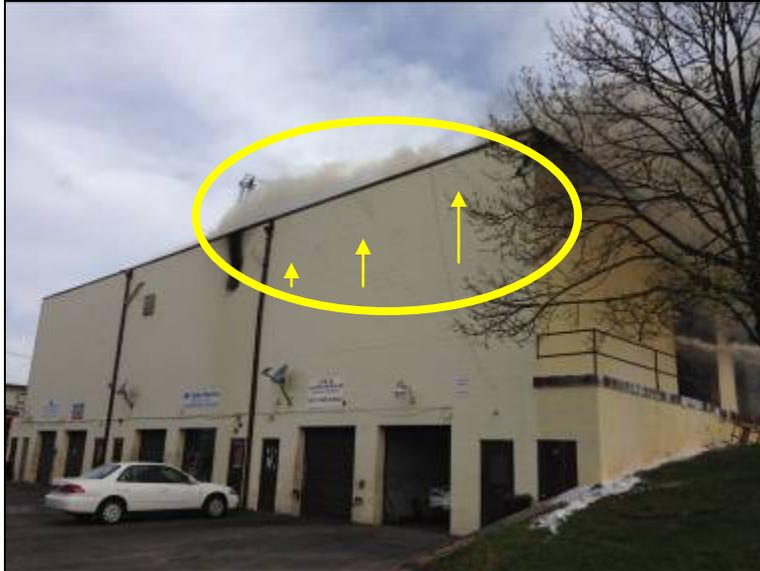
Figure 17: Three cracks have developed in the Side Bravo wall after the roof collapsed. (Photo by MCFRS)

- “Several cracks in the masonry walls on side Bravo and Alpha were noted. There was also wall separation occurring at the top corner of the building where side Alpha and Bravo met.”
- “Went up in the bucket of AT703 to have an aerial view of the structure. Observed several concerns of the structural integrity of the building. Where the steel bar joists had failed and collapsed, left 2 free standing walls. All findings and recommendations not to enter the original fire building were made to command.”

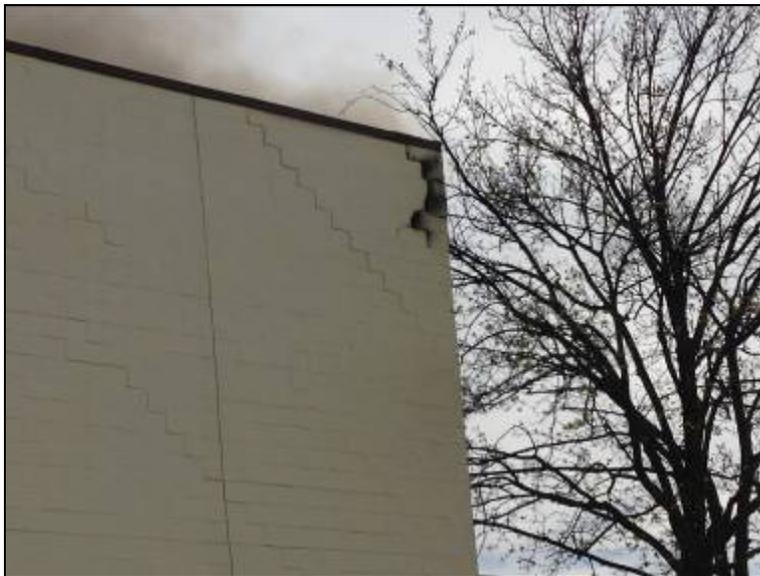
Figure 18: The corner crack is of most concern. When the bar joists expanded, they pushed out the walls some before falling in. (Photo by MCFRS)

- "While working I could see that the building's exterior wall was cracking and separating at the A/B top corner."
- "While operating on the fire scene we experienced a close call. Company 3 was operating their (blitz) monitor nozzle. For some reason we witnessed it lift off the ground and Lt. Ward grabbed onto it to keep it from breaking lose in what would have been a large group of firefighters. I dove on top of Lt. Ward to help keep him from moving. While anchoring it down FF Caudell (E4 PE723) worked his hand into us and was able to shut down the nozzle. I'm thankful that nobody got hurt in this incident but it was proof again that crews should not use that device as a moveable piece while water is flowing. Unlike the original blitz this does not have that shut off and we were reminded of it again."

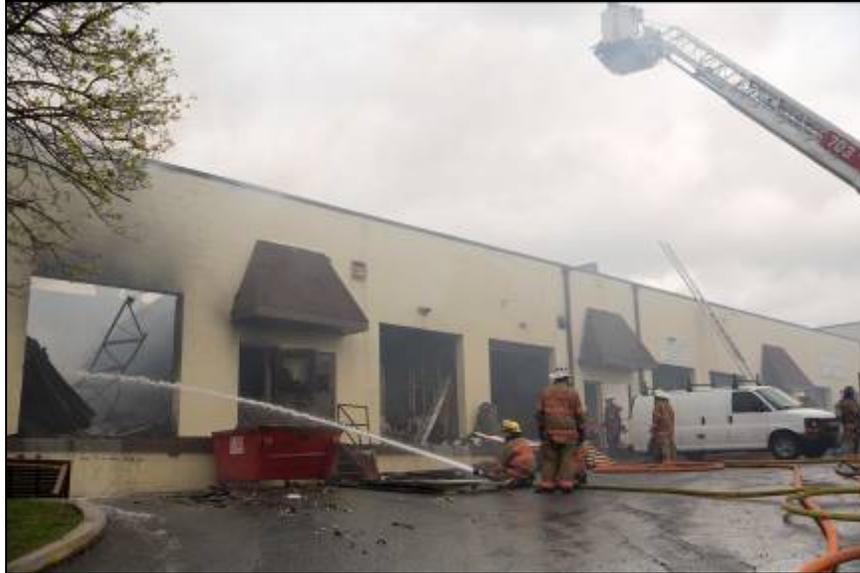
Figure 19: The fire is now under control, but it is too dangerous to send crews inside for overhaul and the collapsed roof prevents aerial application of water. The decision is made to tear down the front wall – so folks are waiting on an excavator. (Photo by RVFD)

Because of the collapsed roof and structurally unsound walls, Command ordered the partial demolition of the building as part of the overhaul operations. An excavator (and operator) from the Montgomery County Department of Transportation's Division of Highway Services was requested and used to remove the unstable walls and as much of the collapsed roof as possible. Final overhaul operations continued for several hours using compressed air foam hand lines.

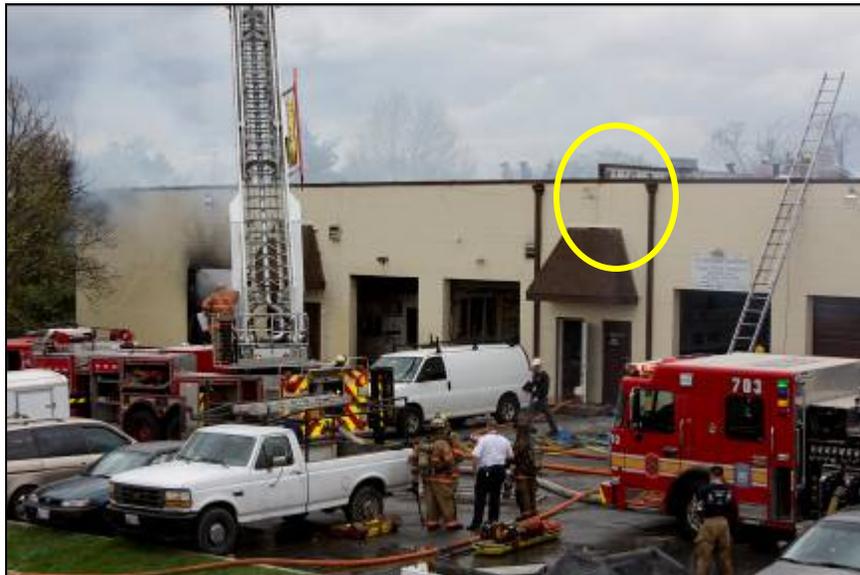
Figure 22: The fire was stopped at the fire wall by placing attack lines on both sides of the fire wall from underneath the roof. (Photo by RVFD)

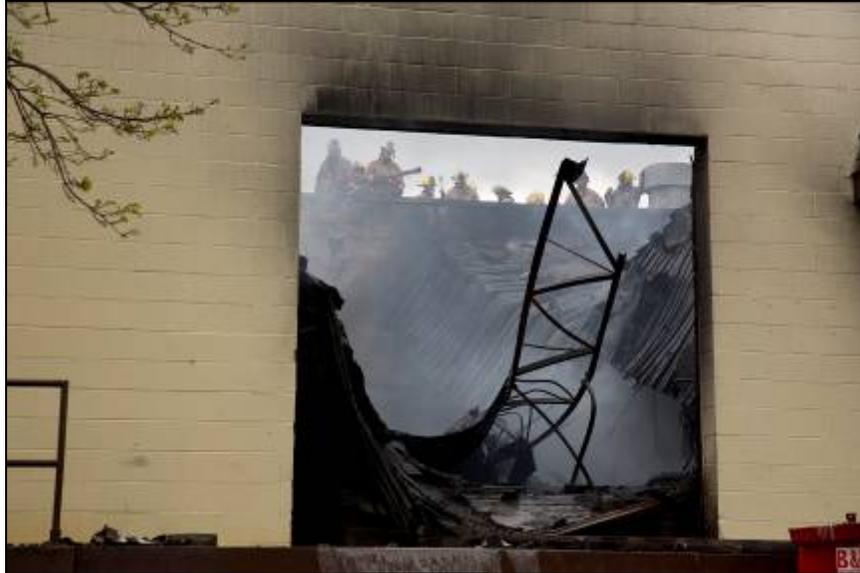
Figure 23: The Roof Division stopped the spread of fire to Side Charlie on the roof deck. They extinguished surface fire and controlled smoldering areas around the firewalls and skylights. (Photo by RVFD)

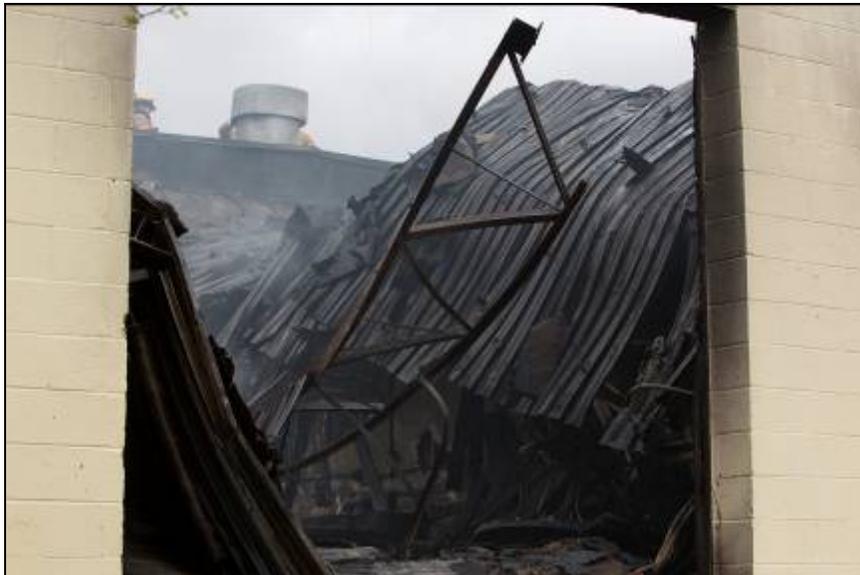
Figure 24: The combustible roof covering is burned away on this part of the collapsed roof. (Photo by RVFD)

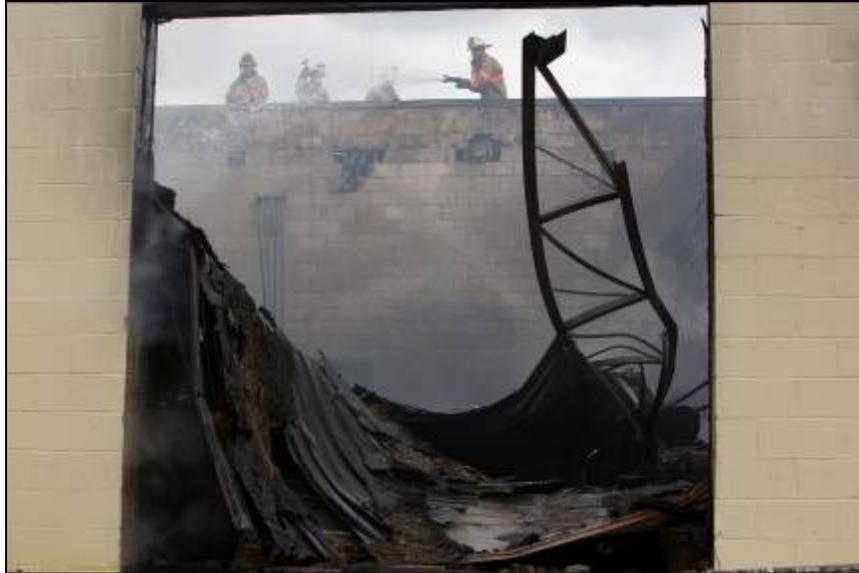
Figure 25: Holes in the Side Charlie firewall can be seen where the steel bar joists once rested. The collapse caused little damage to the Side Charlie firewall. (Photo by RVFD)

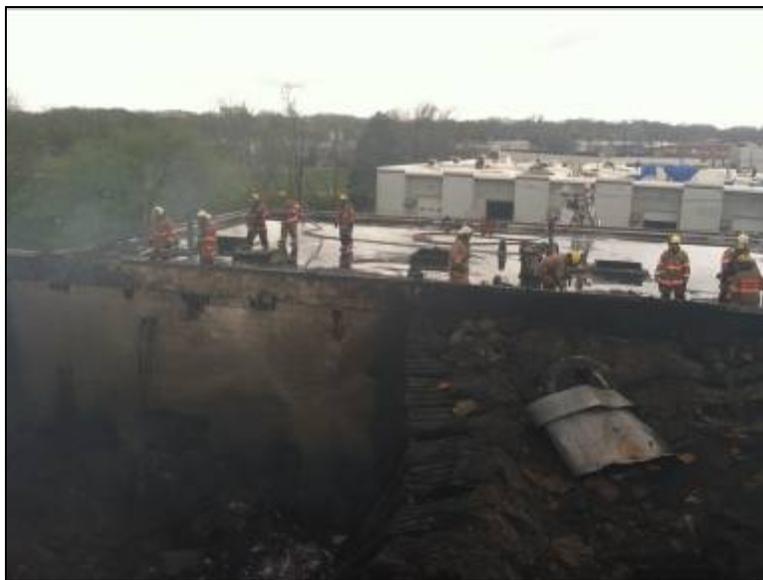
Figure 26: The skylight openings can be seen on the Side Charlie roof deck. Fire spread into those occupancies when the plastic skylights melted. Also – the roof totally collapsed over 1091 Taft and partially collapsed over 1089 and 1087. The partial collapse is what made overhaul operations so time consuming and labor intensive. (Photo by RVFD)

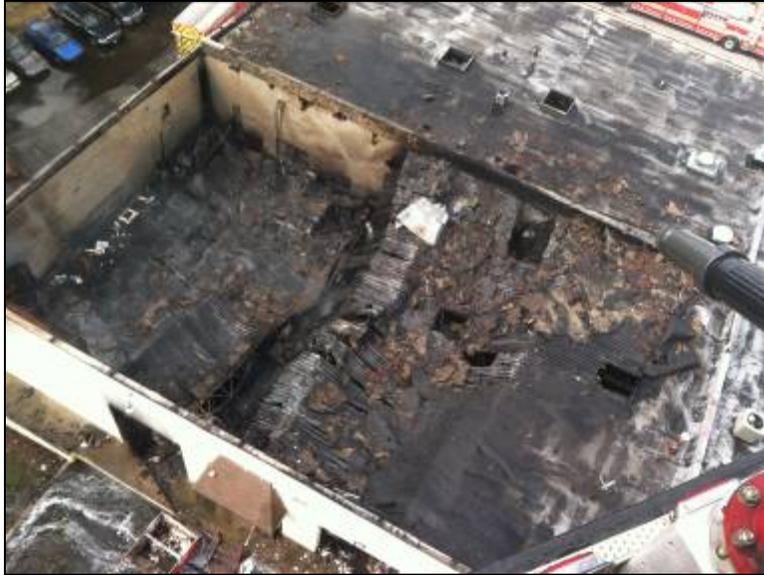
Figure 27: A good overhead view showing the roof collapse. (Photo by RVFD)

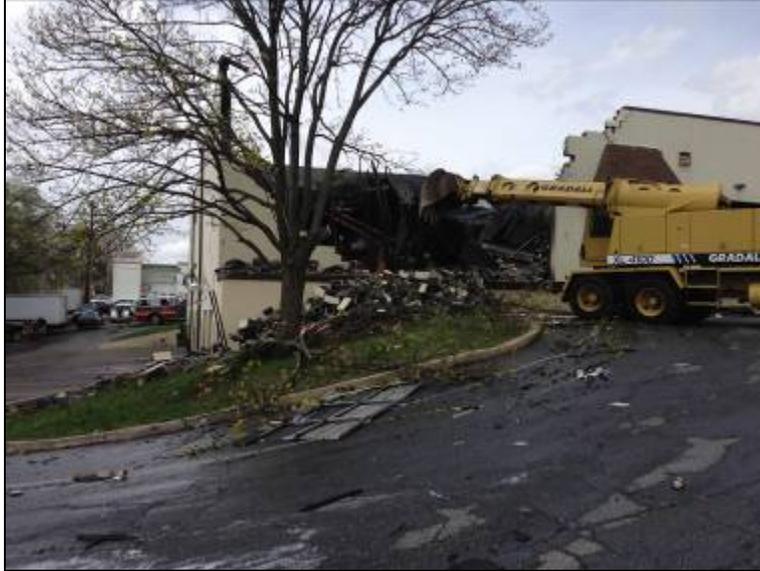
Figure 29: The entire Side Alpha exterior wall was removed at 1091 Taft Street. As much roofing and fire debris as possible that the excavator could reach was also removed. (Photo by MCFRS)

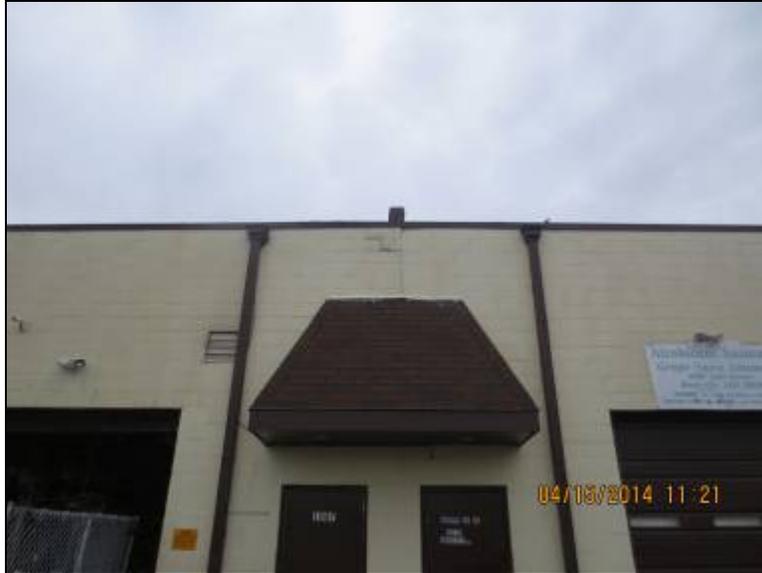
Figure 31: Although cracked, the exterior wall and firewall held up resulting in no damage to 1085 Taft Street. (Photo by MCFRS)

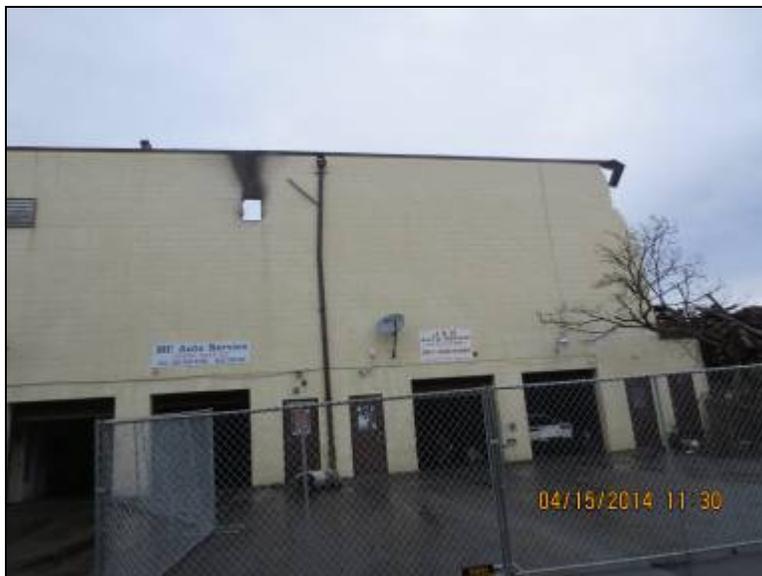
Figure 32: The now free-standing Side Bravo was cordoned off due to possible collapse and left to the property owner to handle. (Photo by MCFRS)

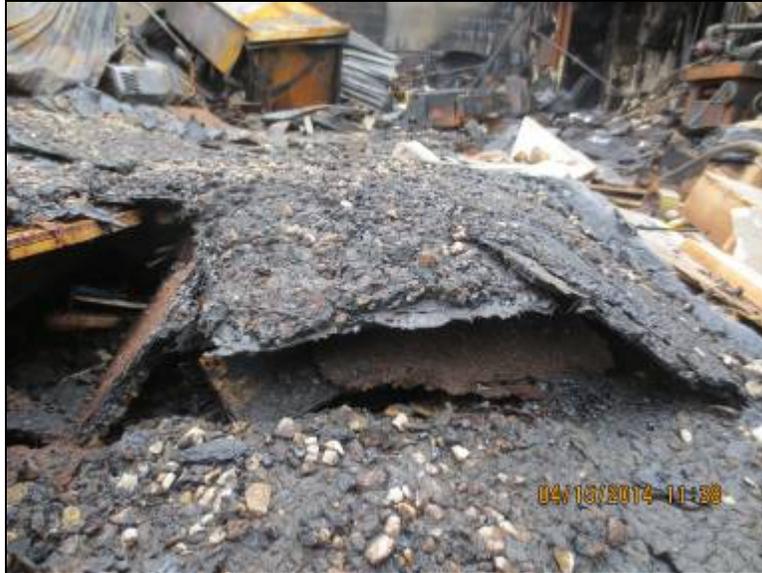
- The roof had been resurfaced at least twice and had a combustible "fiber board" type of insulation layer next to the metal decking. This building up of roofing material extended fire control overhaul operations for several hours.

Figure 33: The built up roofing covering that proved so problematic during overhaul operations. (Photo by MCFRS)

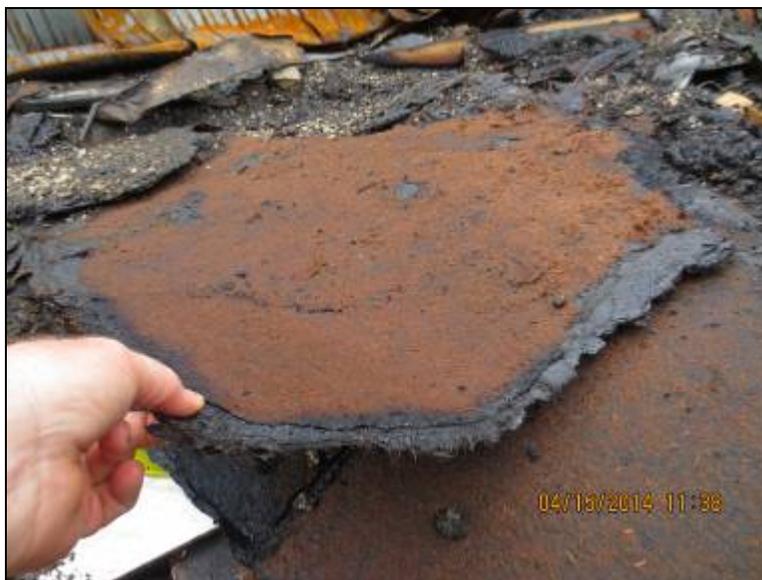
Figure 34: The fiberboard roof insulation that smoldered until uncovered. This insulation was sandwiched between tar and the corrugated metal deck. Some of this material was found smoldering the day after the fire occurred. (Photo by MCFRS)

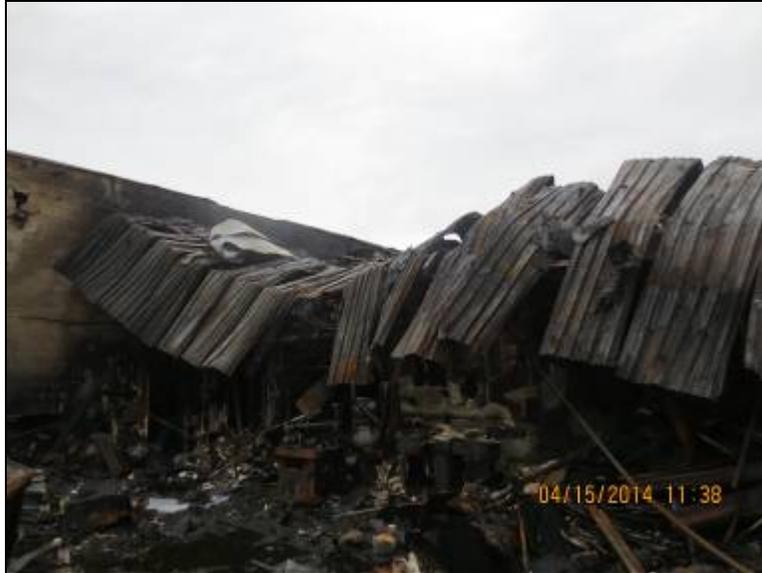
Figure 35: This part of the roof was over 1089 Taft Street – which had a mezzanine level inside used for storage. It was very difficult reaching this area for final overhaul. (Photo by MCFRS)

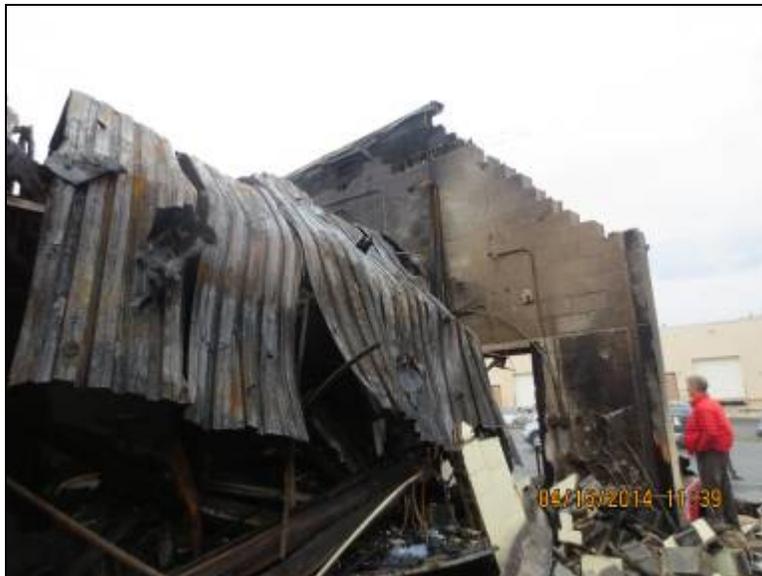
Figure 36: Another view of the same mezzanine problem – looking toward Side Alpha from inside 1091 Taft Street.(Photo by MCFRS)

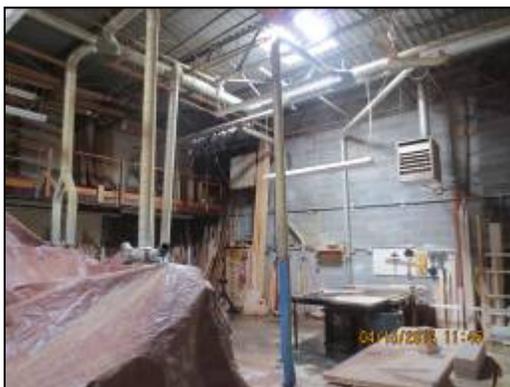
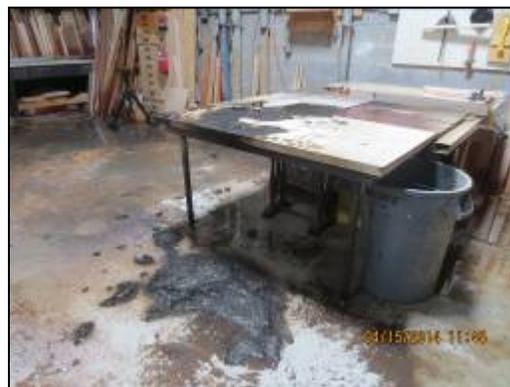
Figure 39: Side Charlie – 1071 Taft Street – the skylight caught fire, melted, and fell in on the work bench. Crews found the small fire while checking for extension. (Photo by MCFRS)

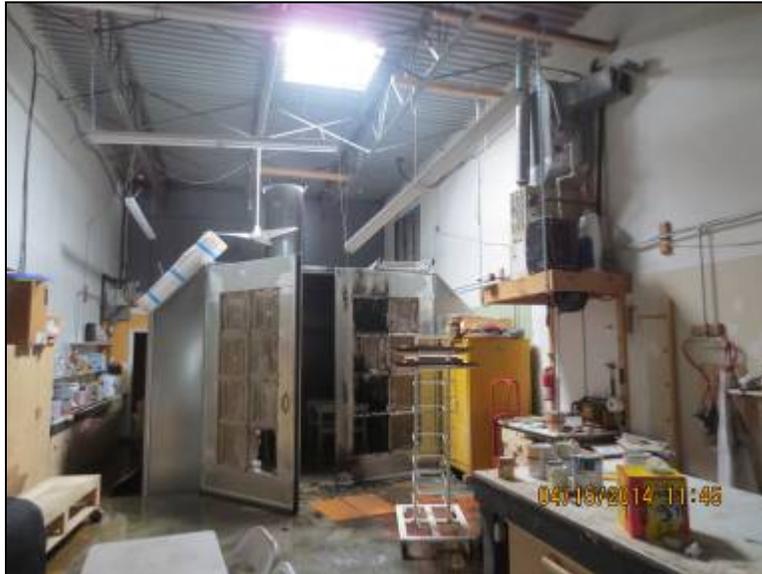
Figure 40: More damage on Side Charlie – note the fire damage to the paint spray booth doors - more drop down fire from a skylight. (Photo by MCFRS)
