MONTGOMERY COUNTY FIRE RESCUE SERVICE POST-INCIDENT ANALYSIS

2 – ALARM SINGLE FAMILY DWELLING FIRE
BOX AREA 31-33
113 Leekes Lot Way
May 14, 2015
Incident # 15-0057400

THE POST INCIDENT ANALYSIS

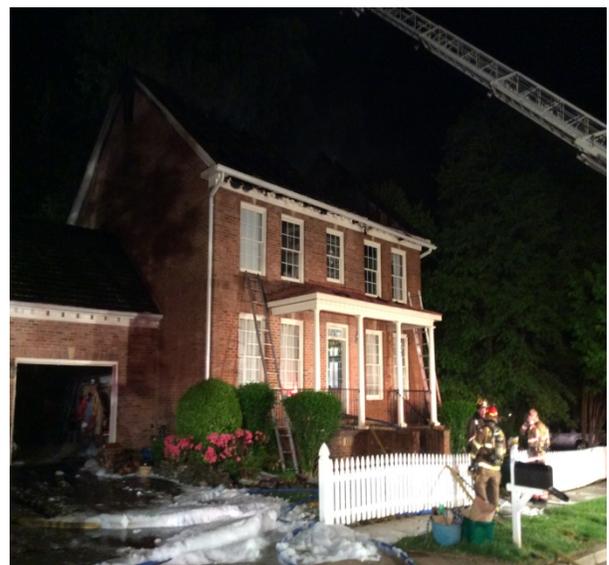
Command noticed that the Alpha-Delta roof had partially collapsed and advised the units

working on the interior of this fact.
