Montgomery County Fire & Rescue Service

POST INCIDENT ANALYSIS

8701 Arliss Street Silver Spring, MD 20910

August 10, 2016

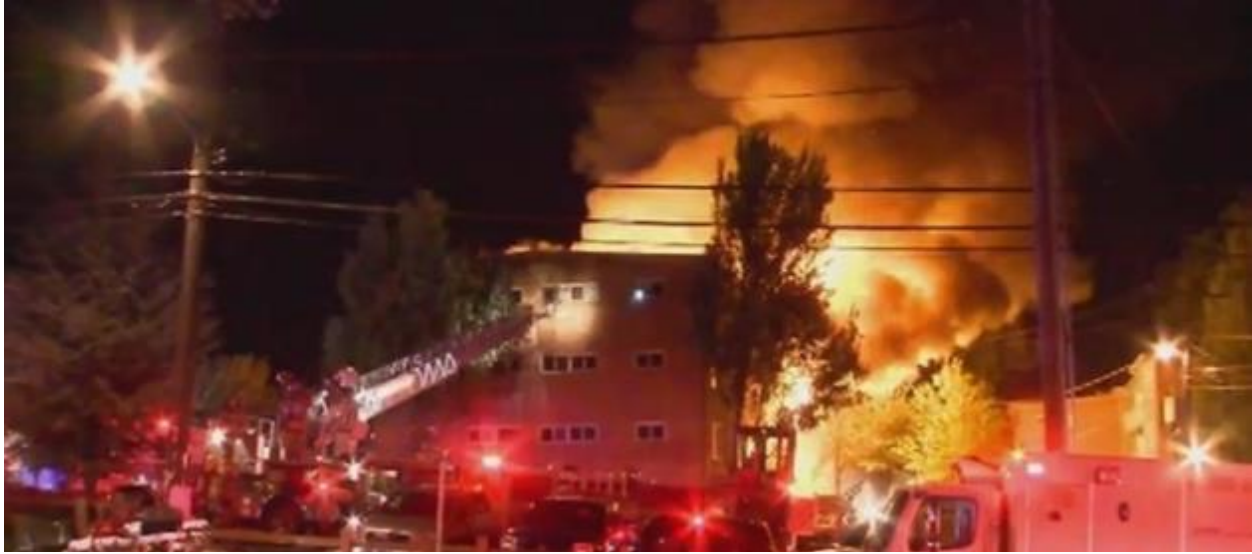
Side Delta of 8701 Arliss Street from Piney Branch Road

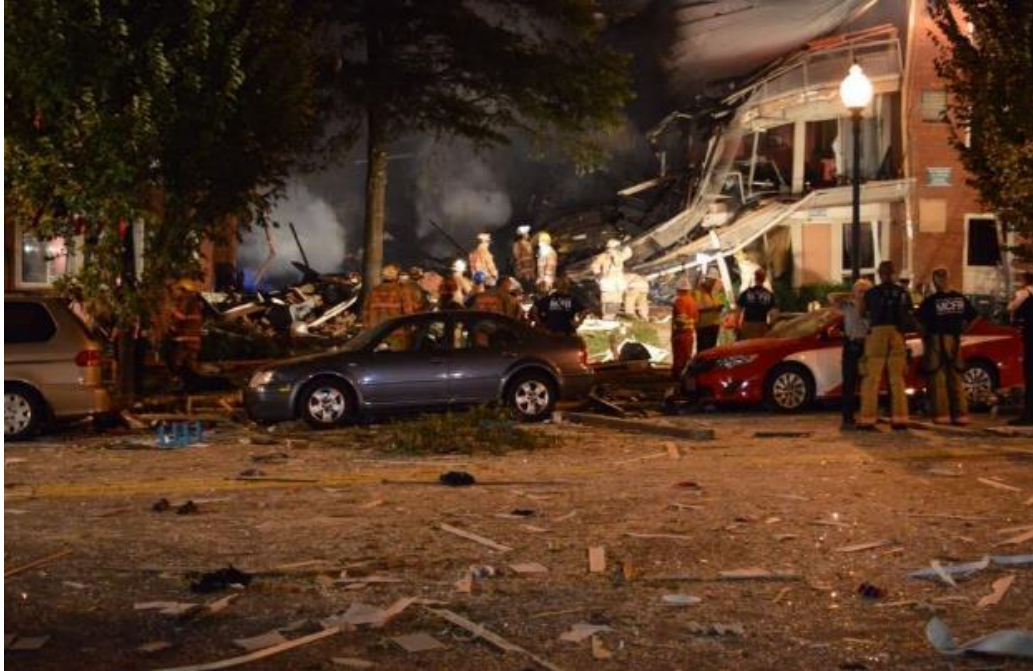
Side Alpha of 8701 Arliss Street. A small part of the debris field is in the foreground. The collapsed area is where the original entryway and stairwell to the building were.

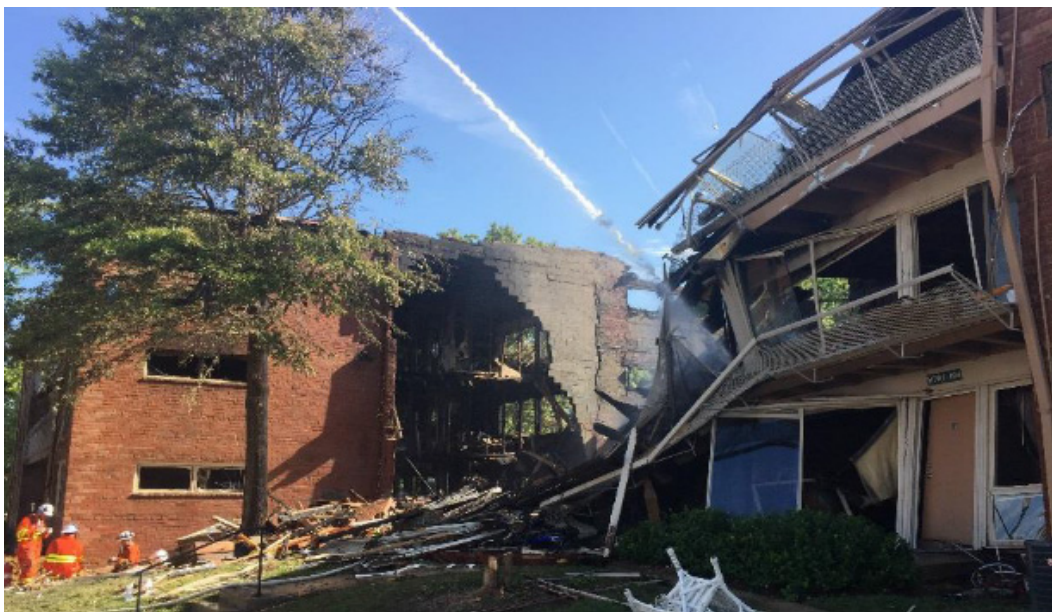
The fire wall that was blown out between 8701 on the right, and 8703 on the left.

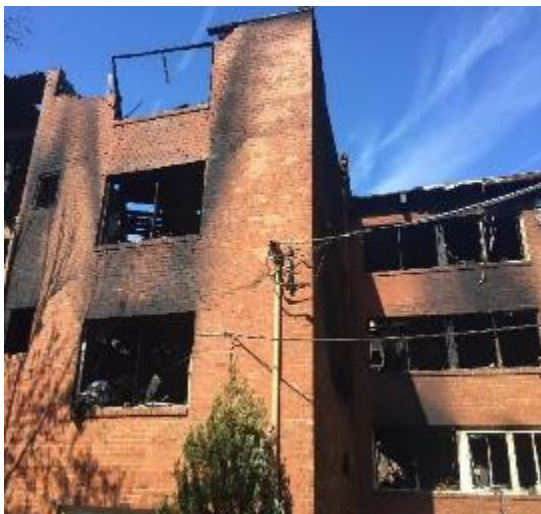
Side Charlie Wall – Cracks and outward bowing noted
noted

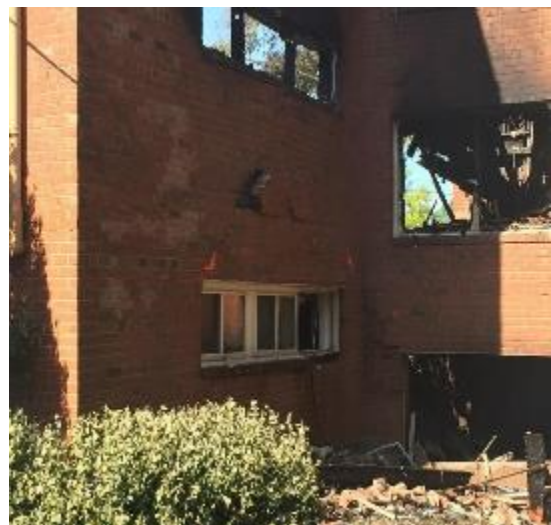
Side Charlie Wall – Cracks and outward bowing

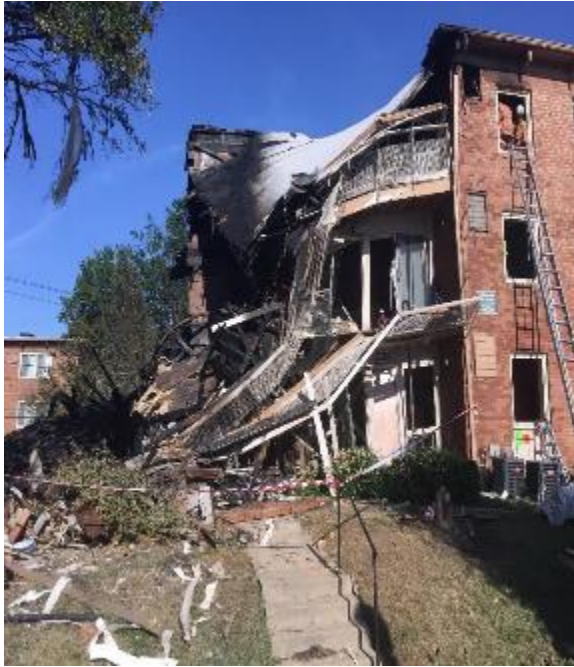
"Lean To" collapse – Side Alpha 8701 – unstable roof
Compromised

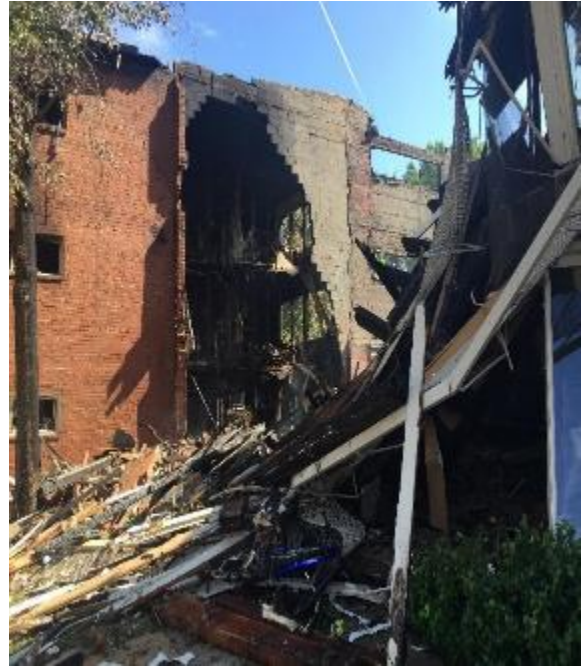
Bravo Wall – Separated 8701 & 8703 -

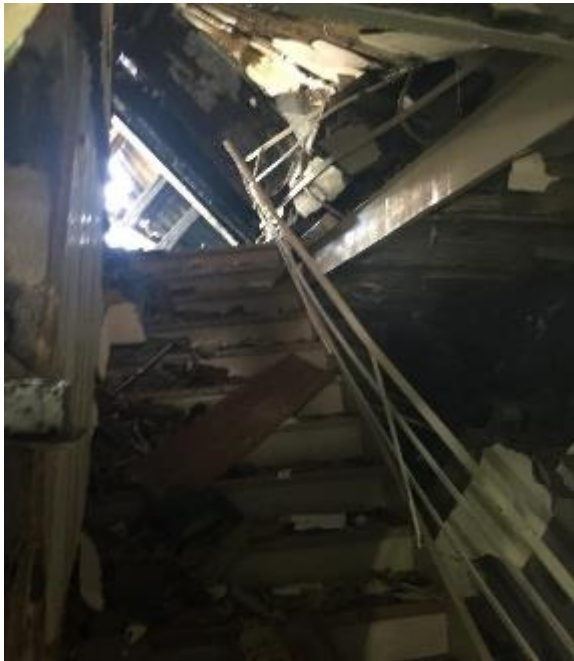
Interior Stairs – 8701 – Compromised

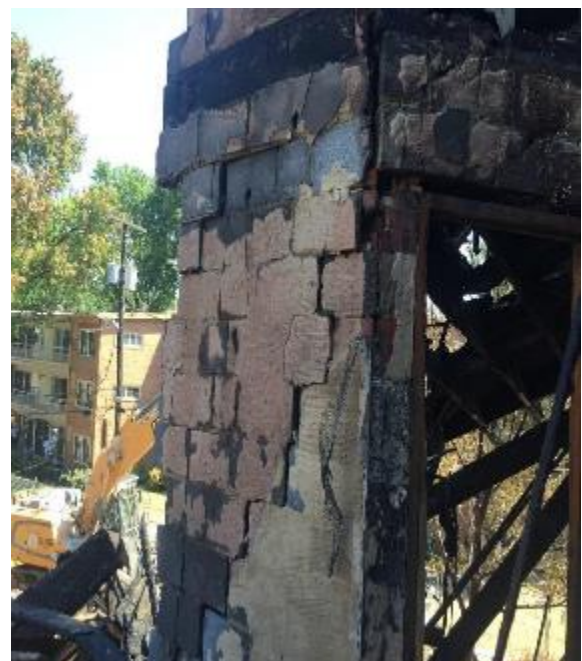
Interior load bearing URM Wall 8701 – unstable

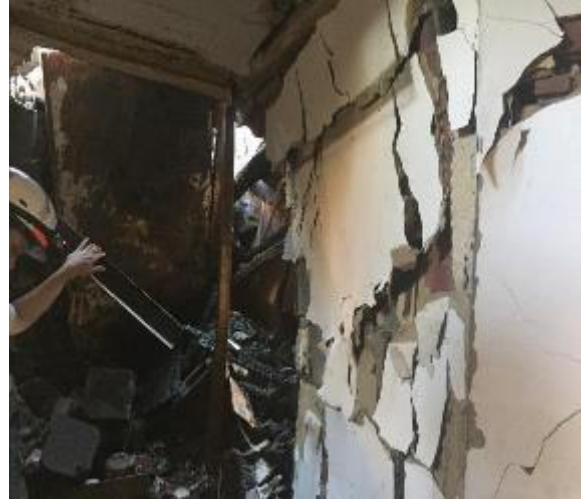
Failing Interior URM Wall – Stairwell - 8701
