MONTGOMERY COUNTY FIRE & RESCUE SERVICE
POST INCIDENT ANALYSIS

19350 Churubusco Lane
March 14, 2016

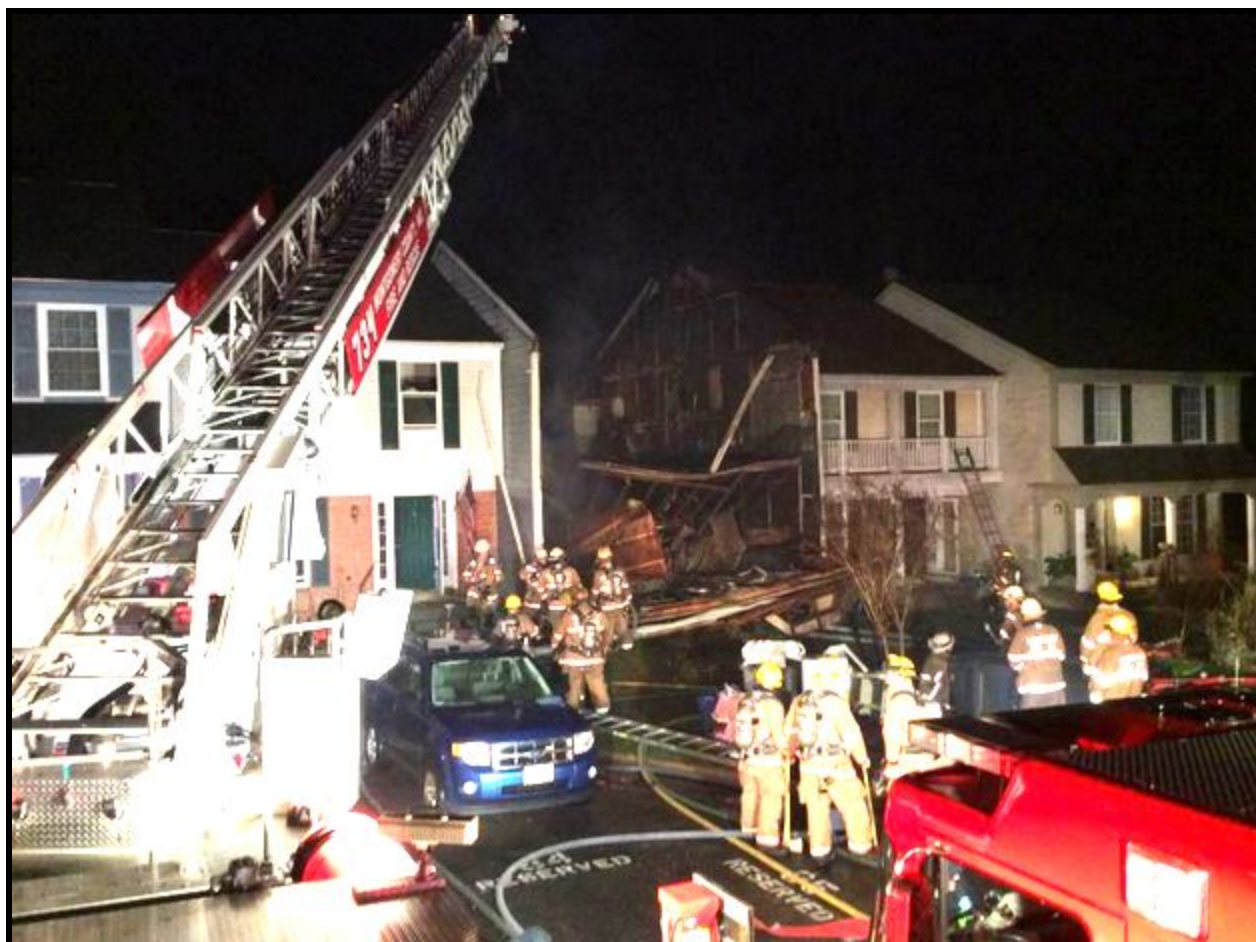
View from Side Alpha after the Mayday was resolved.

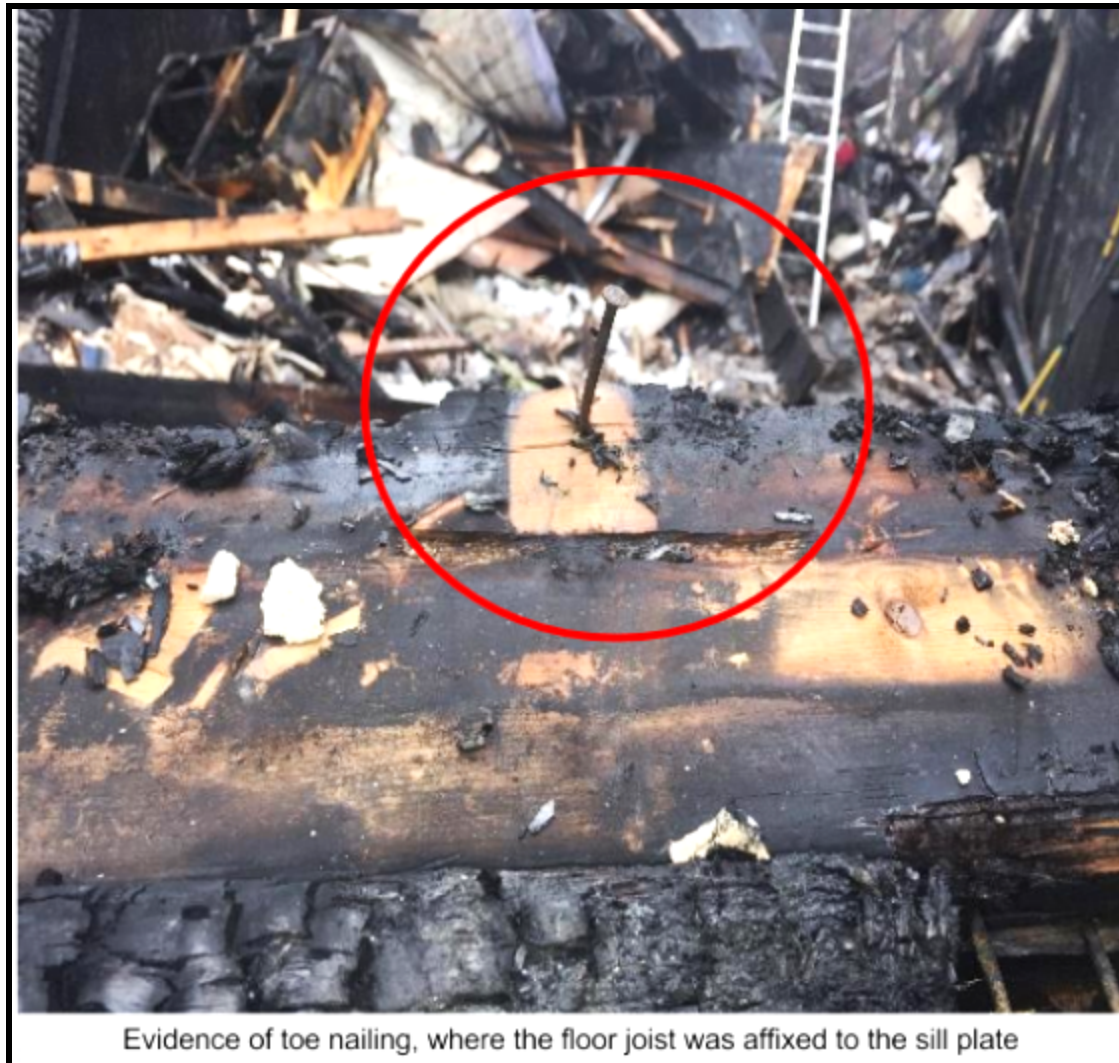
This type of flooring system requires you to “toe nail” the bottom flange of the TJI joist into the sill plate, which is mounted to the top of the foundation wall. In situations where there is no foundation wall, such as the rear wall of Churubusco Lane, then the joists are become fixed to the top plate of the wall framing. Toe nailing is only done to hold the joist in place unit the band board is installed.

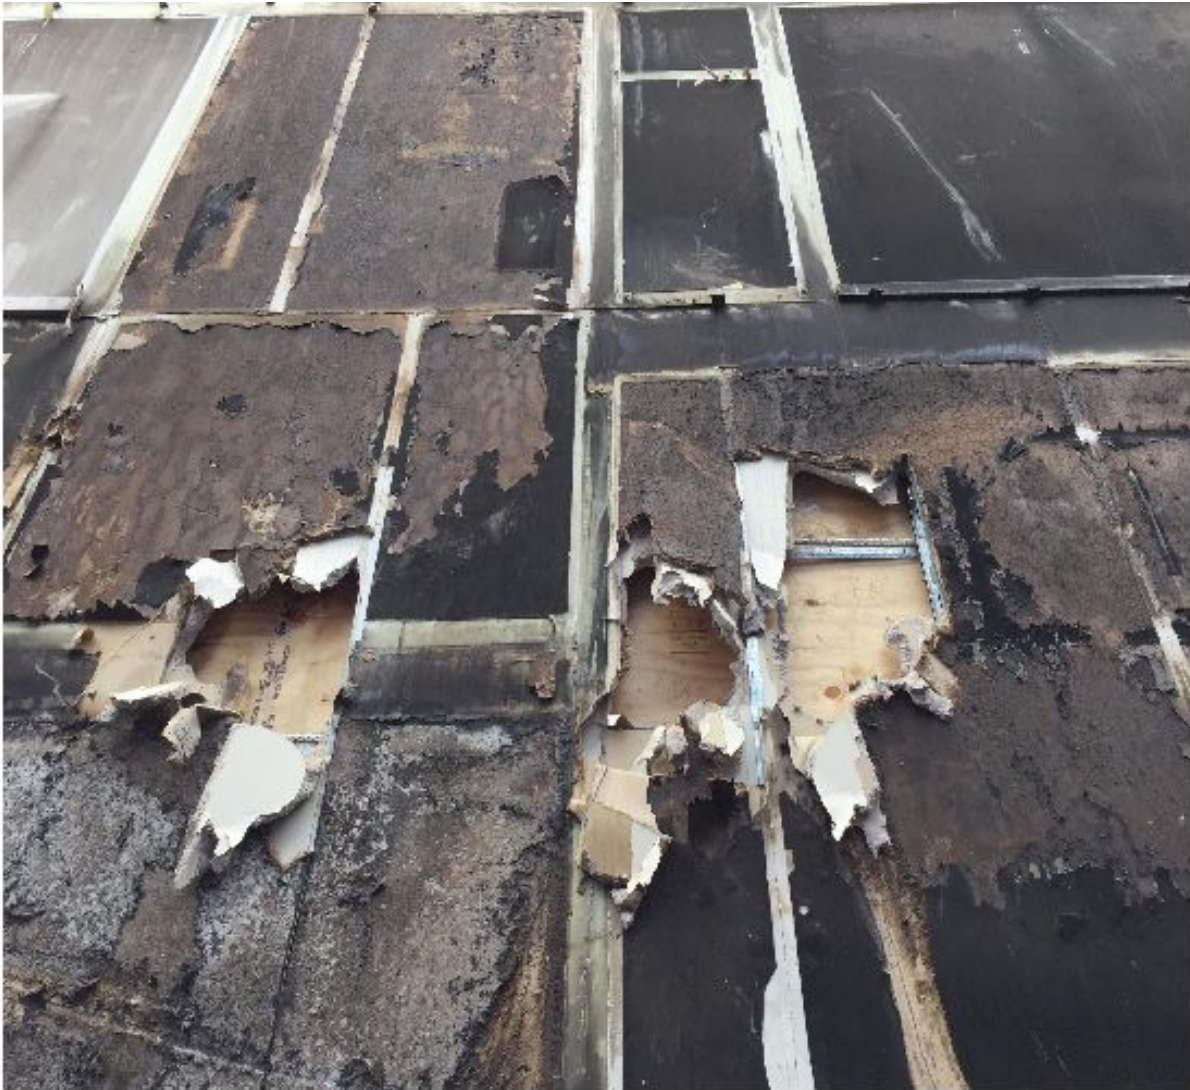
VIEW OF FIRE WALL FROM INSIDE THE FIRE BUILDING

During this fire the fire wall remained intact and appeared to have functioned as designed. While there was minor fire extension noted in the adjacent structures it was likely the result of spread along exterior surfaces.

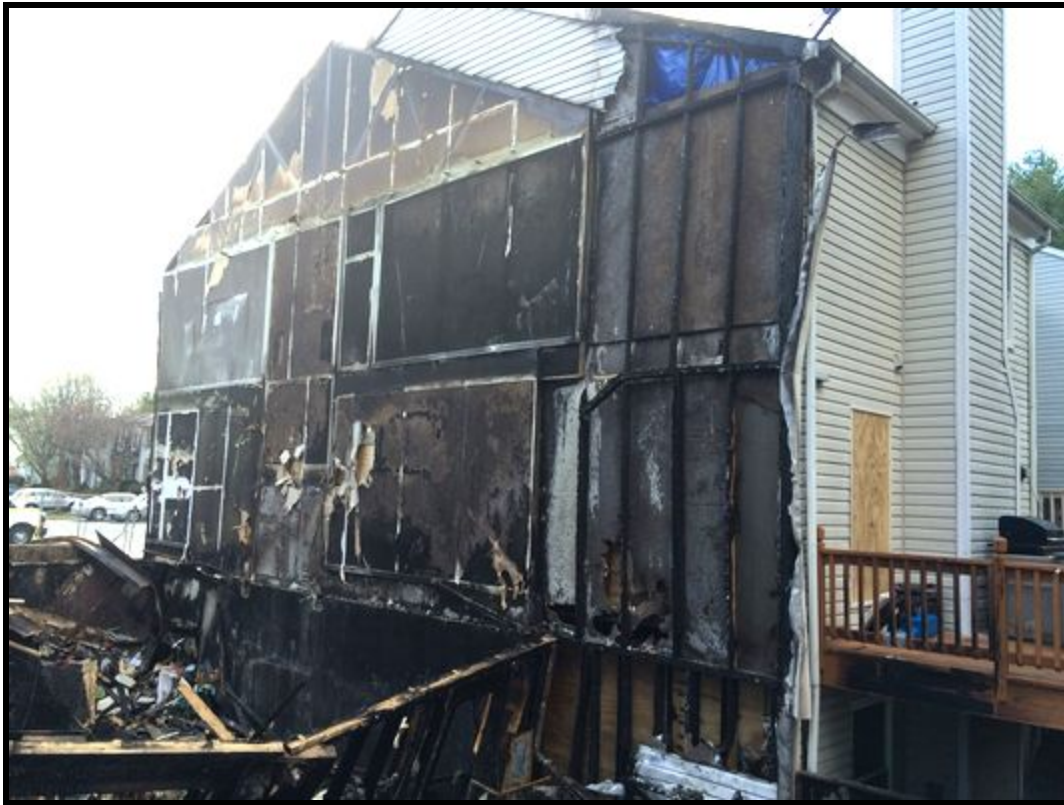
A view of the aftermath from Side Charlie note the basement level exterior wall leaning outwards.
