# Montgomery County Fire and Rescue

## Post Incident Analysis

Second Alarm Building Fire  
Montgomery County Resource Recovery Facility  
21204 Martinsburg Road  
Dickerson, MD 20842

December 8, 2016  
Incident # 16-0152736

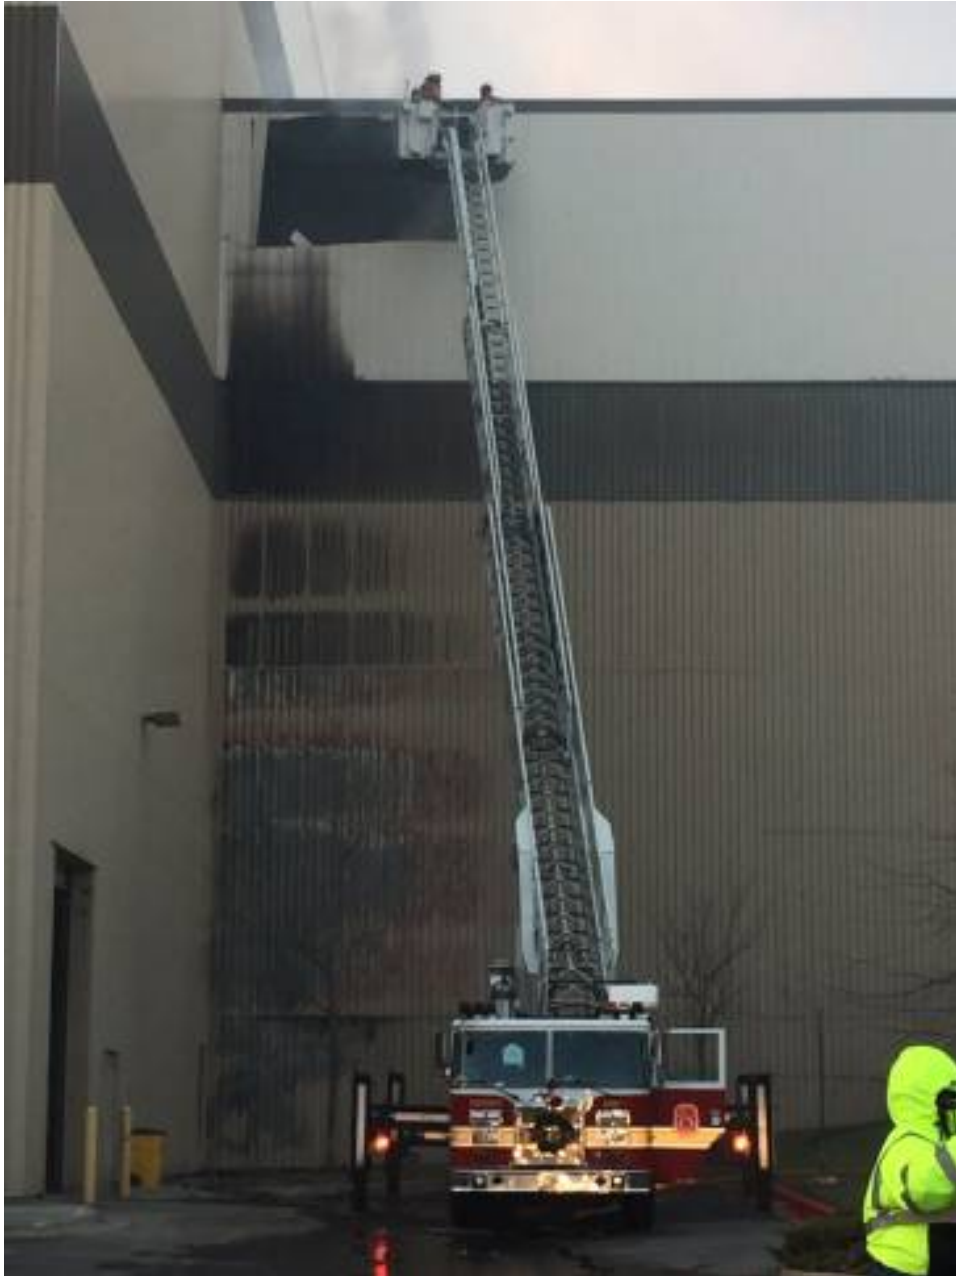
MCFRS personnel work to open up corrugated metal walls of the tipping room 12/09.

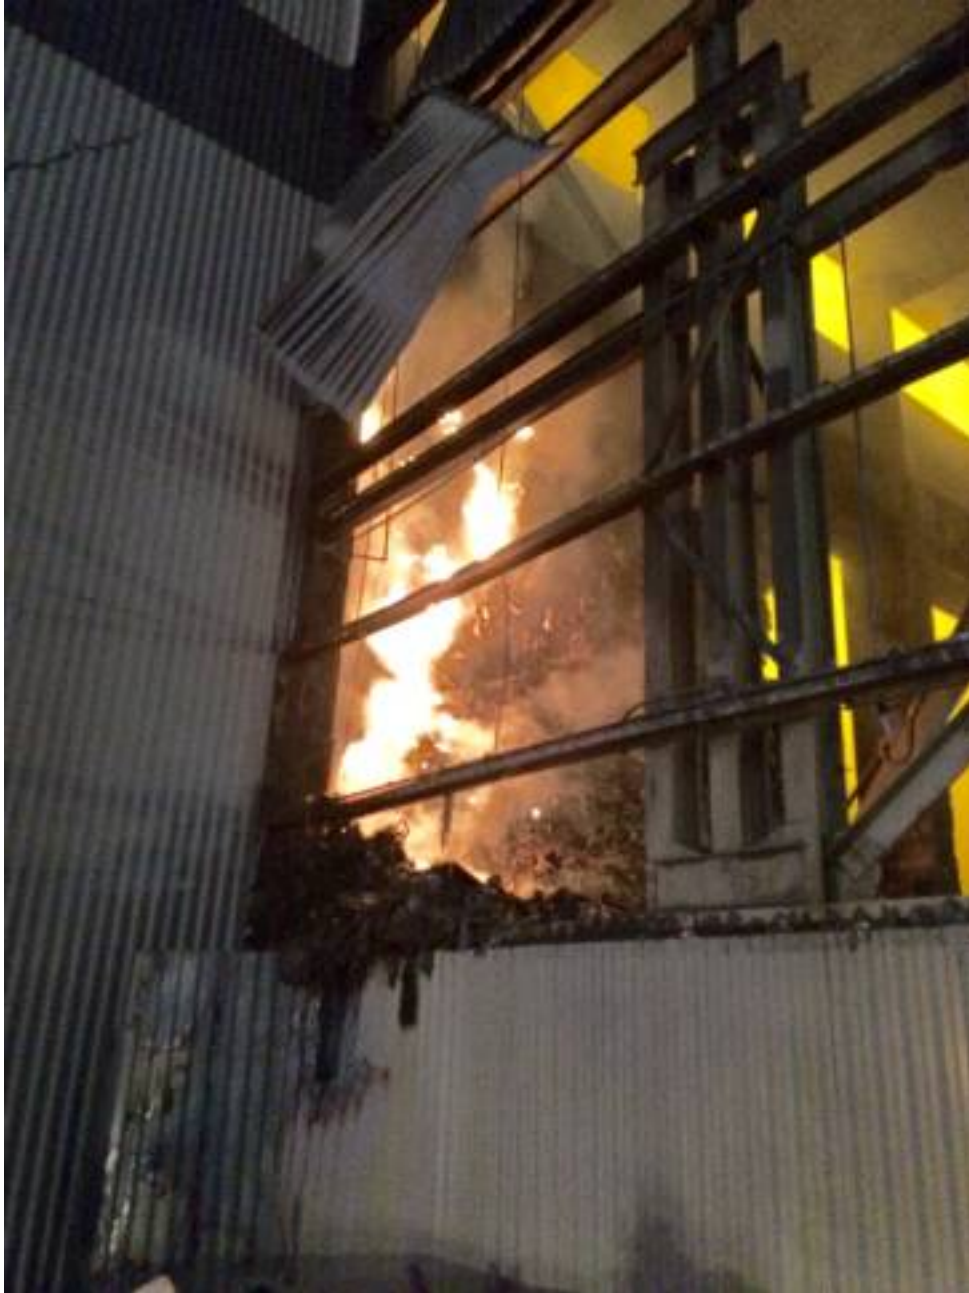
Tipping room after walls removed. Large volume of fire can be seen in Pile "A". 12/10

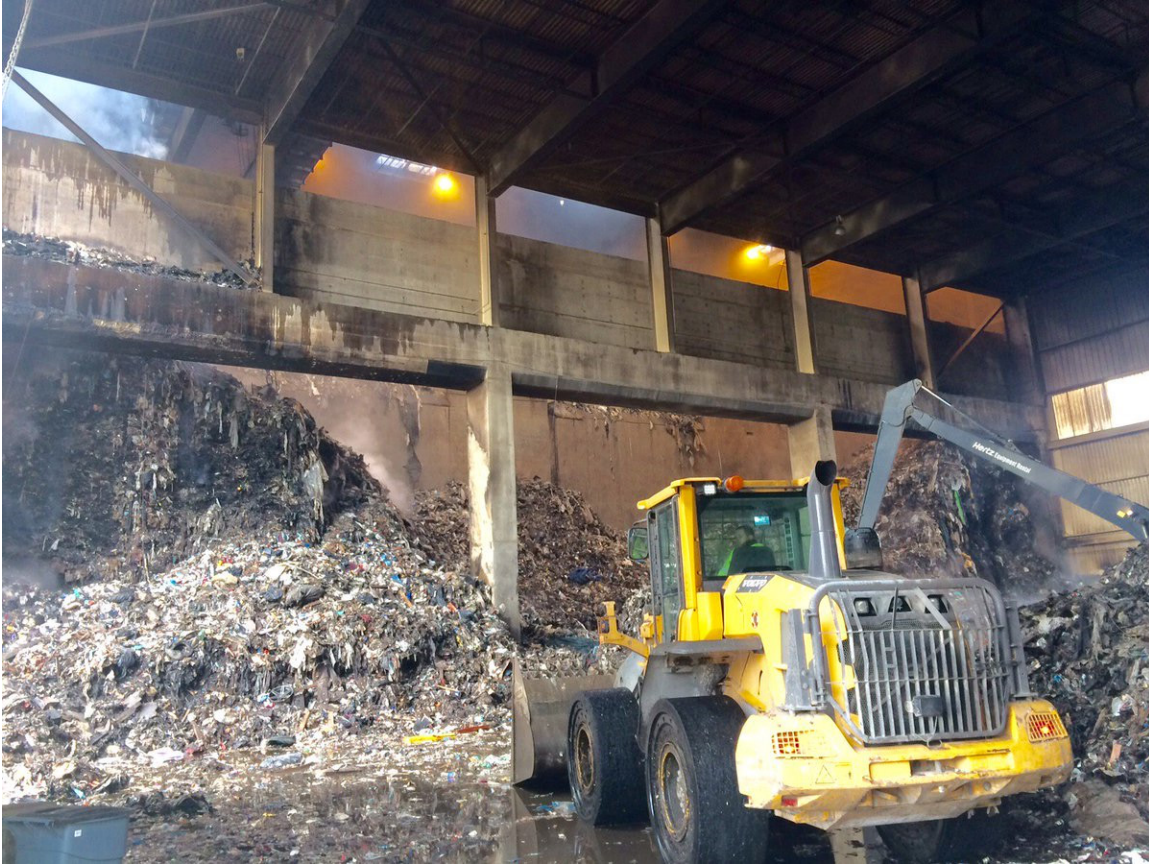
Tipping room floor on or about 12/13
