## Case Study Review 19211 Watkins Mill Road

### *Gas Leak with Catastrophic Explosion June 15-16, 1993*

Presented by: Lieutenant Bill Bindl &  
Battalion Chief Barry C. Reid

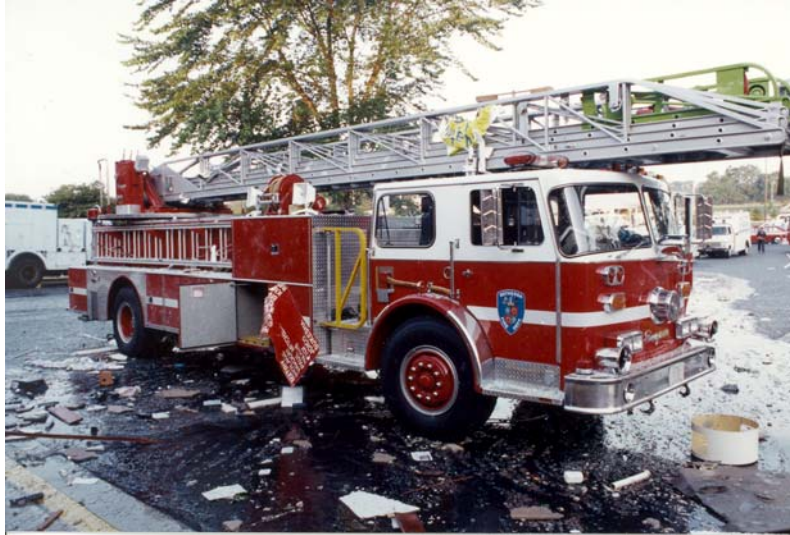
Truck 8 – Parked on Side One in front of the stores where explosion blew glass and debris approx. 200 feet into parking lot when the explosion happened.

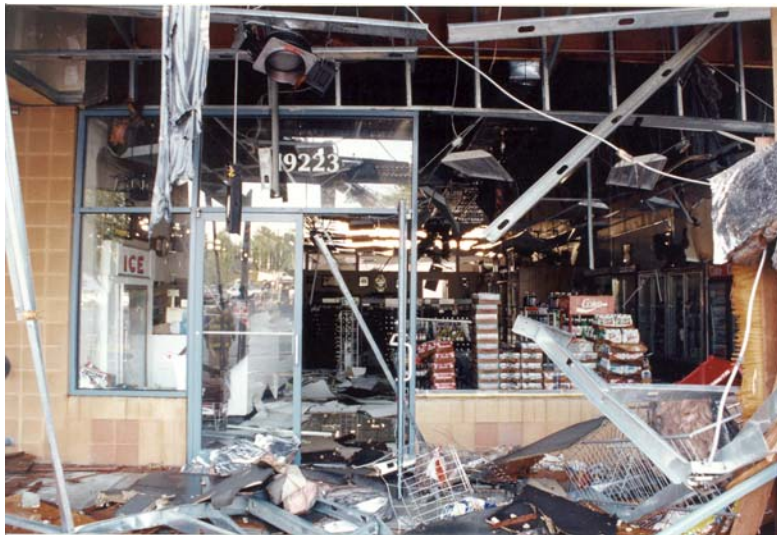
Side One of Grape & Grain Store – 19223 Watkins Mill Road

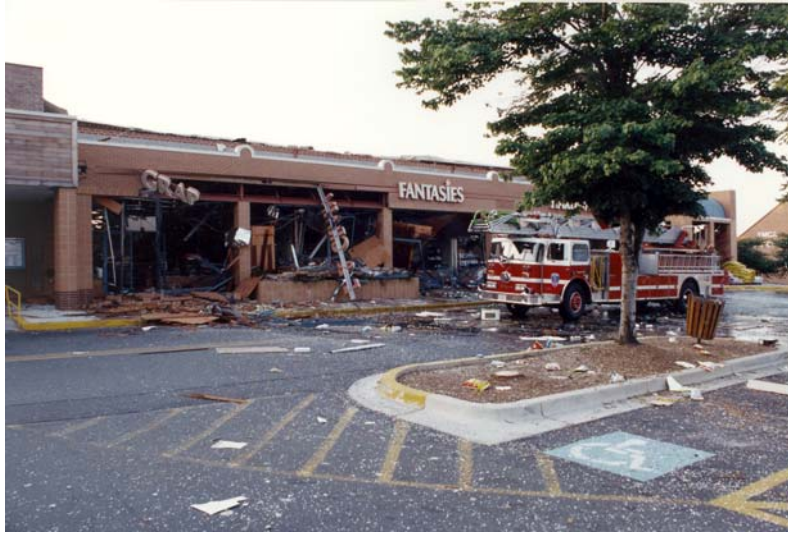
Overview of Side One of stores affected by explosion. Note amount of debris that forcefully blew out front of stores.

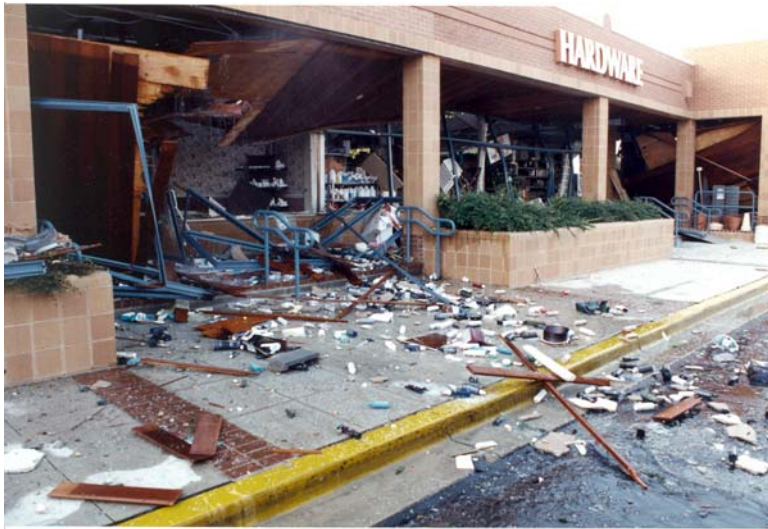
Overview of Side One of stores affected by explosion. Note amount of debris that forcefully blew out front of stores.

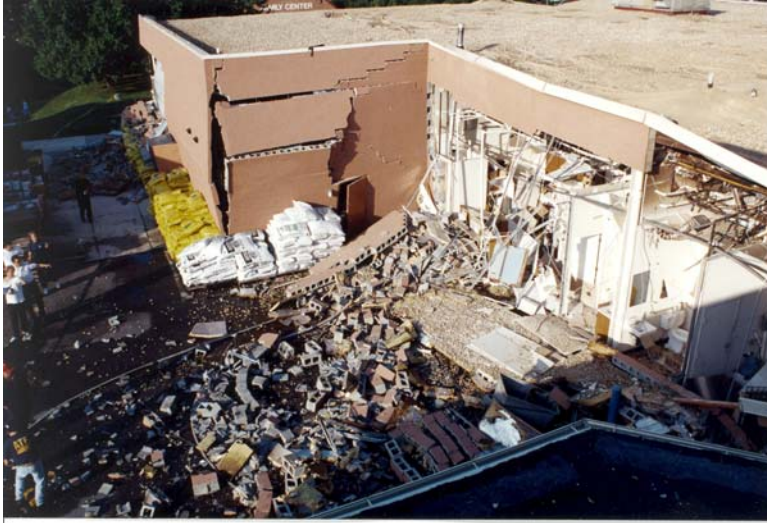
Overhead view from top of Giant food showing Side 3 – Note walls at rear of hardware store – 19219 Watkins Mill Road – Walls posed significant post explosion collapse hazard

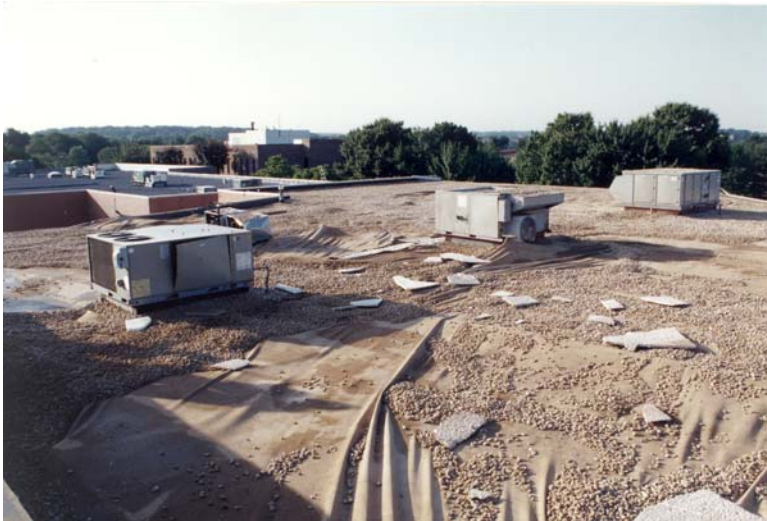
Overhead roof shot from Giant showing damage to roof structure of the three stores involved. Note membrane roofing which moved due to stress of explosion.

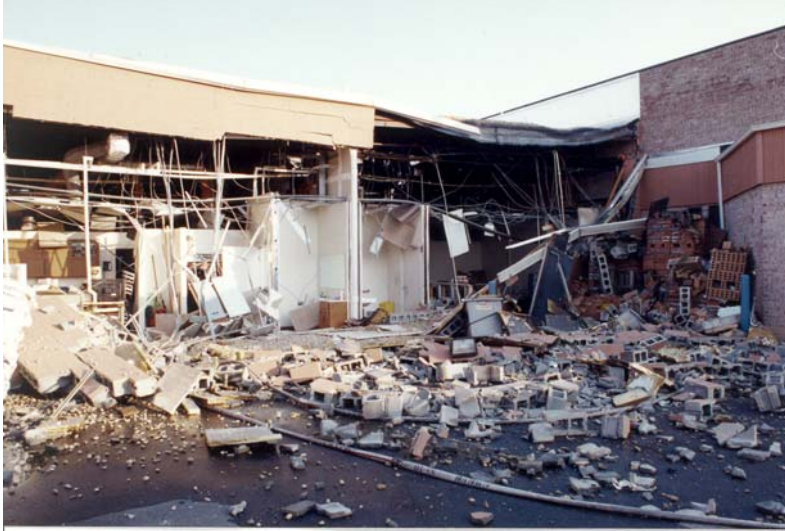
Area to right of center is rear of Grape & Grain – 19223  
Watkins Mill Road – Gas leak & fire in corner to rear of that  
Store - note handline under debris

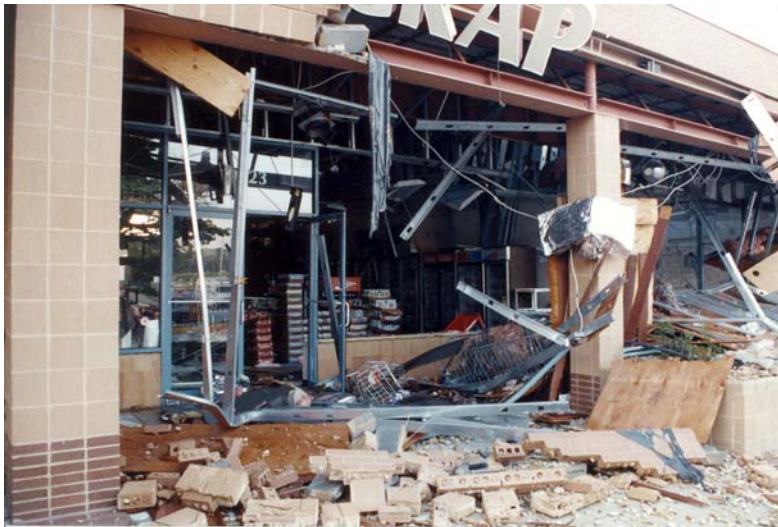
Side 1 – 19223 Watkins Mill Road. Grape & Grain Store

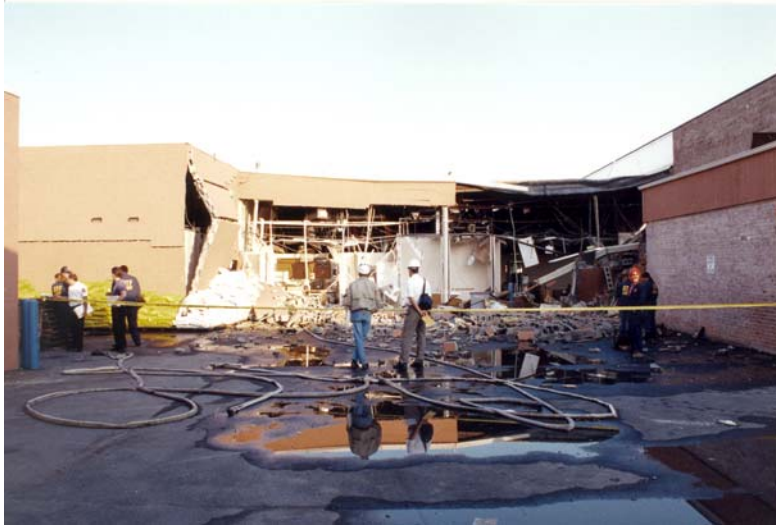
Side 3 – 19219, 21, 23 Watkins Mill Road – Giant Food store  
on right – injured firefighter/gas leak and fire found in corner  
Next to Giant – Note E281's handline under debris

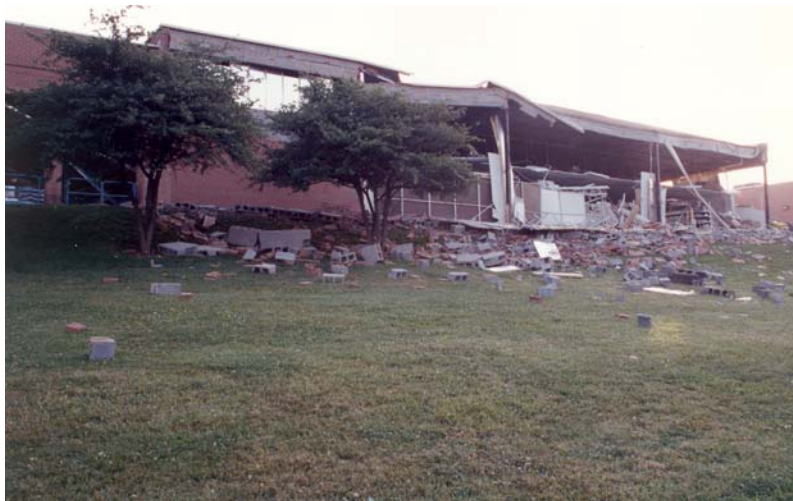
Side 4 of three stores involved in explosion

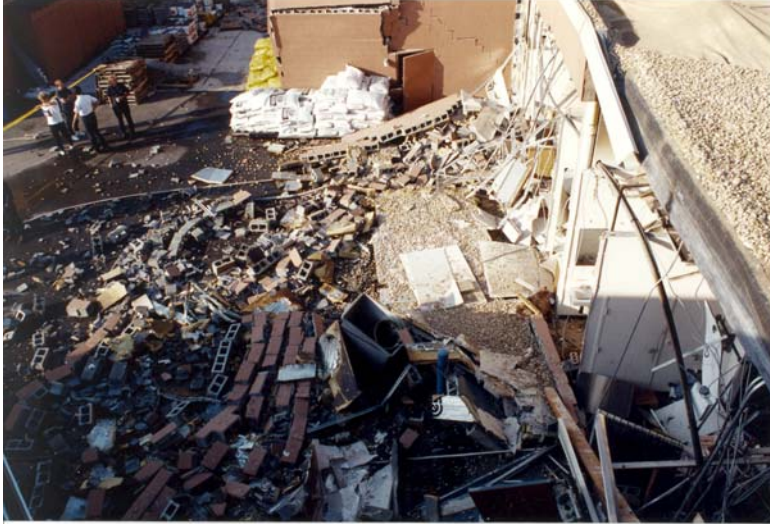
Overhead view of area where some firefighters and one Washington Gas employee were operating at time of explosion. E281's handline was under the debris.

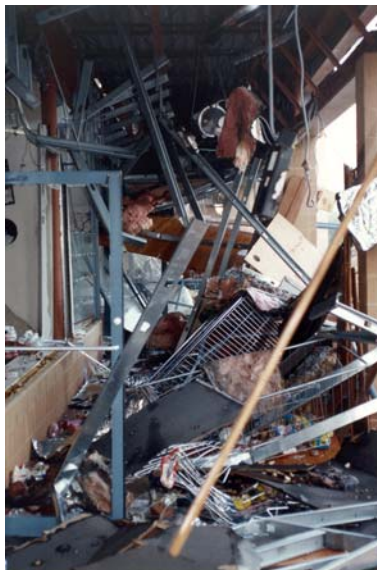
Side one sidewalk area in front of store where explosion occurred.

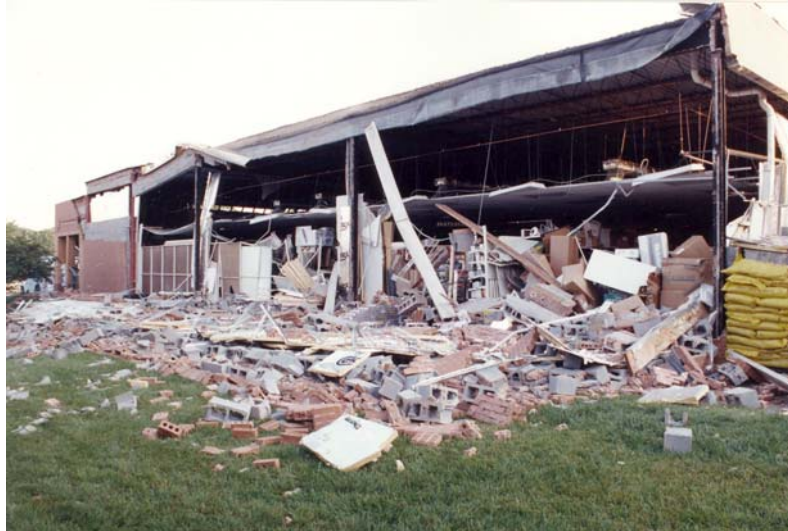
Side four – Hardware store wall
