Natural Gas Explosion
Montgomery Village Center
19211 Watkins Mill Road
June 16, 1993
Box 8-4

7 Firefighters and
2 WGL Employees Injured

The pages that follow along with accompanying video and photos are the core of an after action report following a natural gas explosion at Montgomery Village Center on June 15/16, 1993.

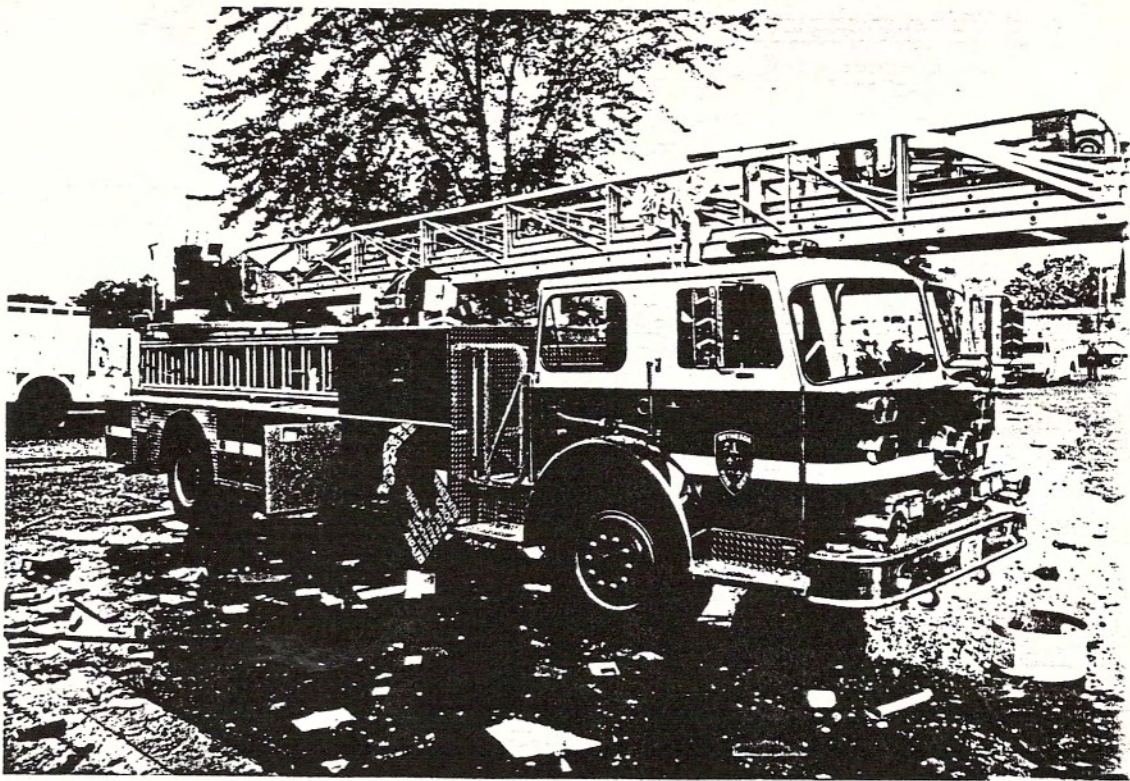
TRUCK 8 - PARKED ON SIDE ONE IN FRONT OF STORES WHERE EXPLOSION BLEW GLASS AND DEBRIS APPROX. 200 FEET INTO PARKING LOT. TWO PERSONNEL WERE BEHIND THE TRUCK WHEN THE EXPLOSION HAPPENDED.

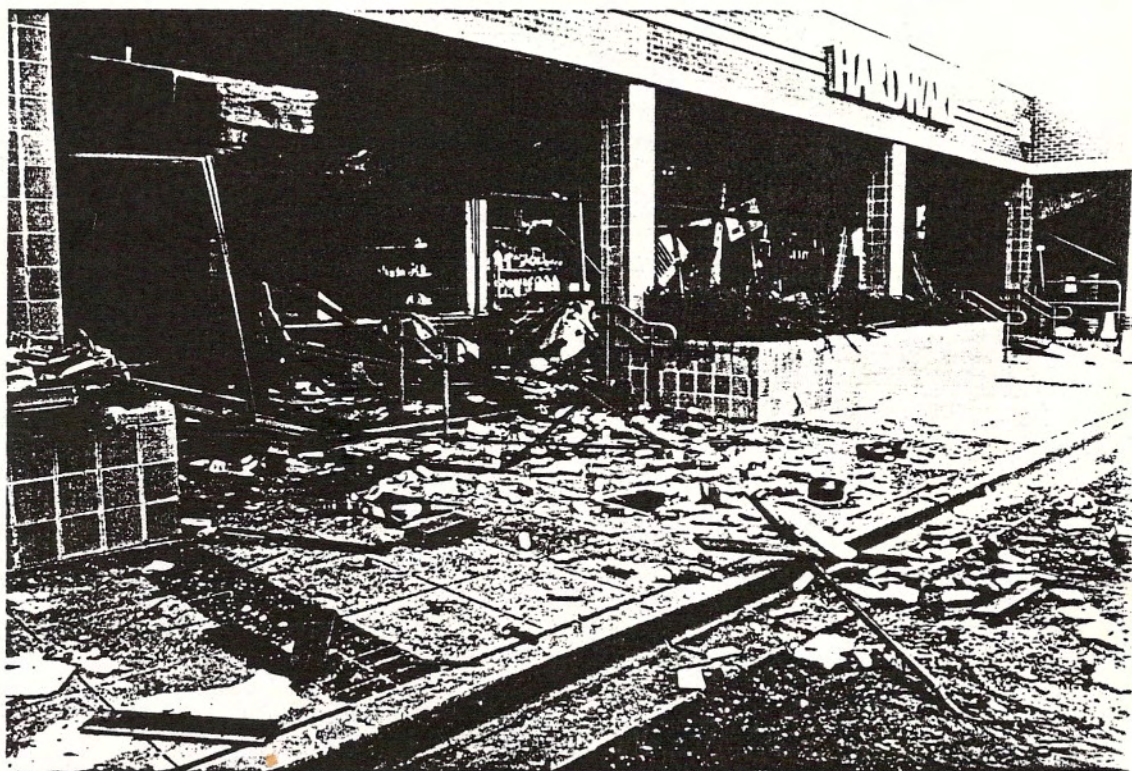
OVERVIEW OF SIDE ONE OF STORES AFFECTED BY EXPLOSION. NOTE AMOUNT OF DEBRIS THAT FORCEFULLY BLEW OUT FRONT OF STORES.

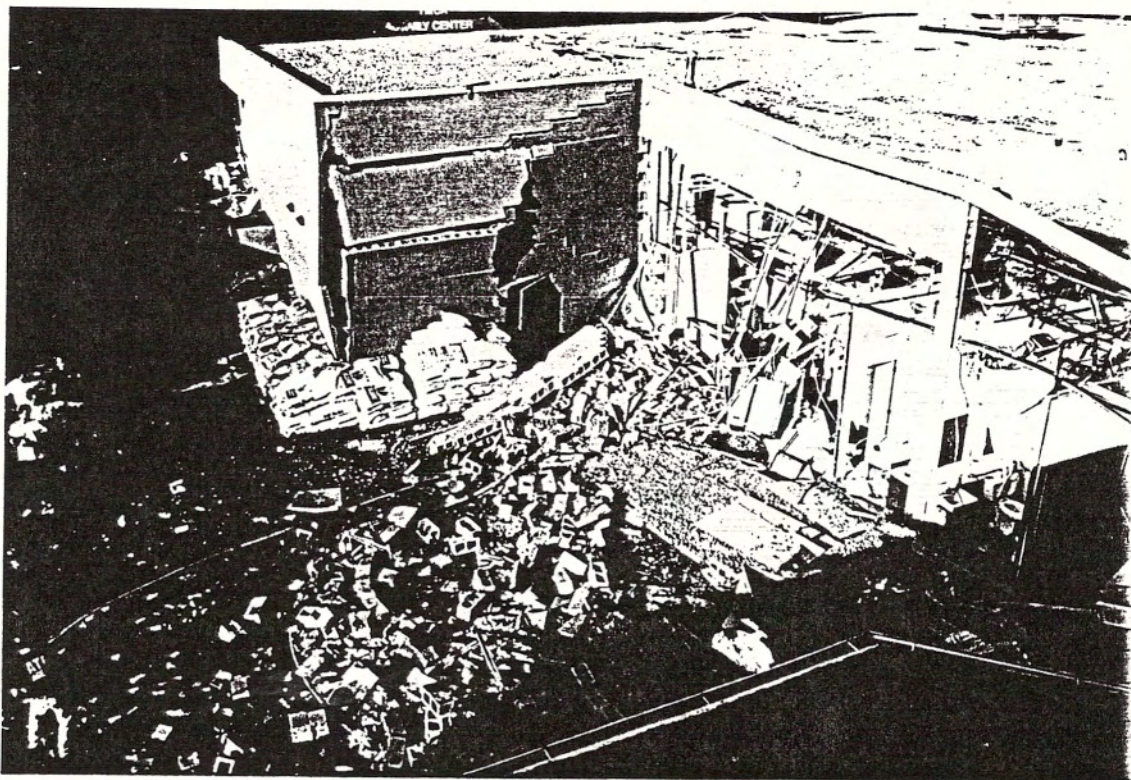
OVERHEAD VIEW FROM TOP OF GIANT FOOD SHOWING SIDE 3 - NOTE WALLS AT REAR OF HARDWARE STORE - 19219 WATKINS MILL ROAD - WALLS POSED SIGNIFICANT POST EXPLOSION COLLAPSE HAZARD.

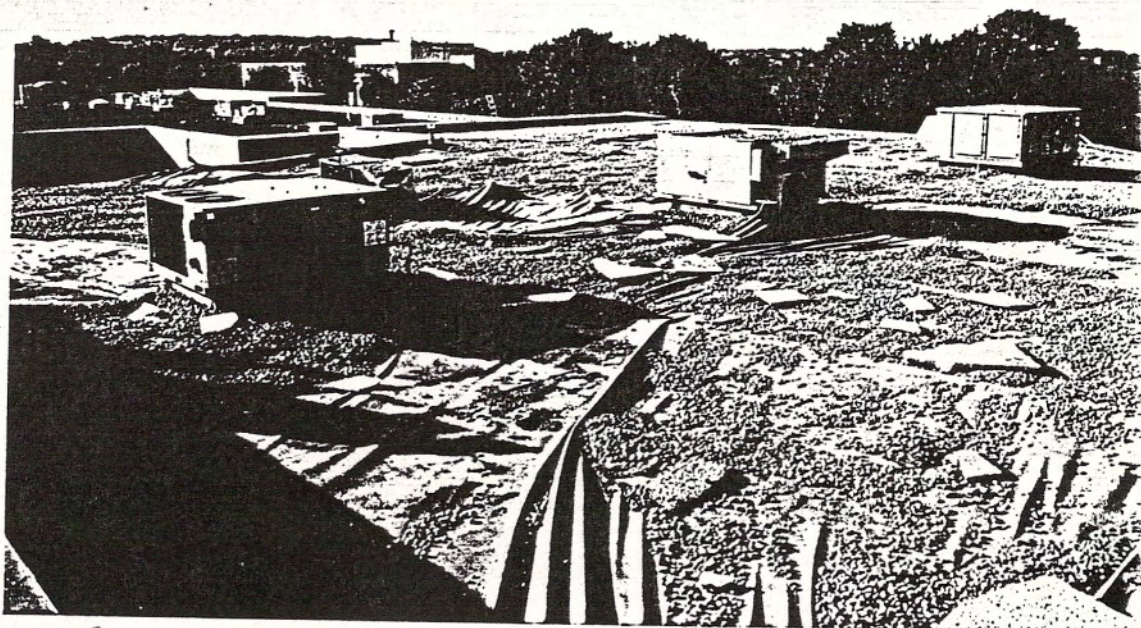
OVERHEAD ROOF SHOT FROM GIANT SHOWING DAMAGE TO ROOF STRUCTURE OF THE THREE STORES INVOLVED. NOTE MEMBRANE ROOFING WHICH MOVED DUE TO STRESS OF EXPLOSION.

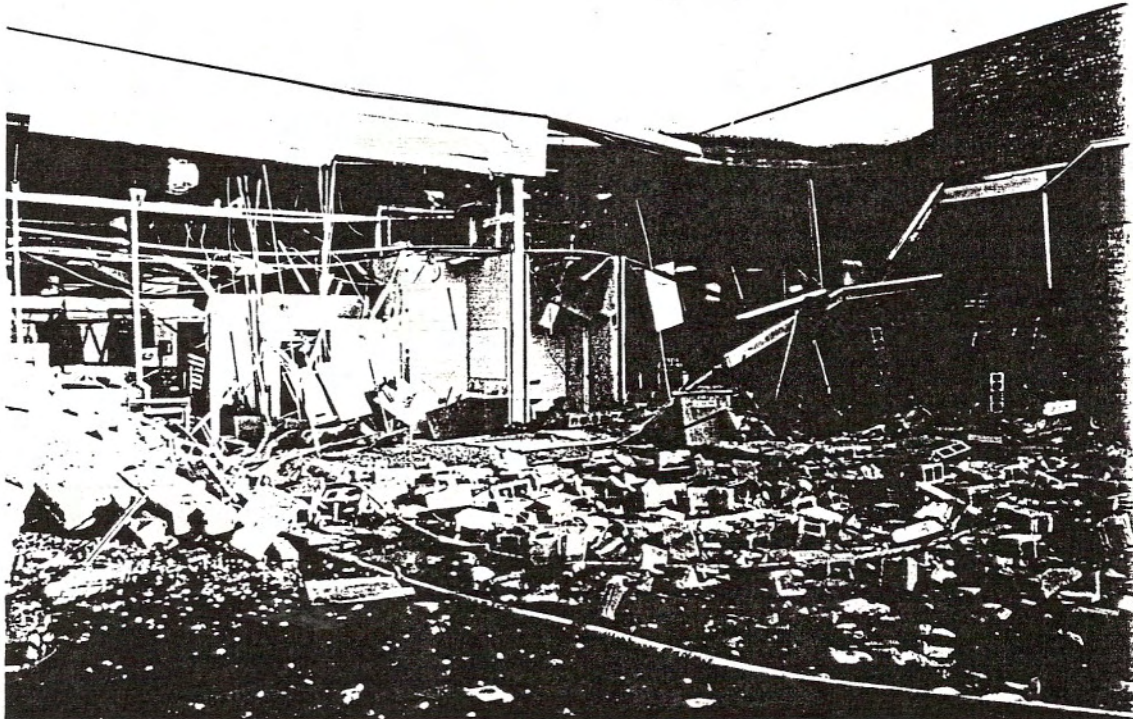
AREA TO RIGHT OF CENTER IS REAR OF GRAPE & GRAIN - 190223
 WATKINS MILL ROAD - GAS LEAK & FIRE IN CORNER TO REAR OF THAT
 STORE - NOTE HANDLINE UNDER DEBRIS.

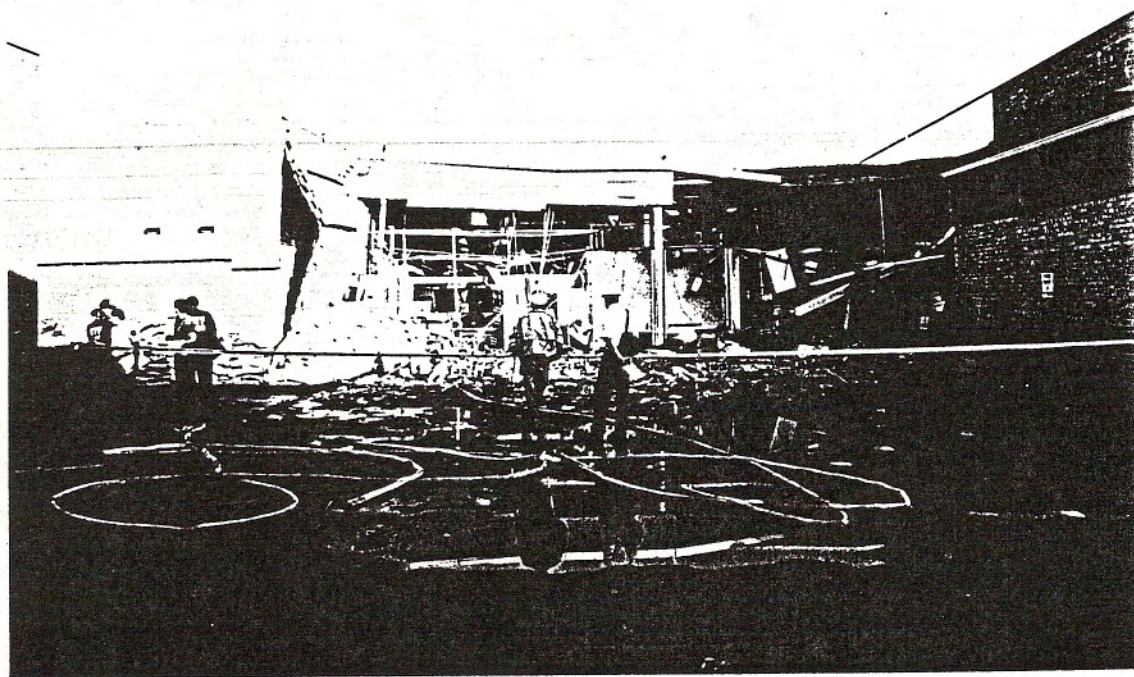
SIDE #3 - 19219, 21 & 23 WATKINS MILL ROAD - GIANT FOOD
STORE ON RIGHT - INJURED FIREFIGHTERS/GAS LEAK & FIRE
FOUND IN CORNER NEXT TO GIANT - NOTE E281's HAND LINE UNDER
DEBRIS.

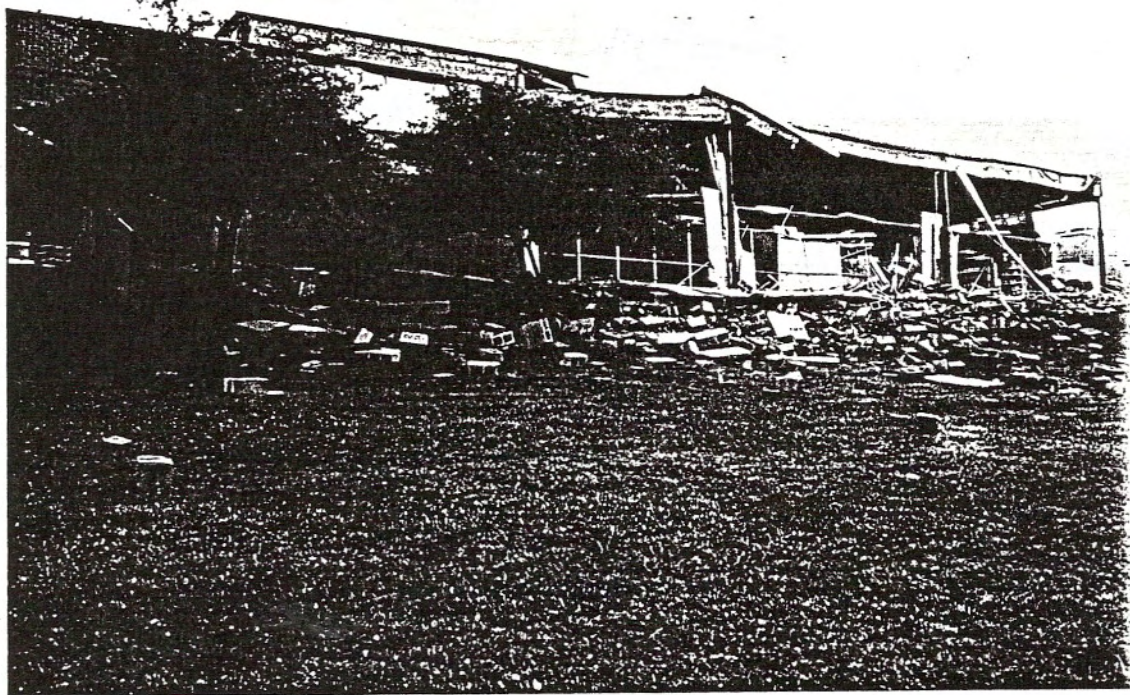
SIDE 4 OF THREE STORES INVOLVED IN EXPLOSION.

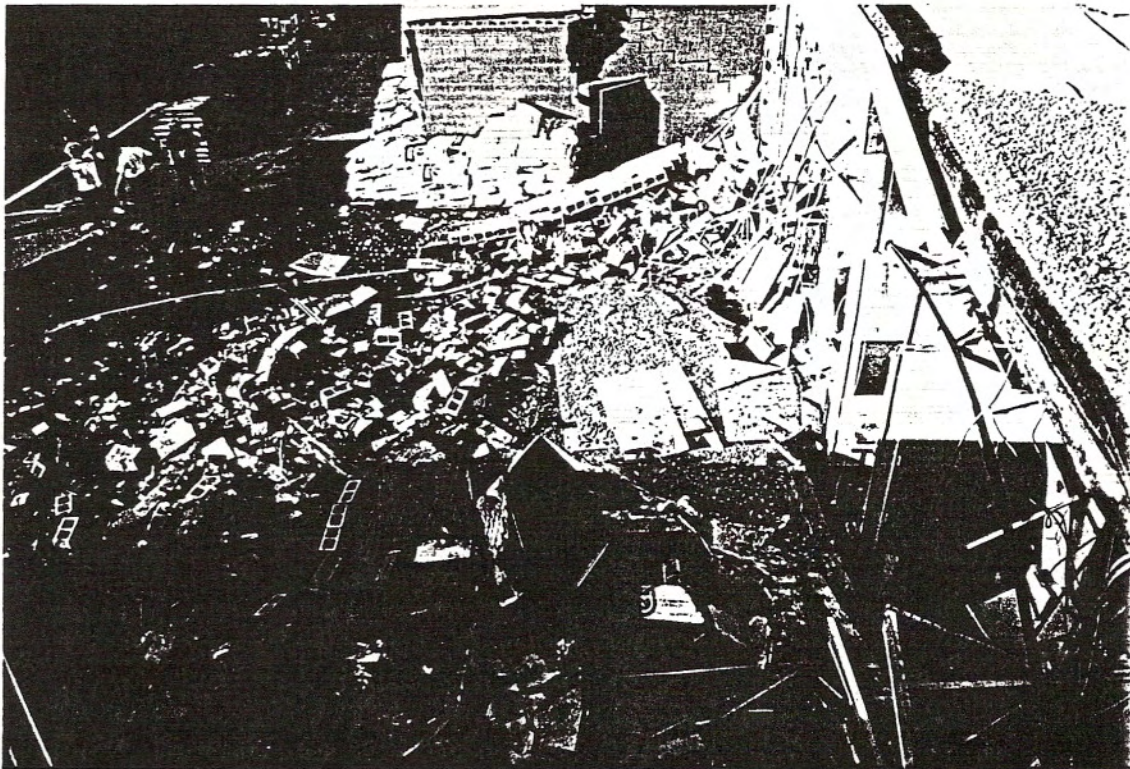
OVERHEAD VIEW OF AREA WHERE SOME FIREFIGHTERS AND ONE WASHINGTON GAS EMPLOYEE WERE OPERATING AT TIME OF EXPLOSION. E281's HANDLINE WAS UNDER THE DEBRIS.

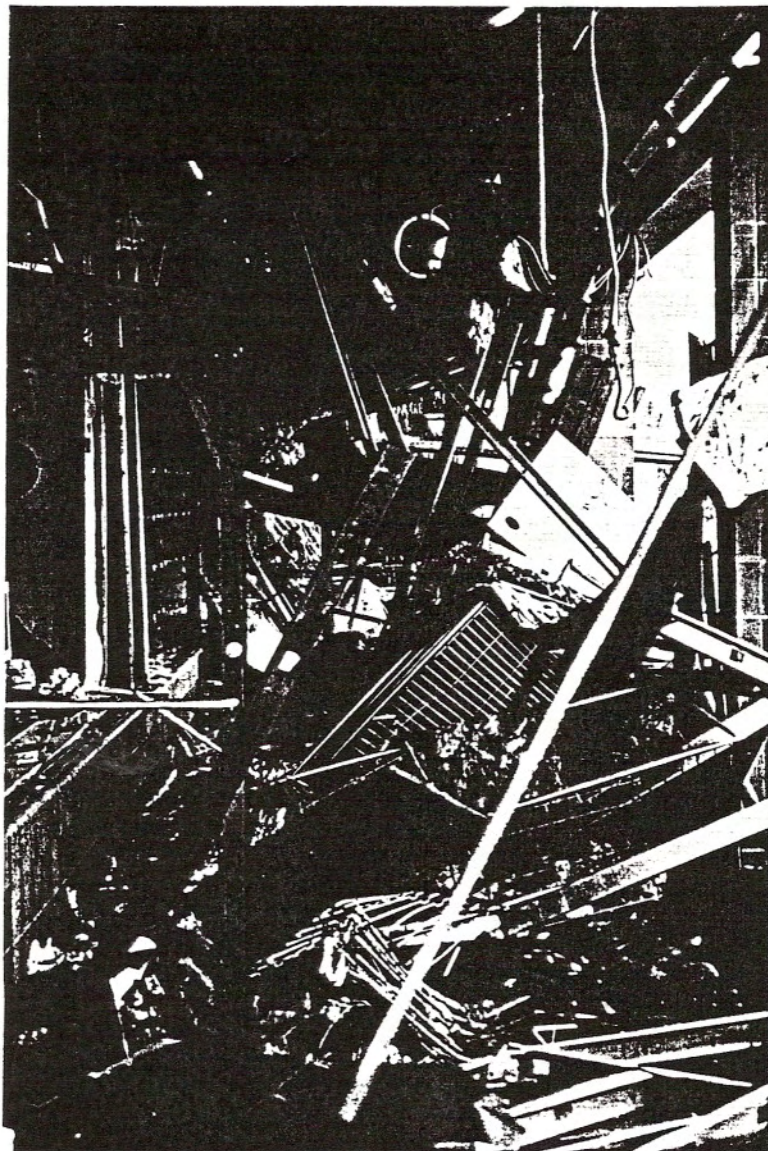
SIDE ONE SIDEWALK AREA IN FRONT OF STORES WHERE EXPLOSION OCCURRED
