Post Incident Analysis

6450 Brookes Lane

November 11, 2007

Post Incident Analysis Brookes Lane

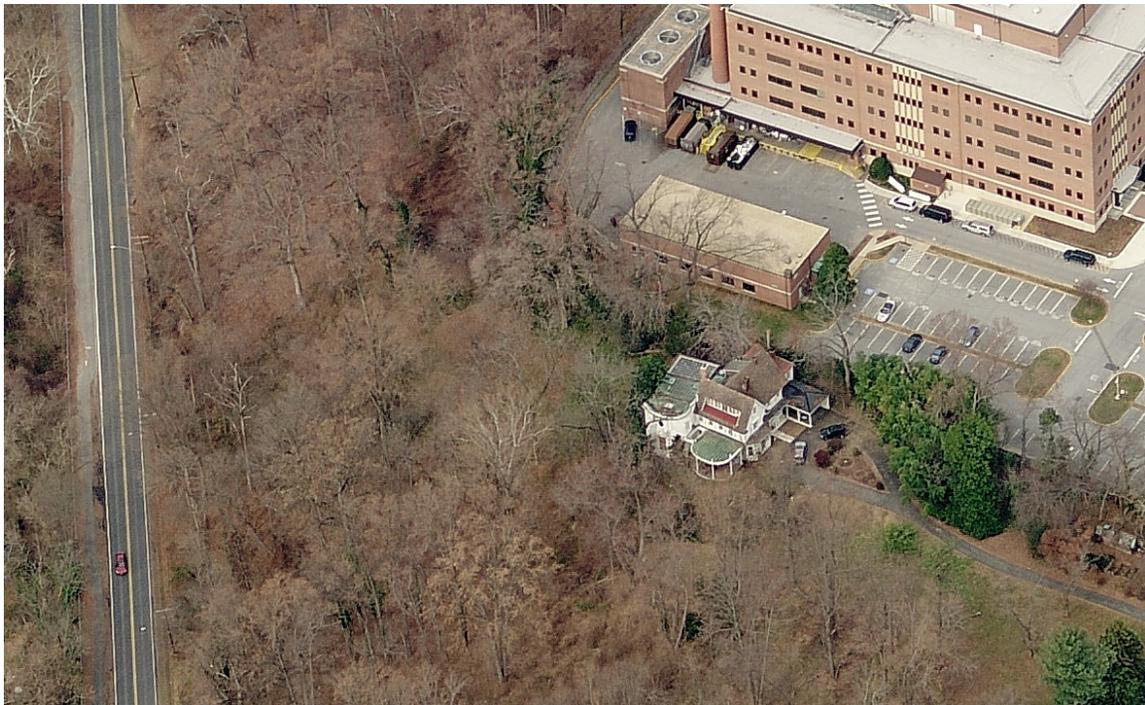
This house fire was dispatched for 6450 Brookes Lane at 2010 hrs on November 11, 2007, Inc#07-0112623. Upon arrival heavy fire conditions were apparent from side Alpha. E711's on scene report was a structure fully involved. Companies initially operated in a defensive mode and transitioned into an offensive attack after the bulk of the fire was knocked down. Several issues challenged the fire department in this incident; including access, apparatus, and equipment, each will be discussed in detail. This incident is still under investigation and was determined to be approximately \$1 million fire loss.

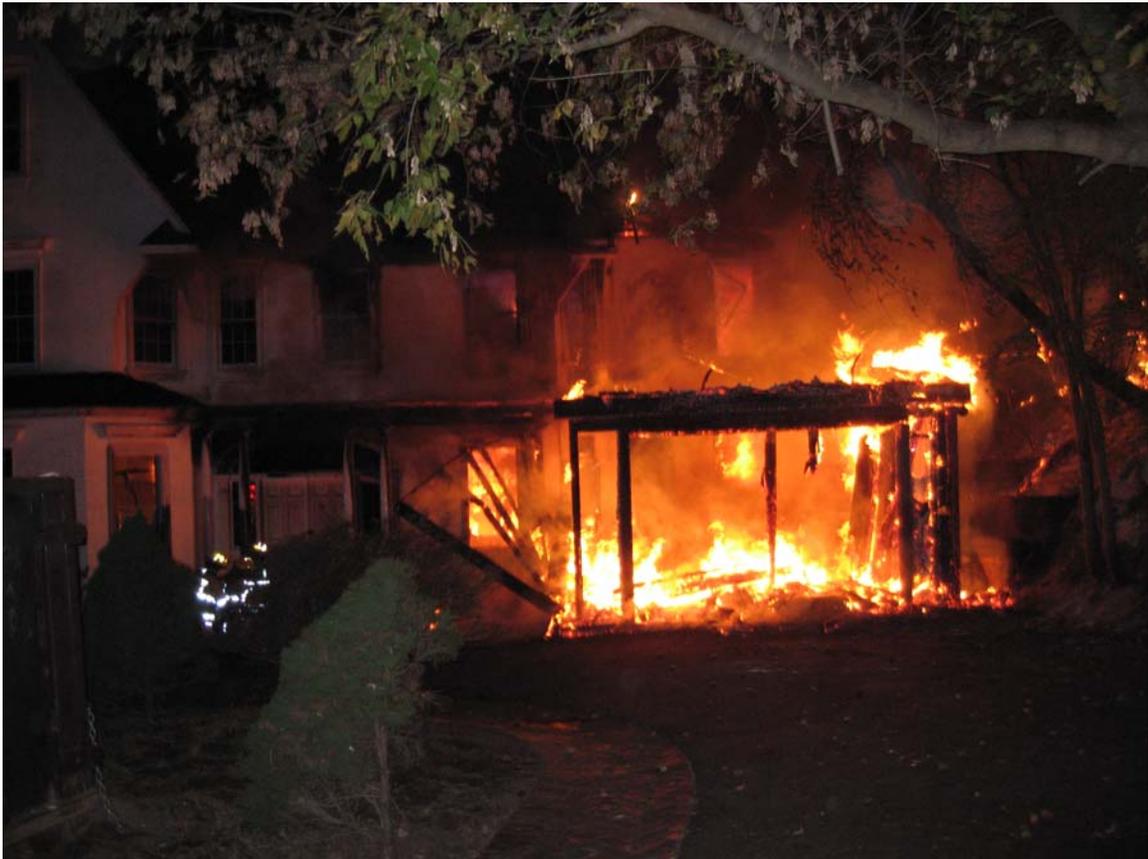
This house is a very large wood frame balloon construction single family dwelling. Attached was an “in-law” suite with carport on side Delta. One of the challenges, was the stairs to the second floor of the “in-law” suite were burned through. Without access from any other area of the house, interior access to the in-law suite was determined to be unsafe on the first floor, so extinguishment in this area was completed by breaching an interior wall of the second floor.

The driveway presented a challenge; two brick columns with gates were present at the entrance to the drive. The driveway in the direction of travel was a greater than a 90 degree turn to enter. E711 damaged their ladder rack entering the driveway hitting

the gate at the entrance. BC702 entered the driveway but no additional apparatus could access the driveway, T706 attempted to make the turn but could not enter. All additional apparatus parked out on Brookes Lane or they positioned in the parking lot of Defense Mapping.

Had preplans or institutional knowledge of the driveway area existed, E711 could have changed their approach to the scene and directed T706 as well to circle around the block to enter the driveway from the other direction, eliminating the damage to E711 and allowing T706 up the driveway.

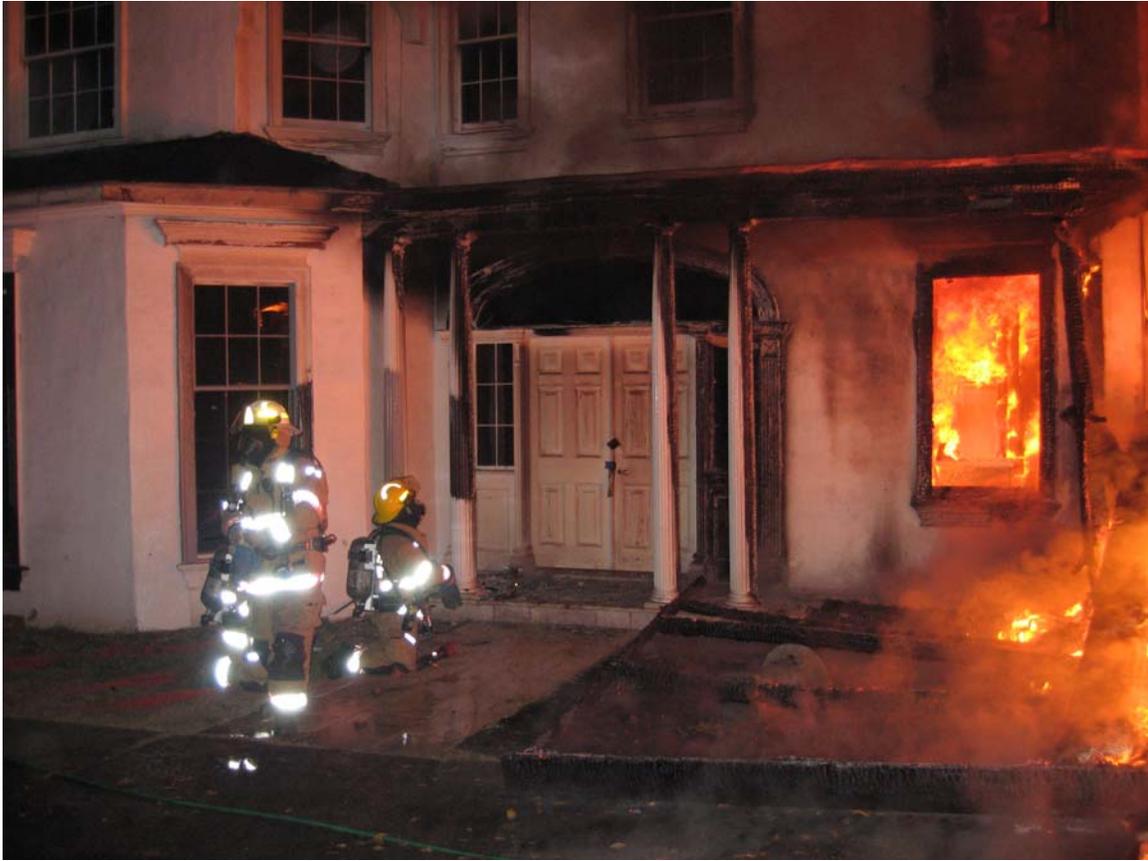
Access to the second floor of the “in-law” suite was cut off due to the stairs burning through as explained earlier. The rear stairs were also burned which required companies entering from the rear to find alternate access to the upper floors. This delayed E710 and T710 in reporting to Division 2 for several minutes. Command was identified with a green light on the buggy as well as via a radio report upon assumption of command. Size up of conditions resulted in the initial engine company operating in a defensive operation utilizing a 2” and 2 ½” attack lines until the bulk of the fire was controlled and then transitioned into an offensive attack.

As stated earlier, apparatus positioning was a challenge because of the width of the driveway. All equipment, with the exception of that on E711, had to be carried up the 500+’ driveway or carried down through the woods from the Defense Mapping parking lot.

E711 had a limited water tank. E711 only has a 500 gallon water tank which limited their defensive attack until a water supply was established by E706.
