**310 UNIVERSITY BLVD WEST
POST-INCIDENT ANALYSIS**

**2 Alarm Church Fire
11 OCTOBER 2009**

**Completed by
Captain Charles Bailey, Acting Battalion 701**

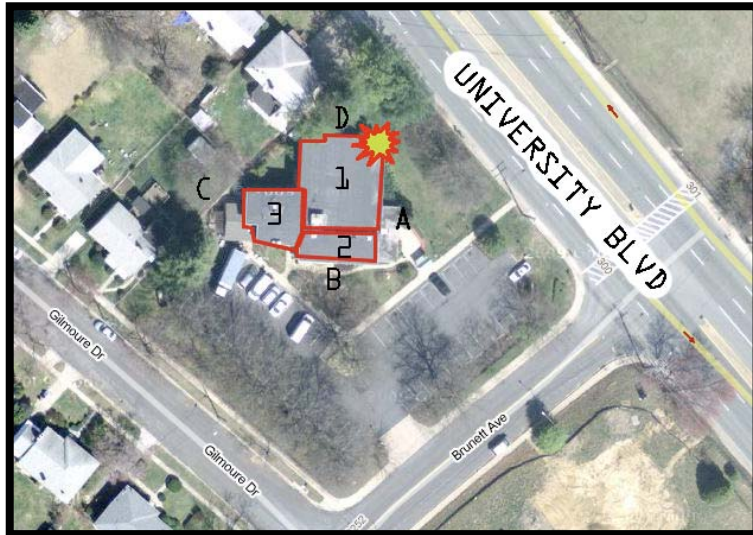
The structure is an active Buddhist Temple. From the address side the building is one tall storey (*a single storey of greater than usual height*). The main area of fire is outlined as (Area #1 in the graphic). Attached to this tall storey, but still integral to the structure was a two storey section used for a residence (Area #3 in the graphic) and a third section also attached and also two stories (Area #2 in the graphic).

The fire began in a first floor closet, marked on the graphic with a star.

Where the main body of the fire occurred there were masonry walls with wood studs and drywall. The overhead was drop ceiling below a metal deck roof with a composite roof covering that left a void space of about six feet between the bottom of the roof and the drop ceiling.

The building construction, more typically expected in strip malls or other commercial construction, allowed the fire to burn unnoticed in the building. The time delay between start of fire and initiation of fire department response allowed the fire to grow in intensity and to spread beyond the area of origin.
