2nd Alarm Garden Apartment Fire
May 2, 2009
14147 Castle Blvd
FS15's area

Post Incident Analysis for 14147 Castle Blvd

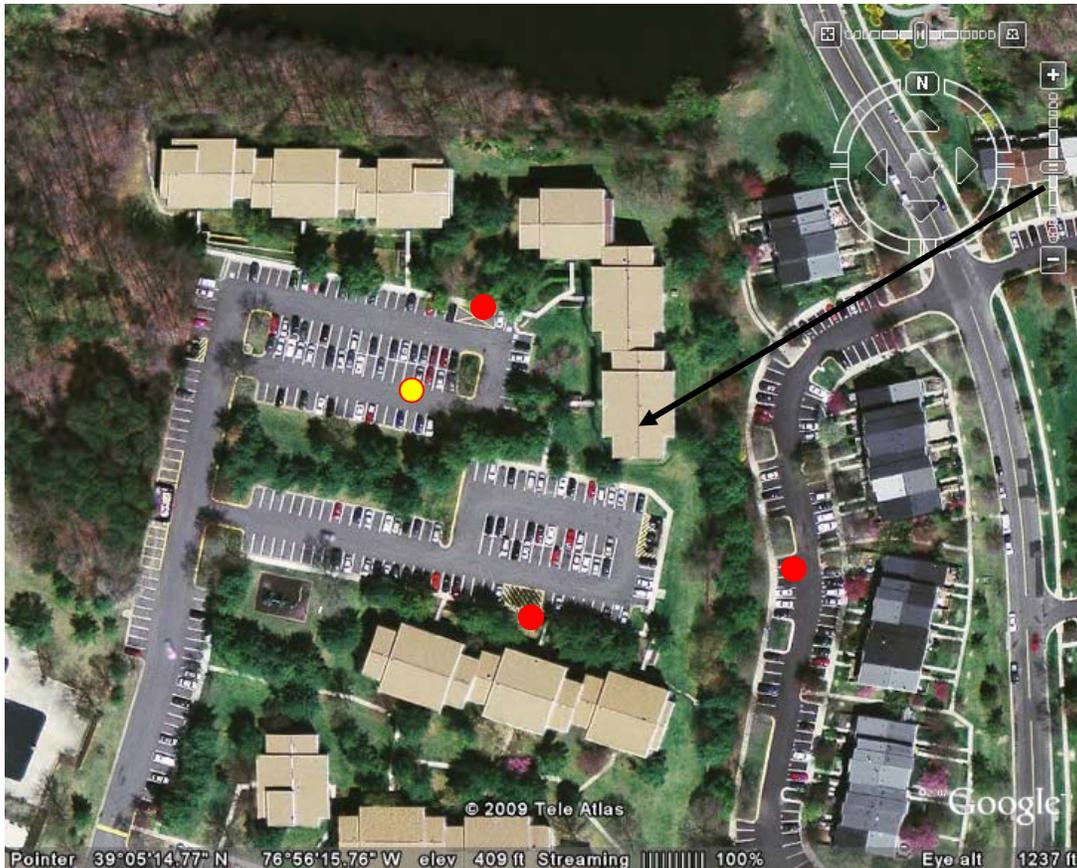
- Fire building identified with black arrow and command post with a yellow dot.
- Three closest fire hydrants are identified with red dots (only three used)
- Ashford at Woodlake apartments which consist of 38 buildings (three & four story garden apartments)

- The complex is broke down into three buildings that are connected or close enough to use the same power feed and utility room for water & gas.
- All of the structures are Type 3 construction with no fixed fire suppression systems.
- The exterior walls are cinder block walls with wood siding (original) and then a second vinyl siding on top with foam insulation in between.
- The roofs of all structures in the complex are pitched and constructed of dimensional lumber in a truss form with a shingle roof.
- There are fire walls between the A & B apartments and the C & D apartments that do not break the roof line.

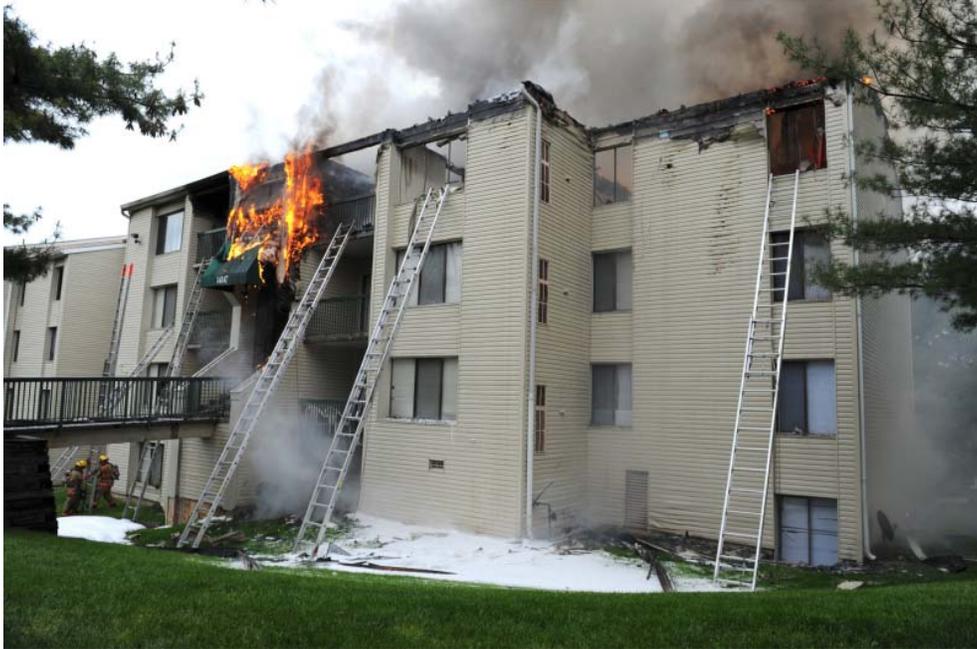
- The fire walls between the three buildings do break the roof line and the buildings are offset.

- There are two stairwells in each building, one on side A and one on side C. Both stairwells run from basement to the top floor.
- There is a two hour fire separation enclosure in the form of a lobby for all four apartments on each floor. Each side of this enclosure has a door for each stairwell.
- For the fire building there is a bridge walkway on side A which puts you on floor #2. On side C the entrance is ground level and puts you on the 1st floor.

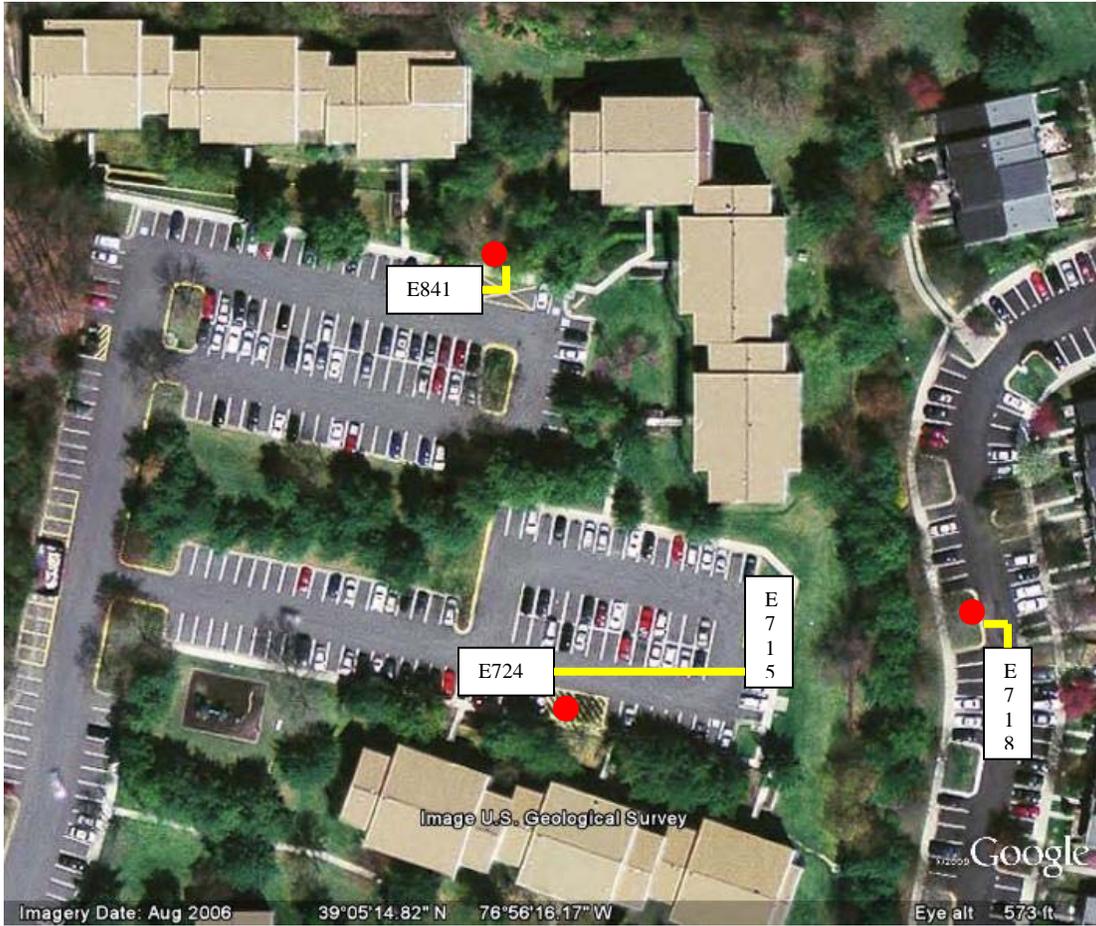
Water Supply

- There were a total of three hydrants on two different water mains used on this fire. The main size is 16" on Castle Blvd and 6" on Aldora Circle.

- 1st due engine (E715) advised en-route that they would be laying a 4" supply line from the hydrant in front of 14159 Castle Blvd and 2nd due engine (E841) acknowledged this message.
- 3rd due engine (E724) advised en-route that they would be laying a 4" supply line from the hydrant in front of 14139 Castle Blvd and 4th due engine (E712) acknowledged this message.
- But 1st due engine arrived on the scene and actually laid out from 14139 Castle Blvd. 2nd due engine arrived on the scene and established their own water supply using their soft sleeve. 3rd due engine arrived and completed 1st due engine's water supply. 4th due engine arrived and parked away from the scene.
- 3rd due engine on the 2nd alarm (E718) established their own water supply through their soft sleeve.

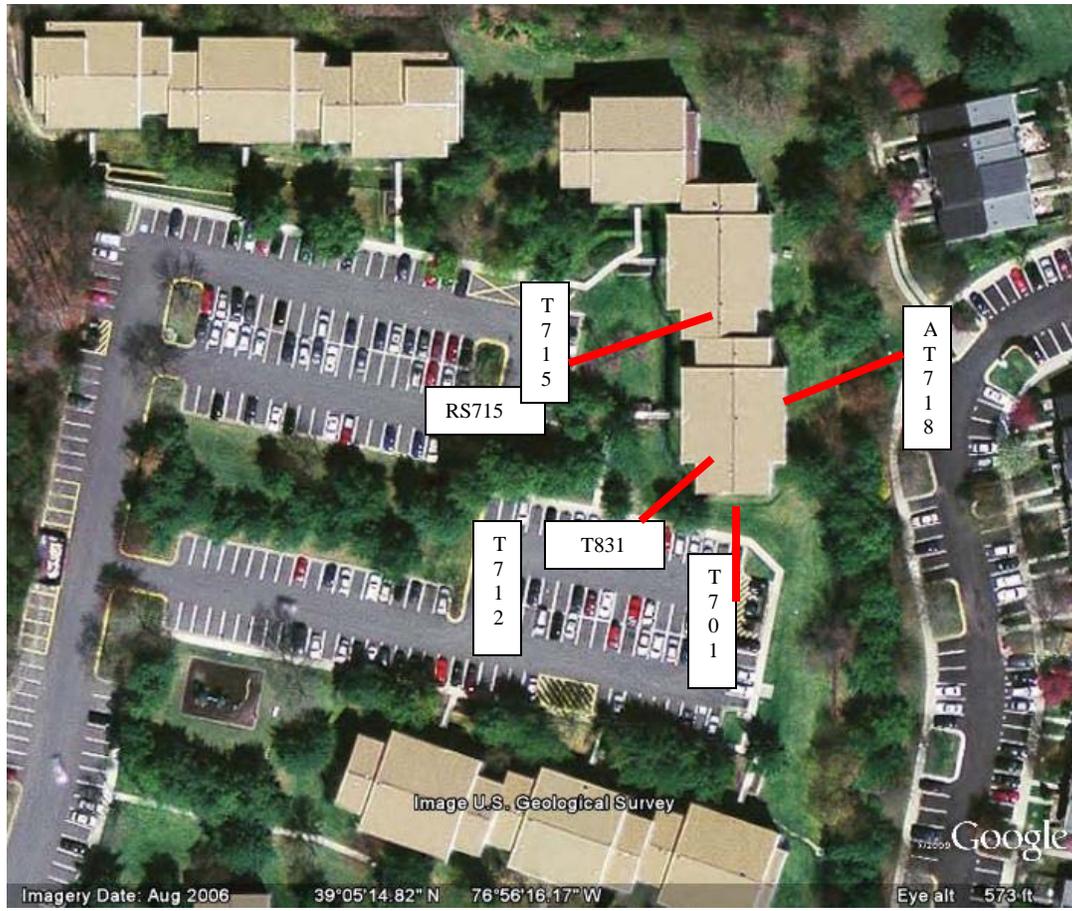
Tactical Positioning

- For a garden apartment complex there was a lot of space available for the 1st alarm units.
- First due truck (T715) took advantage of being one the first arriving units and positioned in an excellent spot. Their positioning allowed them to use their aerial ladder on both the fire building and the exposure “B” building.

- 2nd, 3rd, and 4th due trucks (T831, T712, & T701) all tried to squeeze into an area that one, maybe two trucks only could have covered. The good element of having this many trucks close was the amount of ground ladders used was outstanding.

- 2nd due truck (AT718) took an extra minute and set up on side “C” with an excellent position that covered both the fire building and the exposure “B” building.

- The four engines used for water supply all had good positioning. With the four engines close there was not an issues with the number of attack lines needed for this incident.

- There was one EMS unit (A831) and one Rescue Squad (RS715) positioned too close to the scene. The area taken by these units should be kept available for trucks or towers.
- Staging area was on Castle Blvd and was not an issue. .

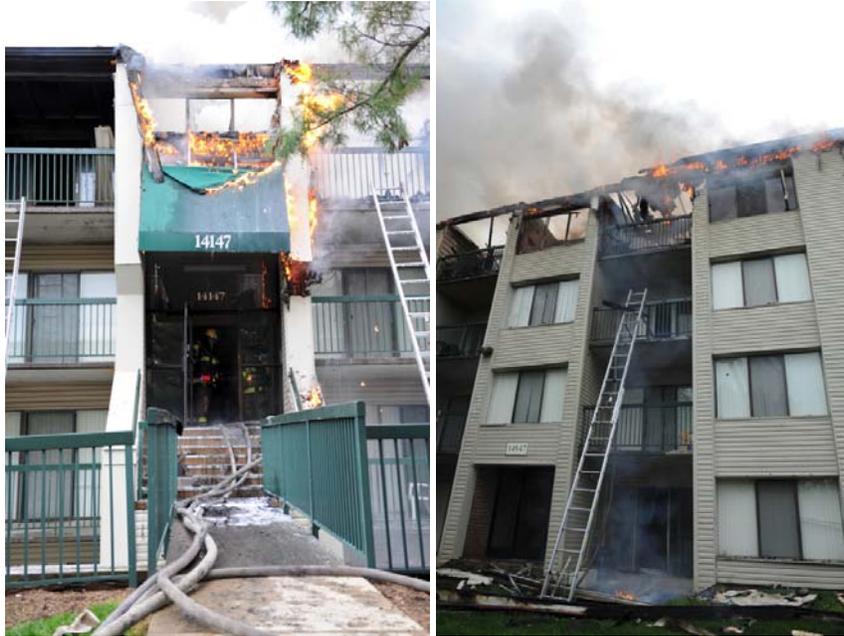
Attack Line Deployment

- There were a total of five hand-lines deployed on this fire with all five flowing water.
- The hand-lines ranged between 1 ¾" & 2" and ranged in length from 200' to 350'.
- E715 (1st Due) deployed a 350' 1 ¾" hand line through side A to the 4th floor. E841 (2nd Due) deployed a 300' 1 ¾" hand line through side A to the 4th floor. E724 (4th Due) deployed a leader line to side C, up a 24' ladder and then to the 4th floor. Two additional hand lines were pulled both through side A to the 2nd and 3rd floor. These lines were a 200' 1 ¾" hand line from E715 and 250' 2" hand line from E841. Having four hand lines deployed through side A, front door, resulted in numerous issues including hose entanglement and burst hose lines.
- E712 (4th Due) assigned to the RIG deployed a 1 ¾" hand line but never used it.

- Hand-line management was an issue through the front door. Crews tried to place four hand-lines in service in the same area. There should be a maximum of two hand-lines in one area, door, or stairwell.
