# Montgomery County Fire and Rescue Service Post Incident Analysis

## Townhouse Fire

**10237 Arizona Circle  
Bethesda, Maryland  
June 14, 2009**

**Incident #09-0061341  
21:31 Hours**

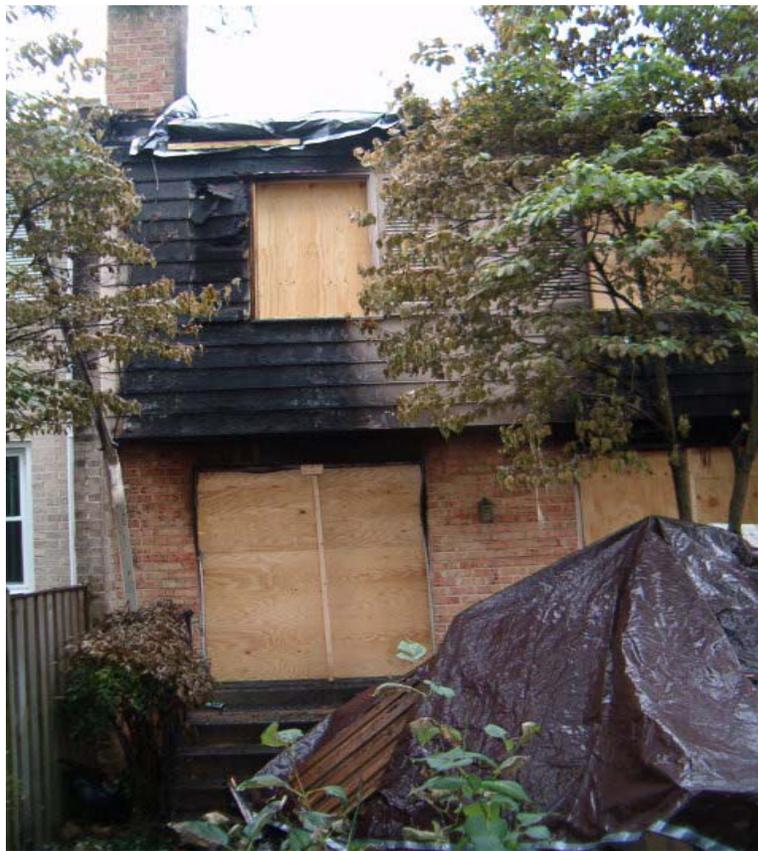
(Side Charlie)

- The structure is a two story townhouse with a basement and constructed in the mid 1970's.
- No exterior entrance to the basement
- Side walls (Bravo and Delta) constructed of cinder block and ran the height/length of the building.
- Square footage of approximately 1500 feet.
- Second unit in from the Delta end.

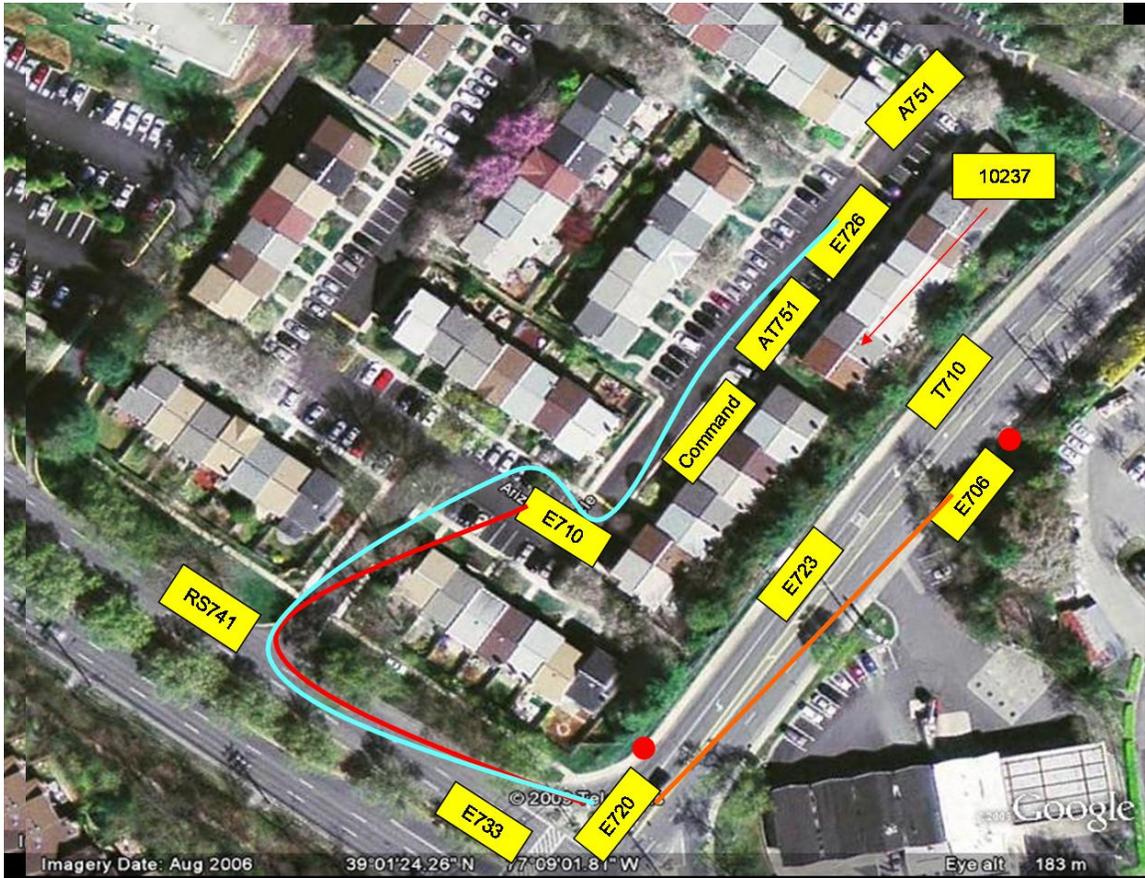
(First Alarm Apparatus Positioning)

Unit positioning was good for the most part. The position of the third due engine company (E710) contributed, in part, to the water supply problems. With a second access point (different than E726's) to the complex and sufficient fire hydrants on Westlake Drive, positioning on Side Charlie would have been most desirable. The second access point off of Westlake Drive would have been a better alternate than accessing the complex off of Democracy Boulevard. E723 should have completed the water supply no matter what position/access E710 decided upon.
