Montgomery County Fire and Rescue Service

POST INCIDENT ANALYSIS

**3rd Alarm Retail Clothing Store Fire
6822 New Hampshire Avenue
Takoma Park, MD**

Incident Date: December 5, 2009

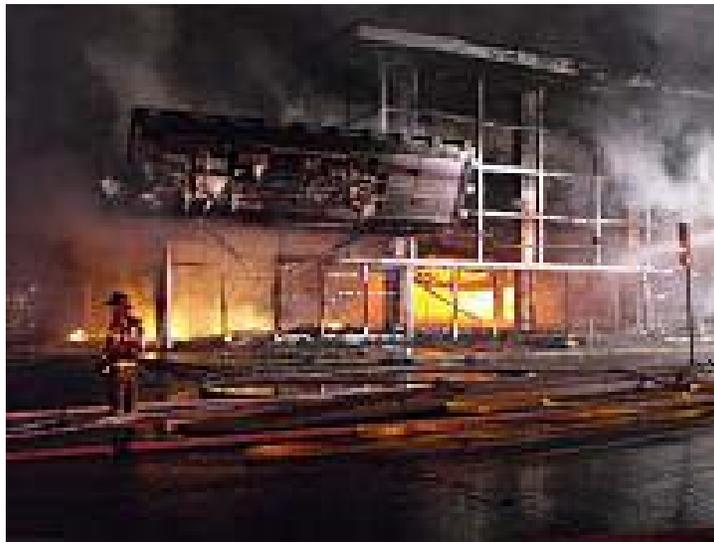
Side A – heavy fire noted in the center core area.

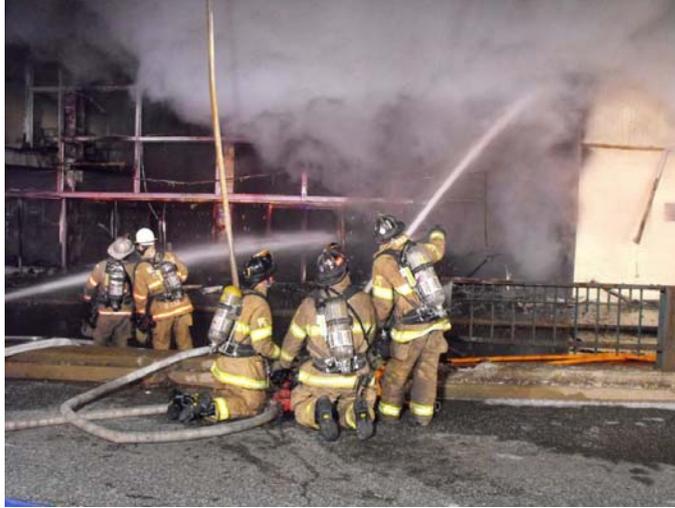
Crews operate a deluge gun and Blitzfire on Side A.

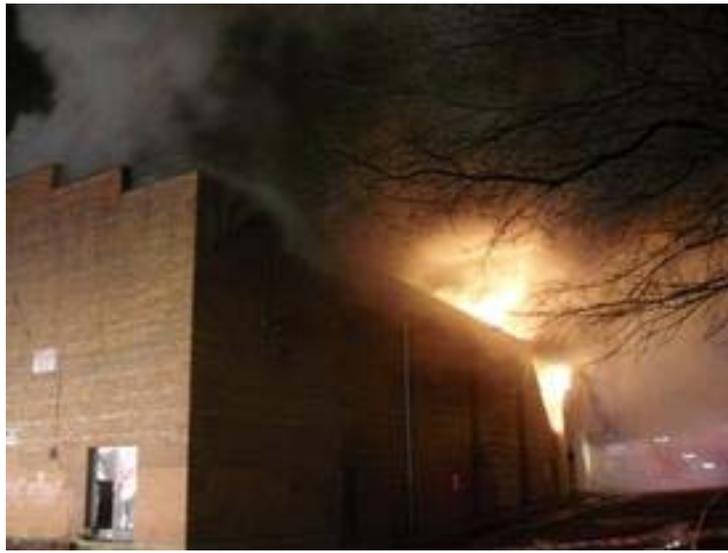
A look at Side B from the rear – fire through the center of the roof.

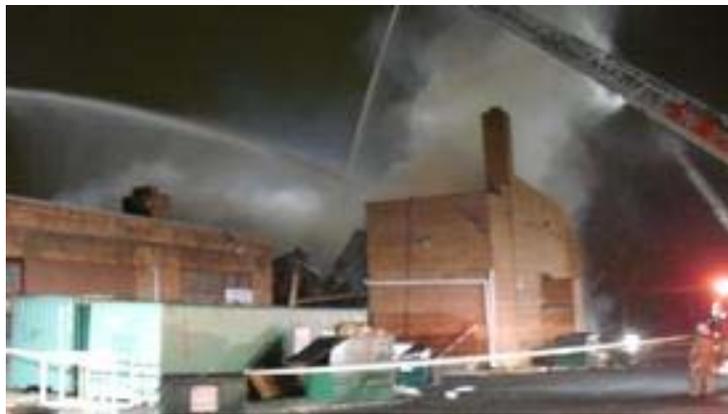
A look from the rear of Exposure D with partial collapse.

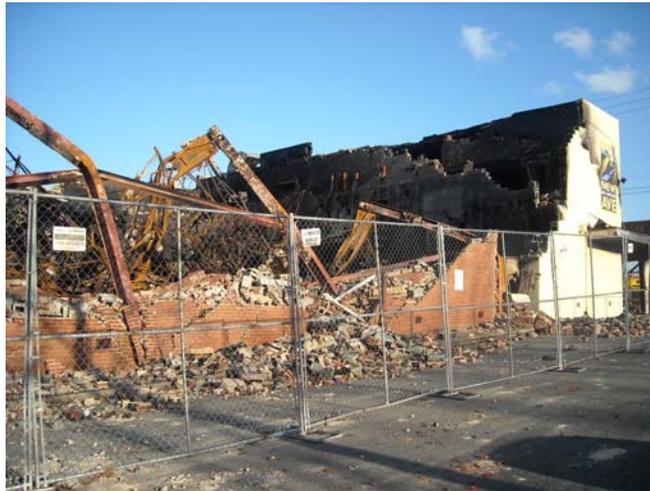
- As the fire progressed, additional collapses occurred bringing in the roof, a large portion of the Side B exterior wall, and a small portion of the Side D exterior wall. Fortunately, all collapses resulted in materials and building components falling into the structure – as opposed to away from the structure.

Collapse damage on Side B.

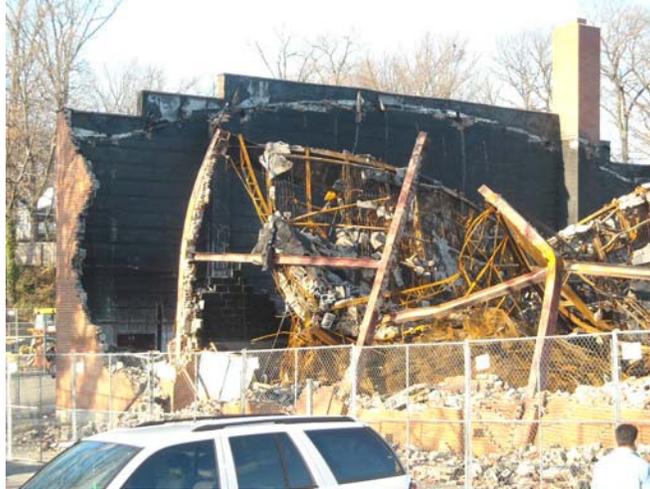
The arched roof outline can be seen on the rear wall.

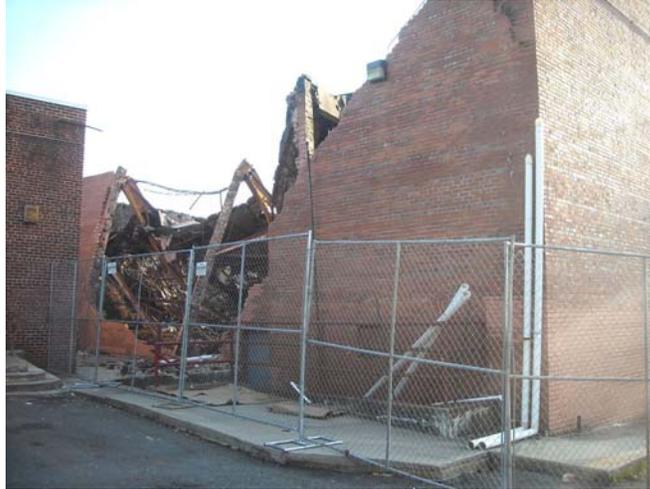
Corner of Sides C and D with some collapse.

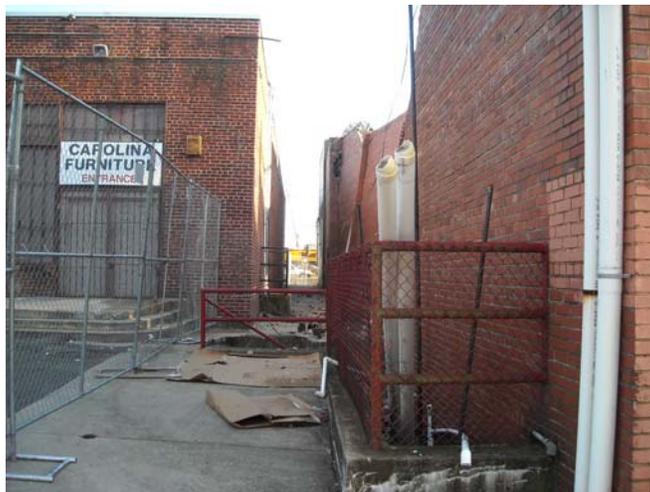
Not much space between Side D and Exposure D..
