Townhouse Fire
13248 Country Ridge Drive
March 1, 2009

**MIDDLE-OF-THE-ROW TOWNHOUSE
FIRE IN THE BASEMENT WITH EXTENSION
TWO FIREFIGHTERS INJURED**

Executive Summary

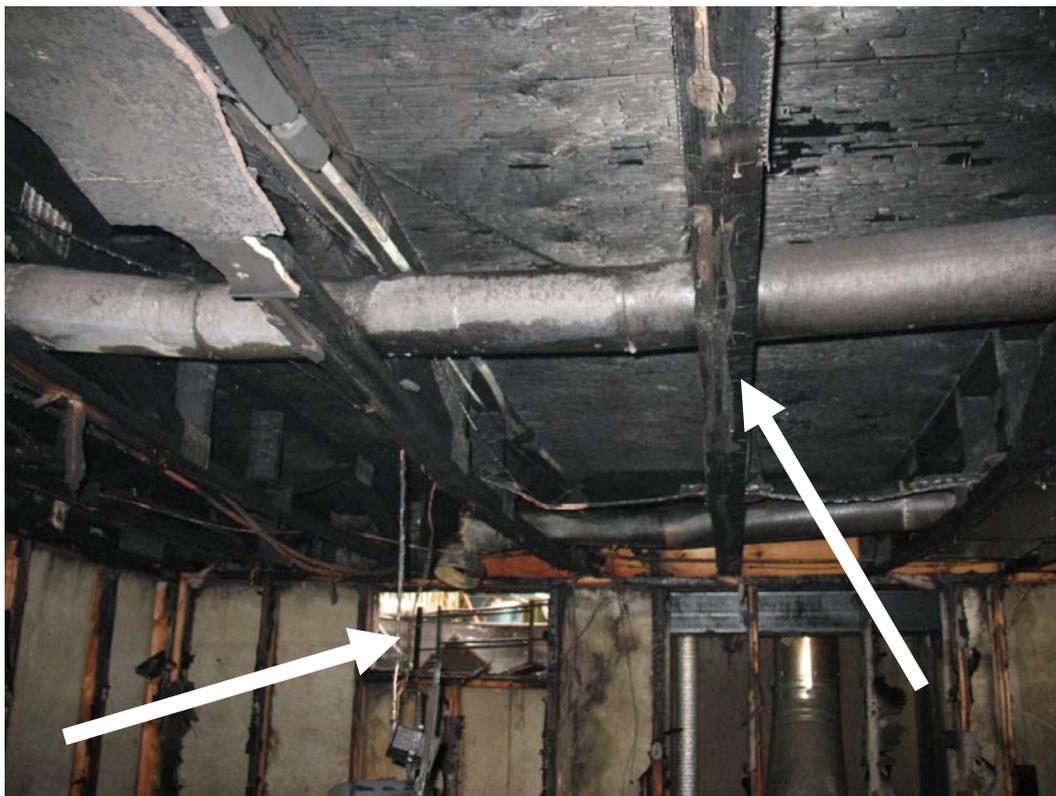
Figure 1

A detailed risk/benefit analysis should have been performed in the basement. The structural instability of the floor/ceiling assembly under the kitchen was an unsafe environment. Overhaul should have been limited and crews should have avoided the area.

Photo showing only window to basement and sagging floor/ceiling assembly

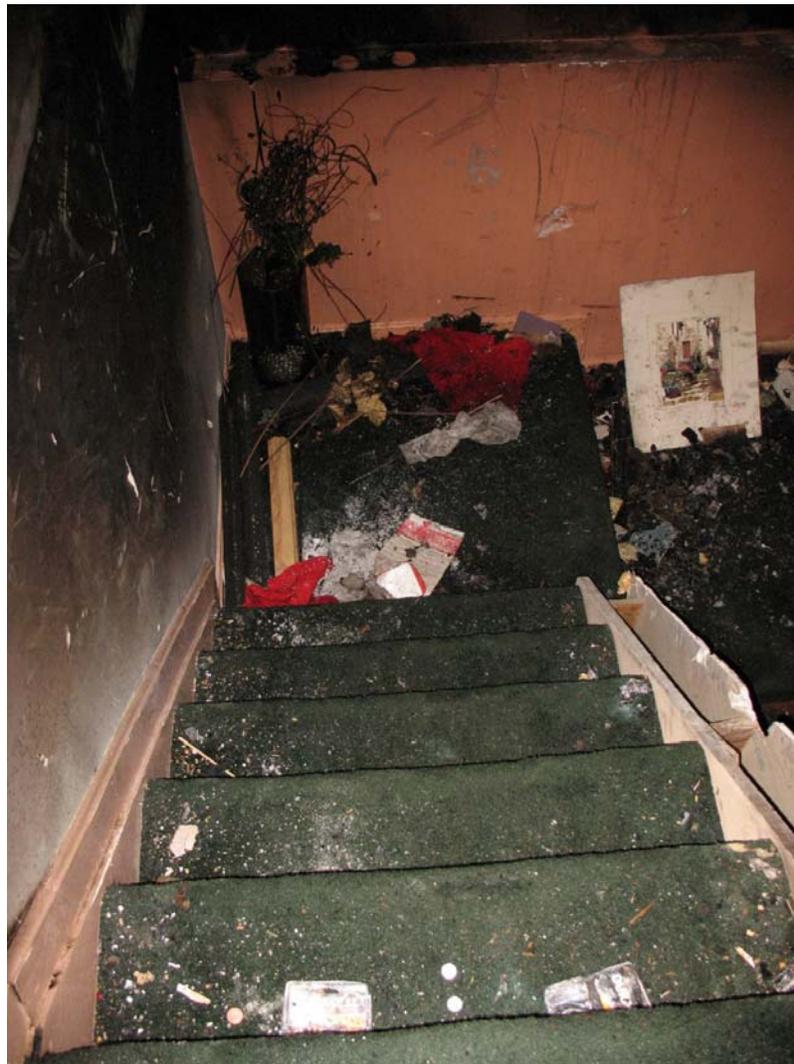
Figure 2

The initial attack plan was coordinated and known to all participants. E729/E722 protected the stairs for the primary search, then “penciled” the stairs in an effort to cool the atmosphere for entry. AT729’s officer then proceeded down the stairs backwards ahead of the charged hose line and kicked an object on the first landing. The object fell on the officer and he sustained injuries. He was able to exit the building (along with his crew).

Construction and fire behavior caused the open stairwell to become a chimney. This was the only place the products of combustion could go. Operating above the fire is already very dangerous. Attempting to take the stairs would be like looking down the throat of hell. Treading ahead of the nozzle is almost suicide in this case. Personnel need to use extra caution and consider other tactics, such as cutting a hole in the floor and dropping down a fog nozzle or distributor. If a distributor nozzle is on a rig, and a basement fire is known, consider bringing it with you.

**Photo looking down stairs from 1st floor to basement.
Officer off of AT729 injured on the landing**

Additionally, if fire is known to be in a basement with lightweight construction, consider laying a roof ladder on the floor to be used as a life boat if the floor collapses.

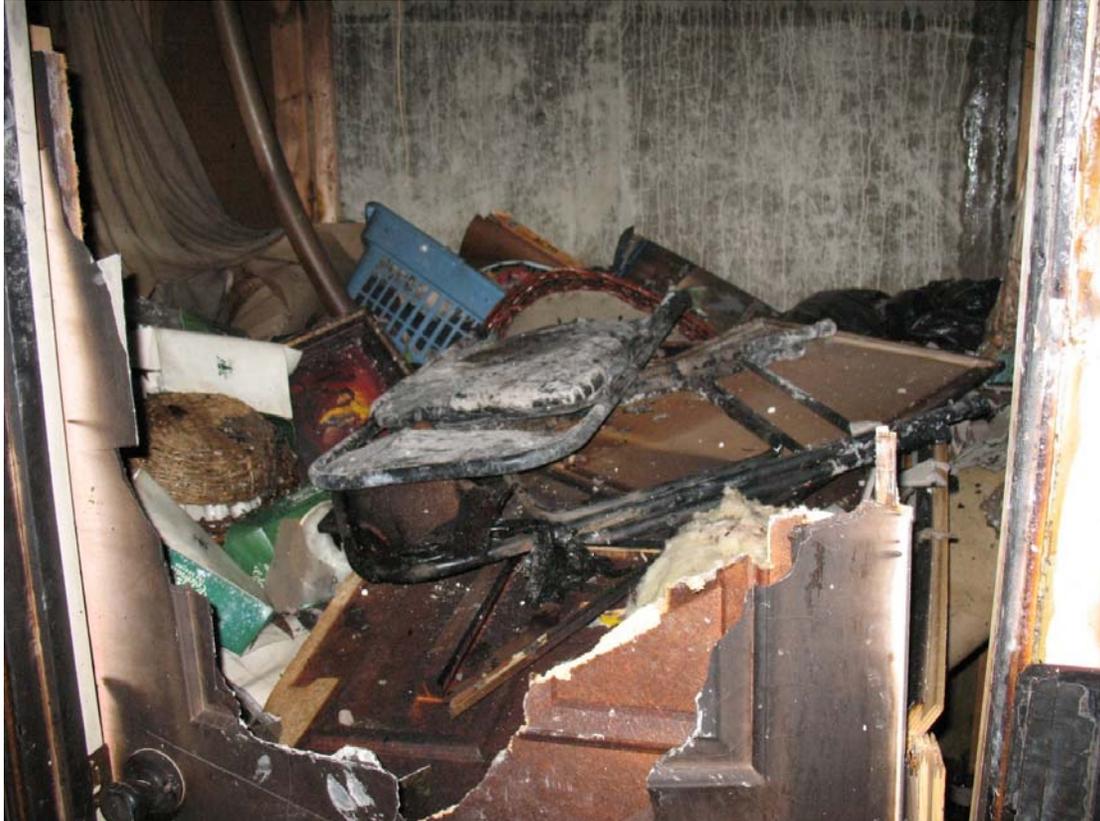
Figure 3 – Considerable fuel loading in basement

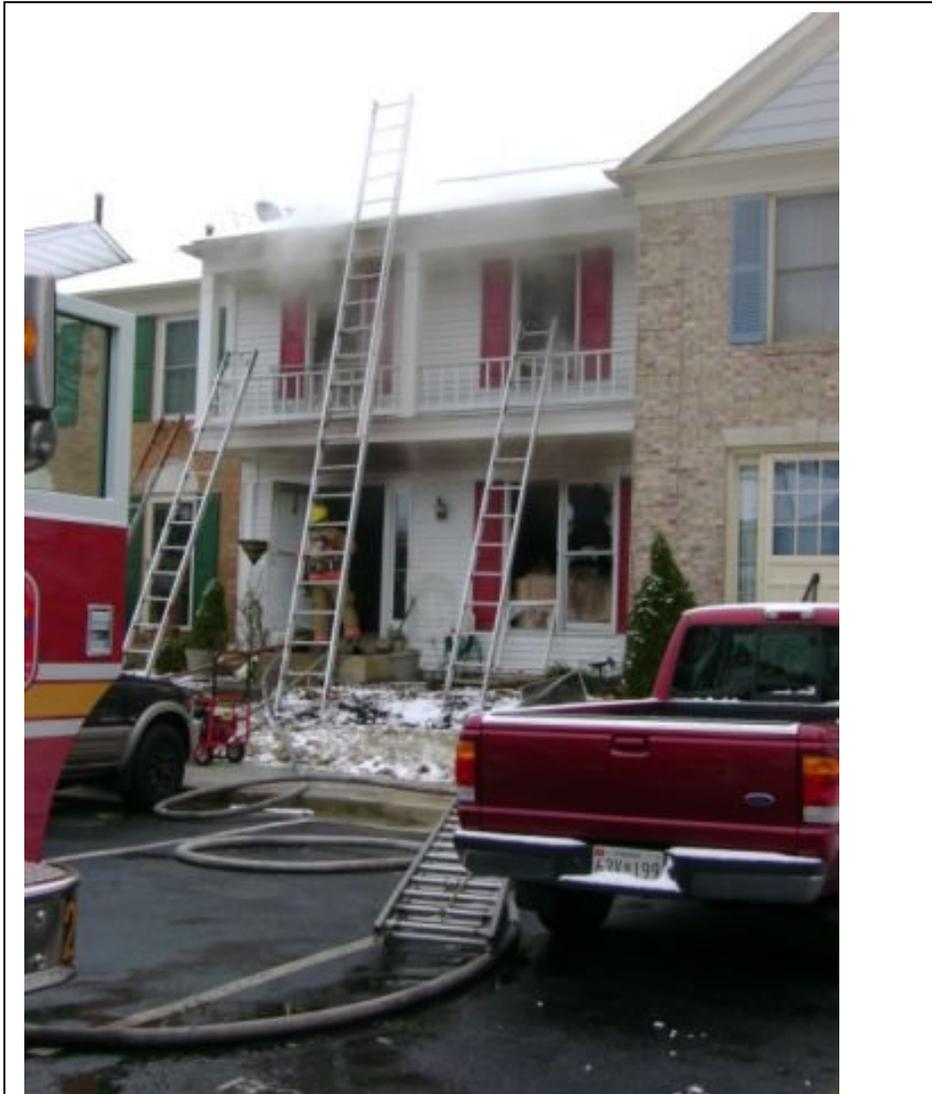
Figure 4
Side Alpha after Knock Down
(Photo courtesy of Idvfd.org)

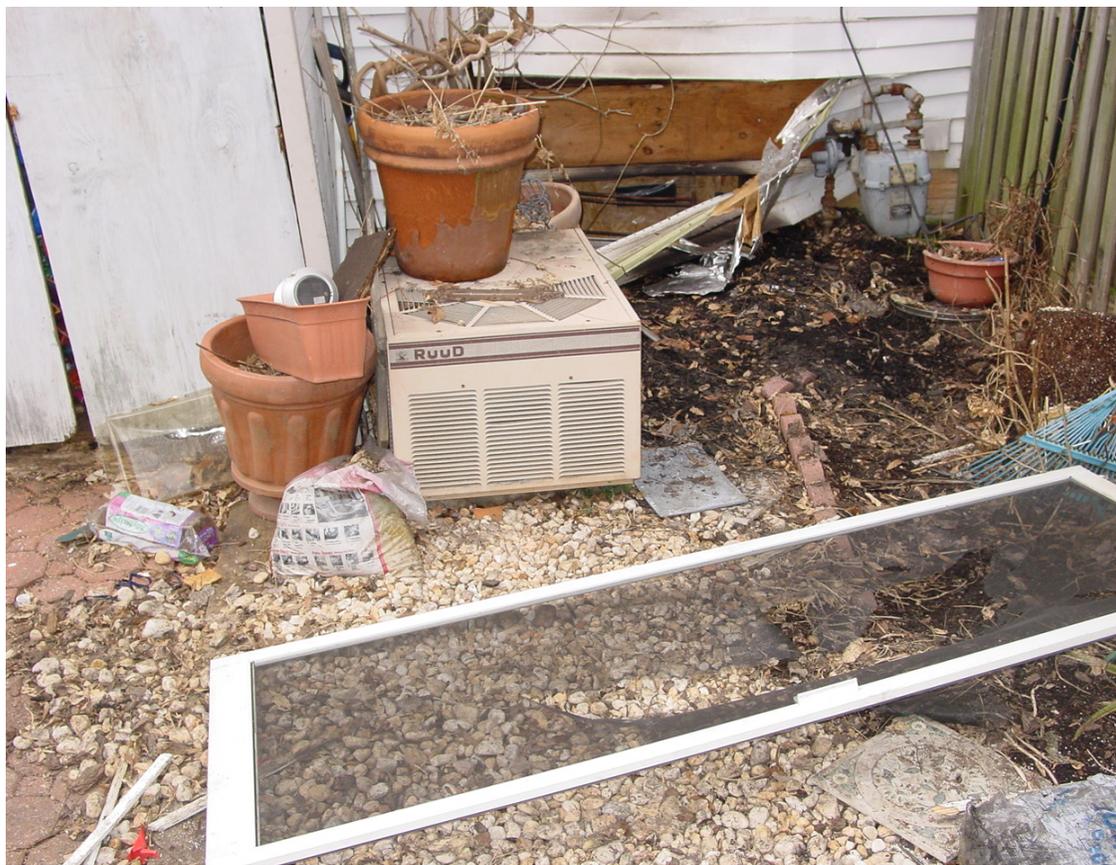
Figure 5

Only access to single basement window. Note proximity of gas meter, security bar and other obstructions.
