**Montgomery County Fire and Rescue Service**

**POST INCIDENT ANALYSIS**

**“Miracle on Mallory Place”**

**March 15, 2009**

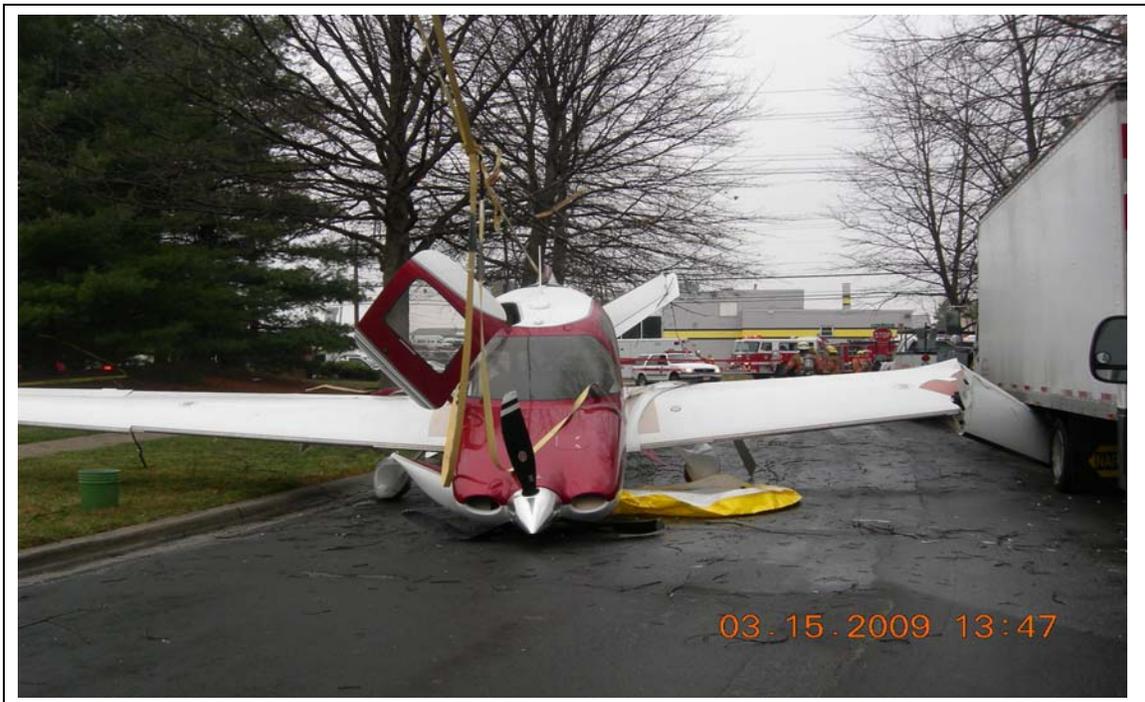
A 2,300-pound Cirrus SR22 airplane lost control shortly after take off veered west over Flower Hill and deployed its emergency parachute and descended onto Mallory Place, narrowly missing the traffic on Snouffer School Road and dozens of homes in the Carriage Walk section of Flower Hill. The pilot walked away from the crash, clipped pine trees lost about 20 gallons of aviation fuel and put a dent in a parked truck.

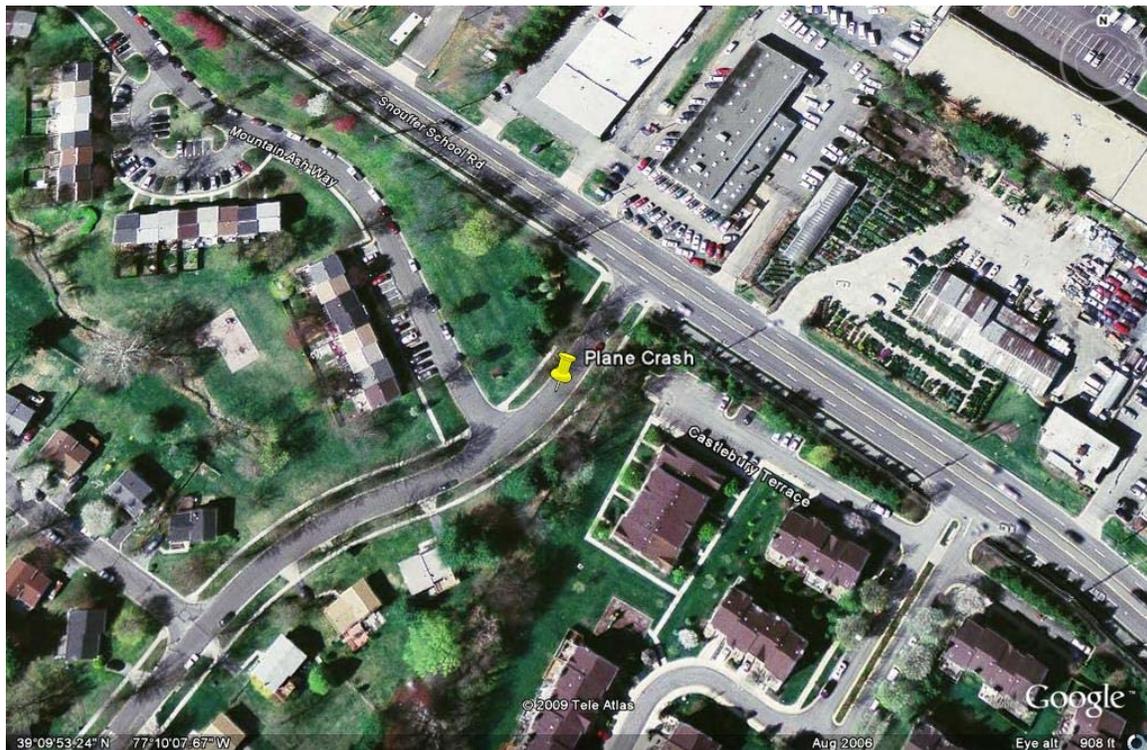
The Cirrus SR22 crashed on Mallory Place about 100 feet west of Snouffer School Road.
