METRO/CSX TRAINS VS. HOT WIRES

Incident #10-0084377

Spring St/Second Ave, Silver Spring, MD

July 29th, 2010

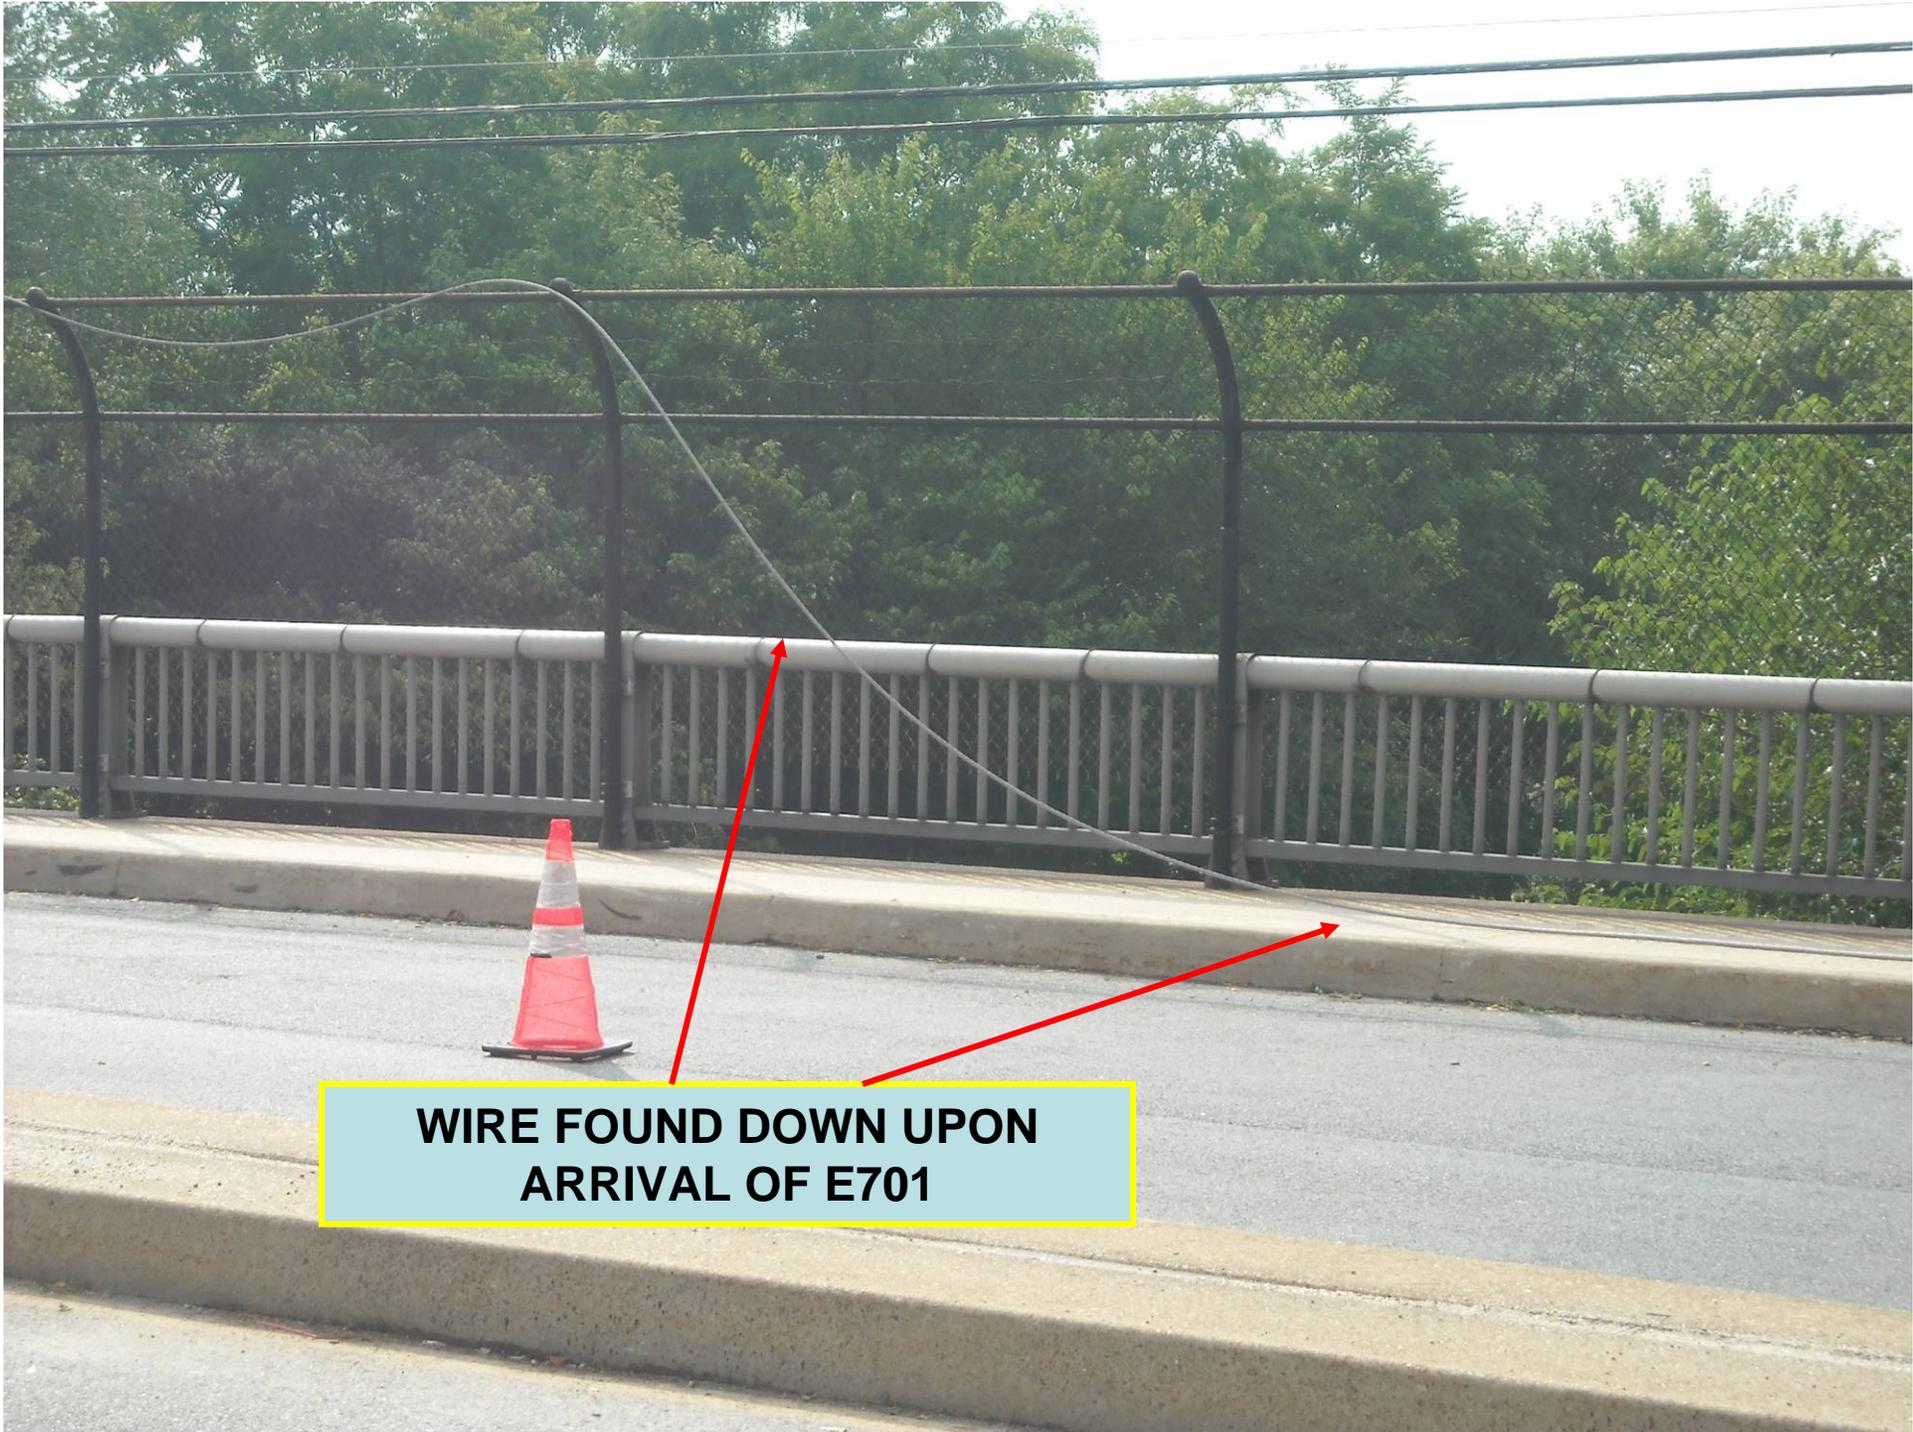
**WIRE FOUND DOWN UPON
ARRIVAL OF E701**

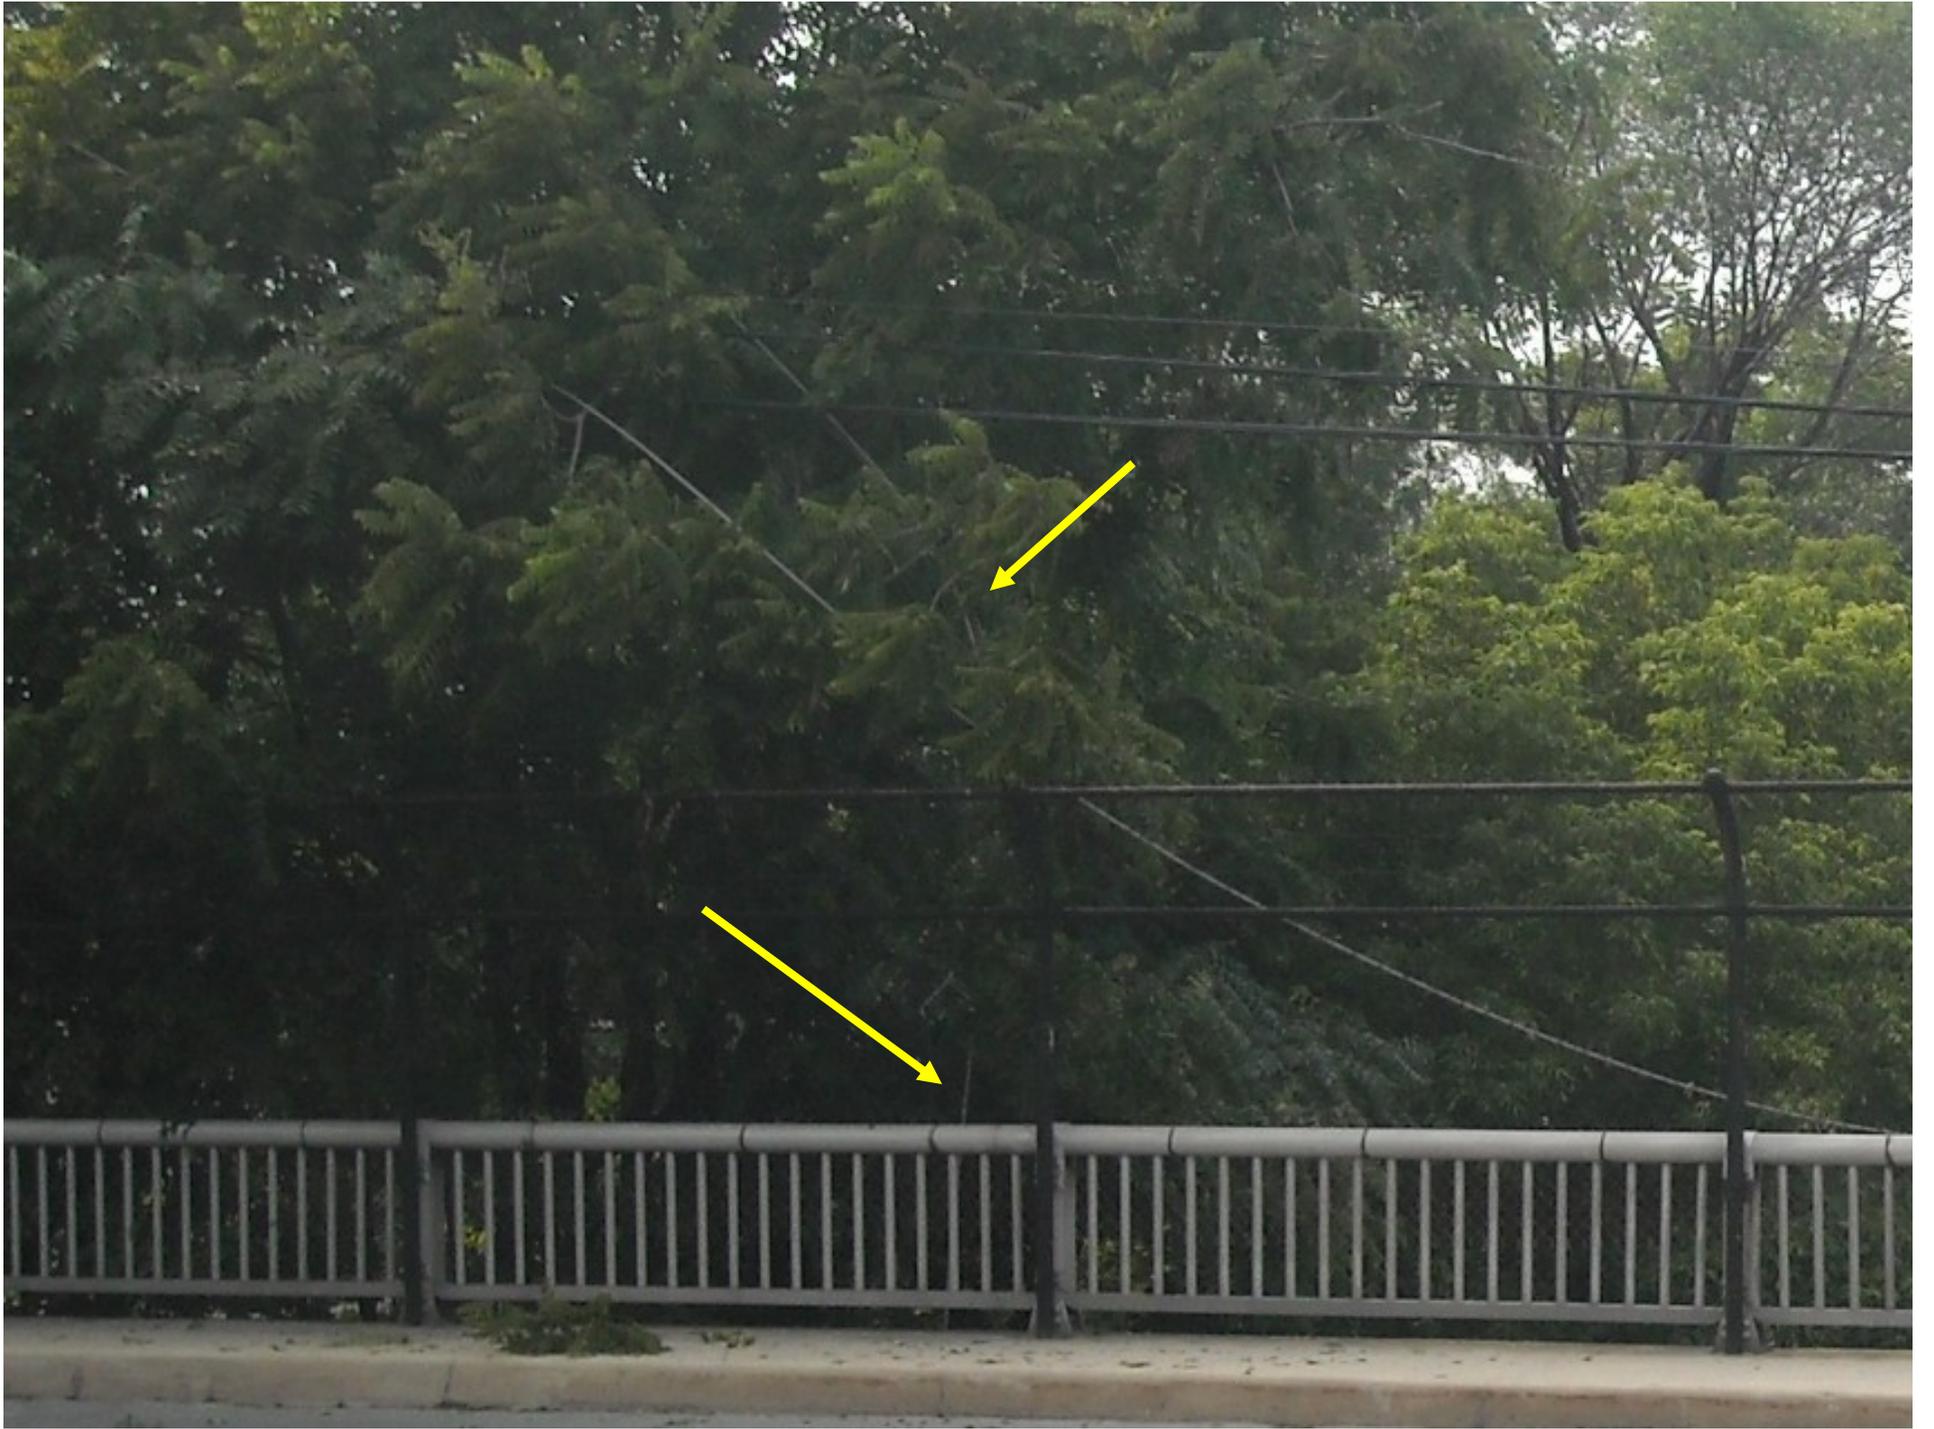
SECOND WIRE

FIRST WIRE

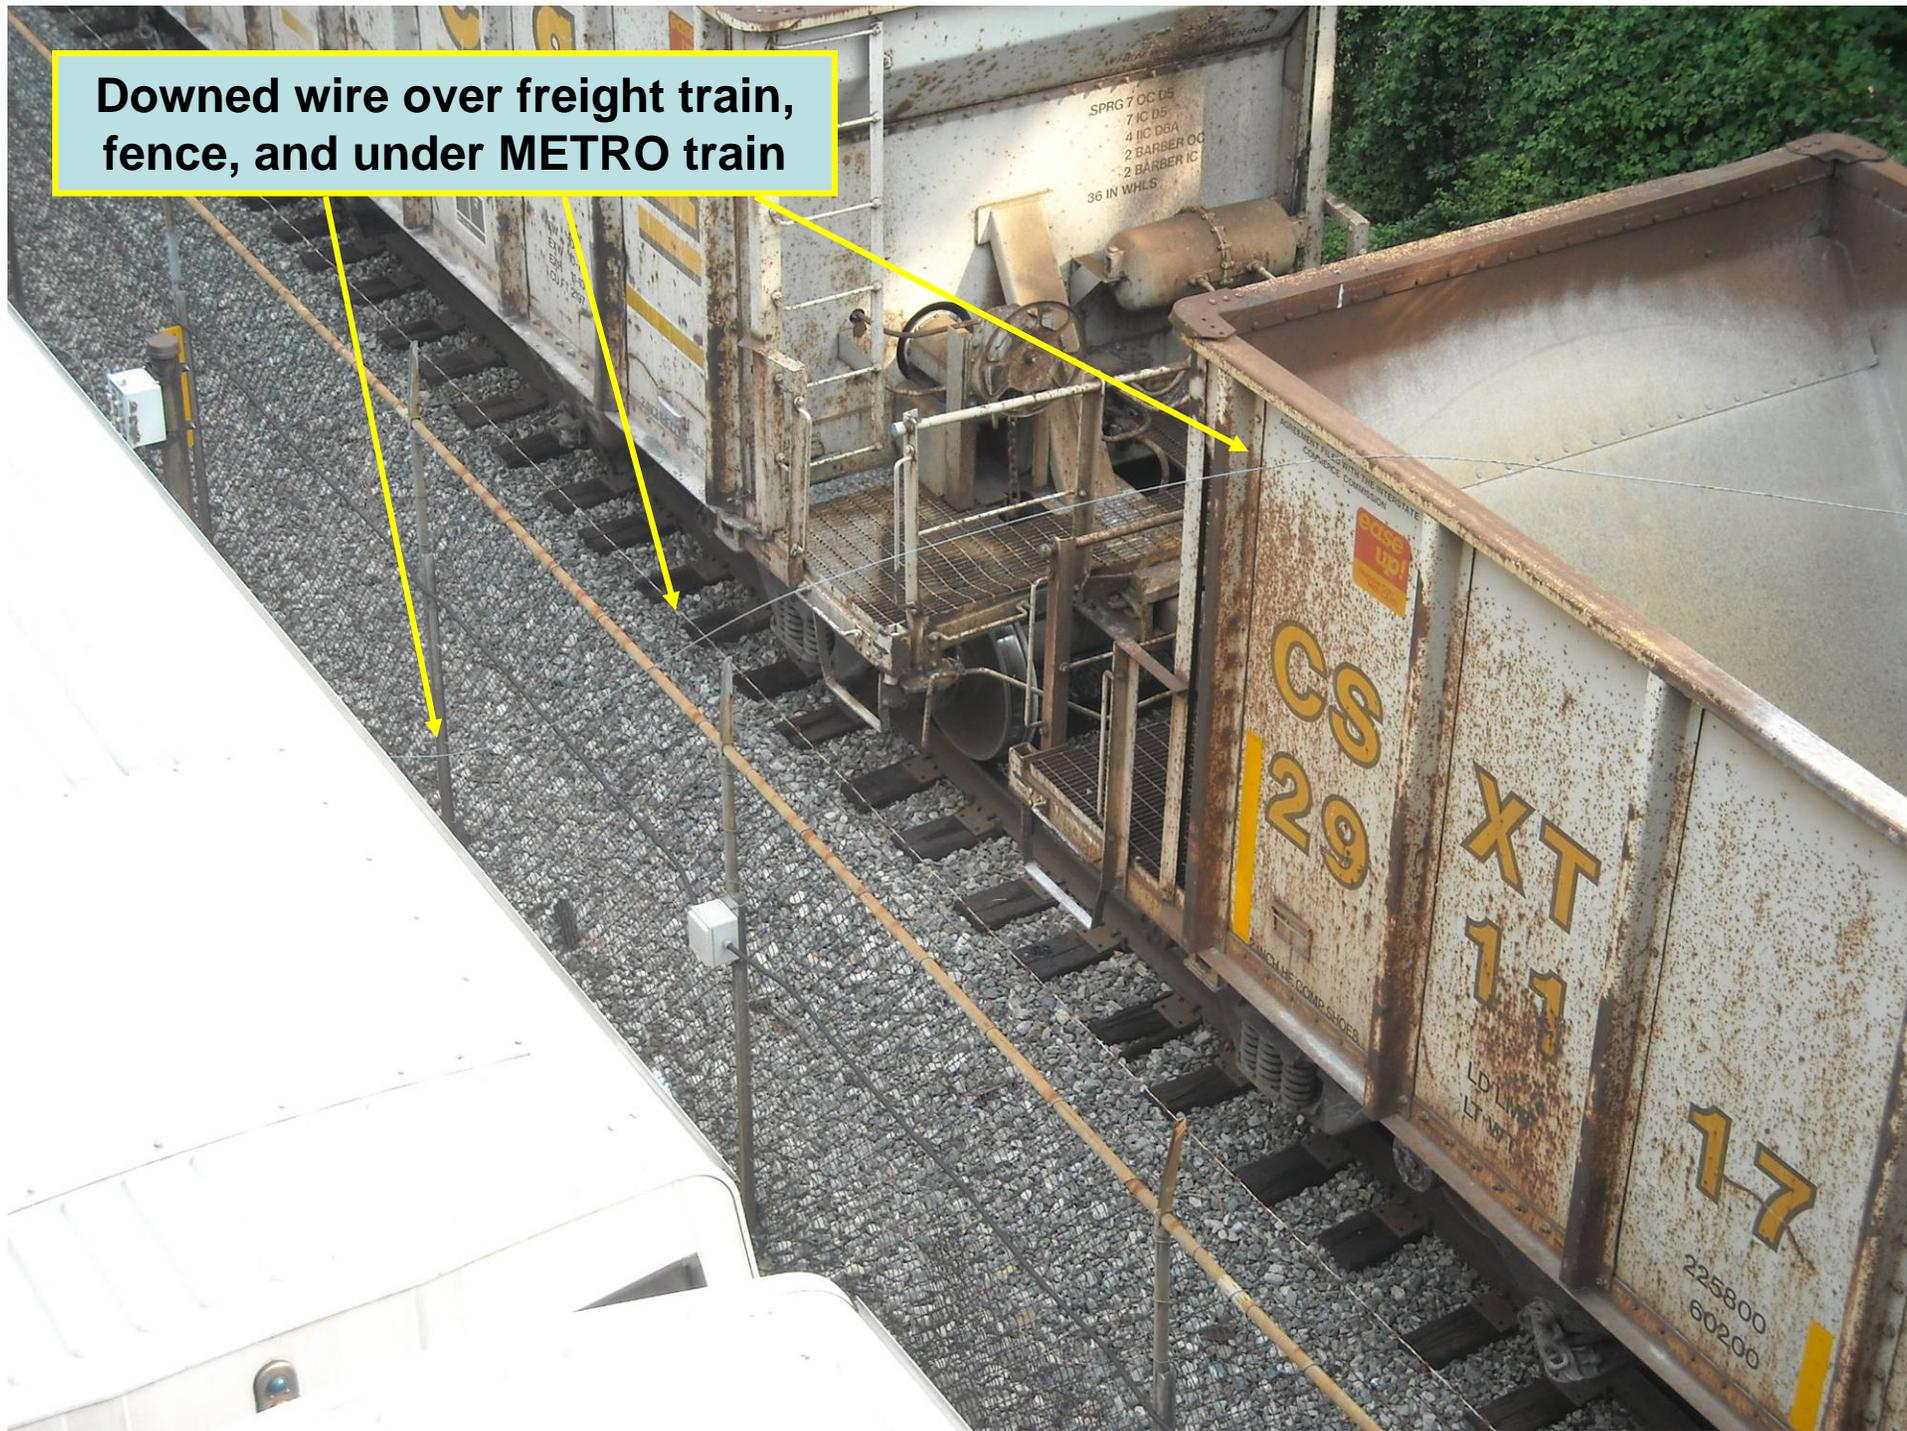
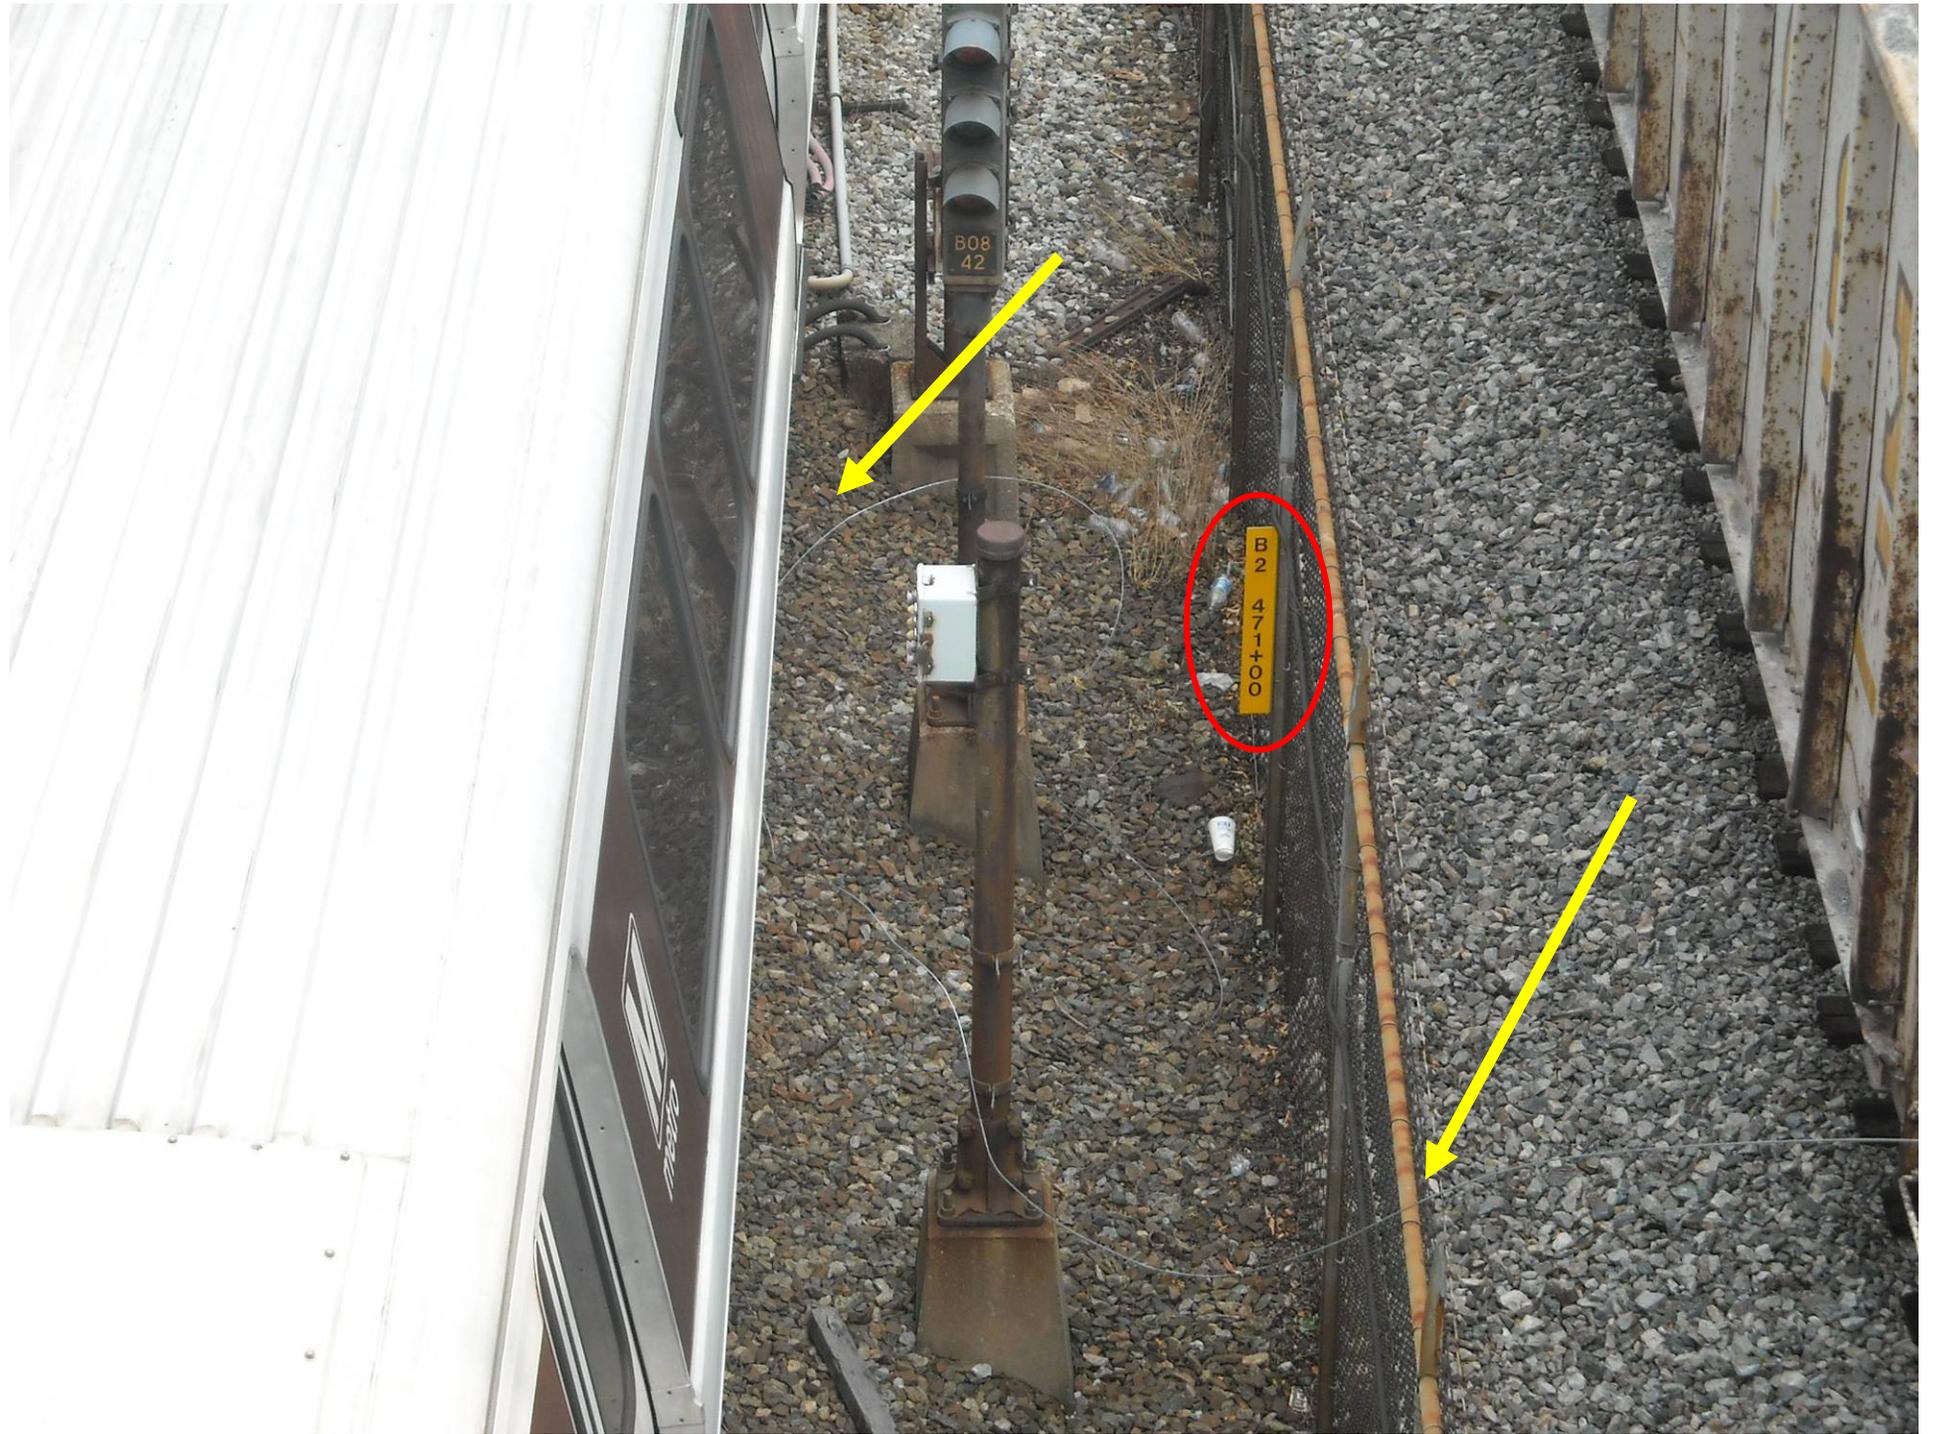
**Downed wire over freight train,
fence, and under METRO train**

- Live wire in ROW, in contact with:
 - CSX Train
 - ROW fence
 - METRO train
 - Running rails
 - Possibly 3rd rail
- Smoking, occupied train
- Poor access to entire section between the Silver Spring Station and portal

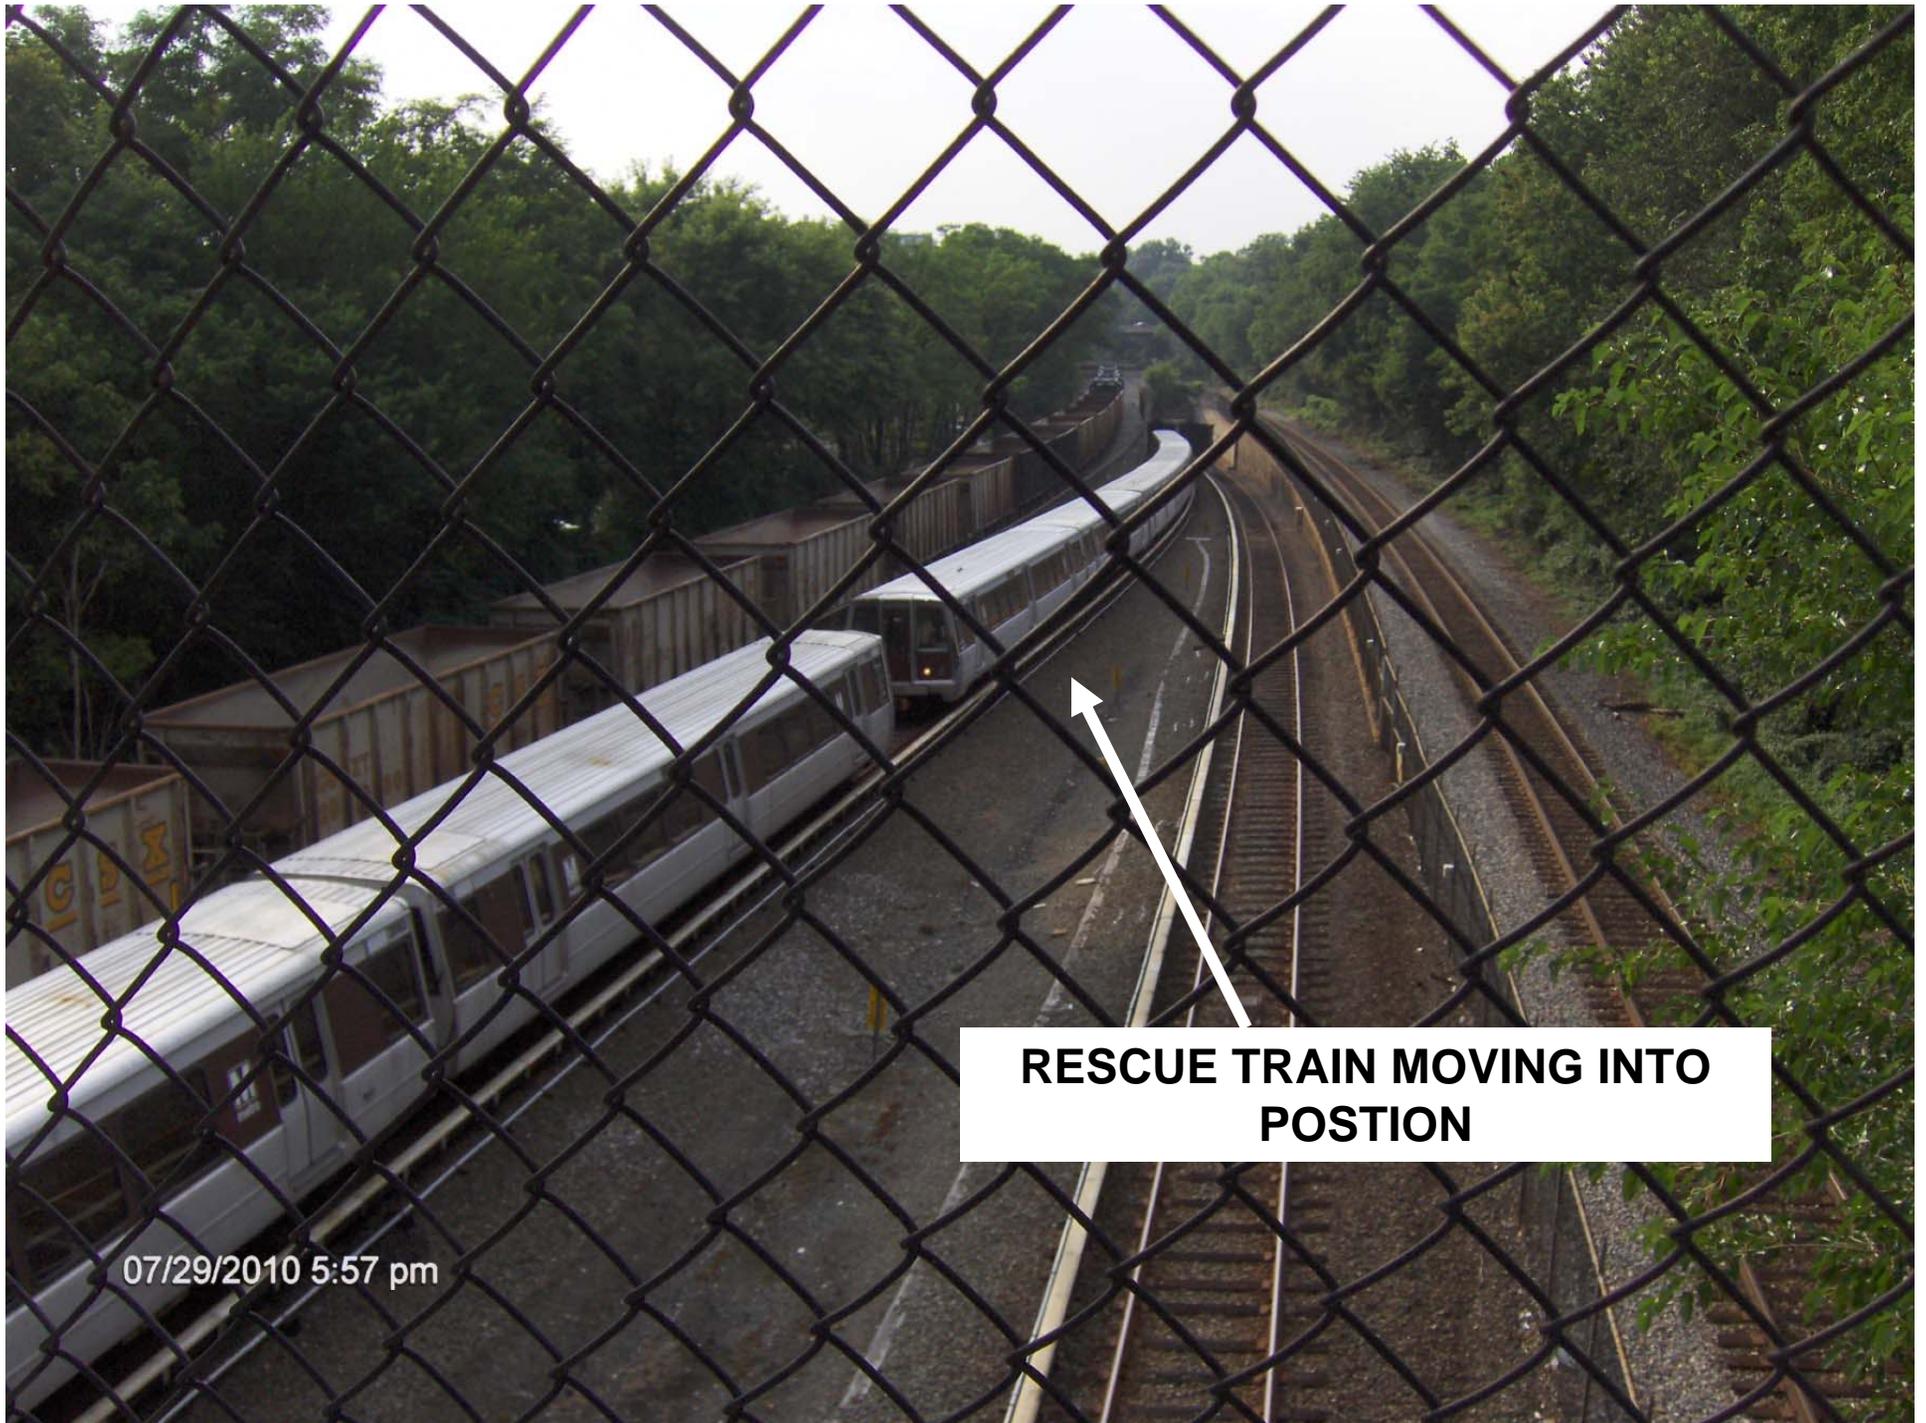
**RESCUE TRAIN MOVING INTO
POSTION**

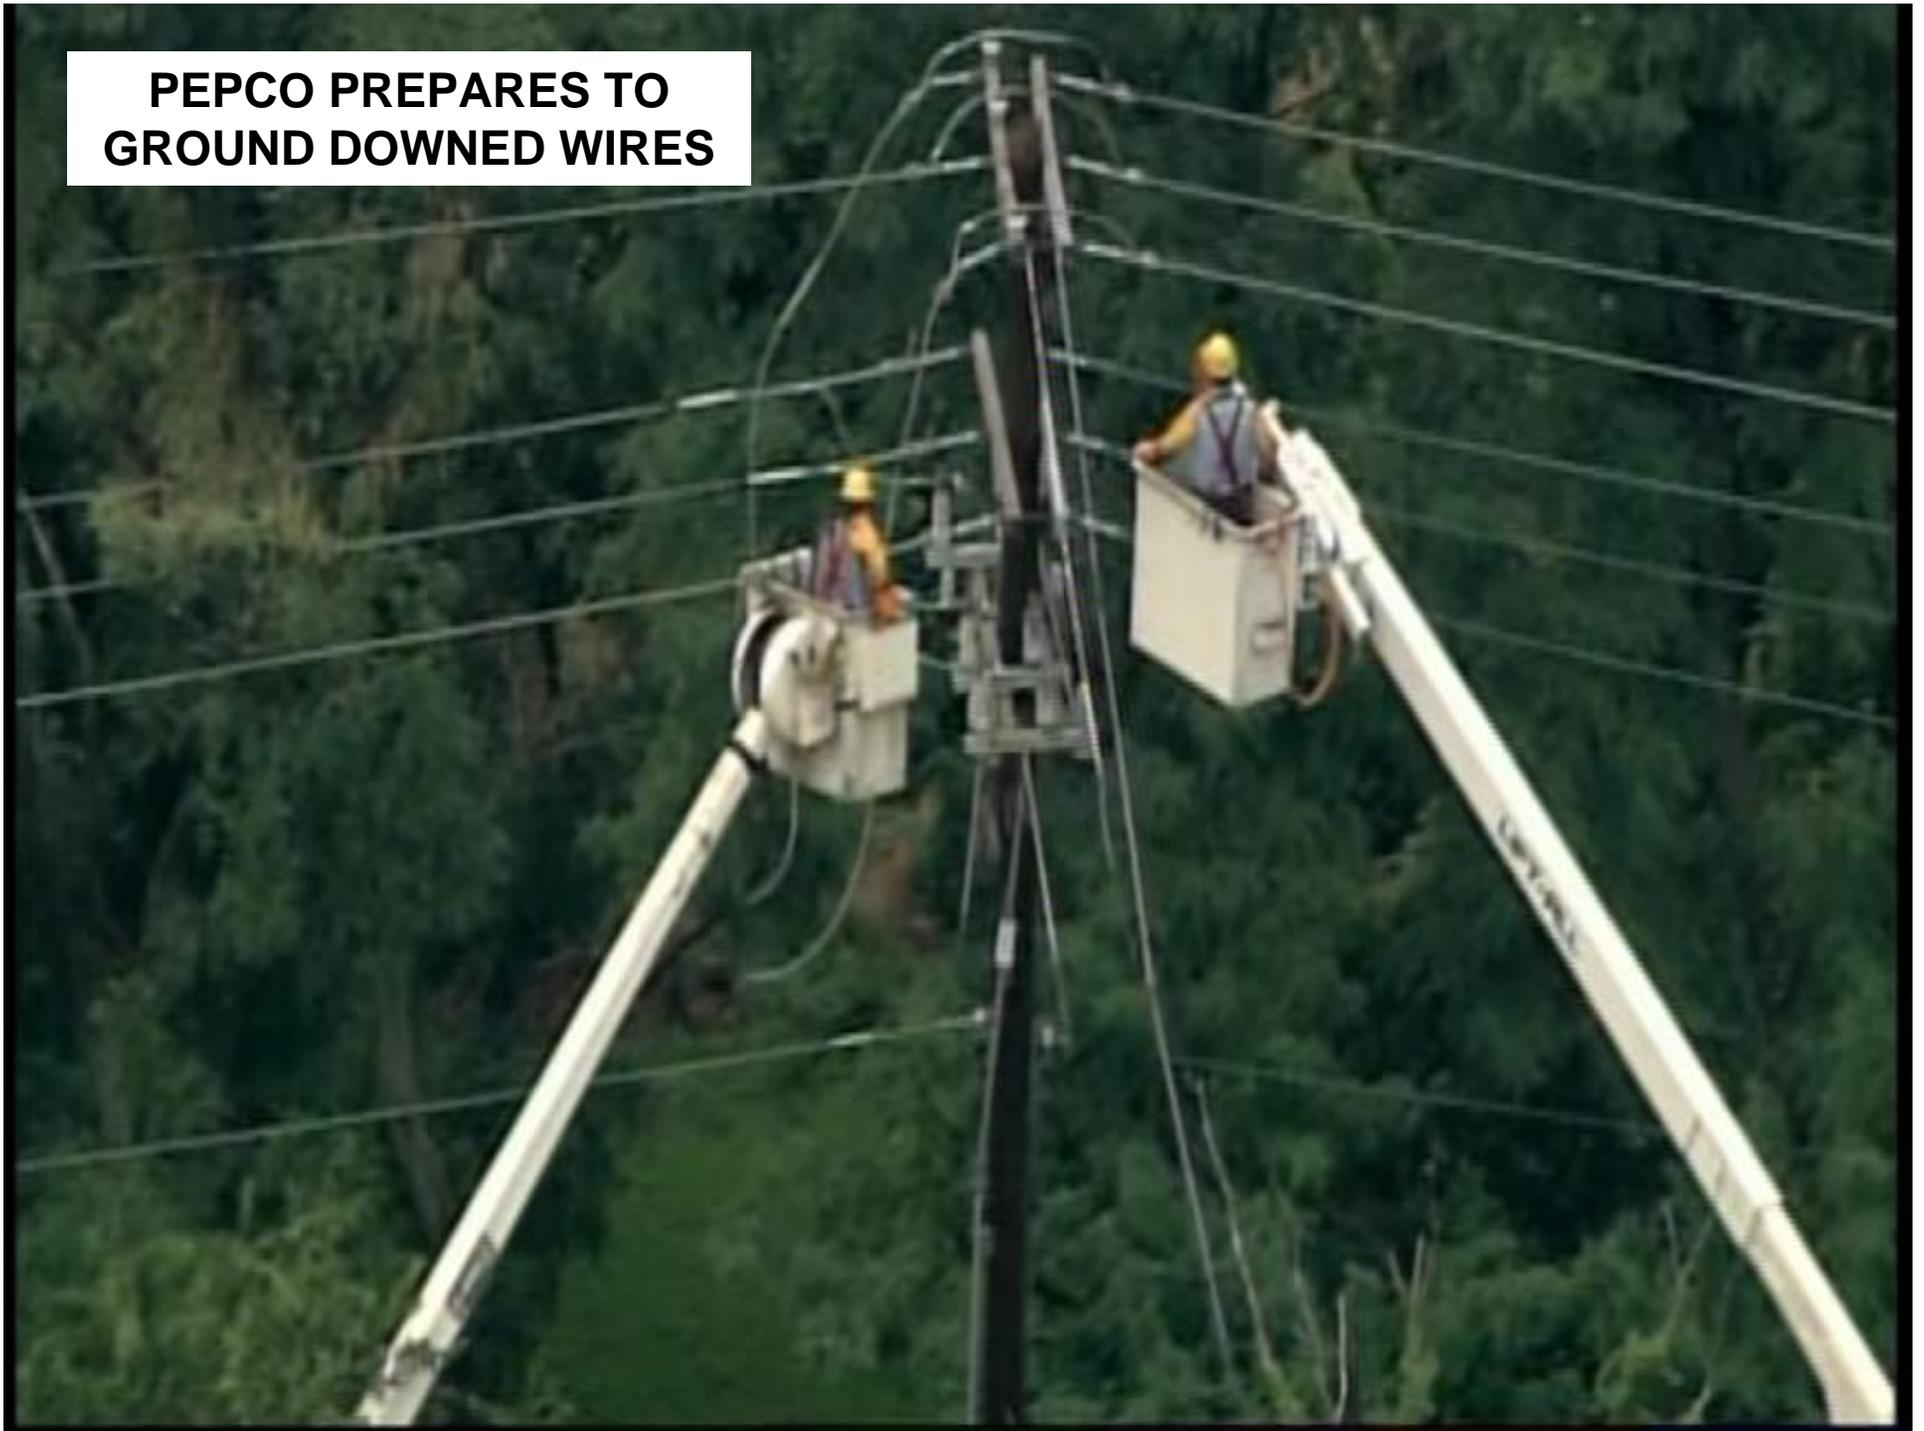
**PEPCO PREPARES TO
GROUND DOWNED WIRES**

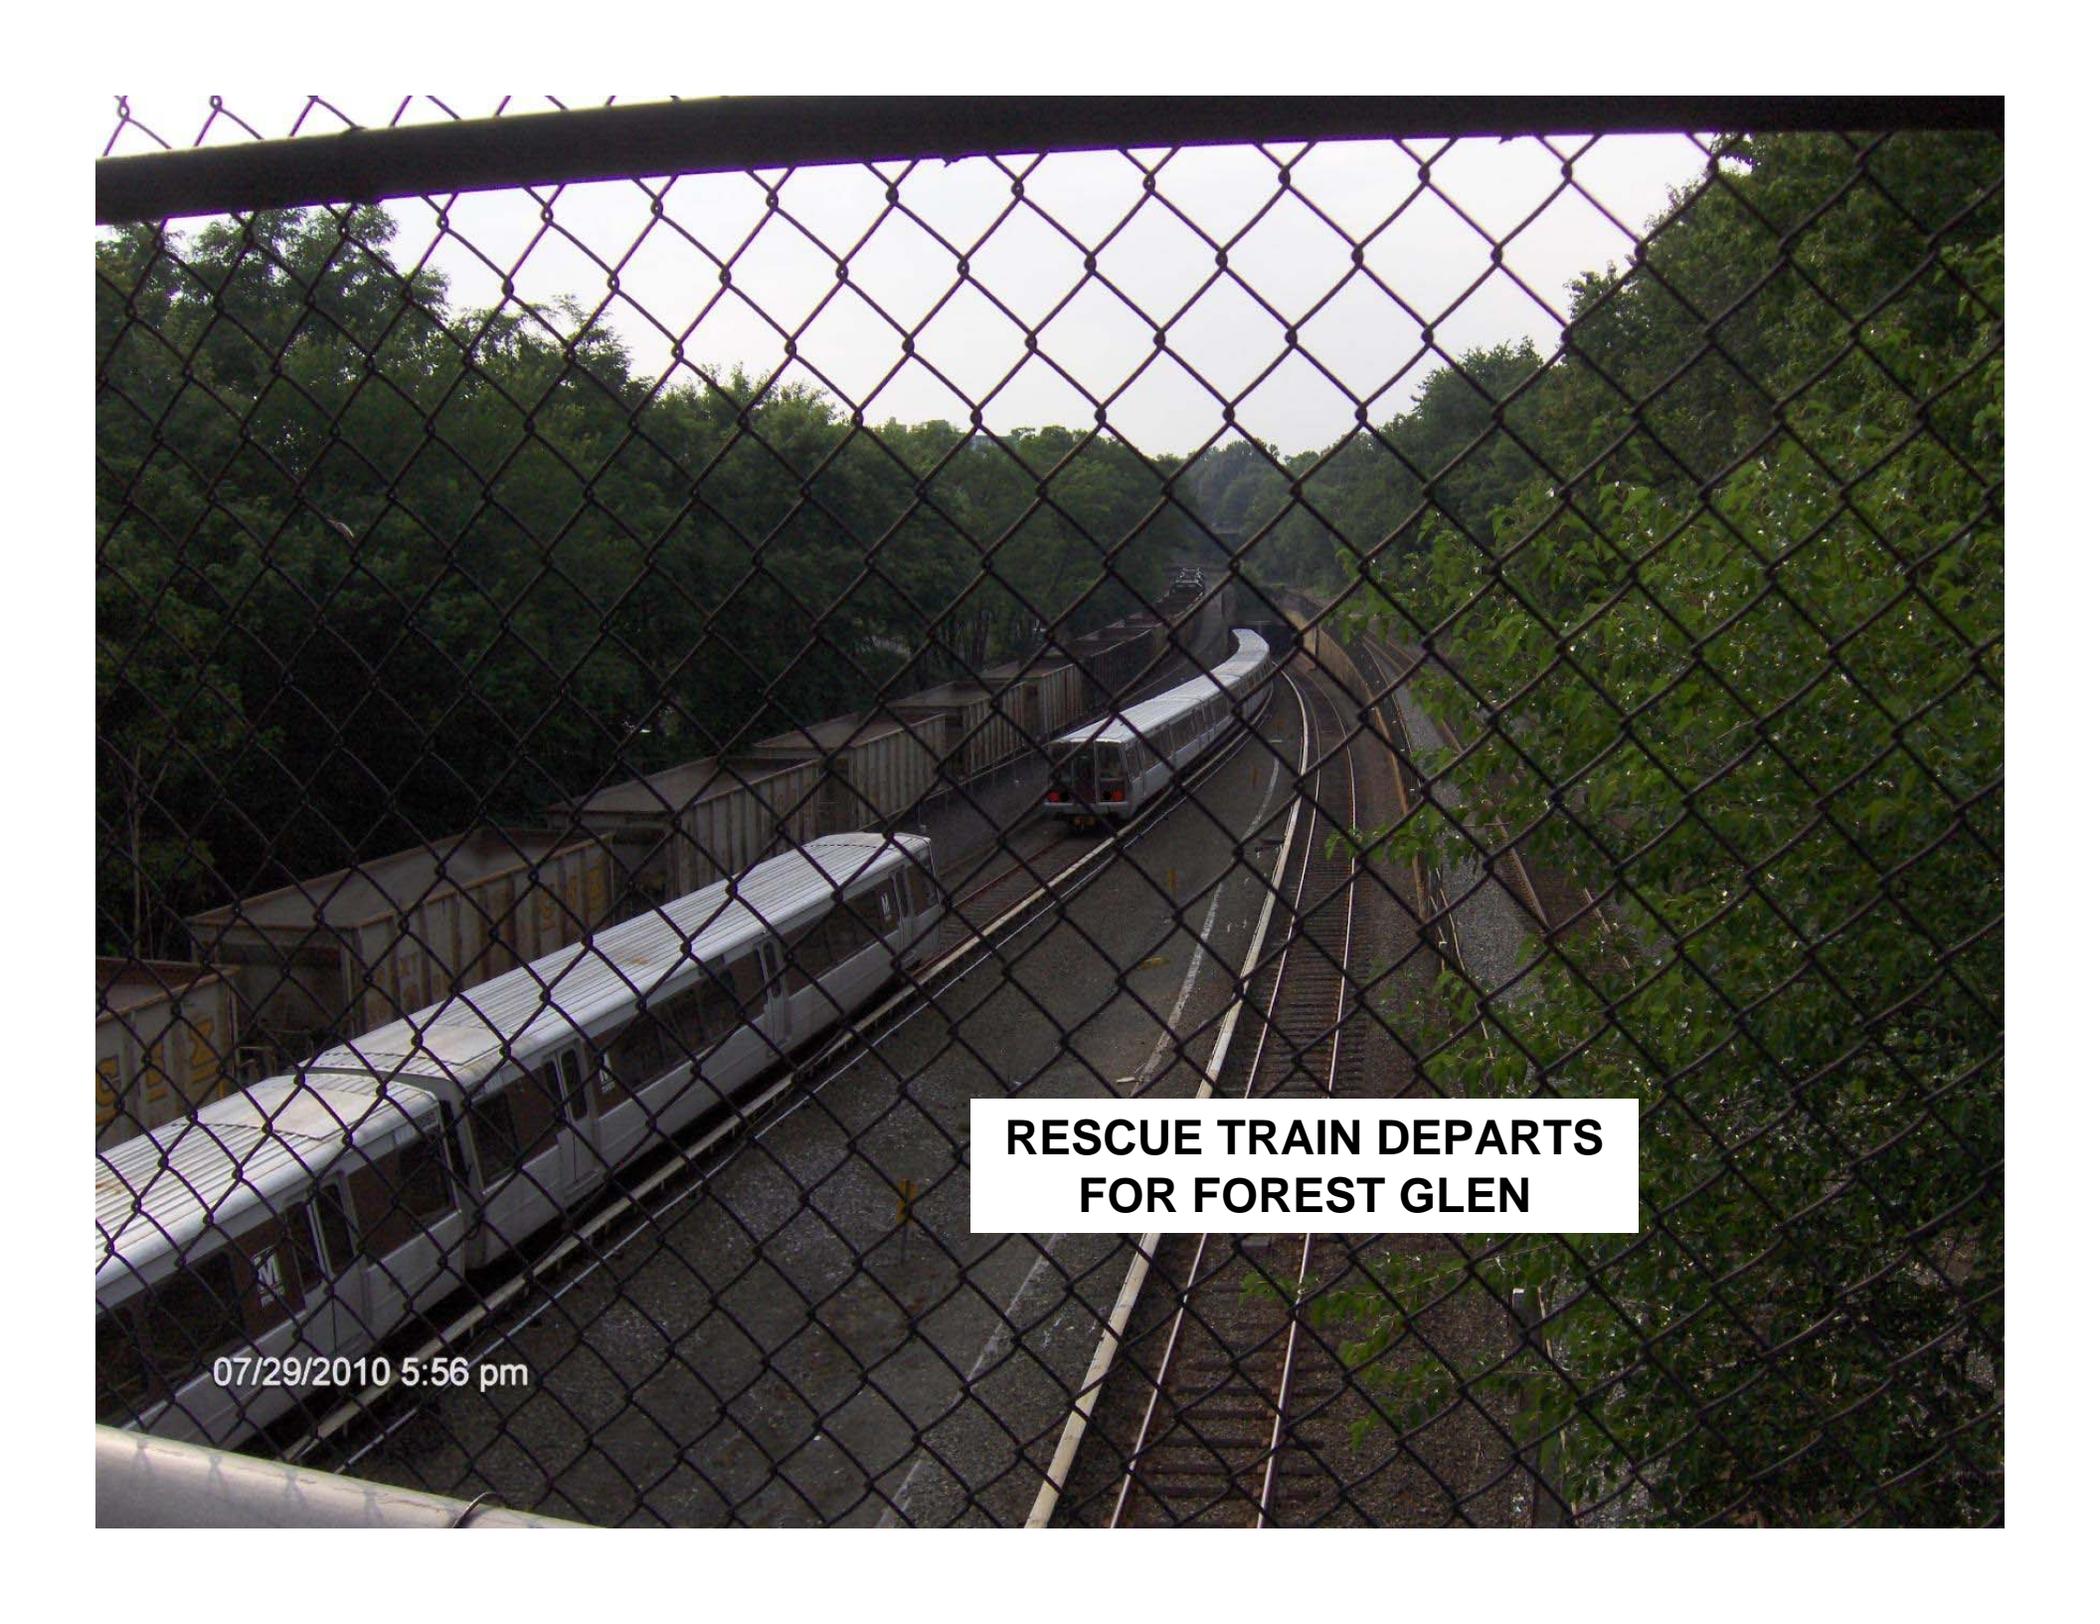
**RESCUE TRAIN DEPARTS
FOR FOREST GLEN**

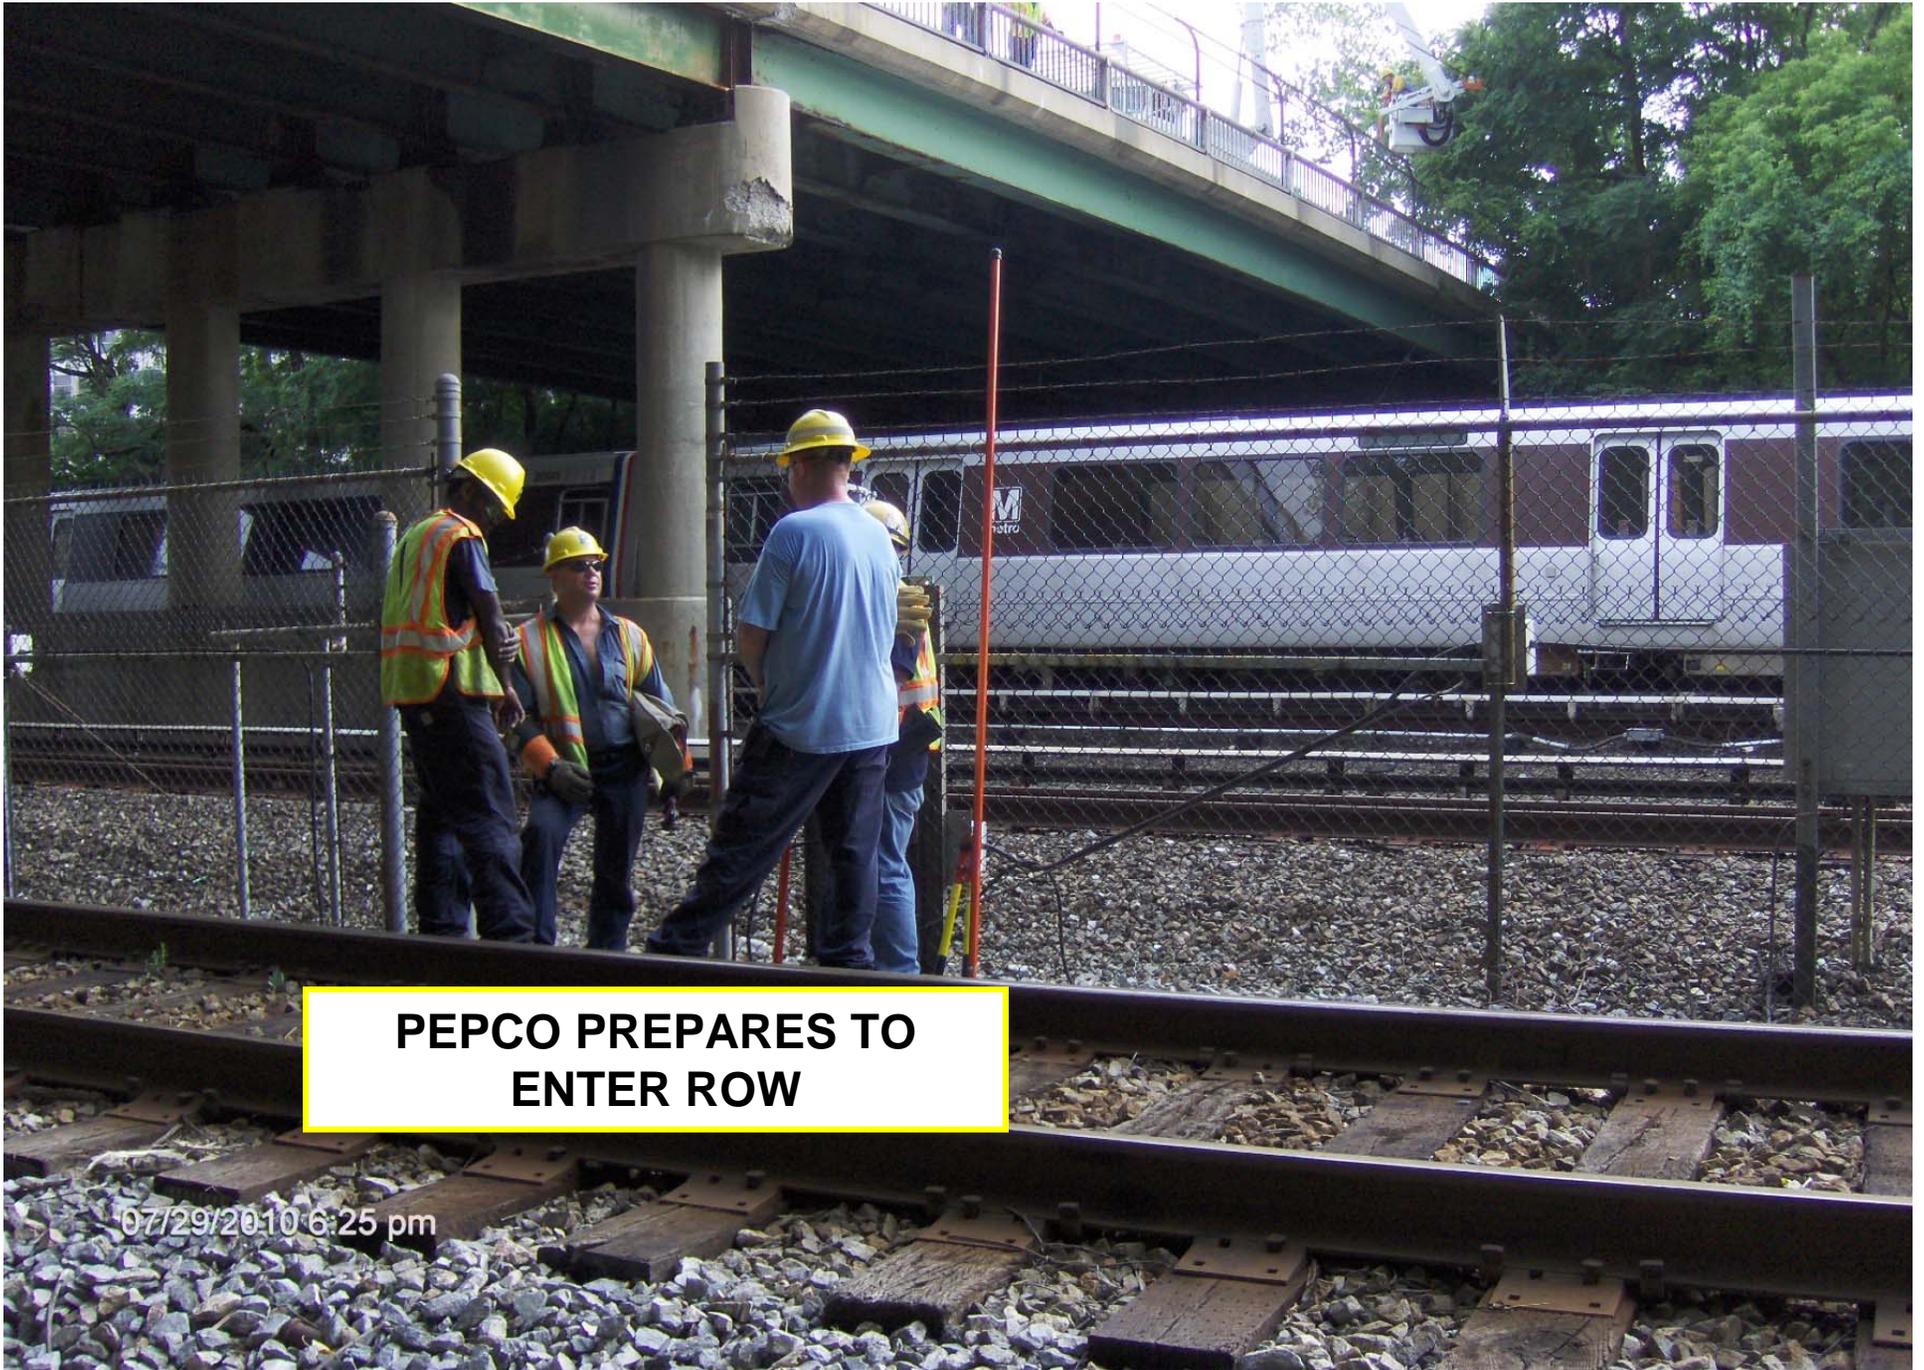
**PEPCO PREPARES TO
ENTER ROW**
