METRO/CSX TRAINS VS. HOT WIRES

Incident #10-0084377

Spring St/Second Ave, Silver Spring, MD

July 29th, 2010

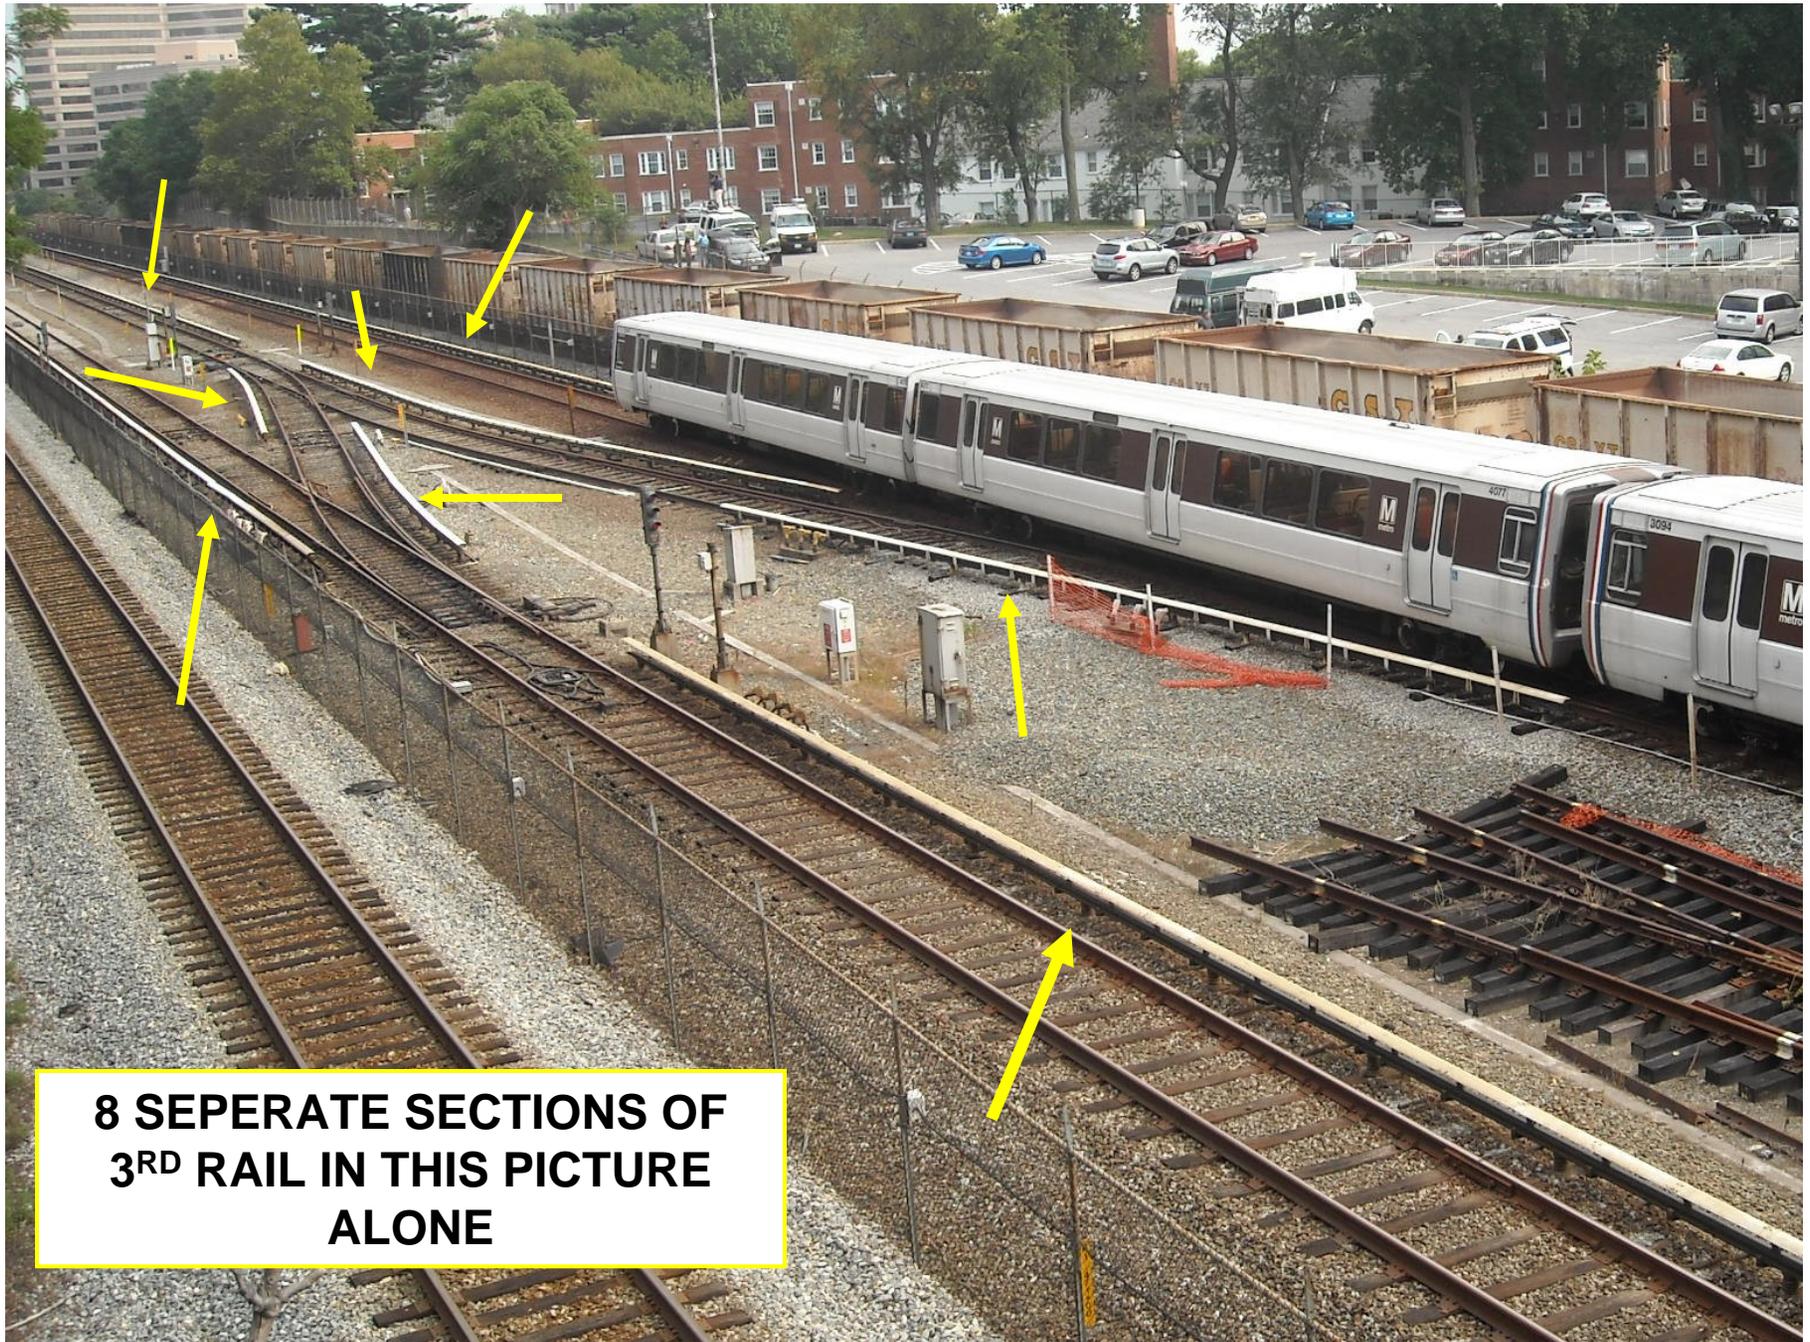
**8 SEPERATE SECTIONS OF
3RD RAIL IN THIS PICTURE
ALONE**
