Event Summary

13526 Collingwood Terrace

August 7th 2010

Tree on house w/ two trapped

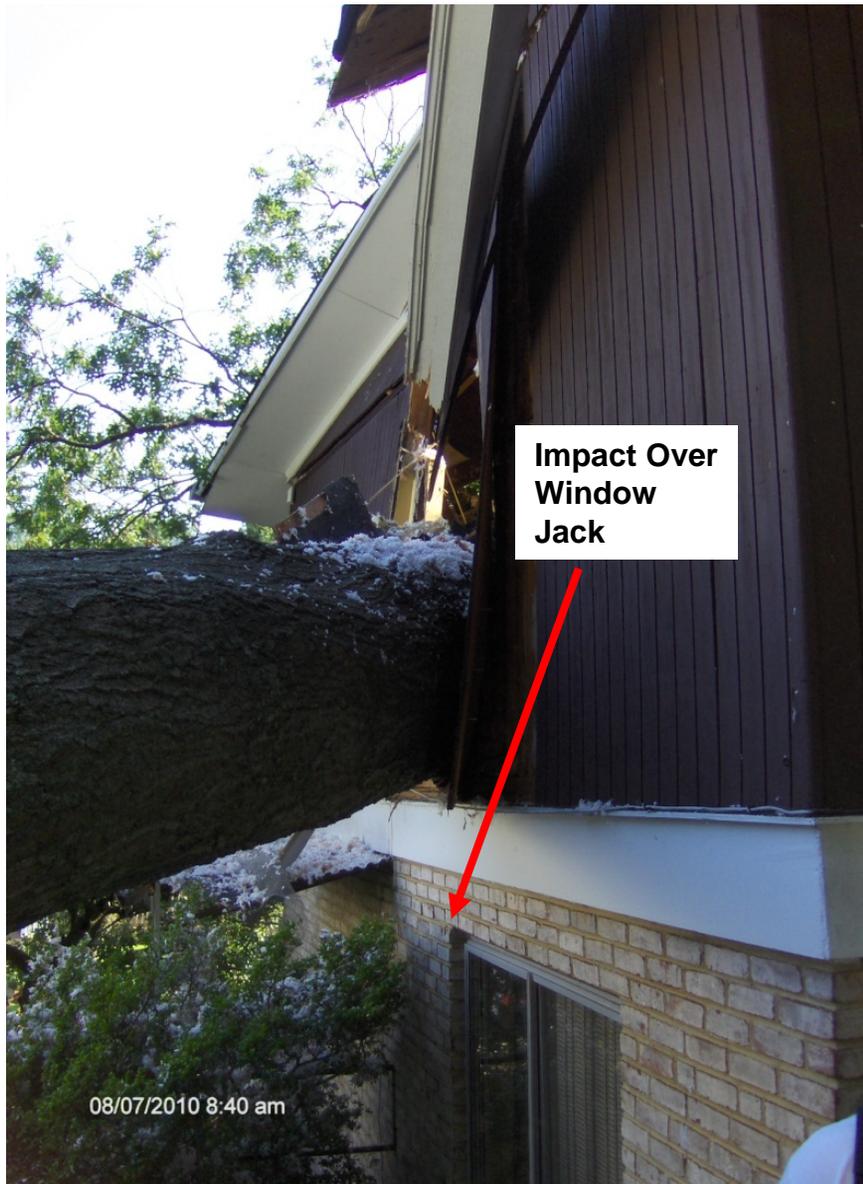
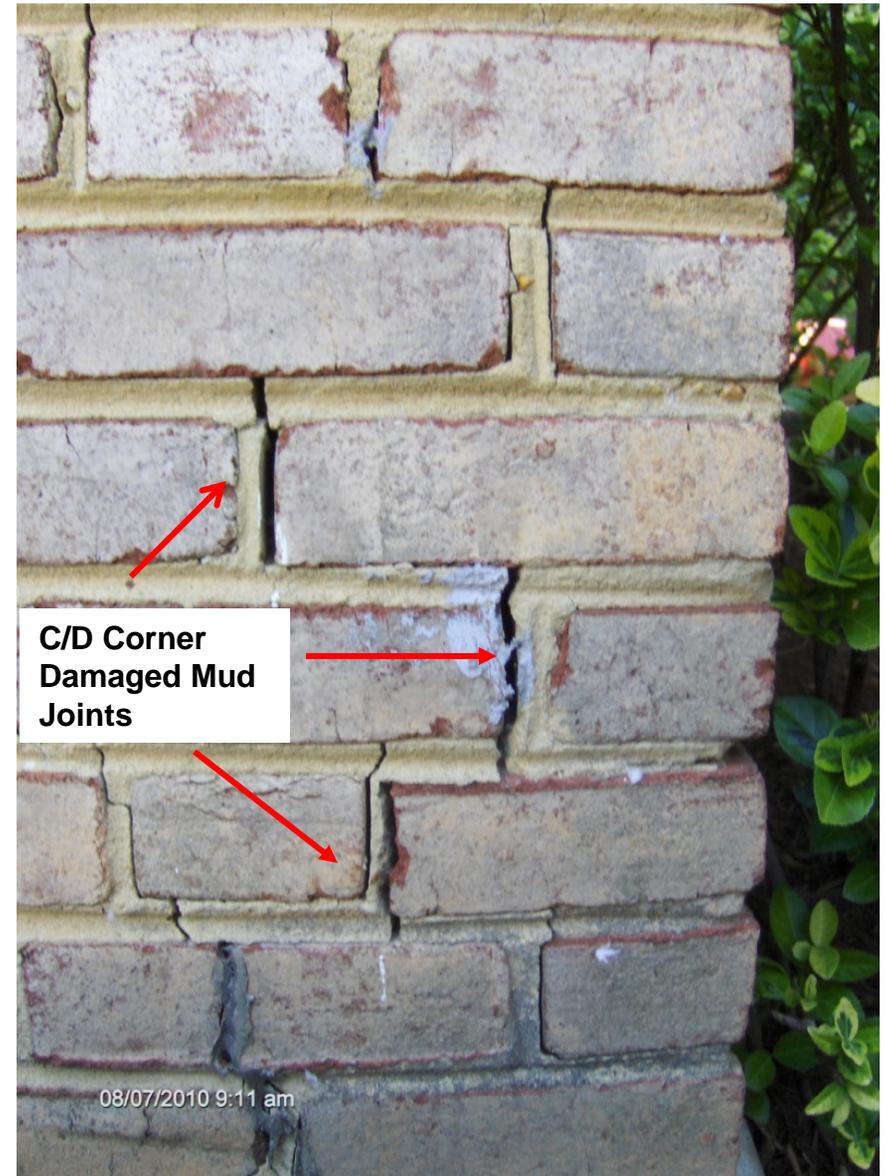
Exterior Assessment: Assessment shows tree contacted the D side directly over the window jack for the first Floor resulting in the header lifting and separation of the mud joints of the brick veneer evident on the C/D corner. Once entry was made this window would need to be shored.

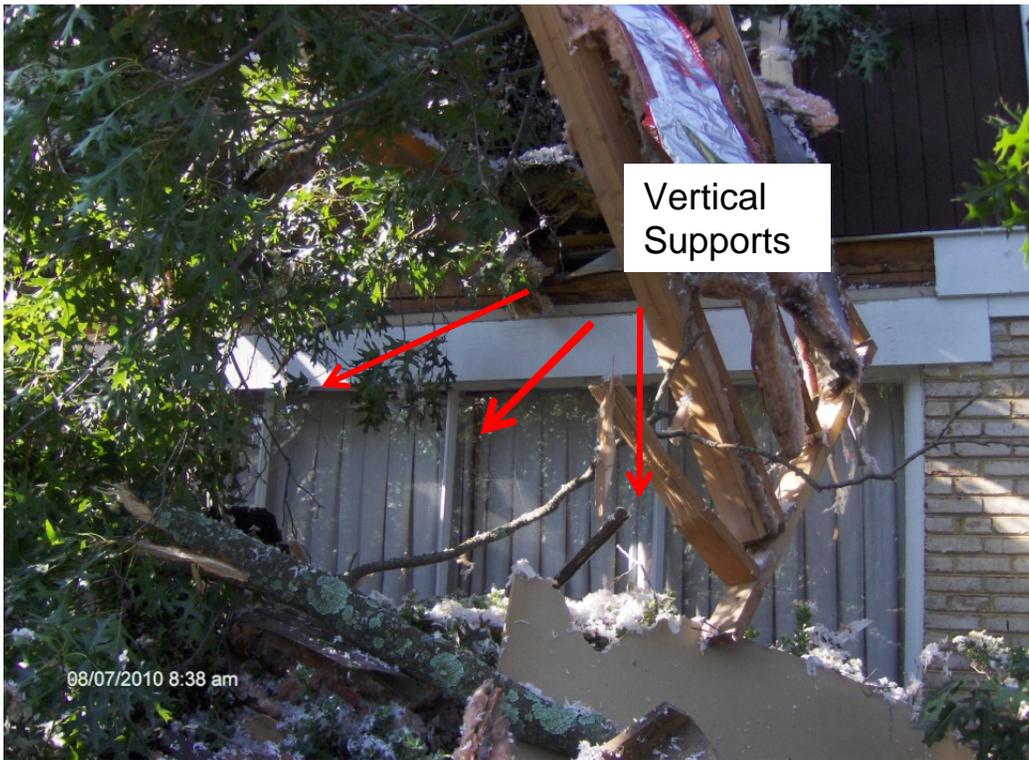
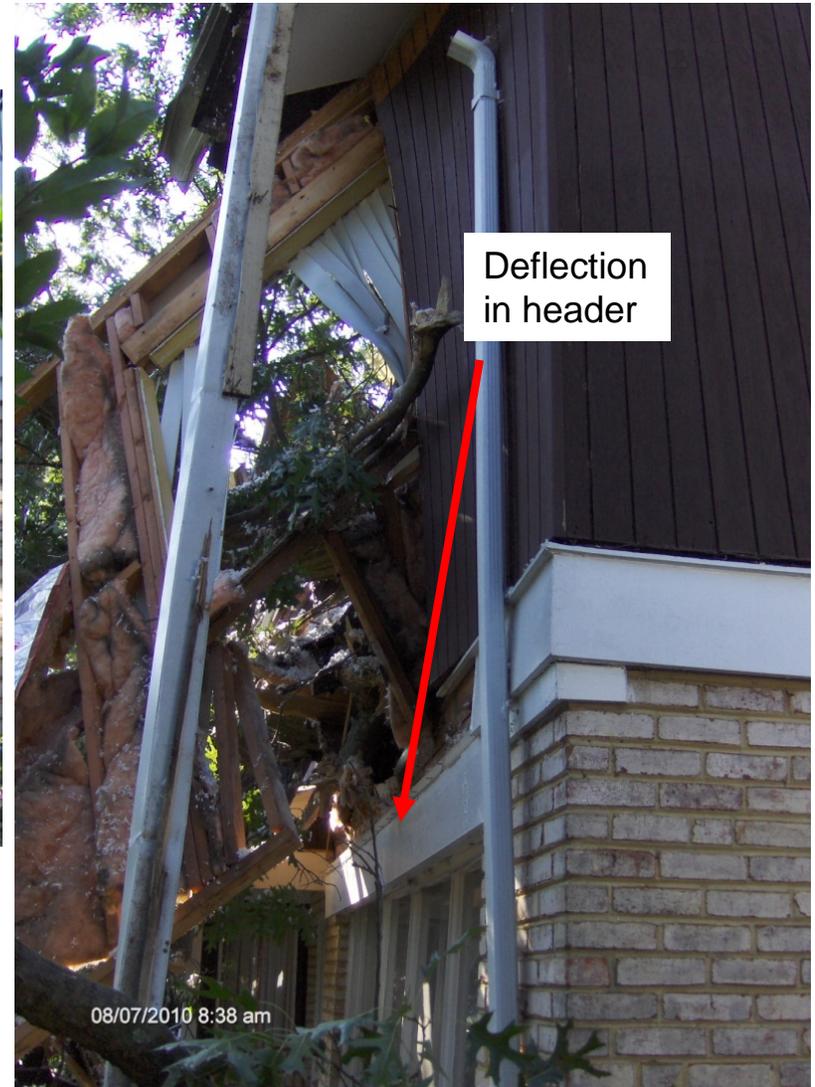
Side A Exterior: The tree exited the structure on Side A over a large window on the 1st floor.

The weight of the tree deflected the window header substantially. Shoring of this window would prove difficult due to the load being applied to the vertical supports

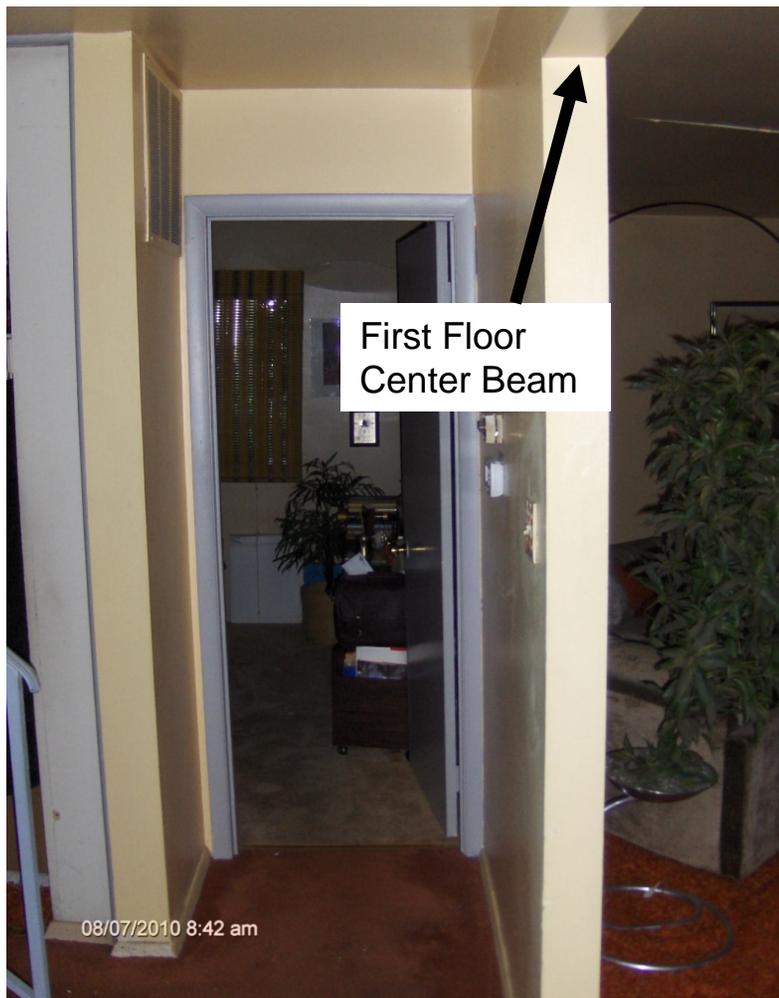
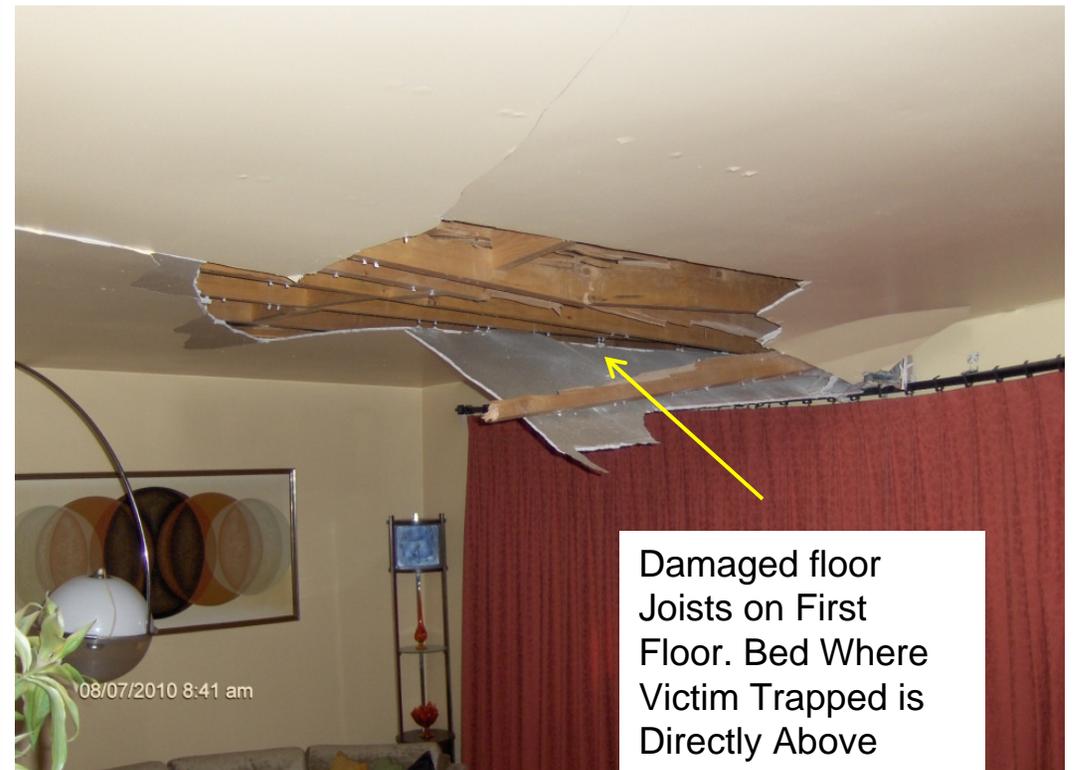
Post incident there was separation and distortion evident on the Side A exterior wall. The center beam in the Basement would need to be exposed prior to shoring

Interior Shoring Needs: Initial shoring would consist of spot T shores on center beam on the 1st floor and basement. The Delta quadrant of the structure would need to be supported with vertical shoring. Due to the weight of the load, a three post vertical was recommended. Lace post shores were also discussed.

Once verticals were complete, the spot T shores should be replaced with tow three post vertical shores. Pictures of the basement were not taken, however the basement was finished with wood paneling.

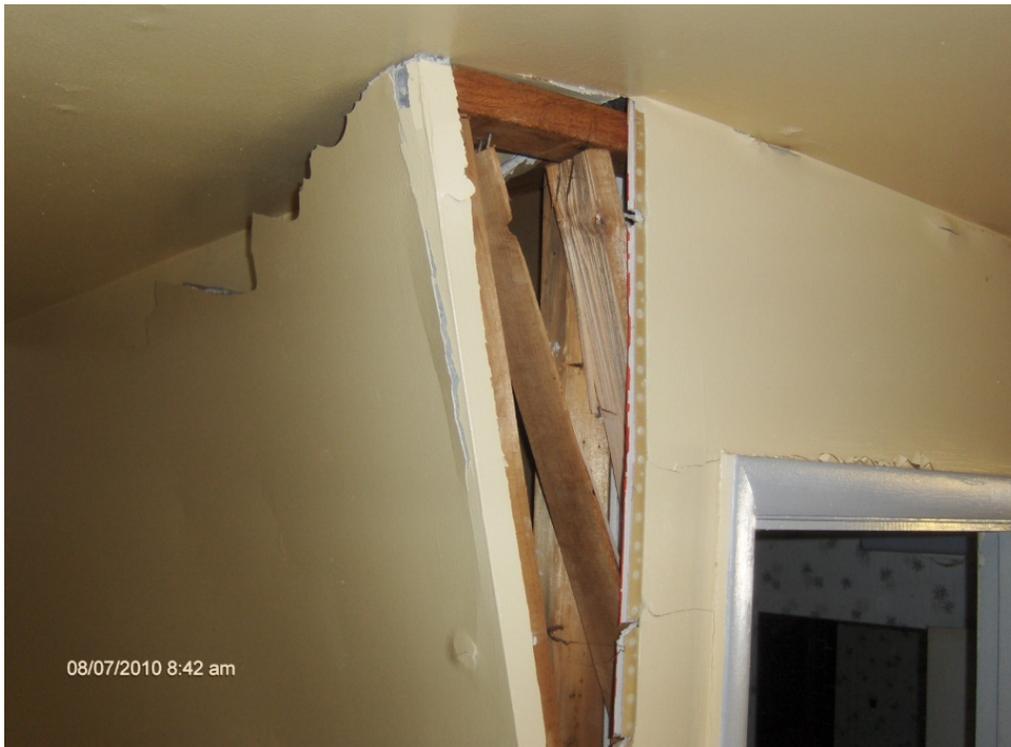
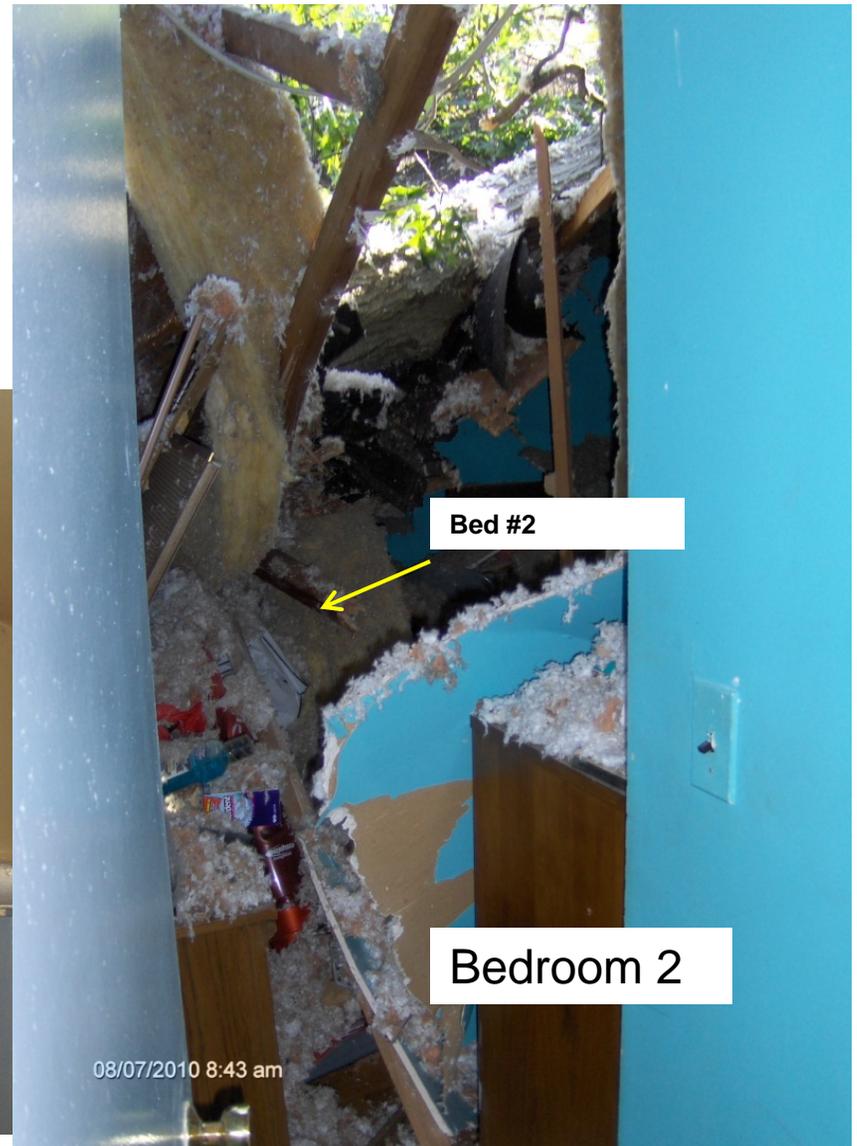
Second Floor: Entry to the 2nd floor shows that the top of the center wall had been racked about 16”.

The second bedroom had substantial damage to the interior and exterior walls.

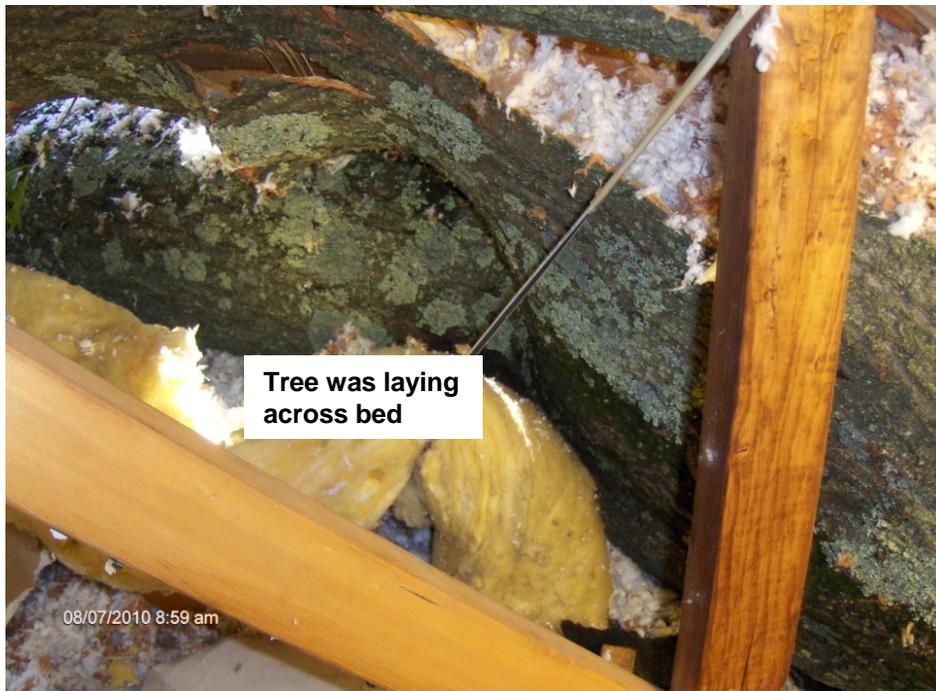
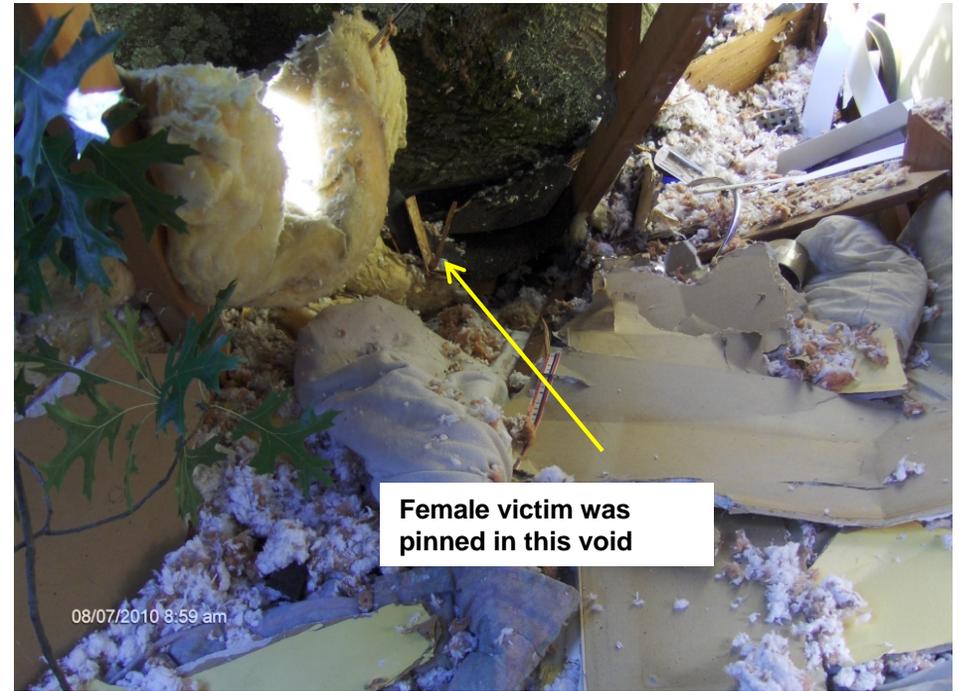
Victim Location: Victims were in bed when the tree fell and were both pinned. The male self extricated and later assisted the female in self extrication. Multiple means of removal were discussed on scene to include opening the A/D corner and removing victims via ground ladder.

The rescue leader established that removal over the tree and via the interior would be more expeditious. If victim was still pinned, the tree would need to be stabilized. Potential options for removal would be to remove the bed after the tree was stabilized.

Other options would include lifting or removal of the tree
