MONTGOMERY COUNTY FIRE AND RESCUE SERVICE
SAFETY SECTION INJURY INVESTIGATION REPORT

8609 Second Avenue
Silver Spring, MD

Incident #F10-0137565
Box 01-02

December 9, 2010

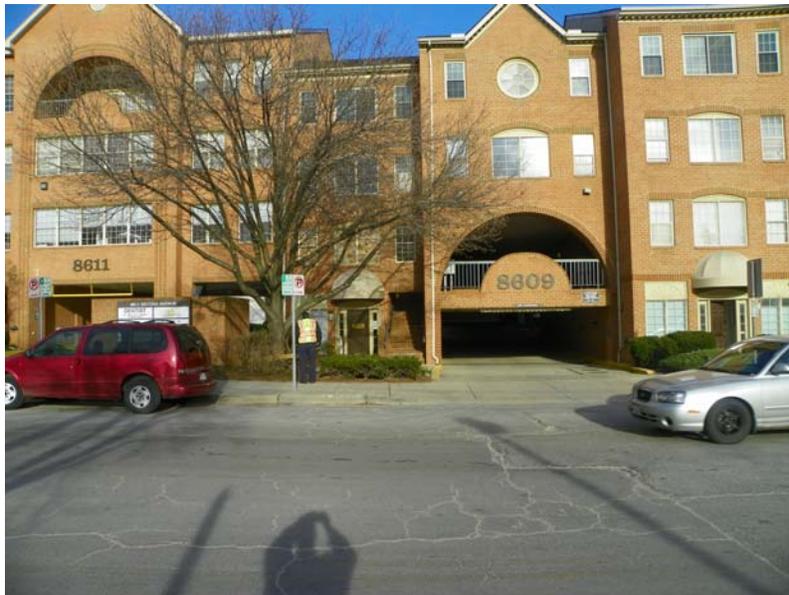
8609 2nd Avenue Side A

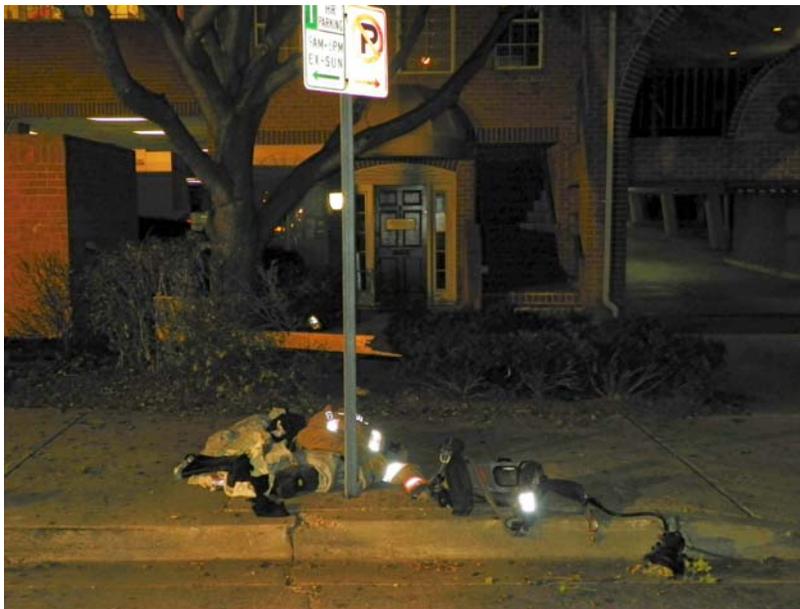
Stairwell to Right of Door was location of E701 Right prior to the Injury

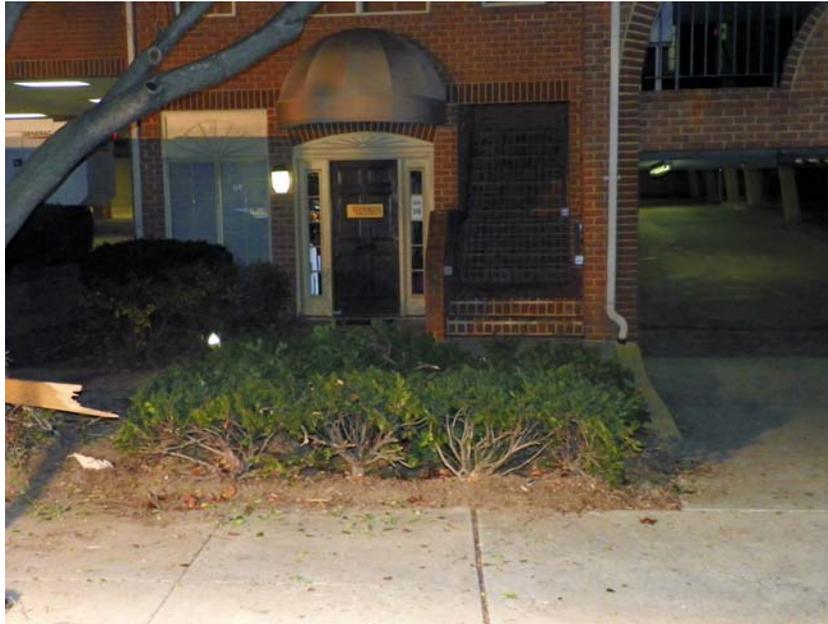
Close up of Side A at 8609 2nd Avenue

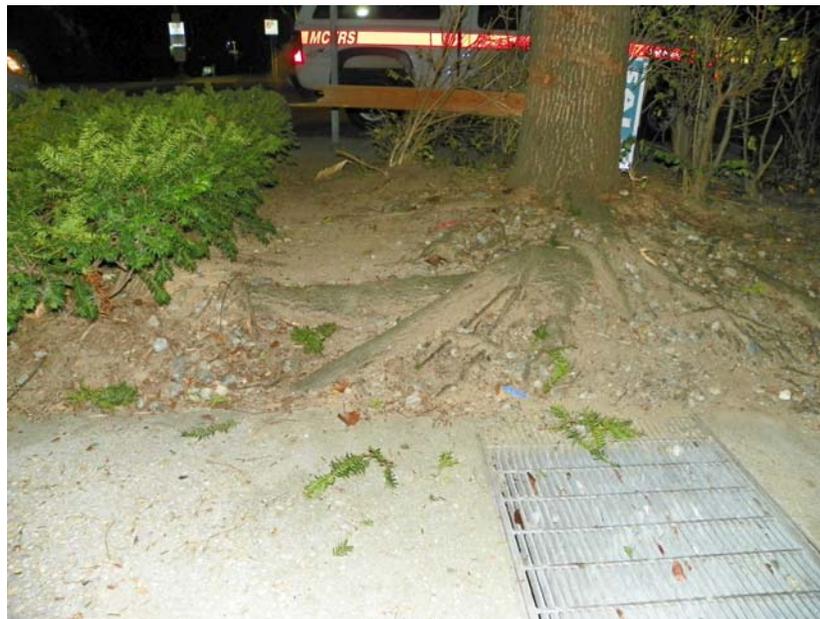
View from landing toward 2nd Ave

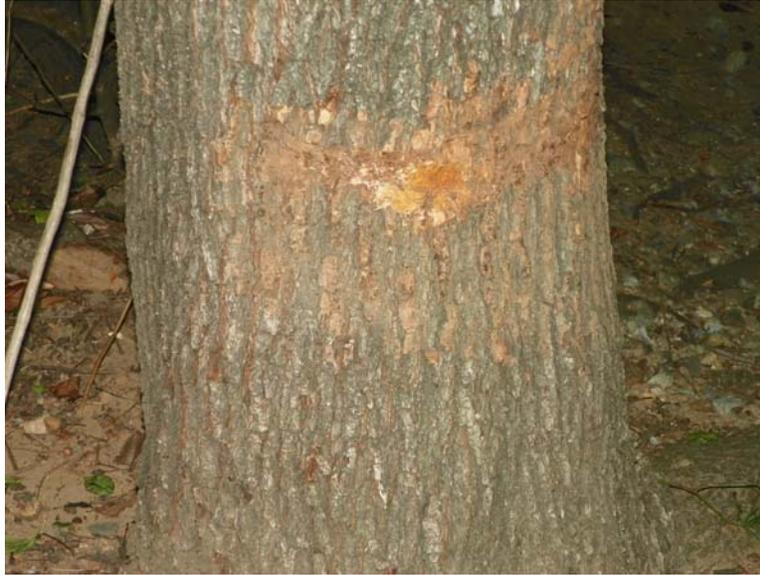
Damage to tree from hose

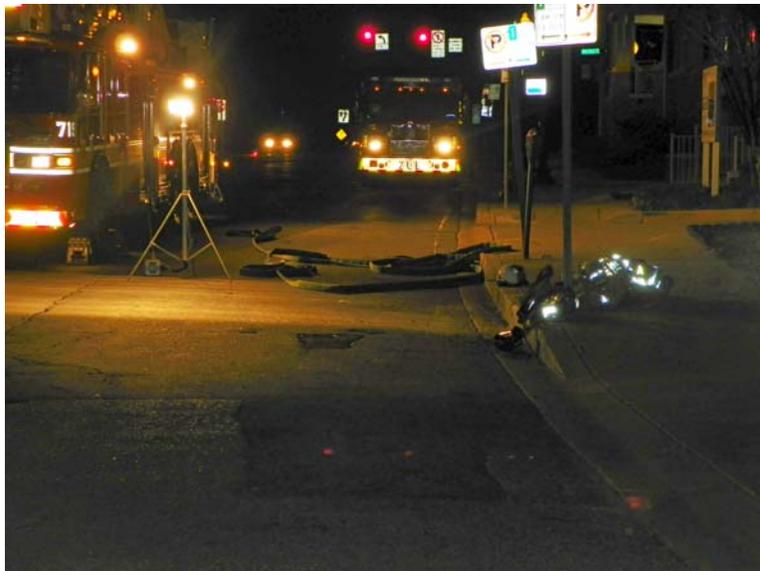
AT719's Driver reported that E701 Right was spinning on his feet like a top. E701 Right was dragged 45 feet, finally coming to a rest in the middle of Second Avenue.

View from 2nd Ave looking toward Spring St.
Area where E701 Right came to rest

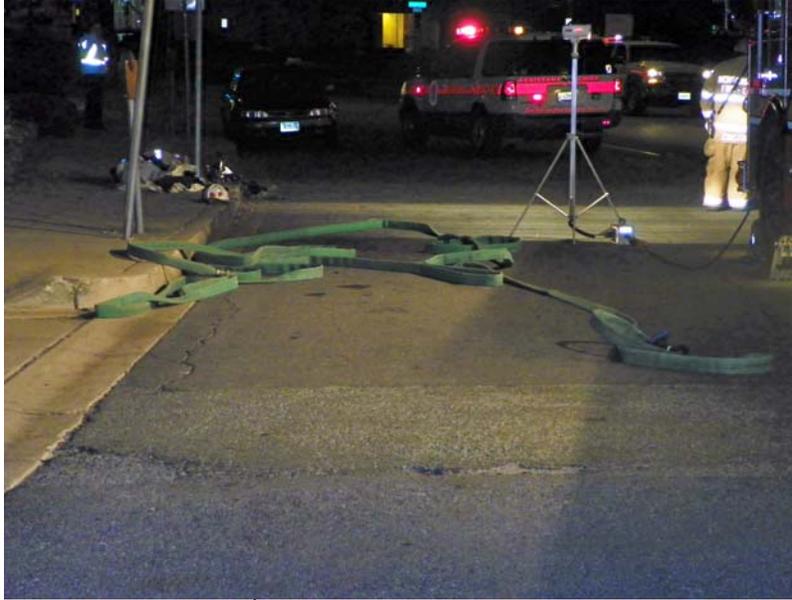
View from 2nd Ave looking toward Fenwick Lane
E701's #2 crosslay

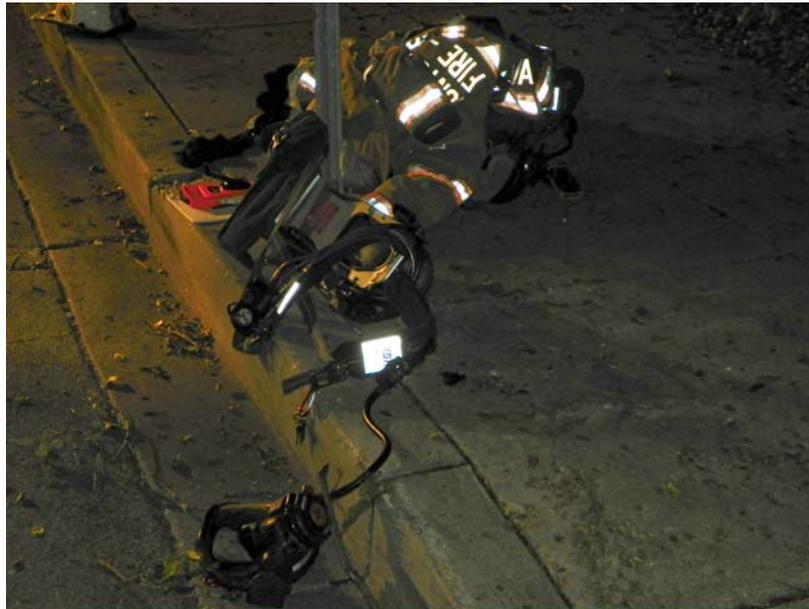
At the time of the injury E701 Right was wearing complete MCFRS issued PPE including SCBA. The SCBA cylinder sustained damage from being dragged and E701 Right's PPE trouser and right boot were destroyed as a result of EMS personnel cutting them off to gain access to his injuries.

E701 Right's PPE and SCBA did not contribute to the injury. It is likely that E701 Right's injuries were mitigated because he was wearing full PPE, including helmet with chin strap in place,

E701 Right's PPE and SCBA

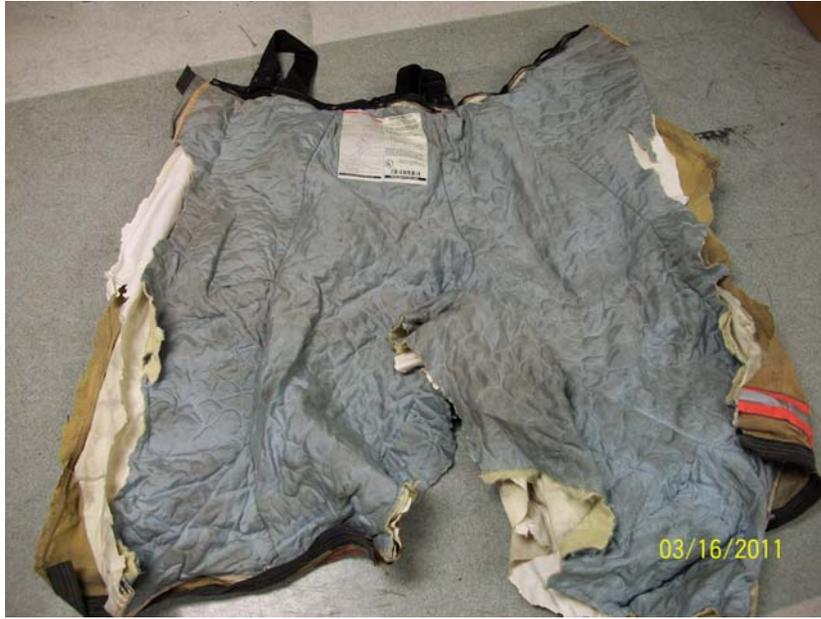
E701 Right's Turnout Pants

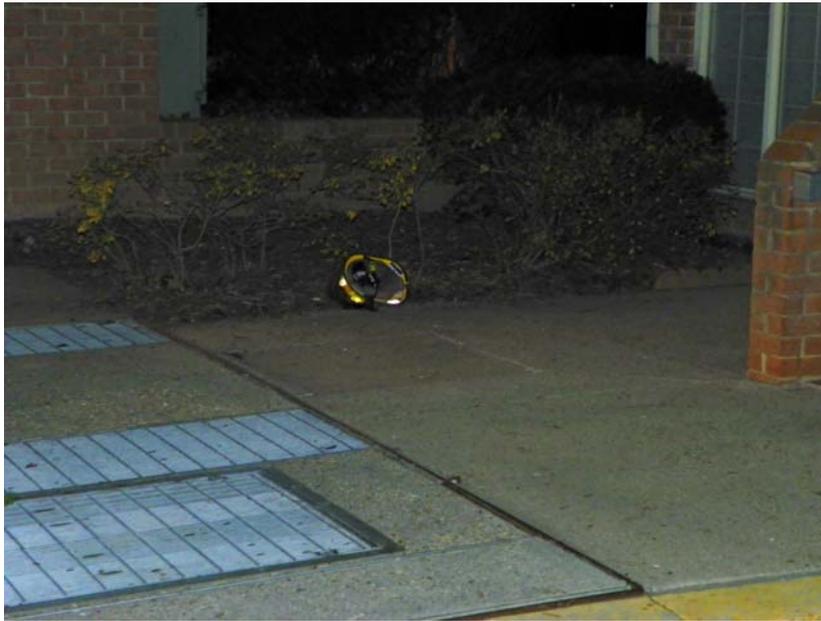
E701 Right's Helmet Located to left of stairwell on Side A
