## Post Incident Analysis for 4716 Iris Street

### 4716 Iris Street November 3, 2011

- 1,200 square foot house
- Three injured Fire Fighters
- One injured civilian
- One civilian fatality
- Heavy fire upon arrival with report of people trapped
- Vent, Enter Search (VES) to remove trapped occupant
- Defensive then offensive then defensive fire attack

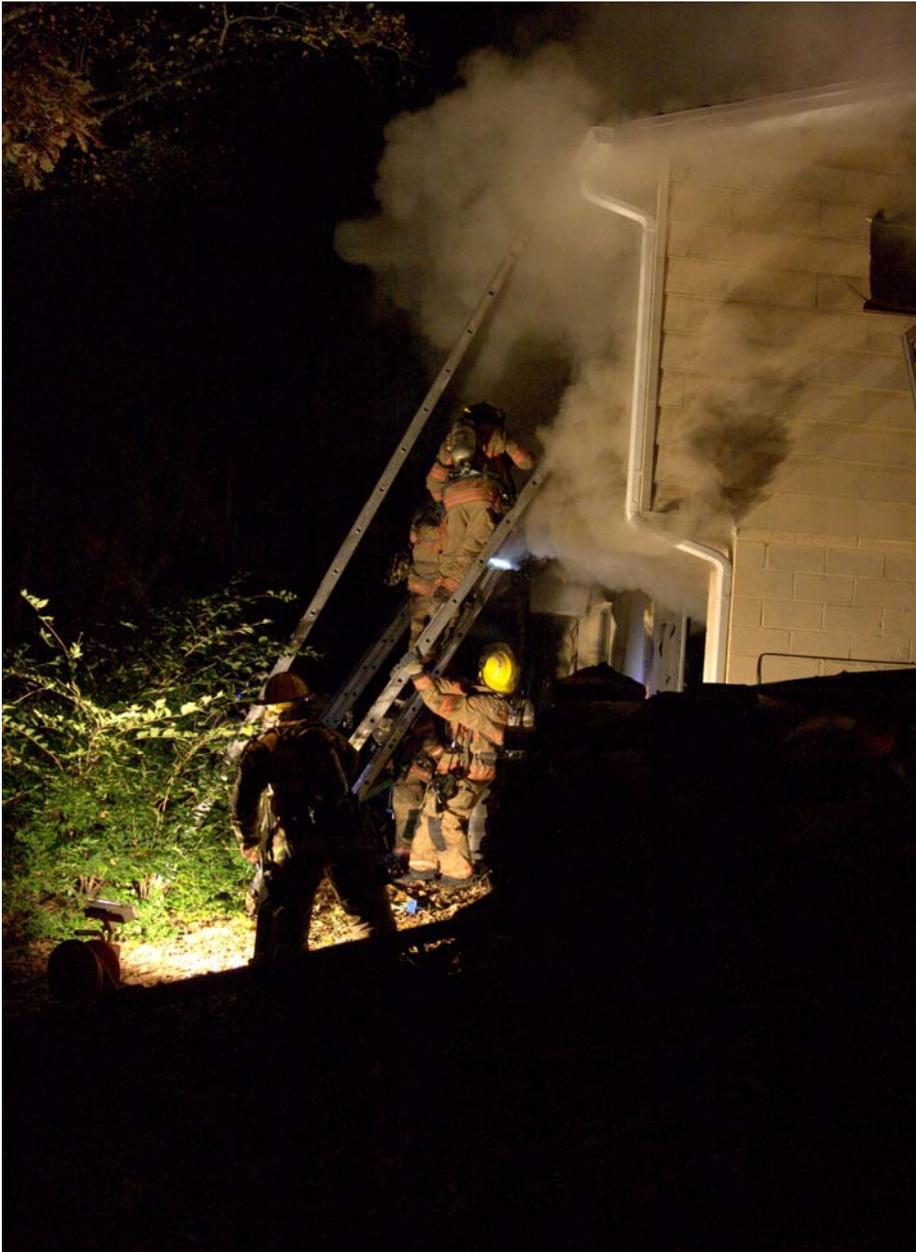
*[Personnel on the exterior enlarged the window opening with chain saws as personnel on the interior located and removed a large patient wedged between the bed and wall covered with debris.]*

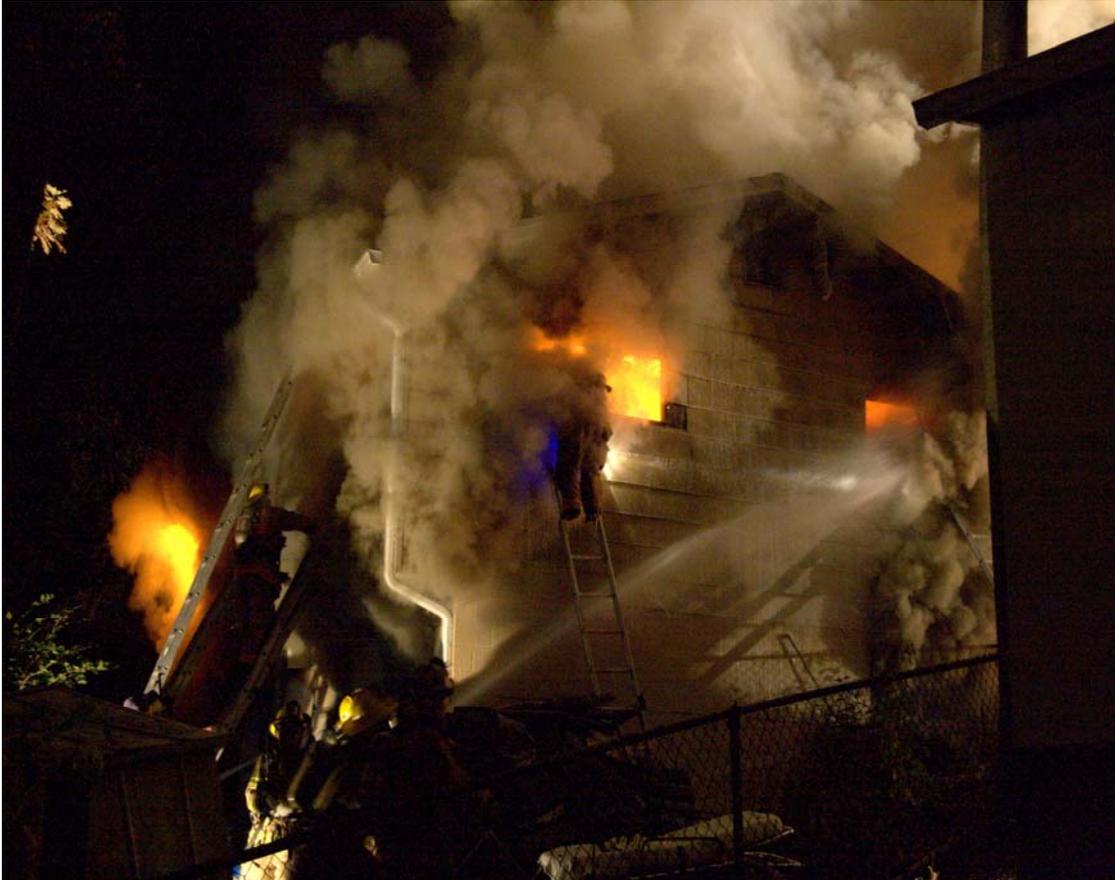
*[Immediately after the occupant was removed, fire conditions deteriorated causing personnel to bail out of a delta side window.]*
