# POST INCIDENT ANALYSIS

## July 29, 2012

2-Alarm Back-To-Back Townhouses  
18212 Fifeshire Drive  
Gaithersburg MD 20877  
Incident # 12-0084968

Submitted by Battalion Chief John J. Gallo

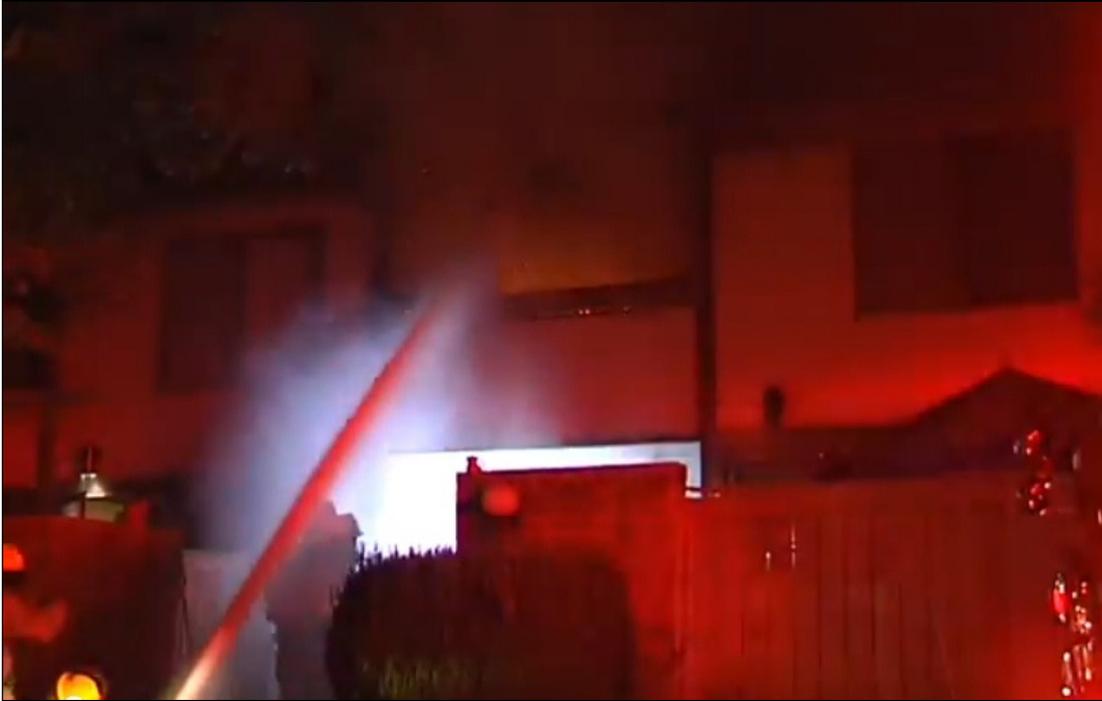
E708 now reports sparking electrical meter on the Alpha side near the front door making entry to the first floor impractical.

Energized Electrical Panel Adjacent To Front Door

RS729 assigned to confirm an all clear of the fire building and control the utilities; electric controlled at the panel and later at the meter by PEPCO. This complex did not have a gas feed. PEPCO in the end pulled meters to four units affected by the fire.

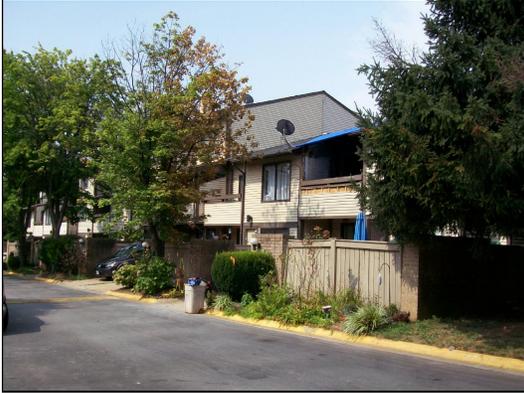
Alpha Side – 18212 Fifeshire Drive

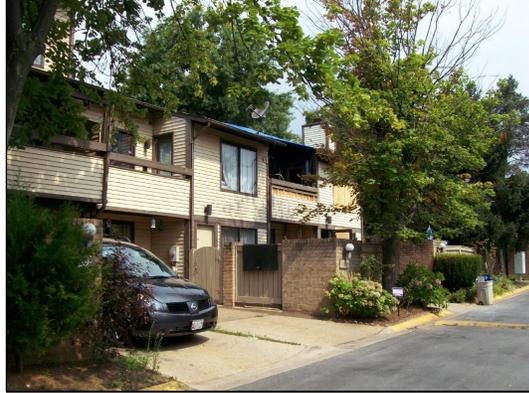
space with large trees and proved not to be a threat. The Bravo Exposure reported no fire penetration and the fire wall still intact.

Bravo Exposure – 18210 Fifeshire Drive

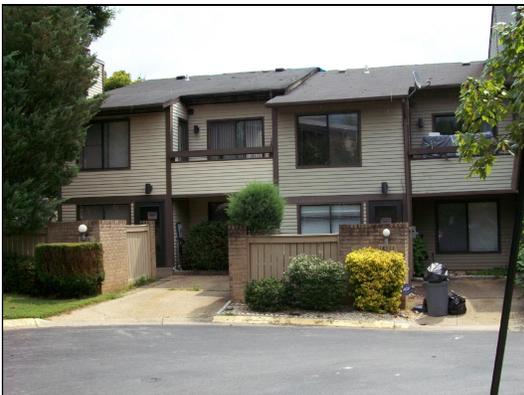
Charlie Side – 18113 Kilrush Court

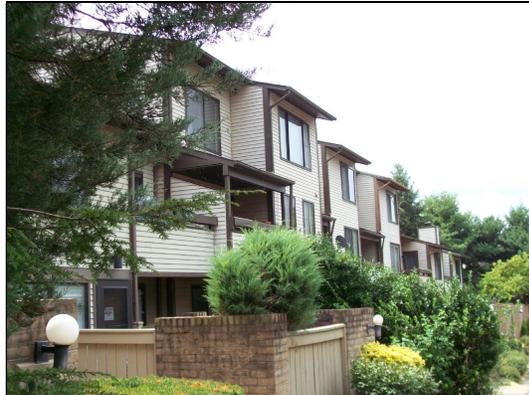
Charlie Side Exposures on Kilrush Ct

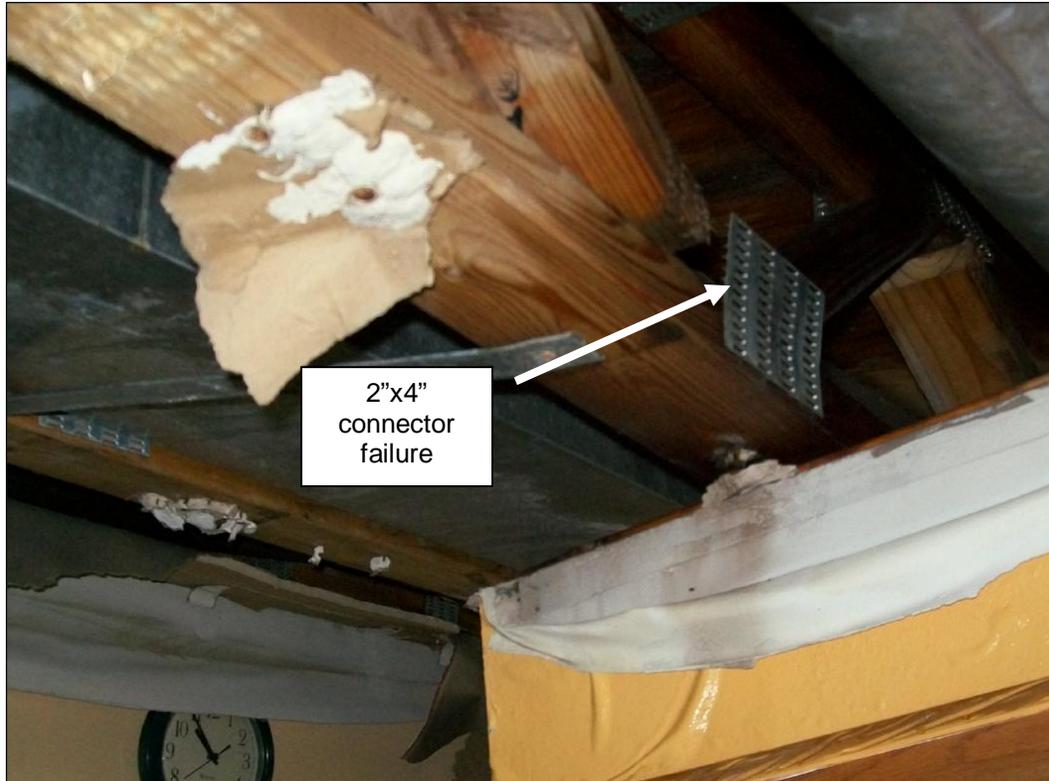
*Note: The floor systems in the alpha/bravo quadrants consisted of a 2"x4" gusseted truss assembly spaced on 24" centers. This assembly ran from the front to the rear unsupported. This floor system failed at the 2"x4" wood connection and the metal gusset holding the system together. The failure was not contributed to exposure to fire. Firefighters must expect this whole townhouse complex is designed in the same manner and to expect early failure of the floor structure based on poor design.*
