Montgomery County Fire and Rescue Service

Post Incident Analysis – 2037 Lyttonsville Rd

Incident # 12-0008256

January 22, 2012

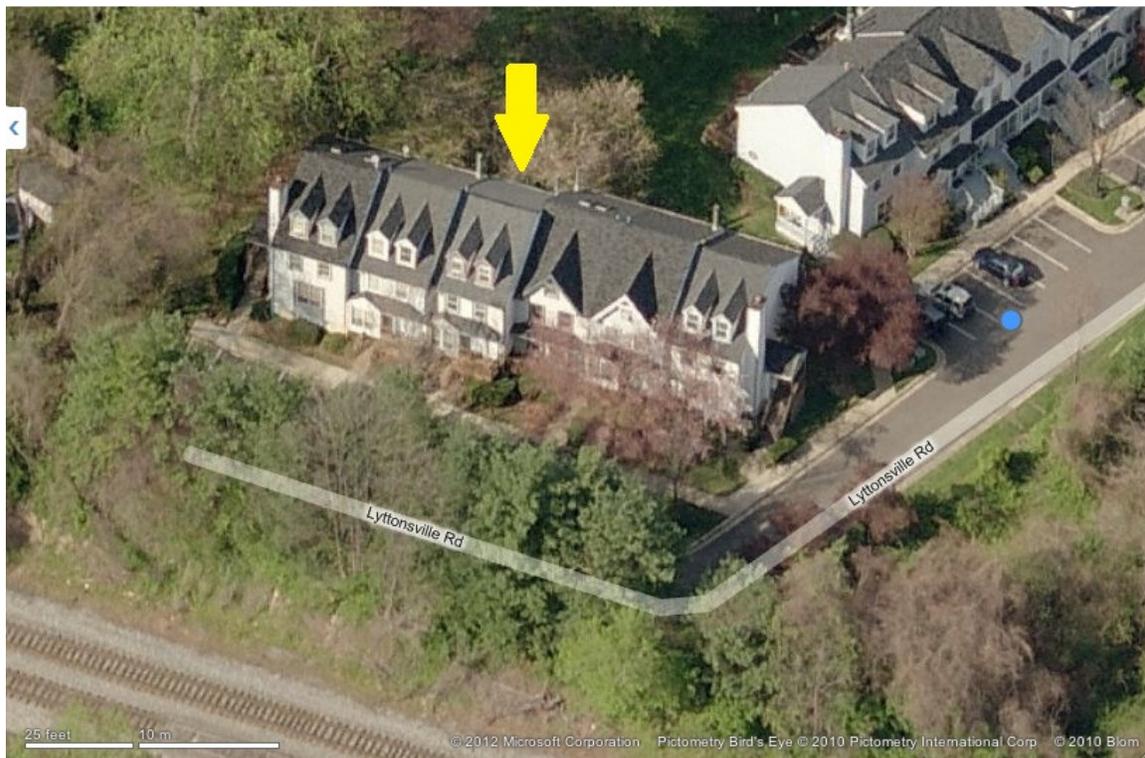
2037 Lyttonsville Rd was a middle of the row, lightweight wood frame constructed townhouse. The building was three stories in the front and four stories in the rear with a walk out basement. An elevated deck was attached to the first floor on the Charlie side. The home had functioning smoke detectors that activated for this fire.

The fire started in the basement in the rear of the structure and quickly spread through the walls and up the outside rear into the attic. The lightweight members likely contributed to the rapid loss of structural integrity.

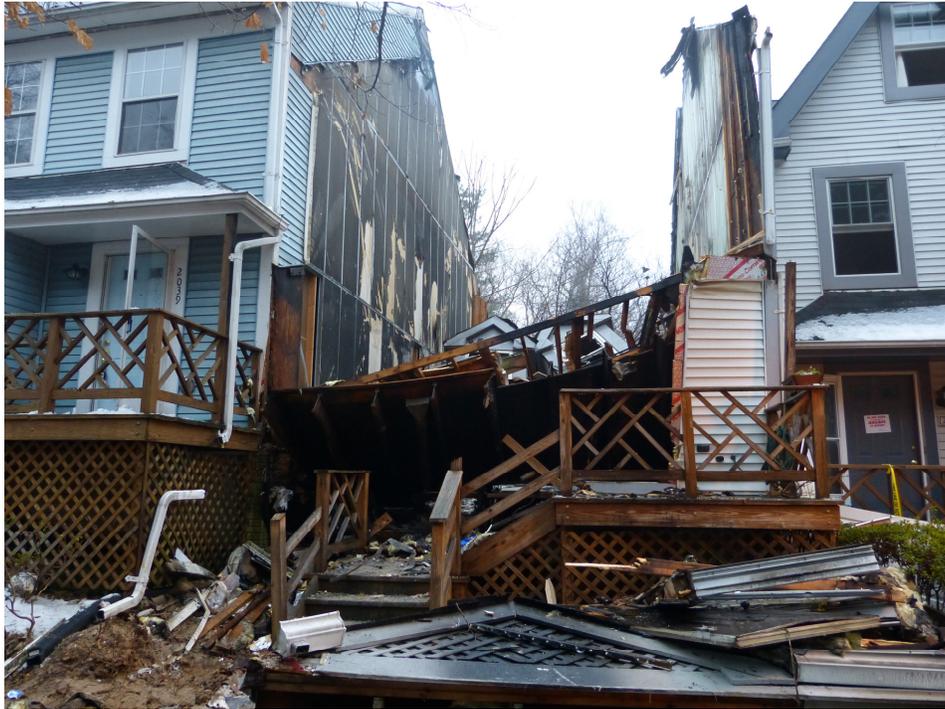
The cause of the fire remains under investigation and it is currently listed as “undetermined”. The collapse of the structure and the hazards associated with the debris from the collapse hindered the investigators ability to determine cause and origin.

The fire spread throughout this structure very quickly. What contributed to the spread is hard to determine due to the collapse. The overall fuel load inside the townhome cannot be established. As noted previously, the home utilized lightweight construction materials and vinyl siding. The lightweight floor trusses were undoubtedly a factor in the early loss of the first floor and the eventual collapse of the building.
