Montgomery County Fire and Rescue Service

POST INCIDENT ANALYSIS

**12695 Monnier Court
Mount Airy, Md.**

High Risk Low Frequency- Mutual Aid Mayday

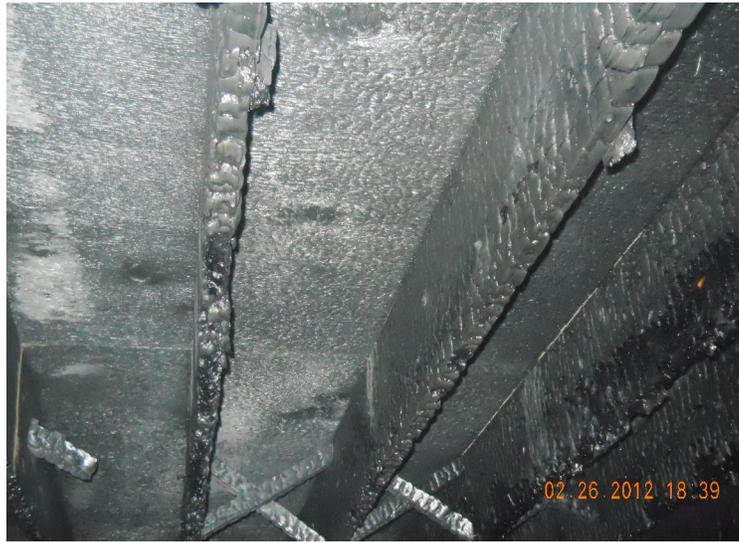
Floor joist looking up from basement.

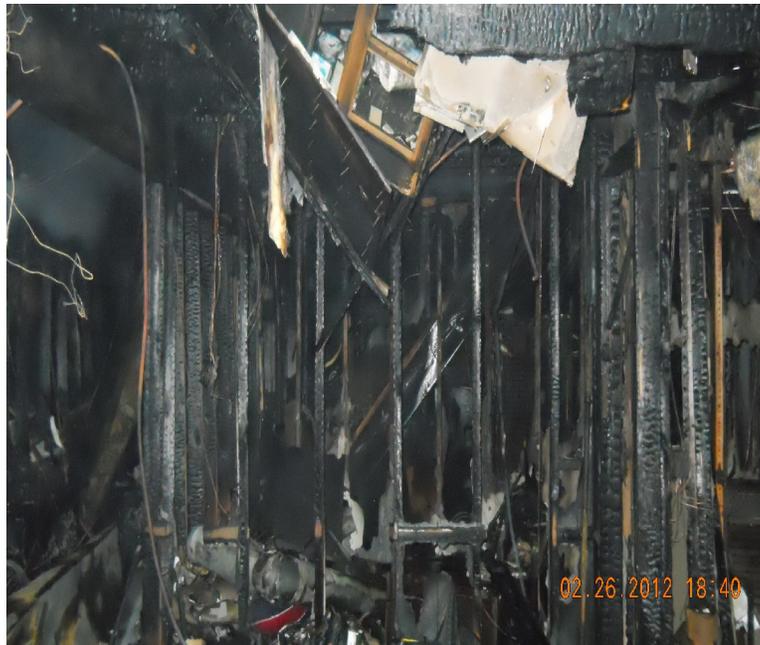
knocked down the fire in the wall, he walked towards that wall to pull the remaining drywall. When he took his next step, his right leg fell through the floor and up to his hip. He tried to lift himself out for a few minutes then realized he could not do so. He did not want to crawl to his right because he thought he might have fallen completely through the floor into the basement. He yelled for his crew to help him then notified command he had fallen through the floor in the front bedroom. The crewmember assisting looked down the hallway and saw another fire fighter. He told him they had a fire fighter through the floor and to call a mayday. A mayday was declared by AT923 for AT735; the crew reported to his location and assisted him out of the hole in the floor but, they had difficulty because his SCBA was catching on the doorframe, the OIC came free and they stood him up.

Hole in first floor looking up from the basement.

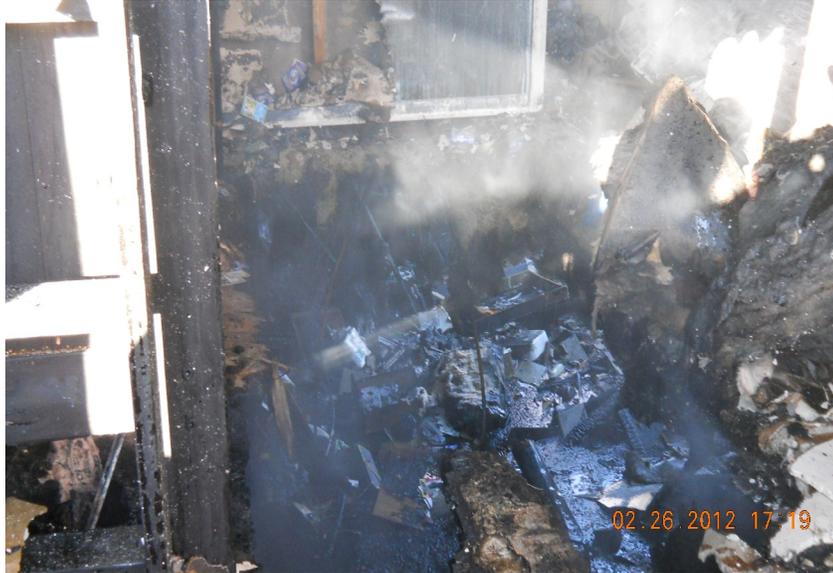
Hole in floor looking from first floor into basement.
