## Special Ops

# Incident Summary

**Incident Location** Darnestown Road near Bucklodge Road  
**Location Description** Rural Road  
**Incident Date** April 11<sup>th</sup> 2012  
**Incident Type** PIC with Overturned Tanker

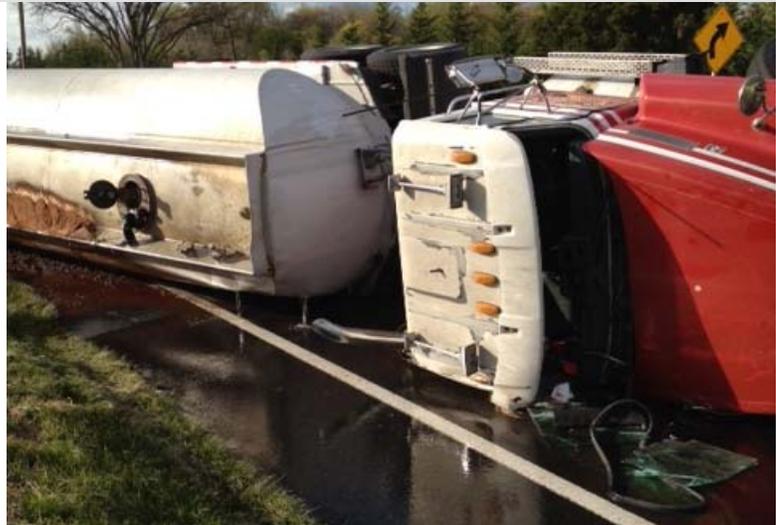
Co14 arrived on scene and found a single vehicle - tractor trailer pulling an 8,000 gallon MC306 tank trailer. The combination was laying on its side on the edge of the road. The driver was report by civilian rescuers to initially be unconscious prior to FRS arrival. Co14 found the driver out of the vehilce and treated him for facial lacerations and rule out trauma.

The tanker was leaking both from the open top fill domes and seam damaged along the front and street side.
