Post Incident Analysis

House Fire with a Firefighter that fell through a hole in the floor

6000 Muncaster Mill Road

May 5, 2012

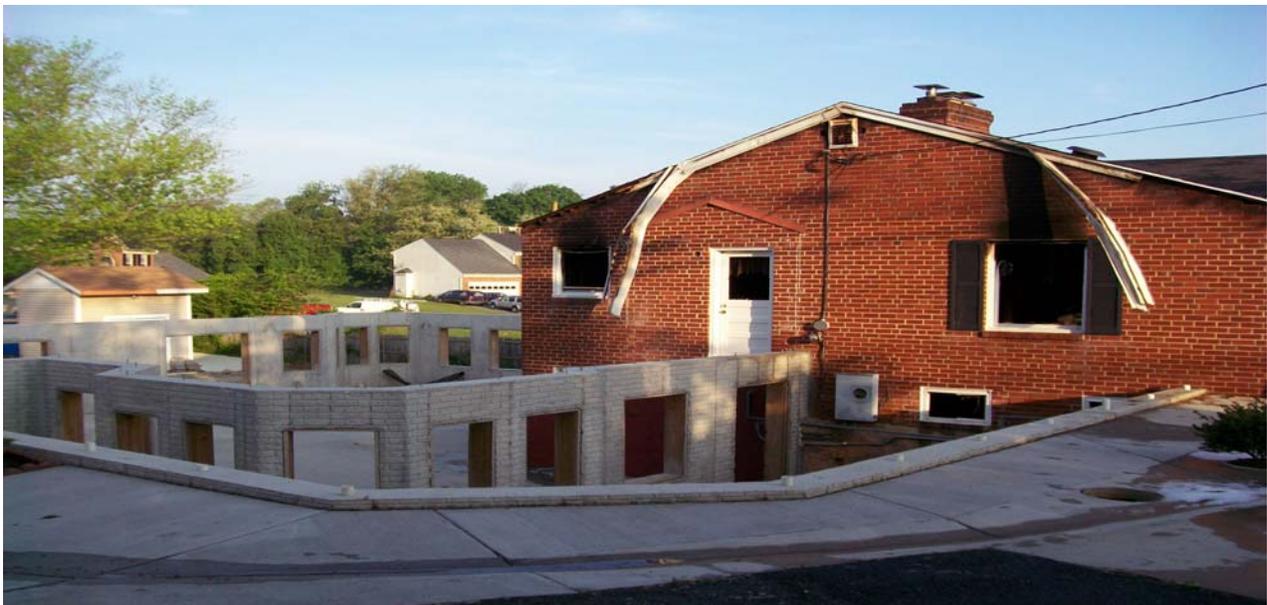
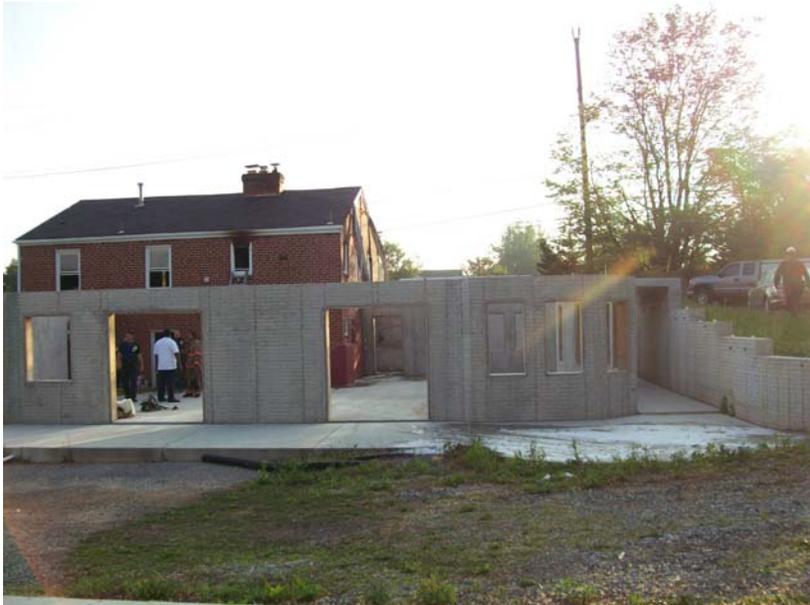
The building: The house is described as a single family dwelling of ordinary construction. There was brick on the exterior of the house. The house had a full basement with 2 walk out doors on side C. The house was fully furnished. What was unusual about the house was that the footers and concrete walls were constructed for a large addition but no other construction had been completed. At first look the walls created some confusion of exactly what the crews were encountering. You actually had to move through the new construction to get to the basement doors. The unfinished foundation could have also created a fall hazard as none of the walls were marked or secured in anyway. The drop off was about 10 feet. Firefighters advancing lines or working in the area could have fallen if the fire due to darkness. Firefighters also did not find any interior stairs connecting the basement to the first floor.

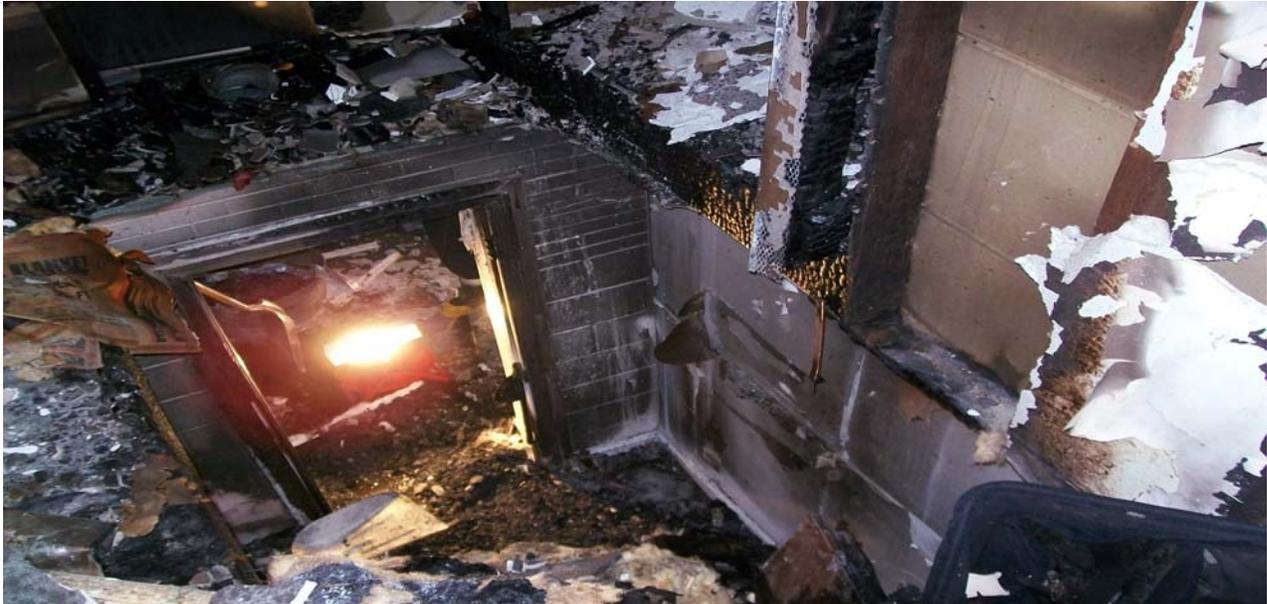
Fire ground Tactics: E 728 arrived and provided a good report. The Captain on E 728 did a circle check and reported fire on both floors. At this time BC 703 arrived and established command on side A with a good look at side A and B of the house and a direct look into the front of the house through a large picture window. BC 704 arrived and the command team was built in the BC 703 buggy. With the report from Engine 728 command asked E 728 where they would commence the initial attack. They choose the side A entrance on the first floor. With that command instructed the second due engine E 740 to begin an attack on the side C entrance to the basement. Command made sure that both engine companies were to stay on the division they were assigned and not to ascend or descend any stairs to avoid opposing hand lines. This tactic worked well. Trucks were assigned to each division, the rescue squad performed searches and controlled utilities and back up lines were in service. RID was set up on side A in the driveway with a look at 2 sides of the house. Approximately 0600, or 19 minutes into fire attack, a firefighter from T 703 fell through the hole that had burned through the floor. The firefighter stated that he was hooking ceilings and was looking up and did not see the hole in the floor. Command actually observed the firefighter disappear through the floor from command post vantage point and then asked the basement division if they heard or saw the firefighter fall. Basement division immediately reported that they had the injured firefighter and they were getting him out of the house. Command also asked if RID needed deployed which they were not needed. A good point here is that the officer on E 740 activated his EB button in which ECC immediately called command and command called E 740. The EB button was activated for the down firefighter. Normal firefighting activities resumed after the firefighter was rescued. The fire was declared under control at 0620.
