## Montgomery County Fire and Rescue Service

### POST INCIDENT ANALYSIS

**House Fire with MAYDAY  
11120 Nicholas Drive  
Silver Spring, MD**

**Incident Date: February 23, 2013**

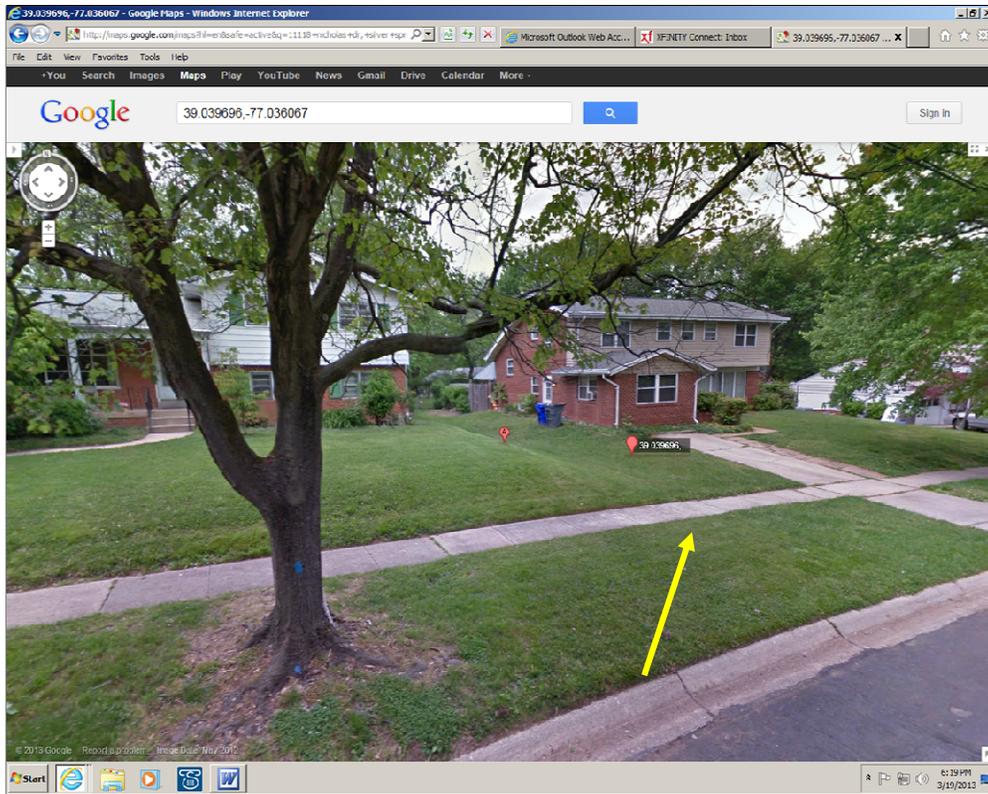
- The house was approximately 2,200 square feet in size and was constructed in 1957. It was built of Type III construction with no fixed fire suppression systems.
- The layout of the house was unusual in that it was a 2-story split level style home; however the split level feature ran side to side rather than the traditional front to back arrangement.

Figure 2: 11120 Nicholas Drive – 2-story SFD – Split-Level House. (Google Maps)

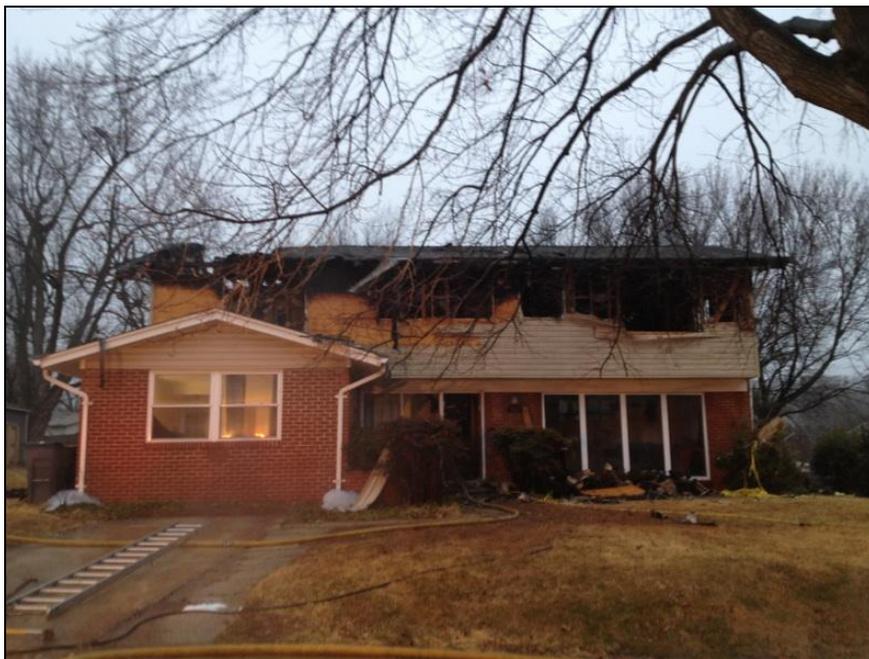
Figure 3: From the Alpha Side, the house appears as a 2-story colonial style home.

- From the Alpha Side (Figure 3) of the structure, the house appears to be a 2-story, colonial style design with two complete floors, a center stairway, and perhaps a basement given its colonial style.

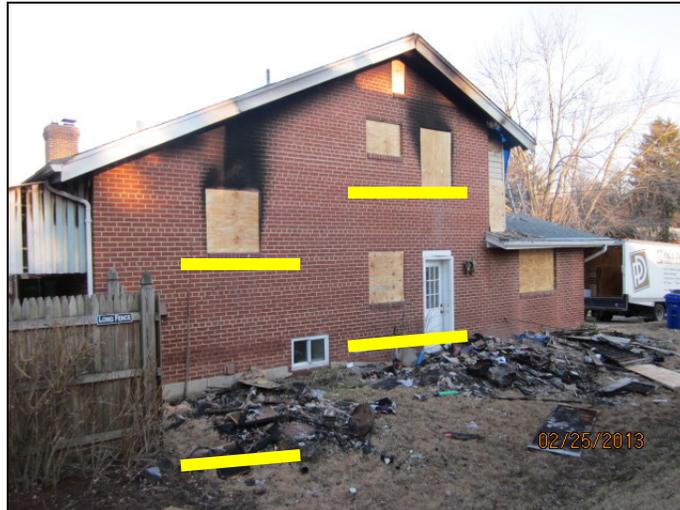
Figure 4: The yellow lines indicate the four different levels inside the house.

- When looking at the house from the Bravo Side (Figure 4), the offset of the windows shows that the house is really a split level design with the “split” feature running from the Bravo to the Delta side.
- The layout of each floor was open, which allowed for rapid fire growth as compartmentalization was minimal.

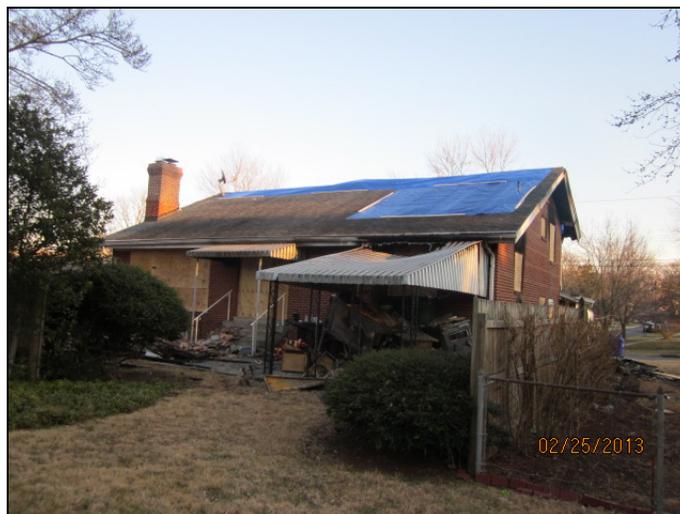
Figure 5: From the Charlie Side, the house appears to be a 1-story structure with a walkout basement.

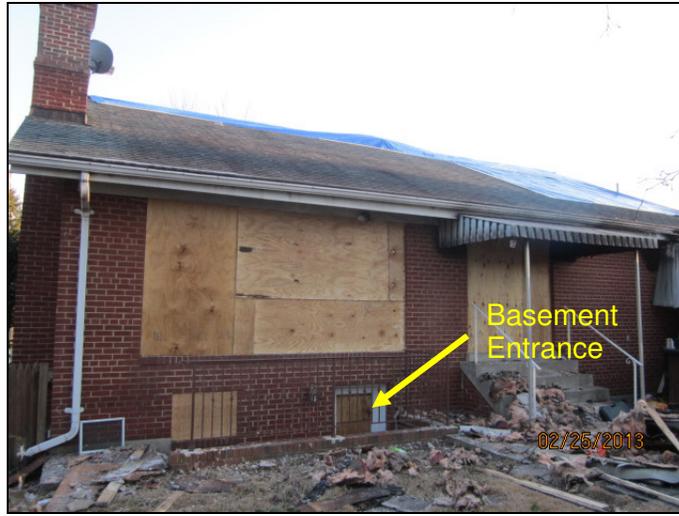
*Figure 6: The basement entrance on the Charlie Side.*

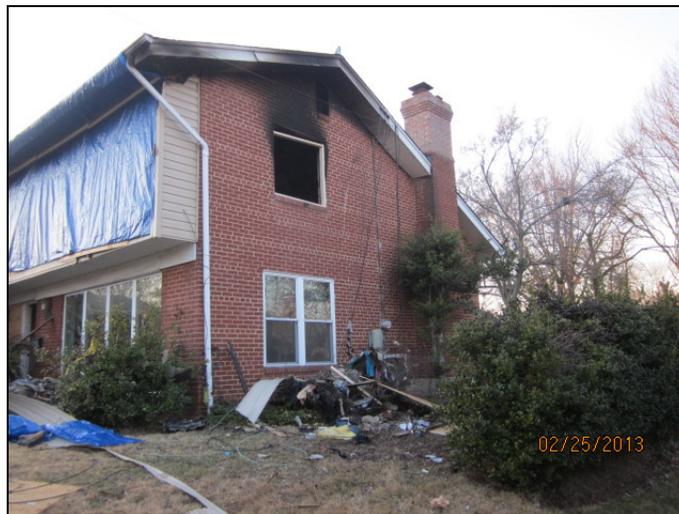
*Figure 7: All utilities entered the structure on the Delta Side.*

- Safety 700 arrived late into the incident and served only in an advisory role.
- The only safety-related issue (other than the fire) was the damaged power lines on Side Delta where the house service entry point was located. The area was cordoned off and the lines were eventually dropped by the power company.

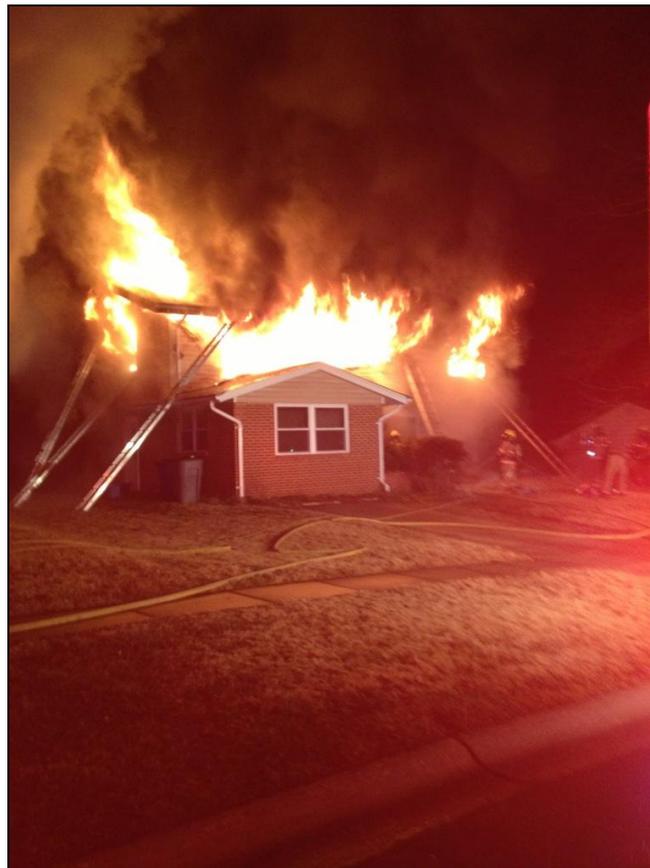
*Figure 8: Side Alpha – as the first hose lines begin to make entry.*

- Attack line selection was adequate for the fire conditions present and the type of occupancy. Although the photos show a significant amount of fire pushing out of windows, the attack lines chosen were adequate
