Piney Branch Special Protection Area

4.3.1 Description of the Piney Branch SPA Watershed

4.3.2 Status of Development in Piney Branch SPA as of June 2002

4.3.4 Summary of BMP Monitoring in Piney Branch

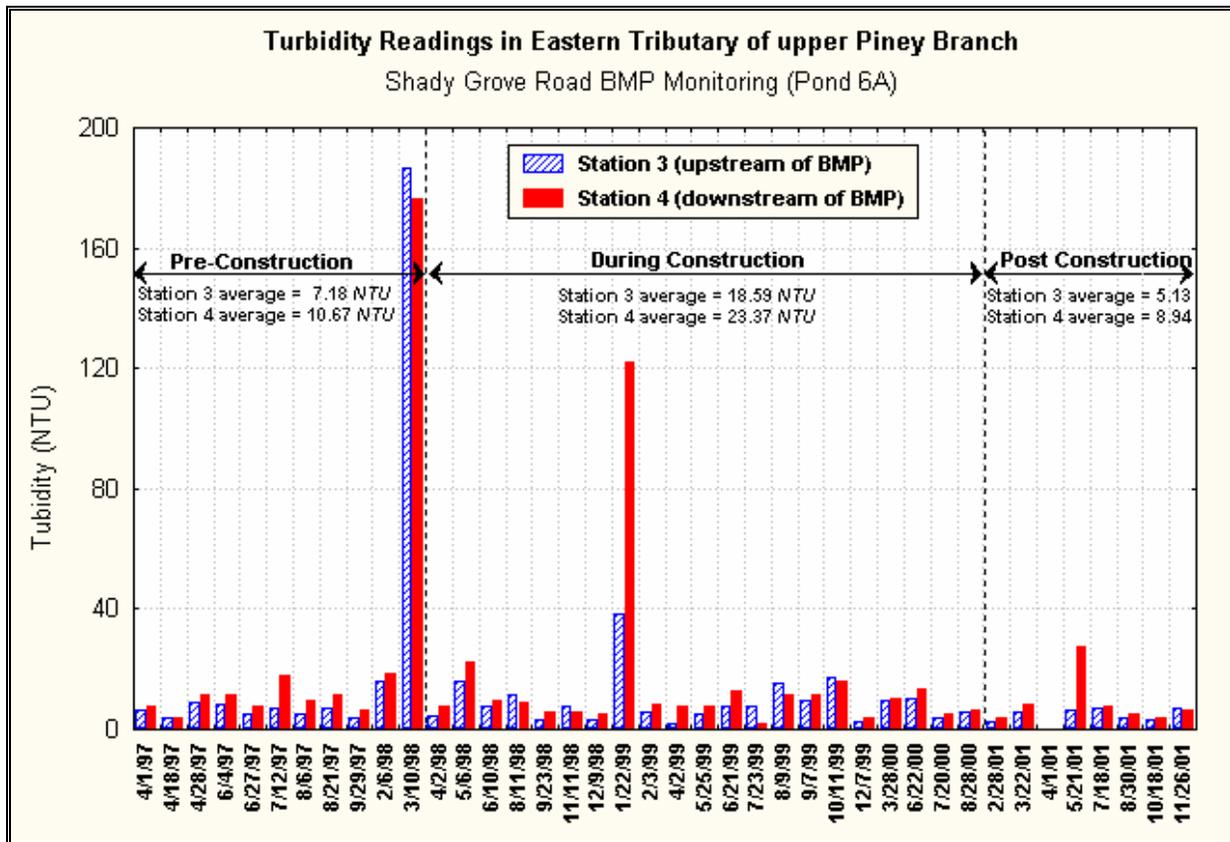
Figure 31. Turbidity Monitoring Results at Pond 6A

At pond 6A turbidity increased between the upstream station 3 and the downstream station 4 during all three phases of the monitoring (figure 31). Turbidity increased at station 4 an average of 48% during the pre-construction period, 26% during construction and 75% during the post construction period to date. For the during-construction phase one precipitation event on 1/22/99 is responsible for driving up the average increase of turbidity. Removing this event from the data shows an average increase of 4% for the during-construction phase. These results indicate turbidity impacts were almost non-existent during the construction phase. This suggests pond 6A functioned exceptionally well in preventing turbidity impacts during the construction of Shady Grove Road.

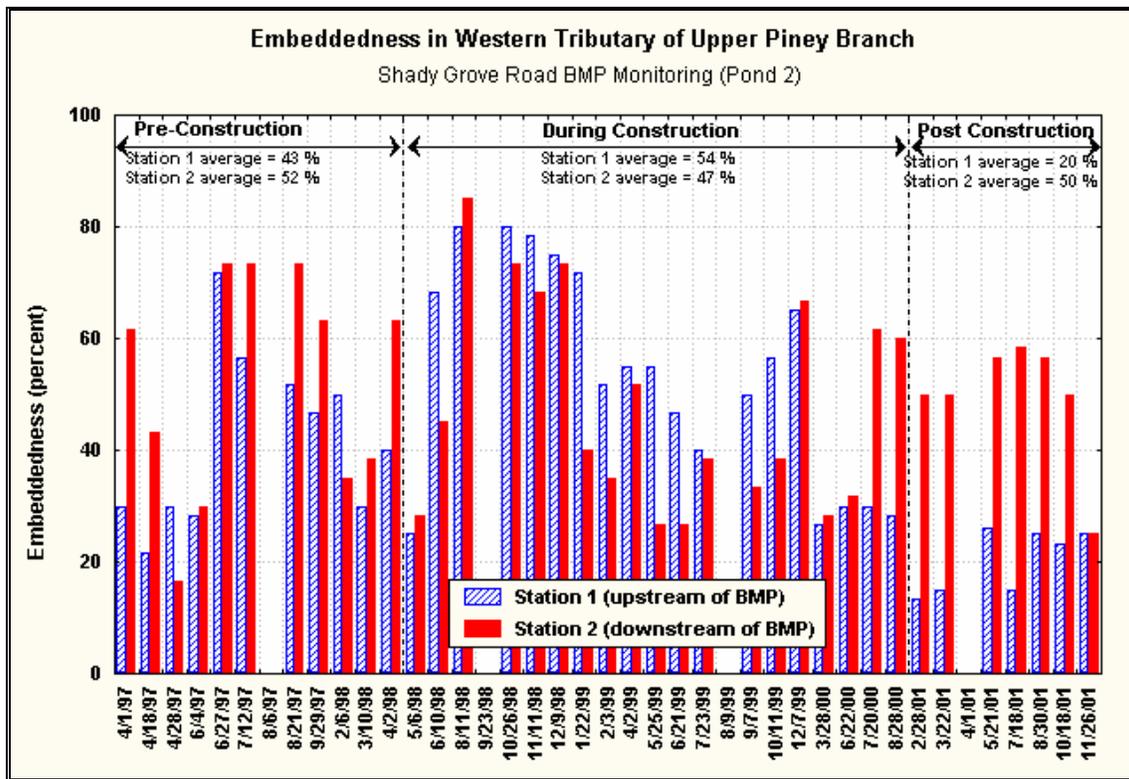
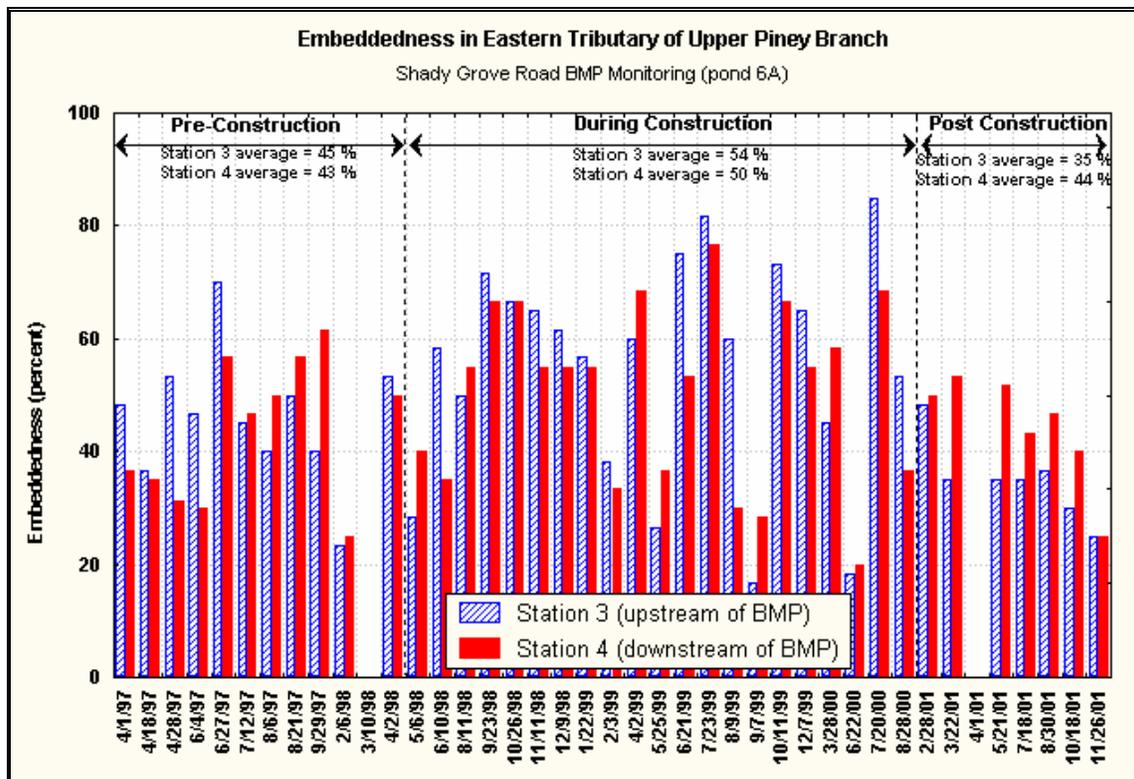
Figure 32. Embeddedness Monitoring Results From Pond 2

Results of embeddedness monitoring show some increase of stream sediment during the construction phase (figures 32 and 33). Average embeddedness values increased at stations 1,3 and 4 by 25%, 20% and 16%, respectively. However, post-construction monitoring indicates a return to pre-construction condition at all three stations. This data suggests that an increase in sediment within the stream channel occurred during the construction phase and subsequently has flushed downstream.

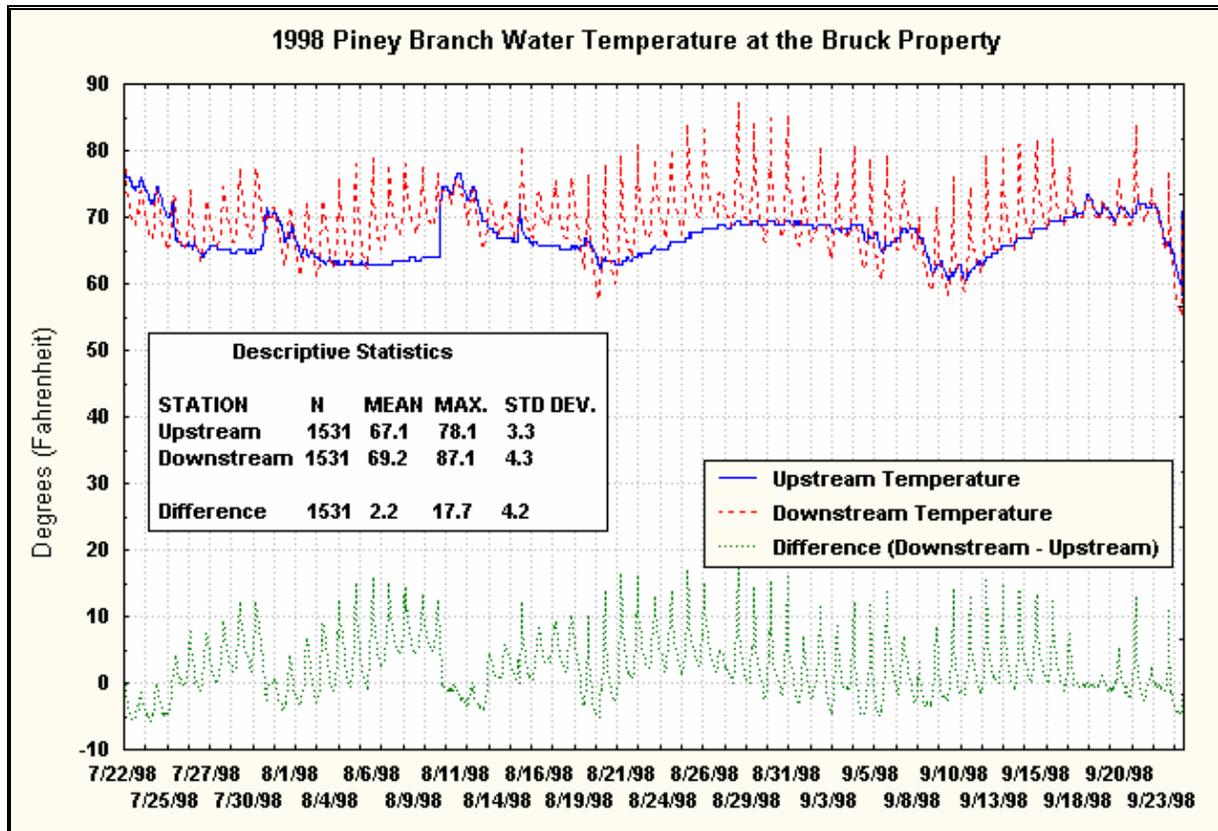
Figure 35. 1998 Stream Water Temperatures, Upstream and Downstream of Bruck Property

Results from 1998 show large daily fluctuations of water temperature at the downstream station (figure 35). DEP loggers in Piney Branch did not show this pattern in 1998. This was not explained by the consultant. However such fluctuations are usually caused by loggers not being set deep enough in the water and consequently being exposed to air temperatures during low flow periods. Because of this, results from 1998 will not be used in analysis of BMP effects on water temperature.

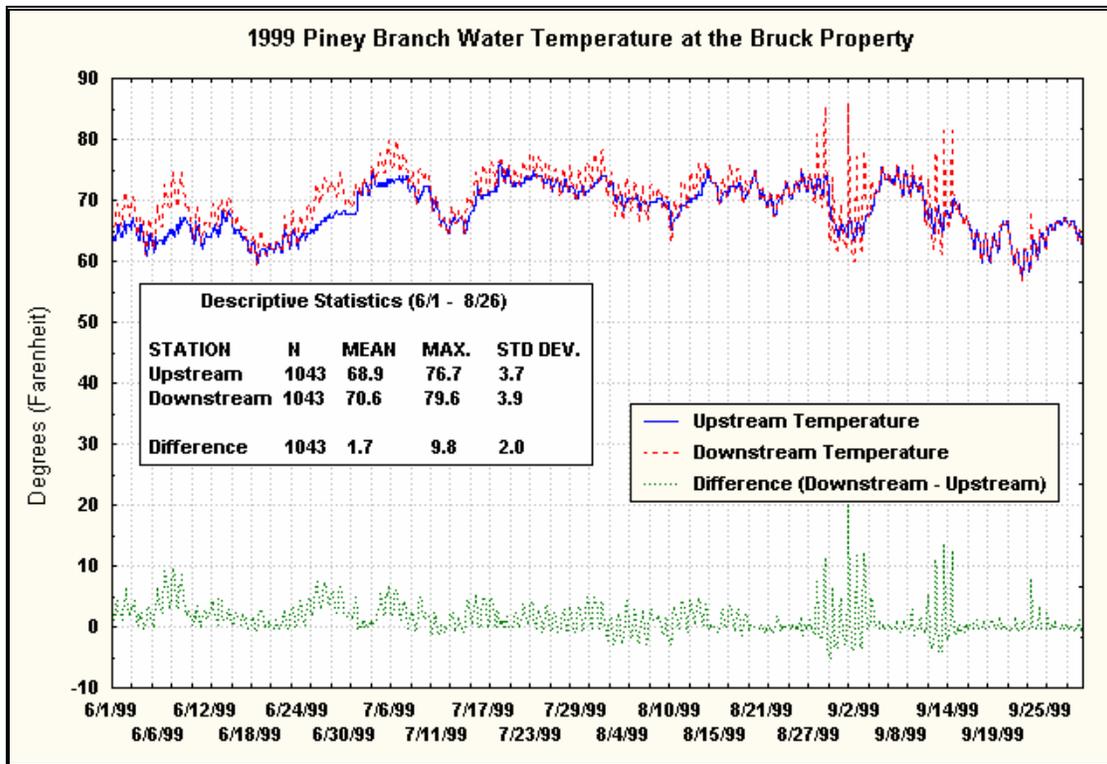
Figure 36. 1999 Stream Water Temperatures, Upstream and Downstream of Bruck Property

Results from 1999 show large daily fluctuations beginning on 8/26 (figure 36). Again, no explanation from the consultant, but presumably the stream level dropped to a point where the logger was exposed to air temperatures. For comparison purposes, the period of time between 6/1 and 8/26 will be used to study temperature impacts during subsequent years of 2000, 2001 and beyond. Results from 1999 will serve as baseline pre-construction temperature condition.

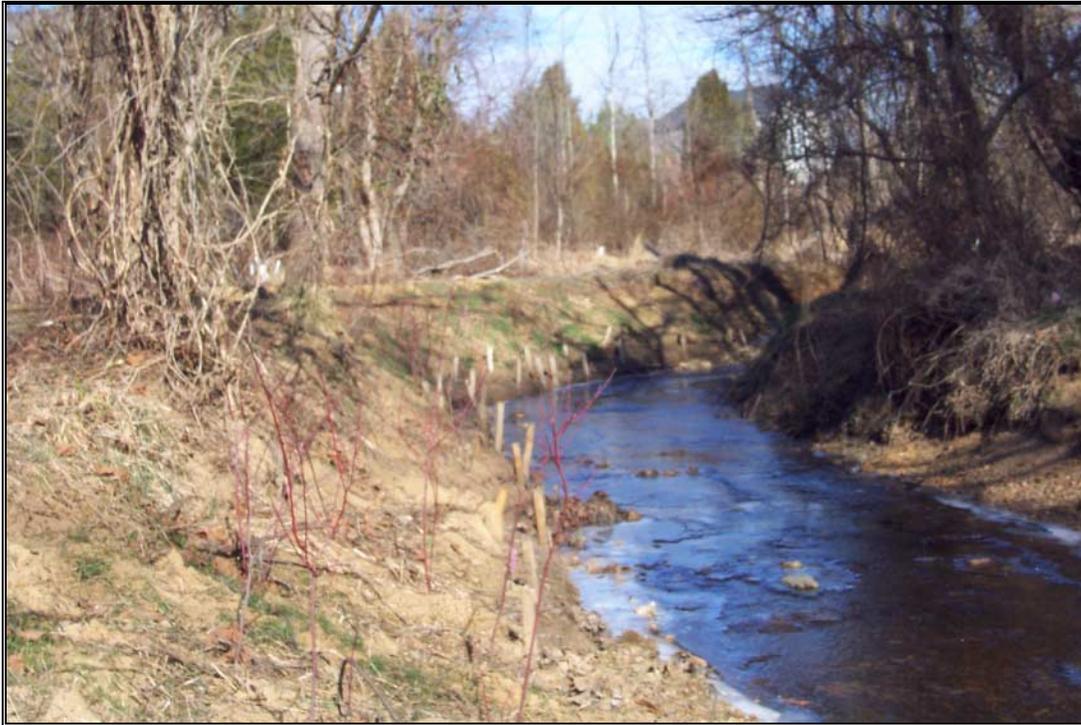
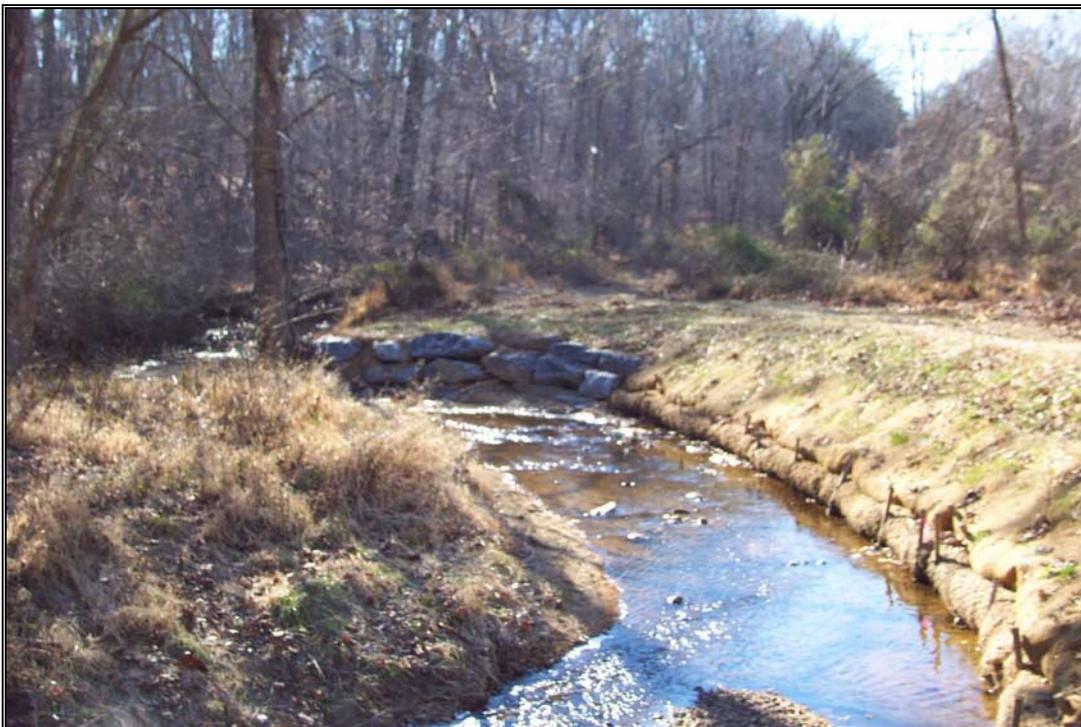
The Final Water Quality Plan for Peters Property called for stream restoration along stretches of Piney Branch where stream banks were in need of stabilization to prevent future sediment input from stream bank erosion. Staff from DEP and DPS met with representatives from Mitchell & Best Home Builders, Loiderman Associates and Environmental Quality Resources on site to walk and identify areas of the stream in need of restoration. Stream restoration included clearing stream banks of invasive vegetation, grading back steep stream banks, stabilizing the toe of the bank (zone of frequent water contact) and planting native vegetation on stream banks. This work was completed in fall of 2001. Pictures of this restoration work are available in figures 50 –51.

Figure 50. Piney Branch Stream Restoration at the Peters Property

Figure 51. Stream Bank Stabilization with Fiber Rolls and Rock Revetment Along Piney Branch at the Peters Property

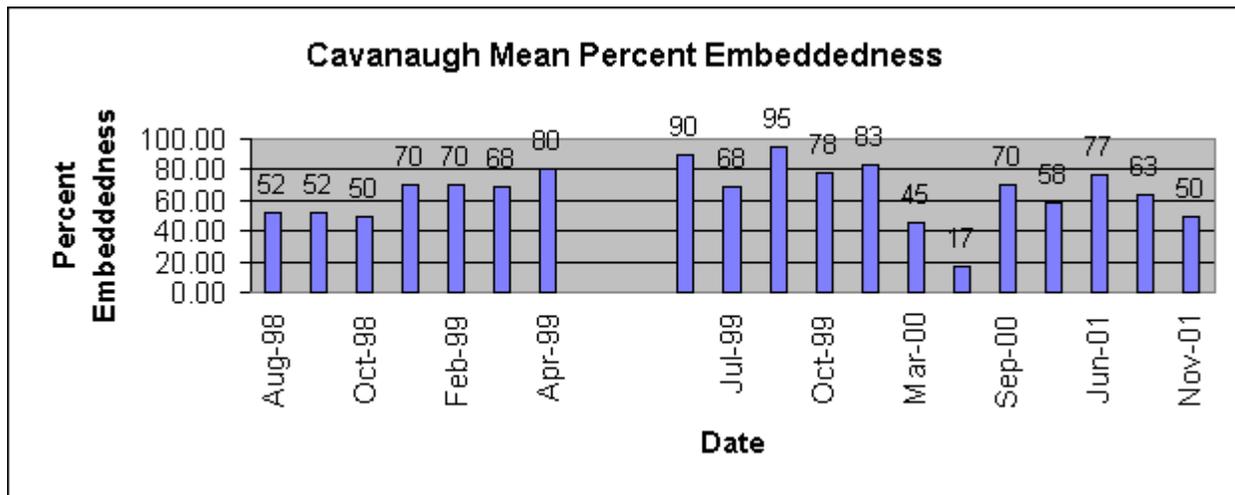
Figure 52. Embeddedness Readings Taken Downstream of Cavanaugh Property

Cavanaugh project preconstruction monitoring was conducted from July 1998 through April 1999. Construction phase monitoring began in June 1999 and is still in progress. At this site temperature data is collected at three stations. Embeddedness data is collected at one station and there are two groundwater wells being monitored. Unfortunately, a beaver dam was constructed at the site this year which interfered with data collection at the downstream end of the project (station 1). Embeddedness values may have been affected and the station 1 temperature logger could not be recovered. Embeddedness values are presented in figure 52 below. Embeddedness values averaged 63.1 % prior to construction. In the early stages of construction higher levels of embeddedness were observed. Embeddedness values averaged 83.0% from June 1999 until December 1999. At least once during this period, fresh sediment deposits were noted in the stream when embeddedness readings were being taken. Beginning in 2000, embeddedness values were more comparable to values observed prior to construction. From March 2000 through November of 2001 embeddedness values averaged 54.3%. These data indicate that the Cavanaugh BMPs were not able to stop sediment from leaving the site and affecting the stream in the early stages of construction when large areas are disturbed. Later on in the construction process, as portions of the site were stabilized and grading activity diminished, the site had a lesser impact on stream embeddedness values.

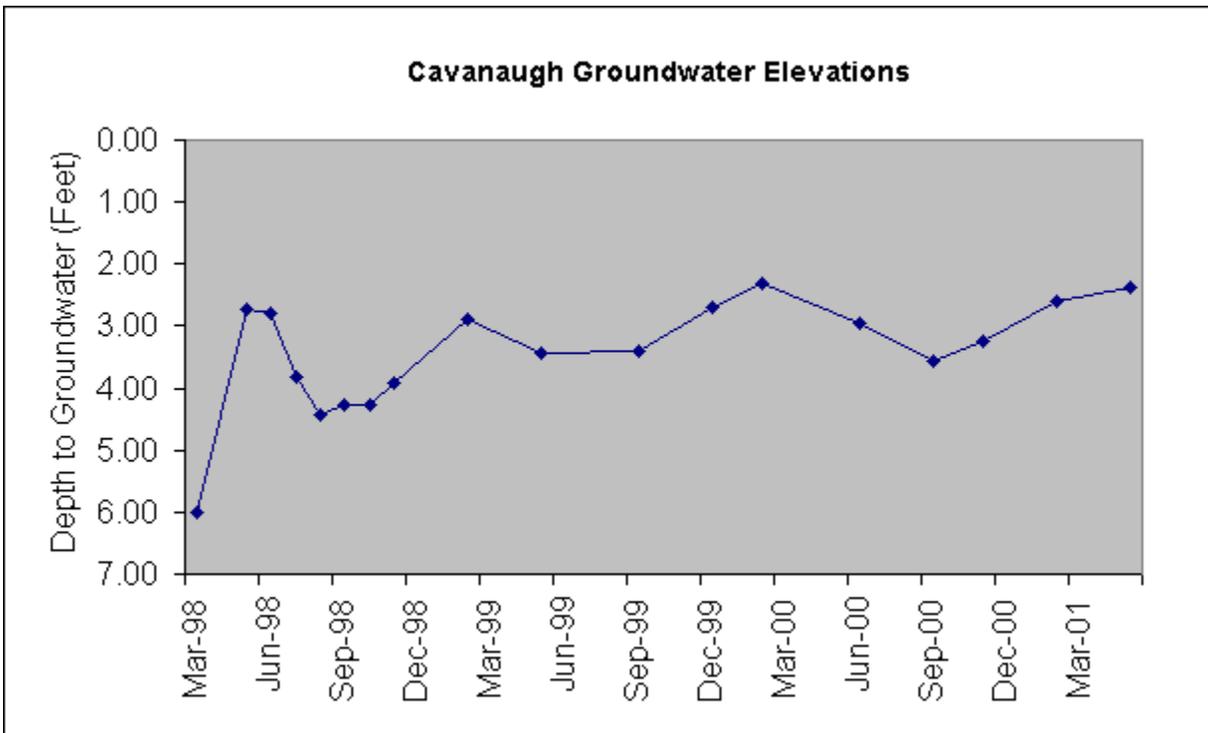
Figure 53. Groundwater Readings From Cavanaugh Property

Groundwater levels at the site are plotted in figure 53 below. Although there are two monitoring wells at the site one well has had water flowing out of the top of the well casing on most days it was checked. Useful readings cannot be obtained under such conditions and the data are not plotted here. The other well has shown generally stable groundwater levels when measured. The last data point DEP has for this well is from May of 2001. The monitoring consultant had difficulty locating the well on a subsequent visit and stopped collecting data. DEP has recently notified the developer that data collection efforts need to resume. As the region is in a hydrologic drought period, DEP is interested to see if groundwater levels are affected at the site.

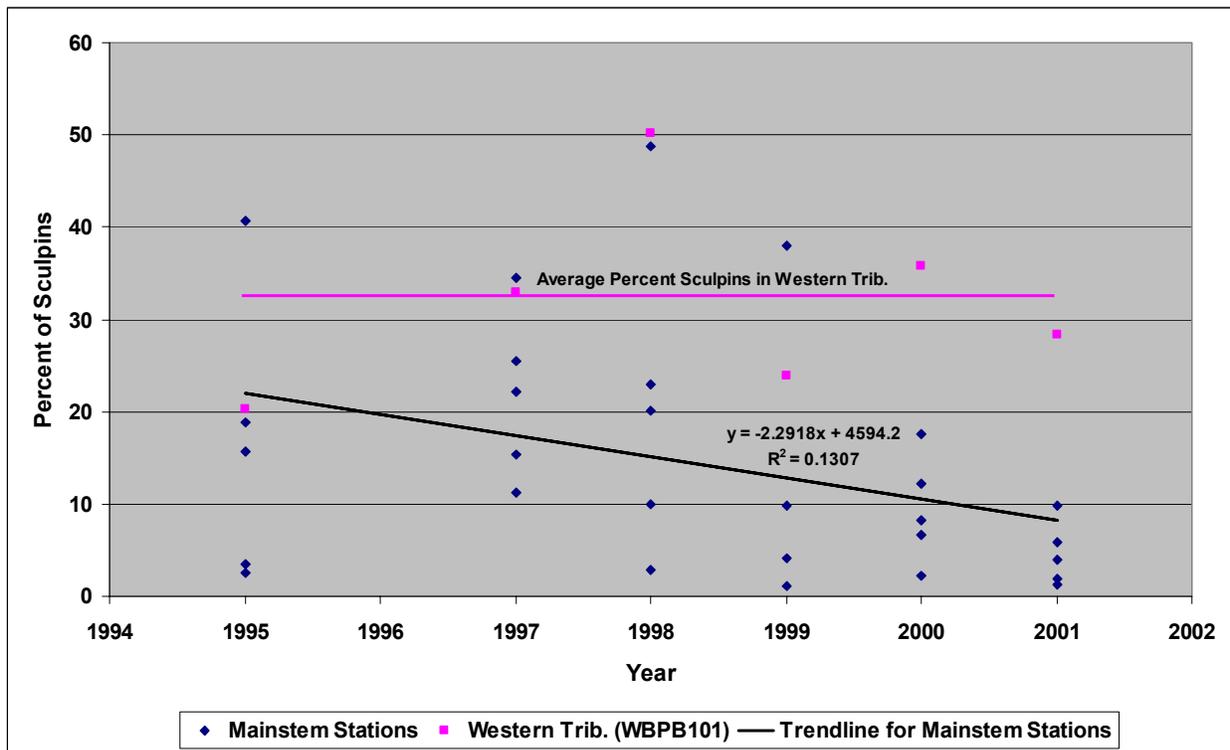
If this trend continues, the regression model predicts that most mainstem sites will have no sculpins by 2006. Sculpins are bottom dwelling fish species that feed on aquatic insects. For successful spawning they require clean gravel and cobble sized stones on the stream bottom, under which they deposit their eggs. For eggs to develop, cool, well-oxygenated water must pass under and through empty spaces between stones. In recent years (since 1999) DEP has noted increased levels of algal growth on the stream bottom. This could be inhibiting sculpin reproduction by clogging the spaces under the stones and reducing the ability of water to flush through. An increase in algal growth is the result of increased nutrients (nitrogen and phosphorus). At this point in time we do not know the source(s) of increased nutrients.

Figure 58. Relative abundance of sculpins. Blue diamonds are data from stations located along Piney Branch mainstem. Black line is the trendline for sculpin abundance at all mainstem stations over the period 1995 – 2001 (p=0.05). Purple squares are data from the Western Tributary (WBPB101). Purple line represents the average percent sculpins. Regression analysis on WBPB101 data shows no significant trend (p=0.83)

Regression analysis on data from the Western Tributary (WBPB101) indicate no statistically significant trend in sculpin abundance over the period of 1995 - 2001 (figure 58). The number of sculpins (expressed as percentage of the total fish community) has remained unchanged indicating stability with this sensitive fish species. It is noteworthy that increased algal growth has not been observed over the period of study in the Western tributary.

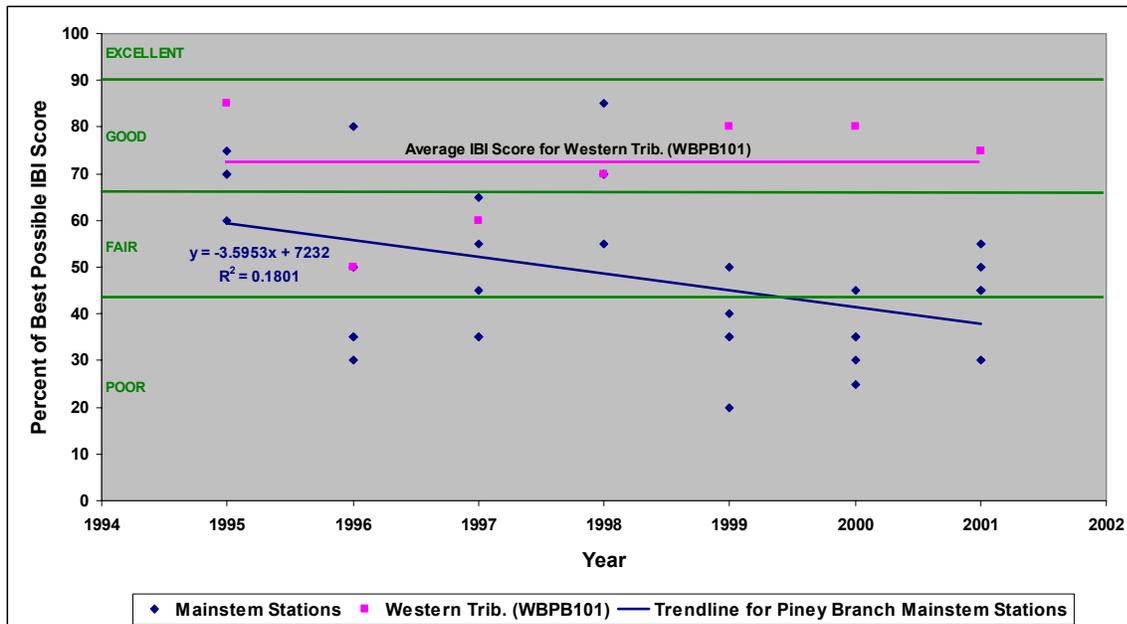
Regression analysis on benthic macroinvertebrate IBI scores from 1995 to 2001 indicate a negative trend within the Piney Branch mainstem from fair condition in 1995 to poor in 2001 (figure 59). This trend is not present in the Western tributary where condition has remained in the good range. This leaves little doubt that the macroinvertebrate community has been impaired along the mainstem of Piney Branch. Whatever the cause, the impact does not exist in the Western tributary.

Figure 59. Piney Branch benthic macroinvertebrate IBI scores 1995-2001. Blue diamonds are mainstem stations. Blue line is the trendline (P=0.014) for mainstem stations. Purple squares are data from the Western tributary (WBPB101). Purple line is average IBI for WBPB101. There is no significant trend in Western Trib. IBI scores.

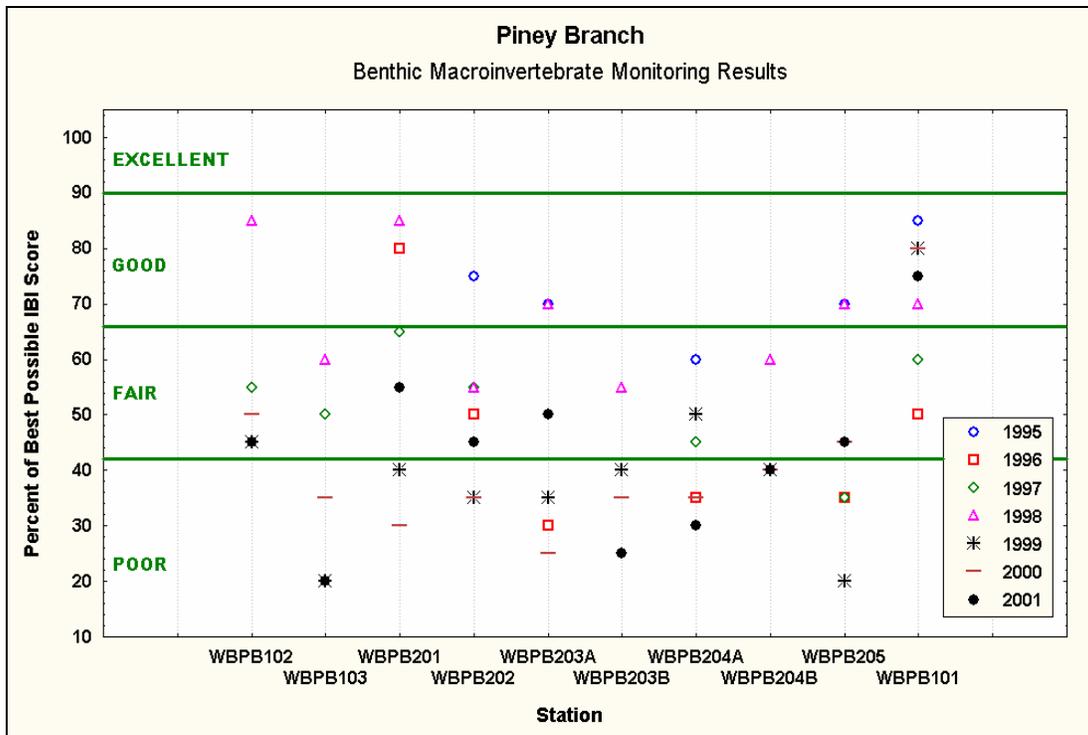
Figure 61. Results of Benthic Macroinvertebrate Monitoring in Piney Branch

Results of benthic macroinvertebrate monitoring from 2001 are presented in Figure 61 along with results from previous years. Overall condition of the benthic macroinvertebrate community is in the lower fair or poor range at all mainstem stations for a third year indicating a shift to a more pollution tolerant community. Results from the Western Tributary (WBPB101) indicate no such shift has occurred there as IBI scores for the past three years have remained in the good range.

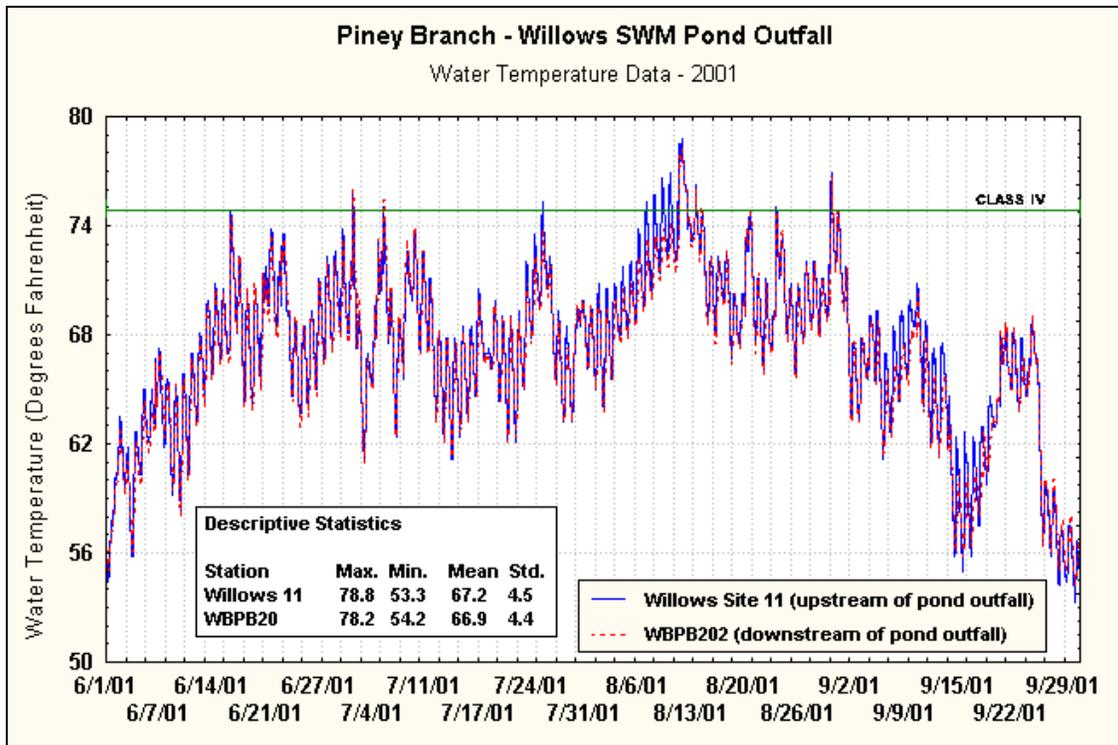
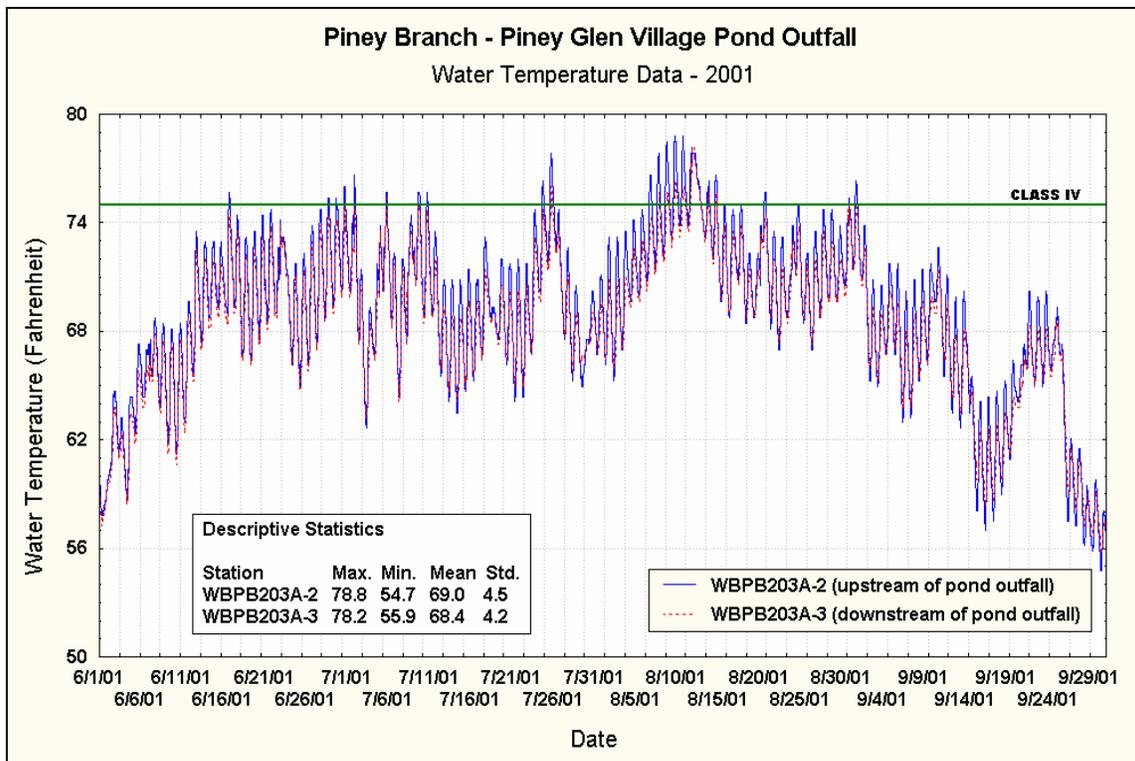
Temperature loggers were deployed in Piney Branch, upstream and downstream of the outfalls from the Willows pond and the Piney Glenn Village pond to study thermal impact (figure 62). Data is not available from WBPB201 as the logger was lost. Data provided by Loiederman Soltész Associates from their monitoring site 11, which is about 35 meters upstream from WBPB201, is used instead. Data from the Willows site 11 and WBPB202 indicate that stream temperature is not greatly affected by the Willows pond outfall (Figure 63). Stream temperatures remained below the 90⁰ (F) class I criteria throughout the summer.

Results from temperature loggers placed upstream and downstream of the Piney Glen Village pond outfall show no thermal impact. Water temperatures are slightly cooler downstream of the pond outfall (figure 64). This could be due to the downstream logger being deployed at a greater depth in the stream. These results are consistent with Loiederman, Soltesz, Associates, the consulting firm conducting stream monitoring during and after construction.

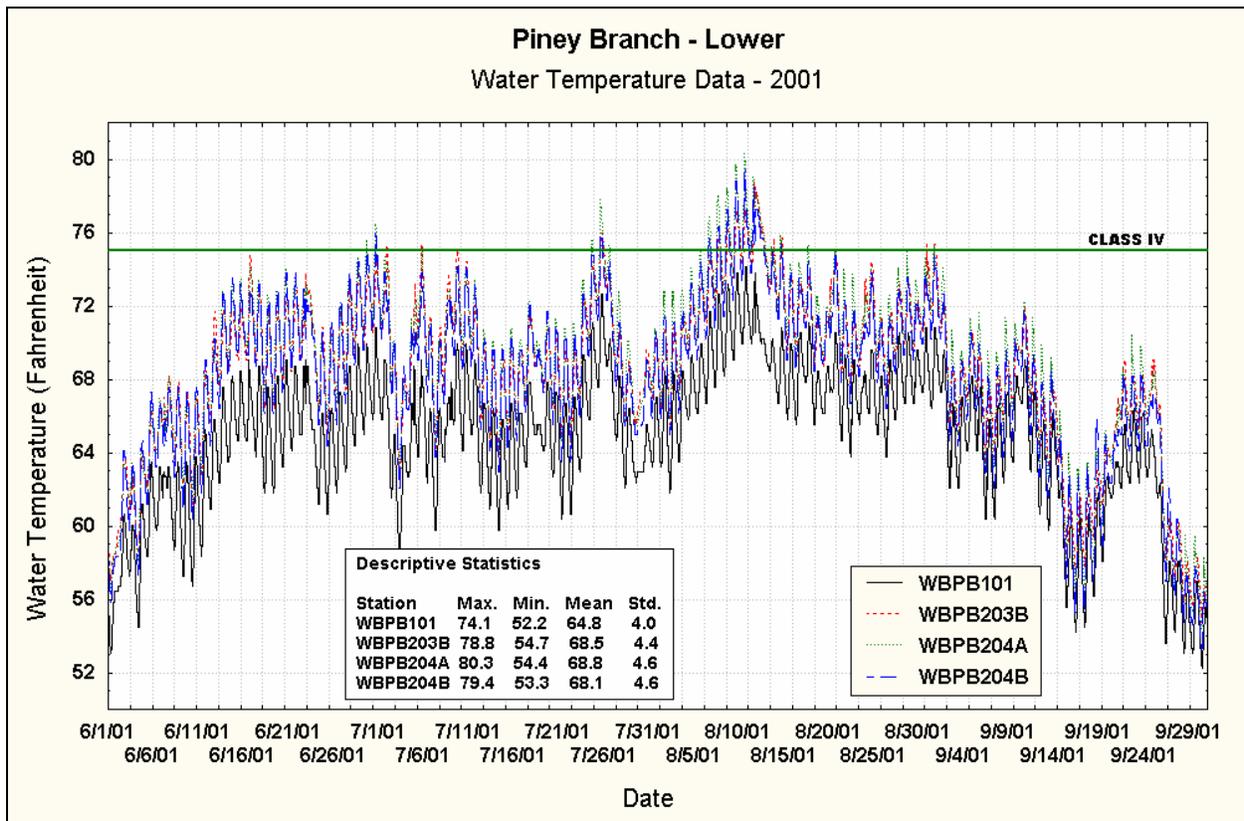
Figure 65. Stream Water Temperature Data From Lower Piney Branch.

Results from temperature loggers placed in lower portions of Piney Branch are presented in figure 65 (see figure 28 for station location). Water temperatures are highest at station WBPB204A, which is consistent with results from previous years. Further downstream at station WBPB204B water temperatures cool somewhat. Between these two monitoring stations the stream flows past three construction projects. Sediment control ponds on these projects are not elevating stream temperature.

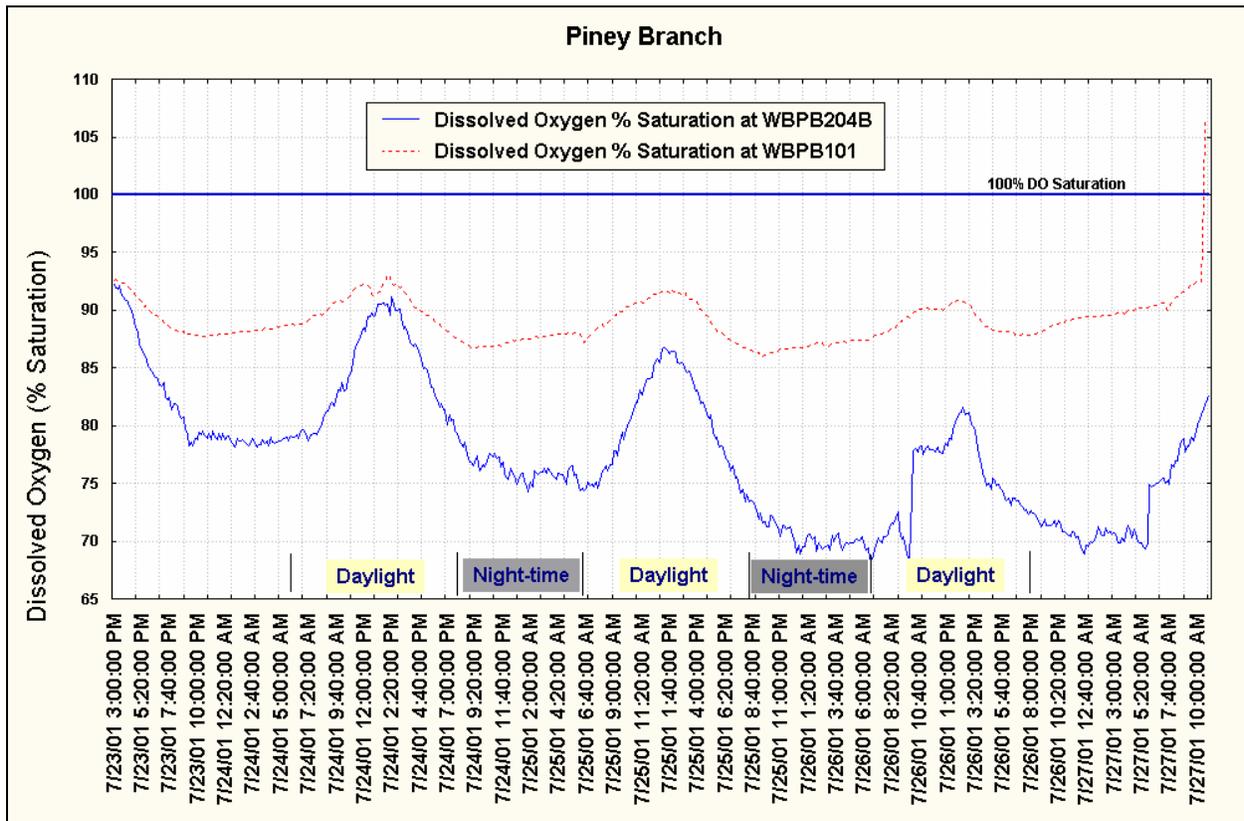
Figure 67. Plot of dissolved oxygen levels from two locations in Piney Branch. WBPB204B is located in the mainstem of Piney Branch at Glen Mill Rd. WBPB101 is located in the Western tributary.

was 7.5 mg/l. It is generally recognized that DO levels of 5.0 mg/l and below are stressful to aquatic life. Dissolved oxygen conditions in the mainstem of Piney Branch are clearly exerting more stress on the aquatic community than that in the Western tributary. This very well could explain why the decline in the biological community is occurring along the mainstem and not in the Western tributary.

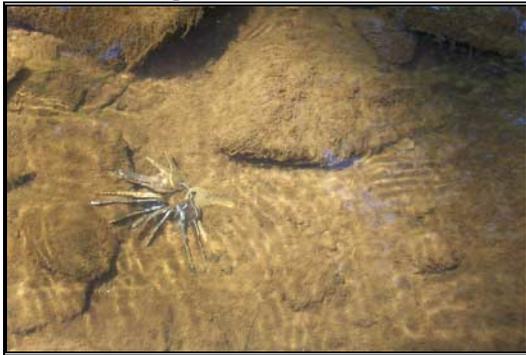
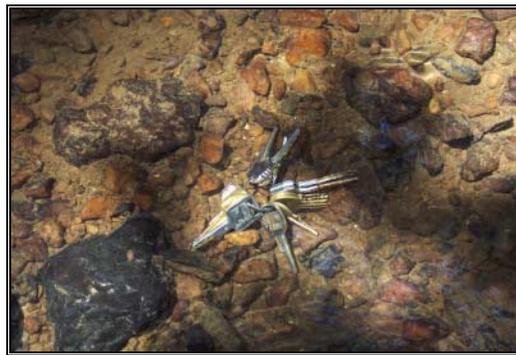
Figures 68 and 69 help explain why there is a problem with DO in the mainstem and not in Western tributary. The photos clearly show more algal growth in the mainstem than in the Western tributary. In the mainstem all stones on the stream bottom are covered with algae and fine sediments. In the western tributary stones are free of algae and only slight amounts of fine sediment are present.

Figure 68. Stream bottom in Piney Br. mainstem Figure 69. Stream bottom in Western tributary

Increased nutrient input is the cause of accelerated algal growth. Where additional nutrients are coming from is the question DEP is currently trying to answer. There are several pathways through which nutrients may enter the stream, including: 1) overland runoff carrying fertilizers 2) excessive fertilizers soaking into groundwater and delivered to the stream through springs and seeps, 3) animal waste 4) bound to fine grained sediments that are discharged from sediment control ponds.

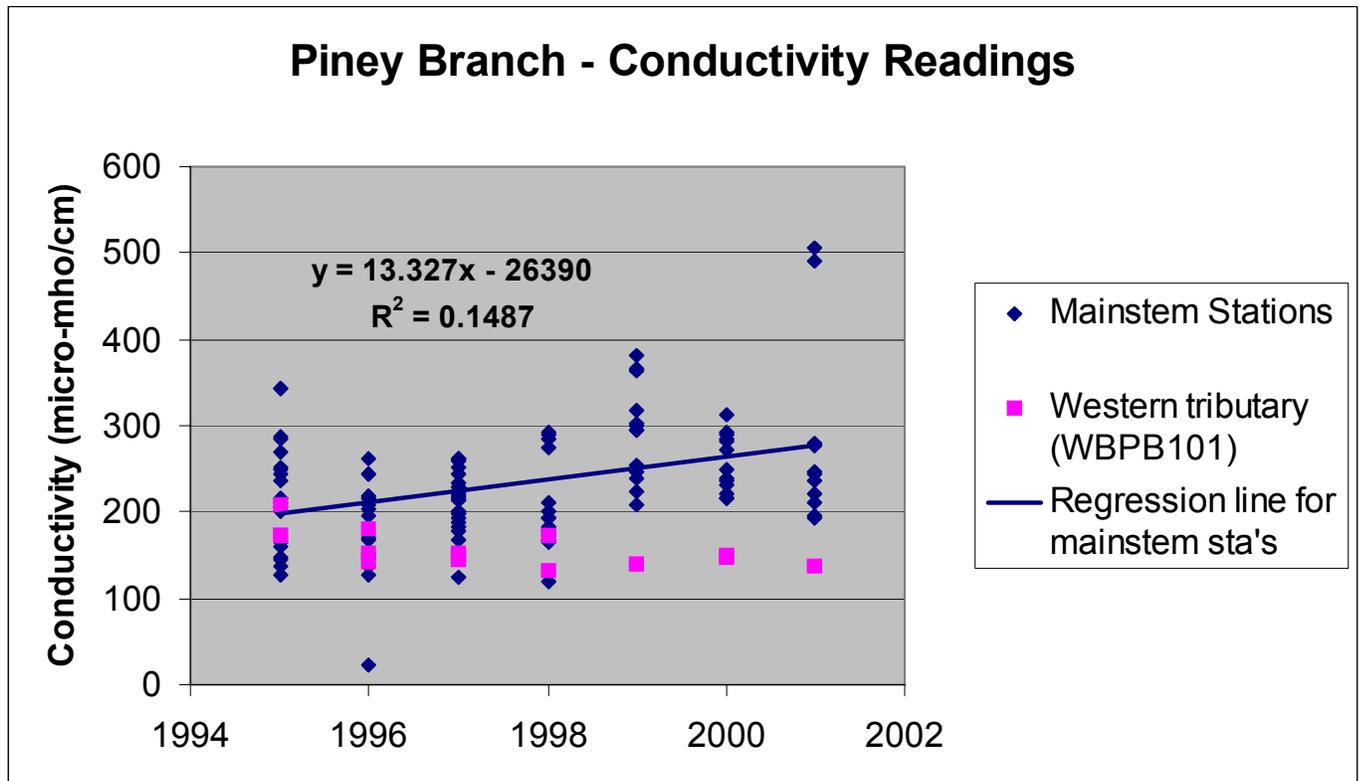
Figure 70. Regression analysis of conductivity data from Piney Branch.

Regression analysis on conductivity readings taken in Piney Branch over the time period of 1995 - 2001 shows a significantly positive trend for stations located along the mainstem ($p=0.000034$) (figure 70). Regression analysis on readings from the Western tributary show a significantly negative trend ($p=0.0156$). These results indicate that conductivity is increasing within the mainstem of Piney Branch. The cause of this increase is unknown at this time. However, it is noteworthy that increased nutrient concentrations can cause higher conductivity values.

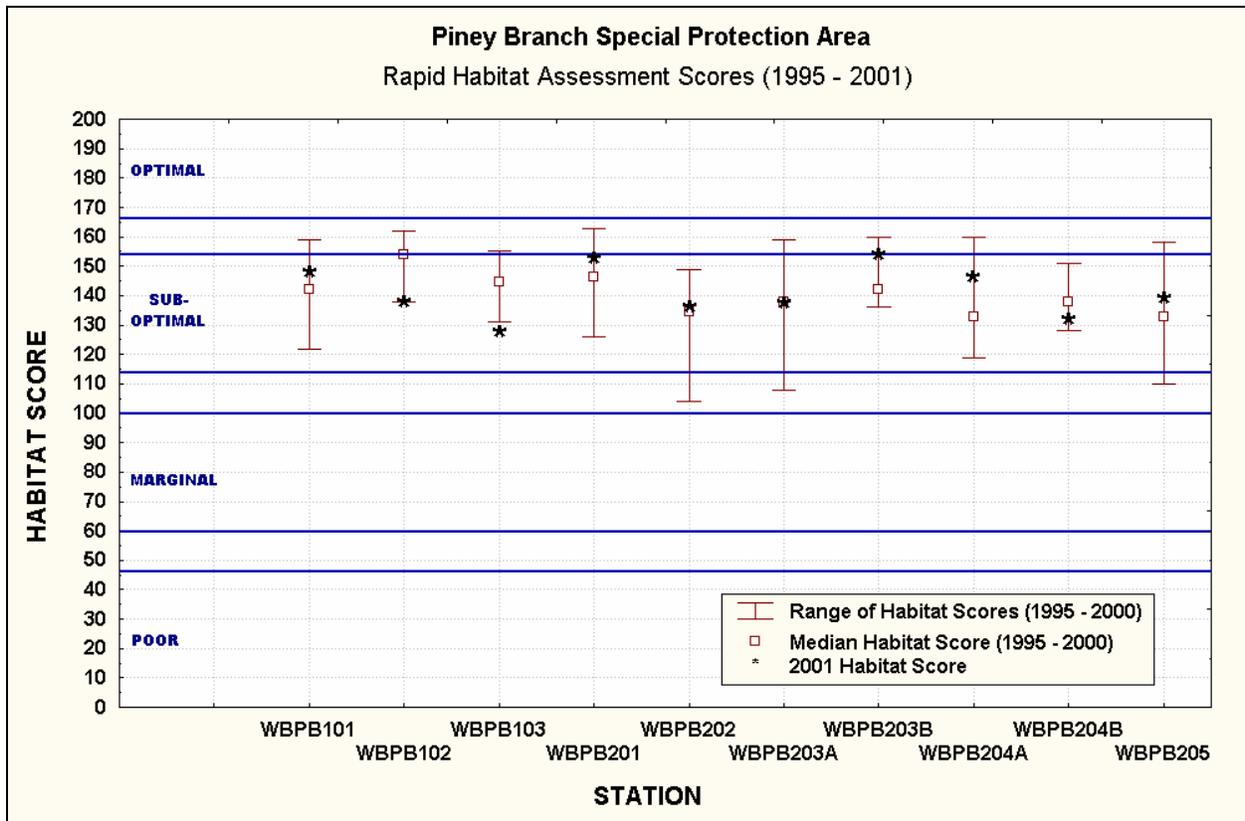
Results of all habitat assessments done in Piney Branch are presented in Figure 71. Habitat scores from all stations have remained in the sub-optimal range. This means that overall, condition of stream habitat is adequate to support a diverse biological community.

Results of habitat assessment completed during 2001 at stations WBPB102 and WBPB103 are slightly lower than in previous years. Analysis of individual parameters that make up the habitat assessment show sediment deposition is slightly lower at both stations for a second year. This indicates that sedimentation continues to be a problem at these two stations located in the headwater portion of Piney Branch. Land disturbances which could be contributing sediment to the stream include construction of Human Genome Sciences campus, on the north side Shady Grove Road.

Figure 71. Summary of All Piney Branch Habitat Assessments (asterisk represents the average of two assessments done in 2001)
