Watershed Restoration FACT SHEET

Batchellors Run I & II Stream Restoration

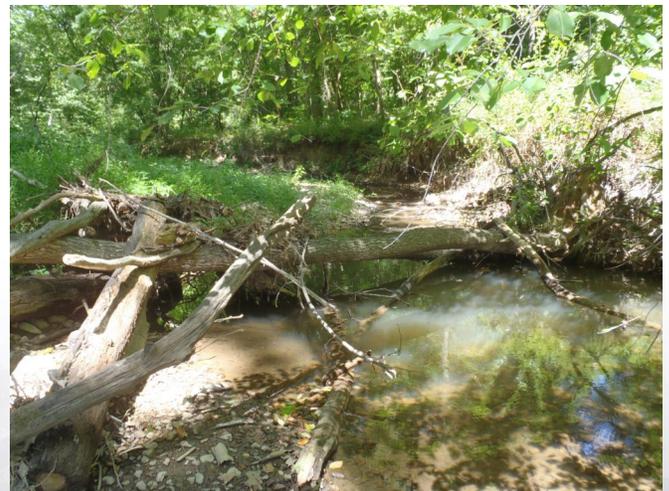
The Batchellors Run tributary west of Layhill Road (phase II), showing streambank erosion, debris jam, and sediment deposition prior to restoration.

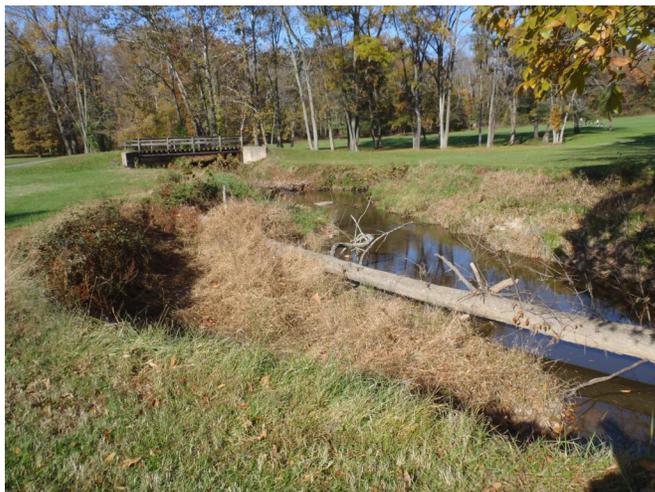
The Batchellors Run tributary east of Layhill Road (phase I) on the Northwest Park golf course prior to restoration. Upstream view shows streambank erosion and lack of canopy cover and riparian buffer.

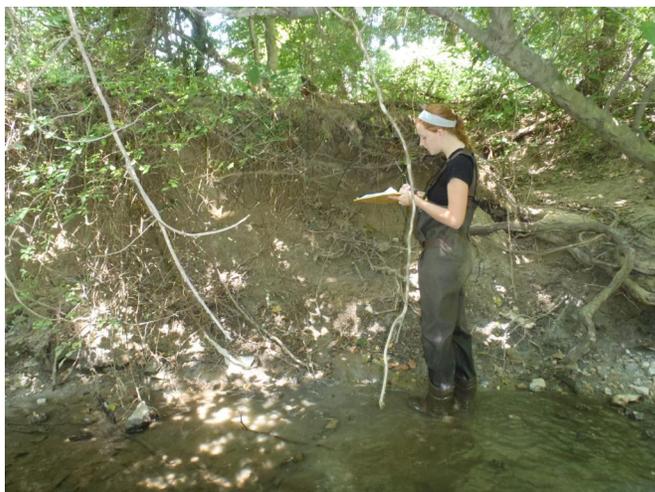
Survey crews take note of the severity of streambank erosion on the Batchellors Run tributary prior to restoration.

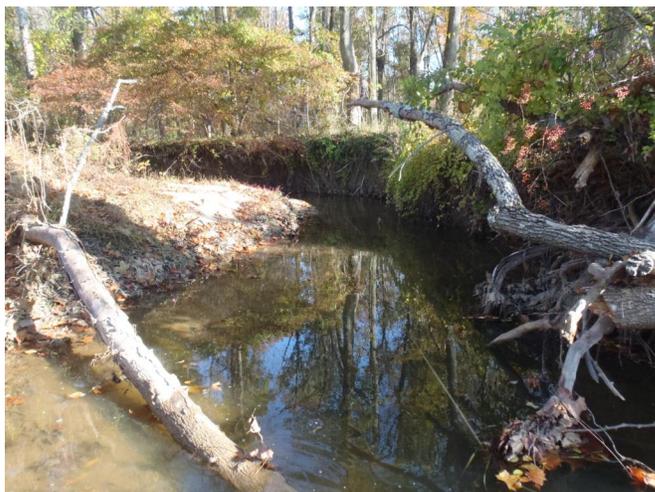
Extent of streambank erosion on the Batchellors Run tributary downstream of the Northwest Park golf course fairway, prior to restoration.
