3.8 Batchellors Run East Stream Restoration

3.8.1 Introduction

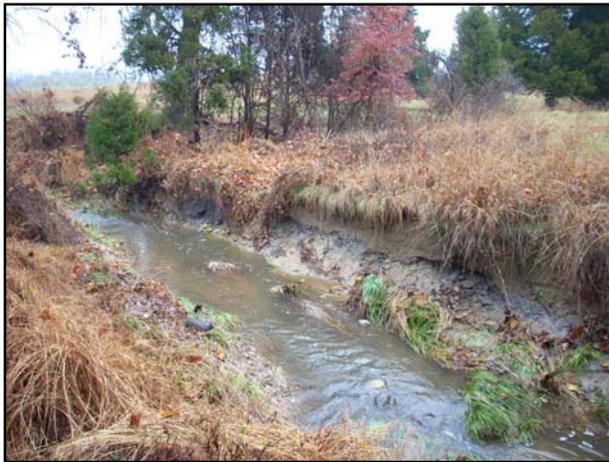
Figure 3.8.3 – Batchellors Run East Prior to Restoration, Picturing Eroded Streambank, Lack of Overhanging Stream Vegetation, and Invasive Plants (Asiatic Tearthumb)

The construction access is anticipated from Layhill Road. Restoration activities are planned for approximately 2,300 feet upstream from the Layhill/Norbeck Road crossing. Stone toe protection with plantings will help provide streambank stability and shade for in-stream habitat. In-stream structures will include log and rock vanes that will direct water away from unstable stream banks, form downstream scour pools, and provide habitat for fish. Other planned stream habitat features include rock wing deflectors and riffle grade controls. Trees will be planted and vernal pool wetlands and floodplain access will be created to enhance the riparian zone alongside the stream.

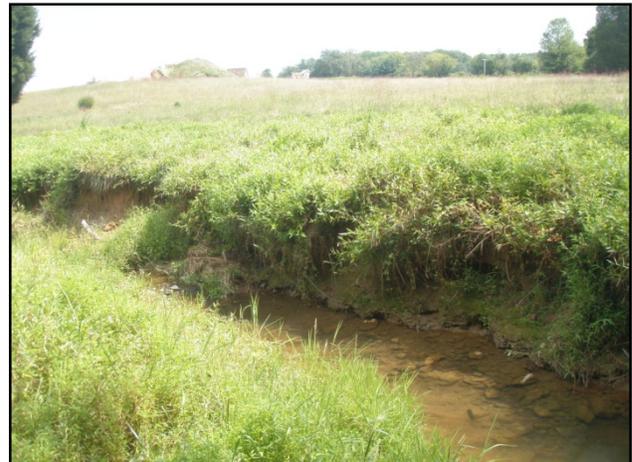
Figure 3.8.4 – Batchellors Run East Prior to Restoration, Picturing Eroded Streambank and Lack of Riparian Vegetation
