Countywide Stream Protection Strategy

2003 Update

This update of the Countywide Stream Protection Strategy provides information on the current status of county stream conditions based on the first five year watershed monitoring cycle completed in 2000.

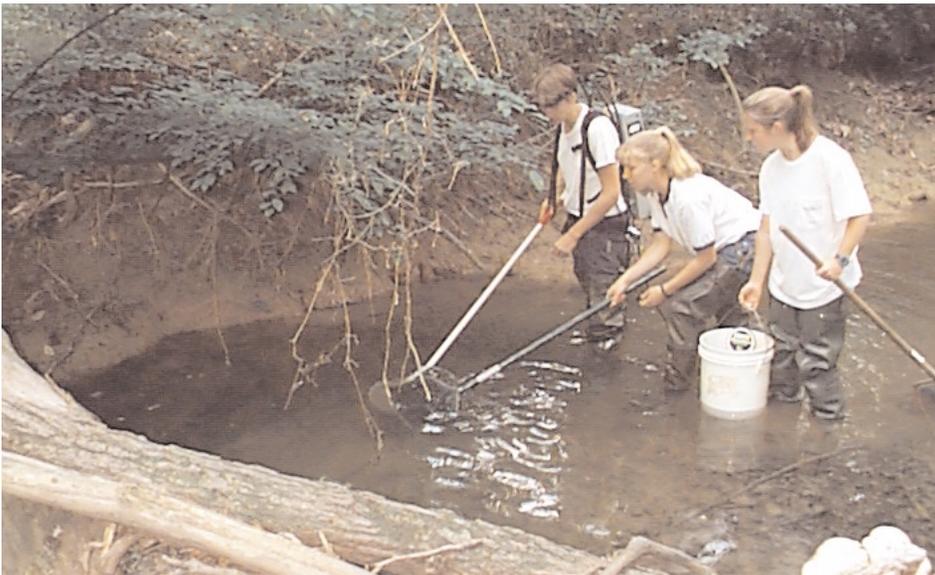
Fish sampling crew

scores are then assigned, for fish and for aquatic insects. To arrive at one rating for a stream, the IBI scores for fish and for aquatic insects are averaged and assigned a narrative condition rating of “excellent, good, fair, or poor.” These narrative ratings are derived from IBI scores representing the county’s highest quality reference streams. For example, a stream rating of excellent means that organisms inhabiting a stream closely compare with those found in the top 50 percent of reference streams.

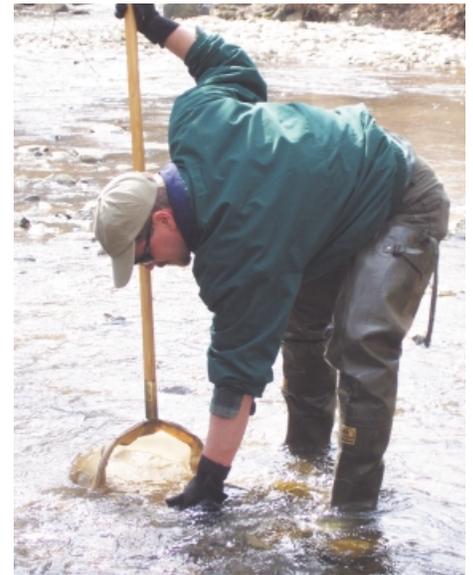
Aquatic insect sampling

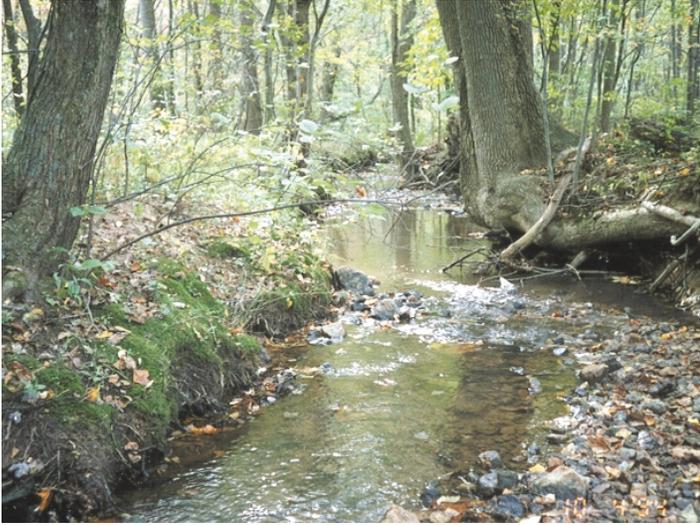
A good stream habitat contains features such as a tree canopy, gravel and cobble-size stones, and stable stream banks.

Streams with good habitat have all the conditions necessary to support a healthy biological community including: 1) tree canopy to shade the stream and provide food in the form of leaf detritus for aquatic insects; 2) in-stream cover such as rocks, logs and undercut banks that provide protection for fish and aquatic insects; 3) little or no fine

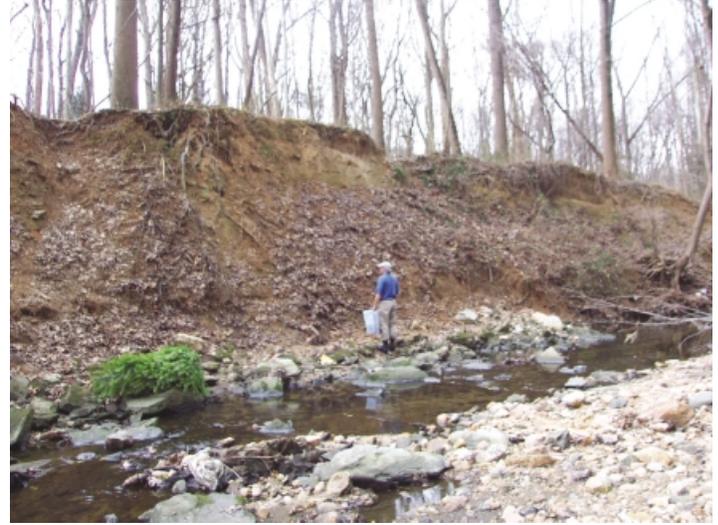
Poor stream habitats have very steep banks which lack vegetative cover, which are vulnerable to erosion during high flow events.

The primary cause of poor stream habitat in this county is altered stream *hydrology* [G](#). Increases in stormwater runoff associated with watershed development have accelerated channel erosion, habitat loss, and sedimentation damages in county streams. These impacts started with the clearing of land more than three hundred years ago for timber and agricultural purposes. Stream channels continue to adjust to alterations in stream hydrology as watershed development has gradually shifted from agricultural to residential and commercial uses to accommodate the county’s population growth.

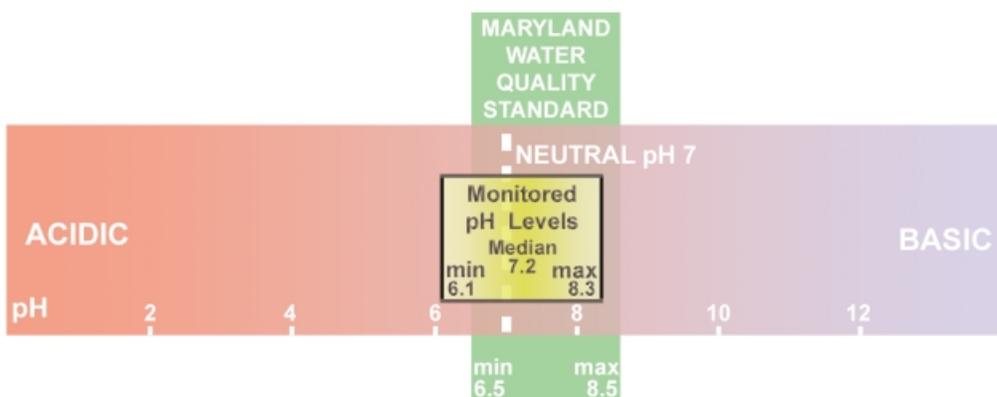
(LEFT) FIGURE 3B. 92% of 1,455 pH readings taken in Montgomery County streams during the period of 1994-2002, are within the Maryland water quality standards.

pH is a measure of the acidity or alkalinity of water on a scale of 0-14. Lower pH readings are more acidic while higher readings are more alkaline. Rainfall is naturally slightly acidic with a pH of around five and one half due primarily to the interaction with carbon dioxide in the atmosphere. As rainfall flows over or infiltrates the land surface, county soils and geology buffer the acidity to the extent that in-stream concentrations of pH are typically between seven and seven and one half. Ninety-two percent of all pH readings taken in county streams during 1994 to 2000 were within Maryland water quality standards (COMAR 26.08.02.03-3 (T)) (Figure 3B).

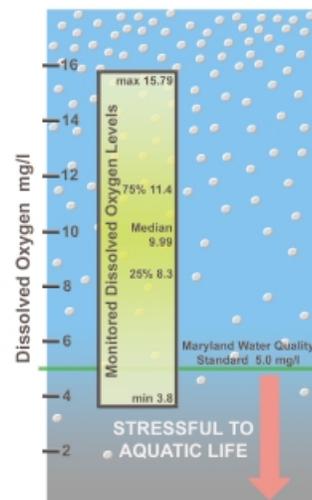
(RIGHT) FIGURE 3C. 98% of 1,463 dissolved oxygen readings taken in Montgomery County during the period of 1994-2000 are above the Maryland water quality standard of 5.0 mg/l

the county average 75 degrees Fahrenheit (F). The physical properties of cool water are able to sustain higher levels of DO than warm water. Many resident species have tolerances to DO conditions that can only be supported by relatively cool water (75 degrees F or less). Some of the higher quality streams may stay at or below 68 degrees F throughout the summer. Cold water species, such as brown trout, require these average cooler temperatures and the higher DO levels they can sustain to survive.

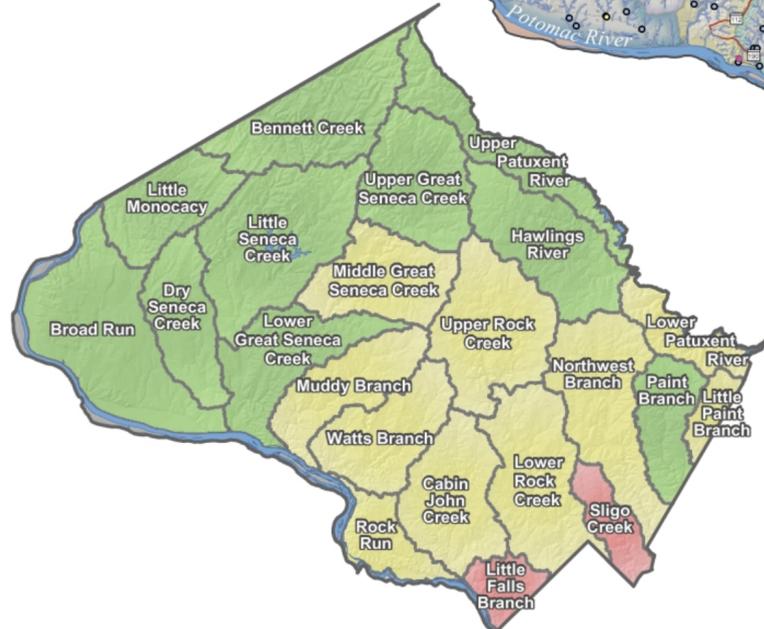
FIGURE 4A. Average Stream Conditions in Major County Watersheds
Based on actual weighted IBI scores/acre for subwatersheds depicted in Figure 4B.

Figure 4A describes average stream conditions found within each of the county's 23 major watersheds. Average watershed condition ratings were based upon combining results of observed stream conditions from the smaller drainage areas to each of approximately 400 monitoring stations countywide (Figure 4B). Examination of the smaller, individual monitoring station drainage areas allows more in-depth examination of the varying conditions found in the county's major watersheds. These results can also be compared to the stream conditions described in the 1998 CSPA. conditions.askdep.com

Following is a summary of average watershed conditions, organized by the major watersheds shown on Figure 4A. Watershed summaries also refer to information on some of the more detailed monitoring results depicted on Figure 4B. The urban watersheds, with moderate to high density land uses, are discussed first, followed by the rural watersheds, which generally contain lower density residential or agricultural land uses. Within these two categories, the individual watershed summaries are presented in alphabetical order.

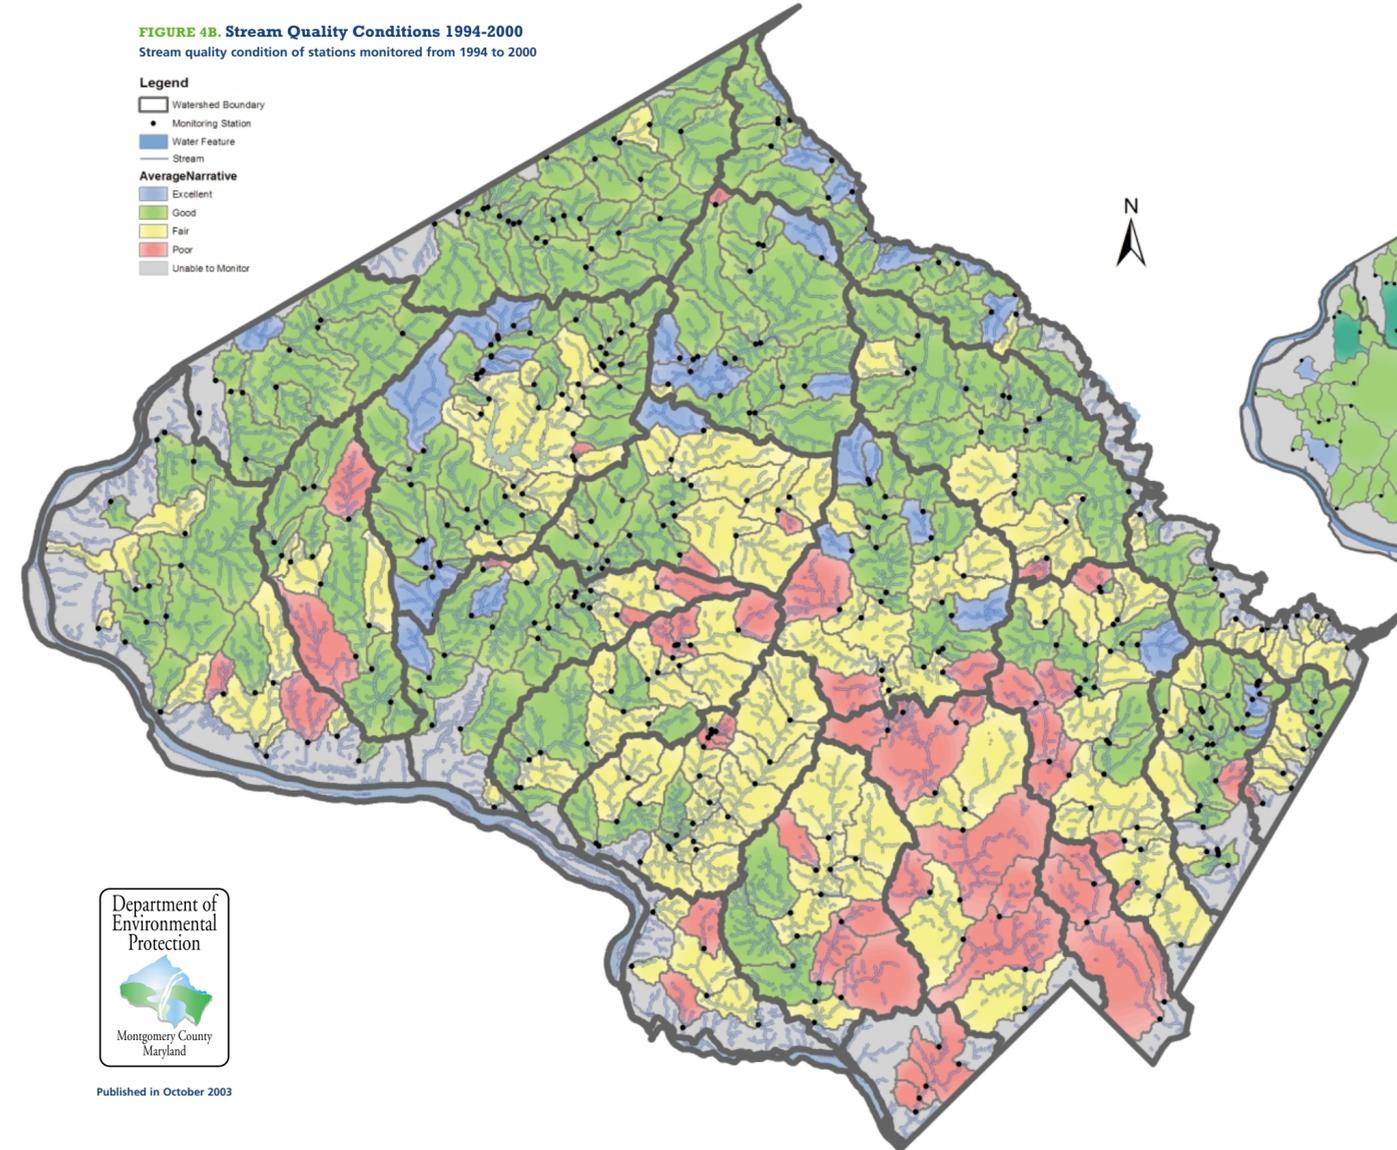
FIGURE 4B. Stream Quality Conditions 1994-2000
Stream quality condition of stations monitored from 1994 to 2000

Ratings of stream conditions in most county watersheds (Figure 4B) did not change substantially from those derived in the original CSPS. Older, established urban areas generally have the poorest water quality and continue to reflect the impacts of outmoded practices that piped stream headwaters and/or lacked adequate stormwater management controls. Conversely, watersheds located in the more northern and western areas have a "good" or "excellent" stream condition rating. This apparently reflects a number of factors, including generally lower development densities and/or improved stormwater controls and stream buffers accompanying new developments, and the use of low or minimum till farming practices in the County's Agricultural Reserve.

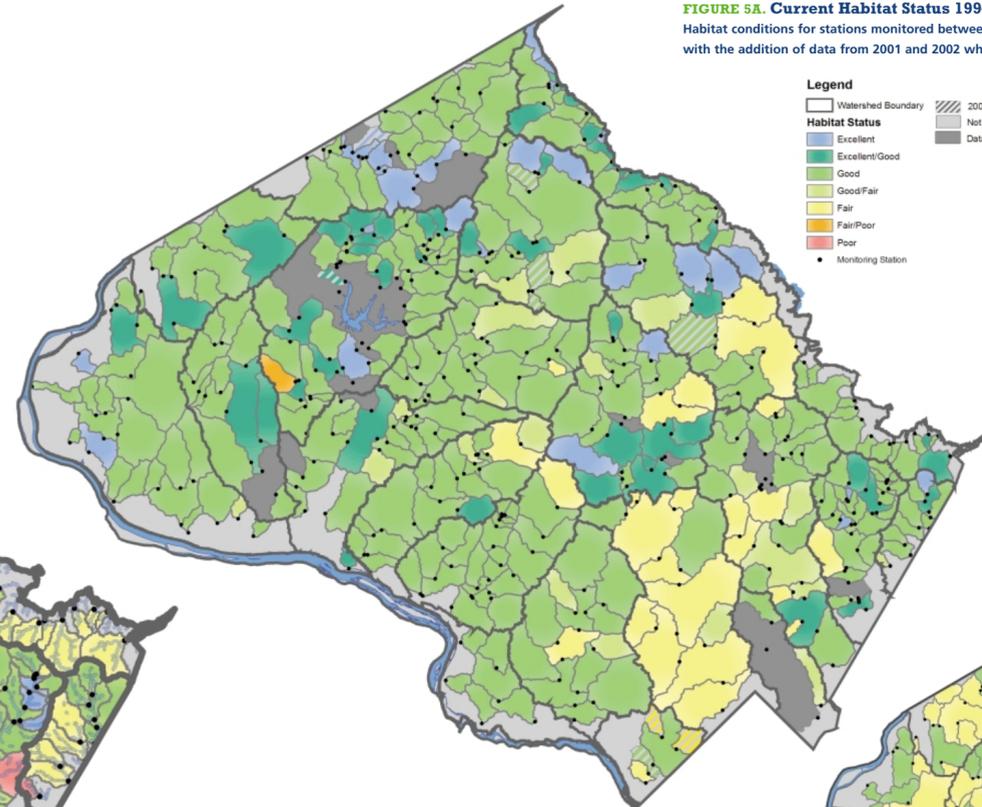
FIGURE 5A. Current Habitat Status 1994-2000
Habitat conditions for stations monitored between 1994 and 2000 with the addition of data from 2001 and 2002 where needed.

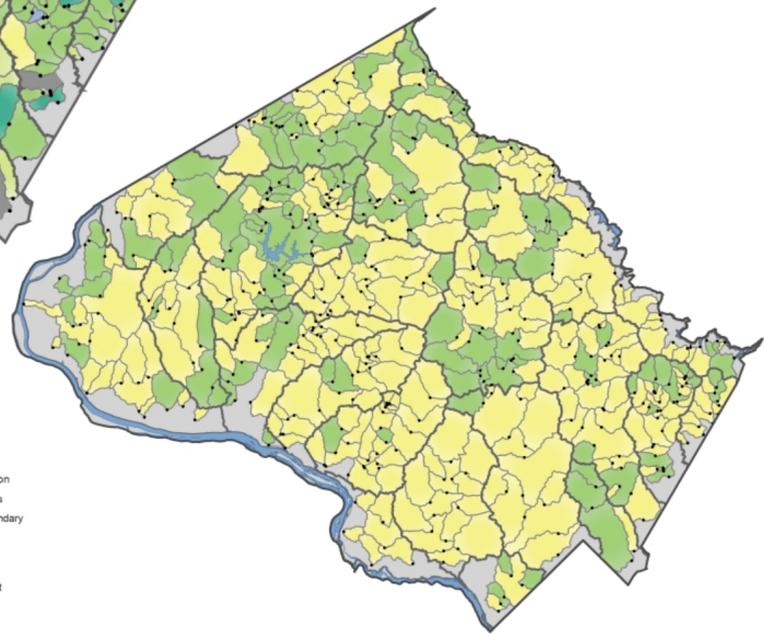
FIGURE 5B. Habitat Stability 1994-2000
Stations that scored fair or poor on at least 1 out of 4 stability parameters are considered unstable.

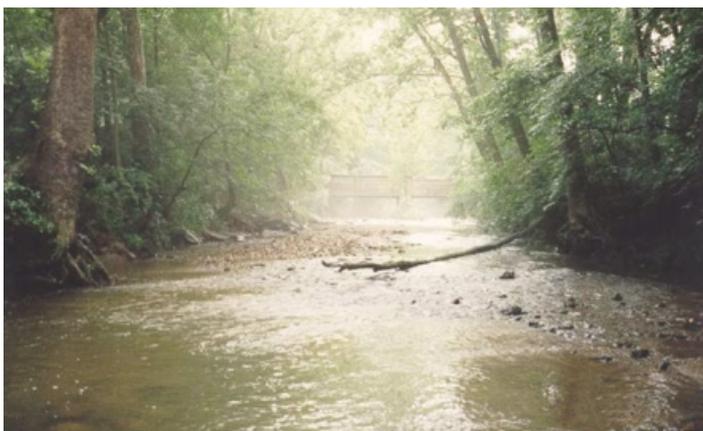
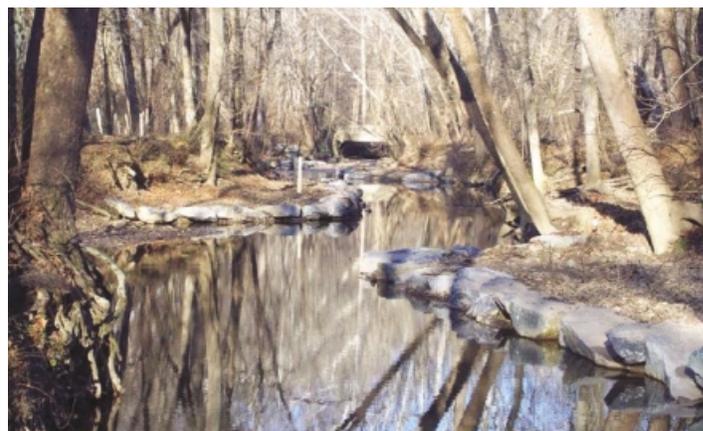
Northwest Branch Restoration below Randolph Road, 2002. Before (left), overly widened shallow channel. After (right), habitat restored.

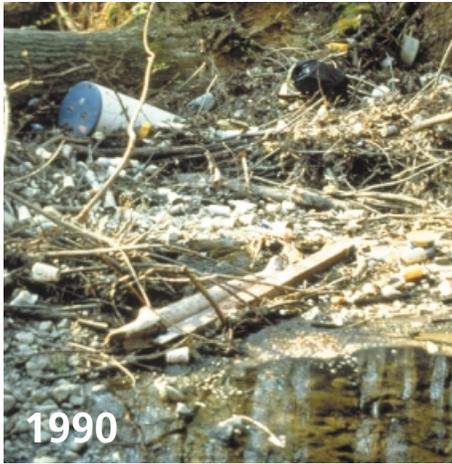
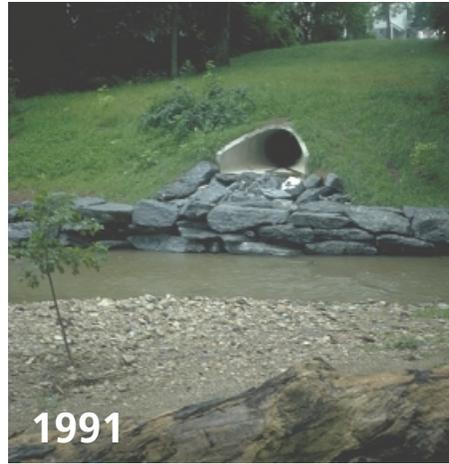
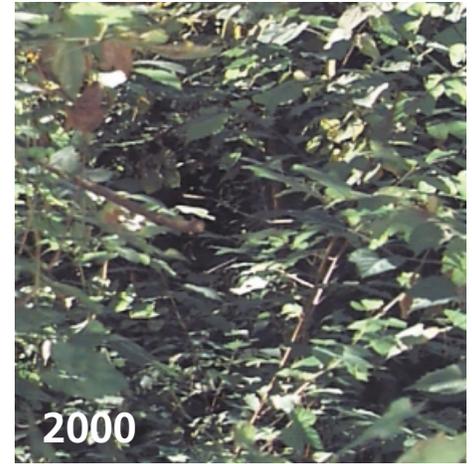
Progress in Wheaton Branch Stream Restoration. 1990 (left) devastation, 1991 (center) restoration, 2000 (right) nature's healing (showing vegetative growth seen at site of 1991 improvements).

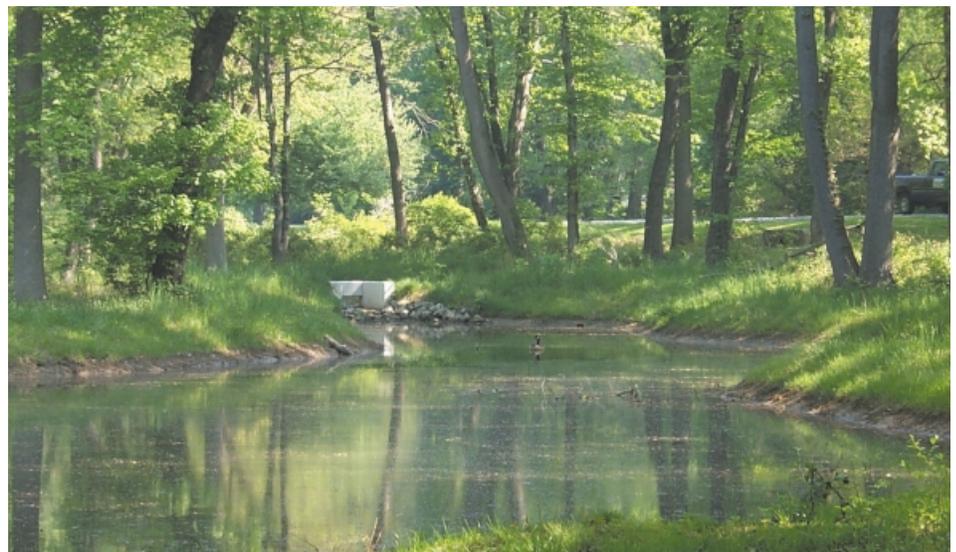
Sligo Creek — New Godwin Drive Constructed Wetland
