Annual Report for FY12

NPDES Municipal Separate Storm Sewer System Permit

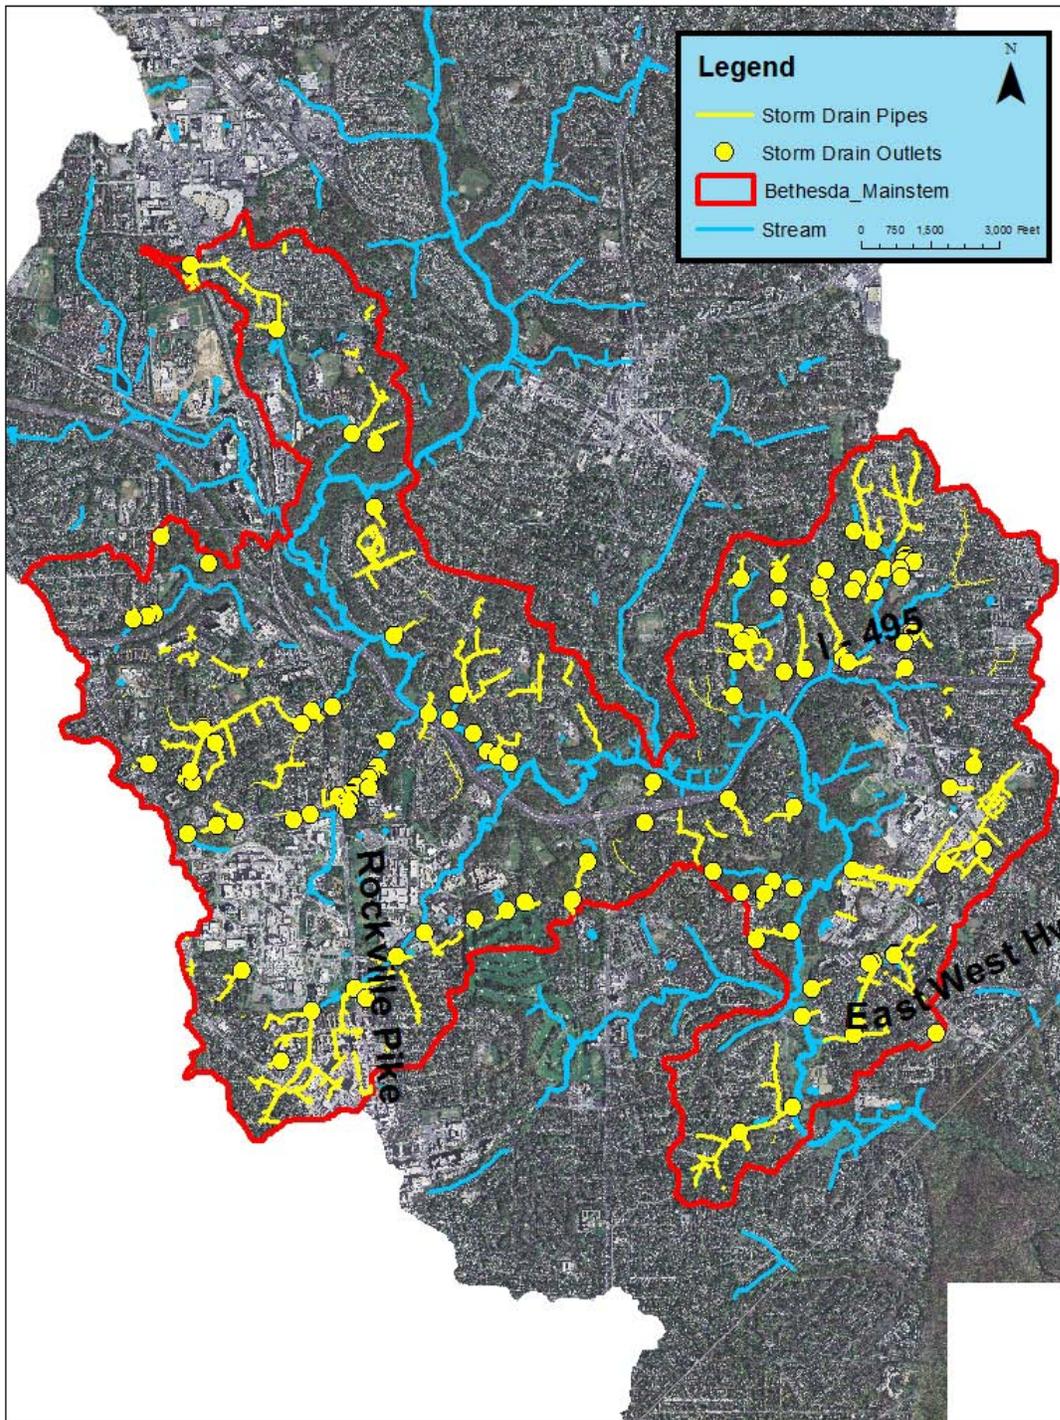
Figure III-E1. FY12 Outfall Screening – Bethesda Main Stem of Lower Rock Creek Watershed

In late March and early April 2012, DEP performed outfall screening in the Bethesda main stem of the Lower Rock Creek subwatershed. The DEP screened a total of 193 outfalls, and found that 43 had dry weather flows, of which 21 had elevated water quality parameters that suggested illicit discharges. Follow up investigations were conducted. Two discharges were found to be water line leaks and were repaired by Washington Suburban Sanitary Commission (WSSC). Six discharges were tracked back to, and referred, to a federal facility, the Ft. Detrick, Forest Glen Annex (formerly known as Walter Reed). Source tracking was unsuccessful in the areas of the other 13 outfalls. The DEP did distribute 19 storm water discharge educational letters to local businesses in the area of one of the impaired outfalls.

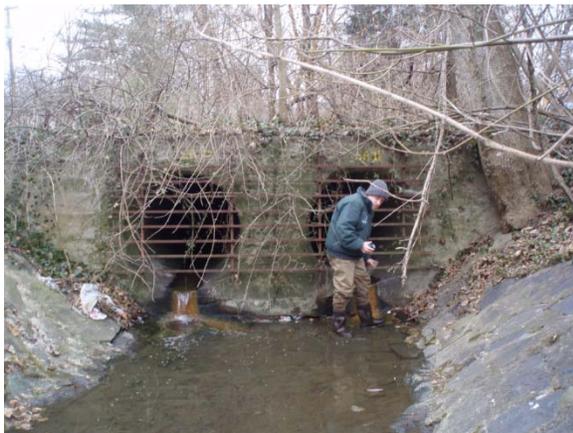
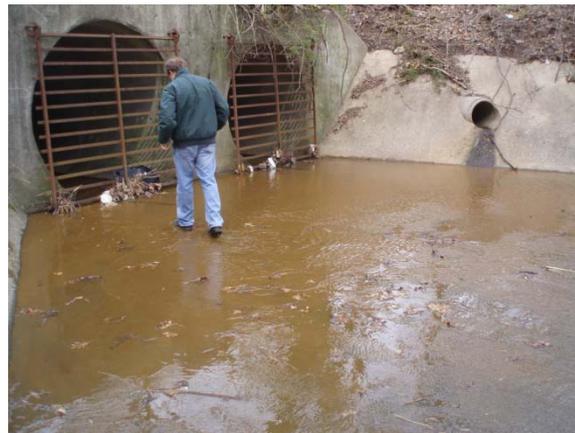
Figure III-E2(a). Bennington Outfalls and (b) Maple Ave. Outfalls

The Bennington outfall drainage is 115 acres with its headwaters in downtown Silver Spring and its outfall east of Bennington Dr (Figure III-E3). The Maple Ave drainage is over 550 acres with its headwaters in Northeast District of Columbia and its outfall south of the intersection of Maple Ave and Sligo Creek Parkway in Montgomery County. The Bennington outfall consists of two 48" concrete pipes (Figure III-E2a) and the Maple Ave outfall consists of two 72" concrete pipes (Figure III-E2b). Both drainage areas have complex underground piping systems.

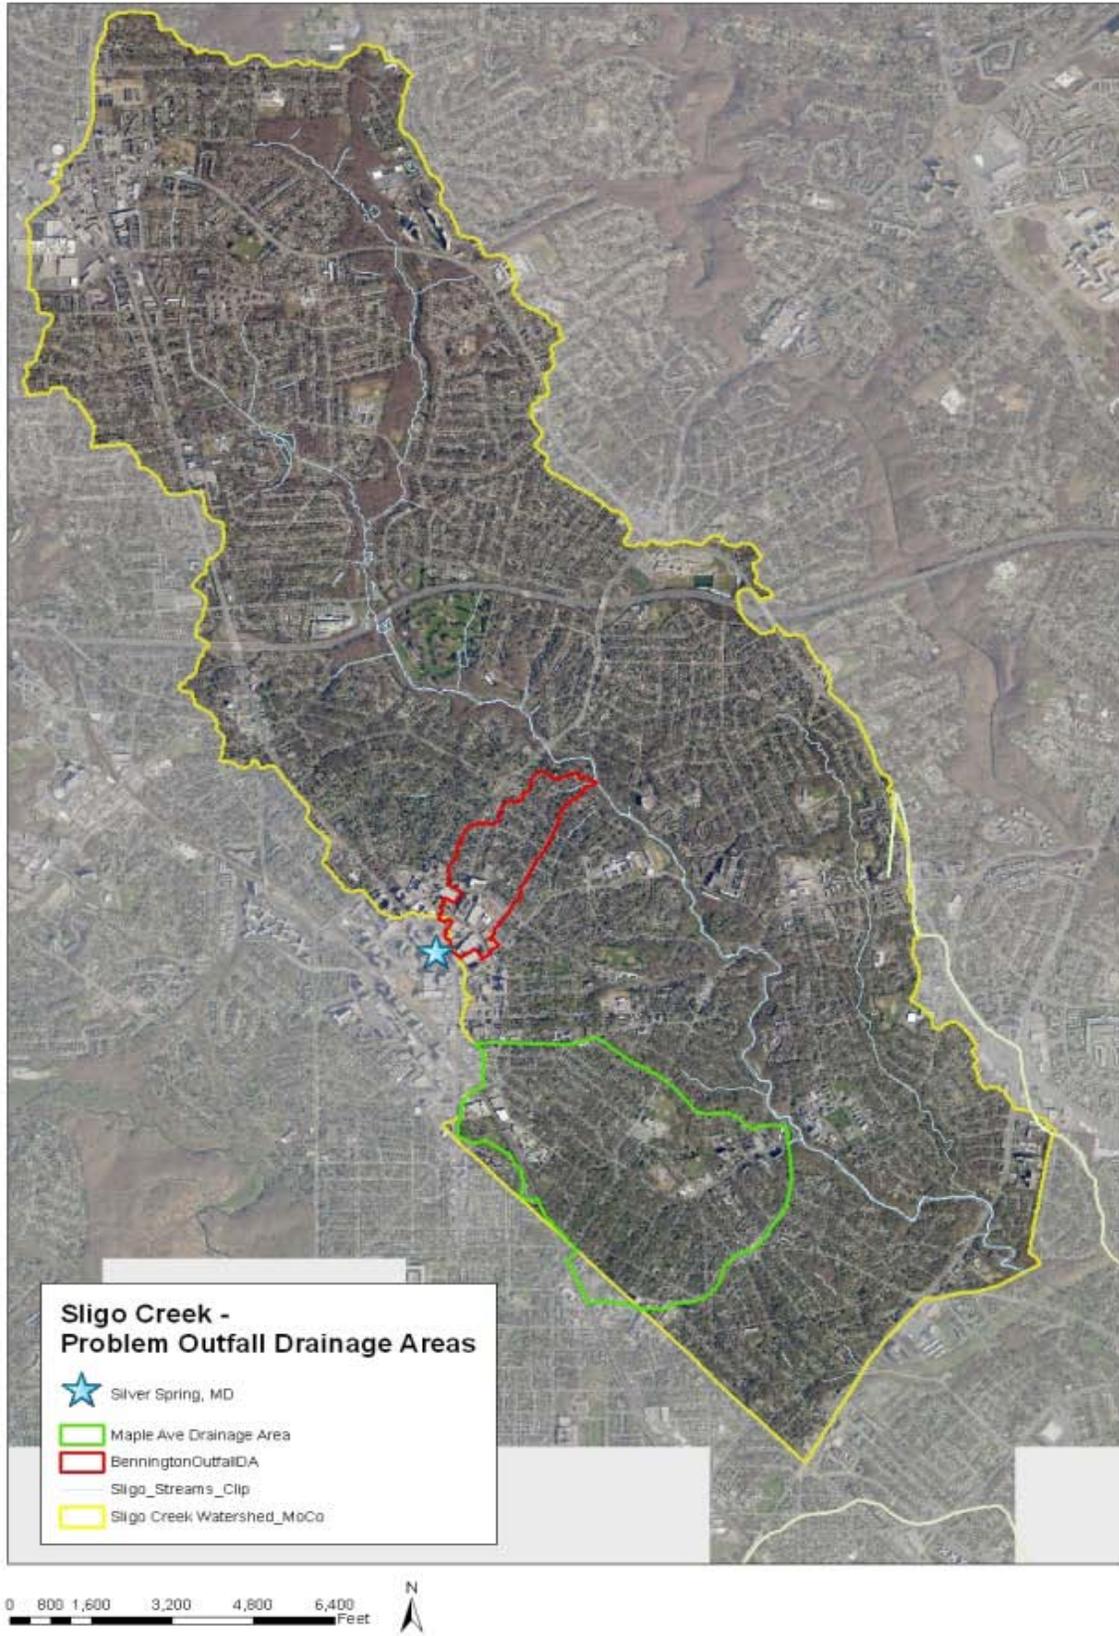
Figure III-E3. Location of Problem Outfall Drainages in the Sligo Creek Watershed, Montgomery County, MD

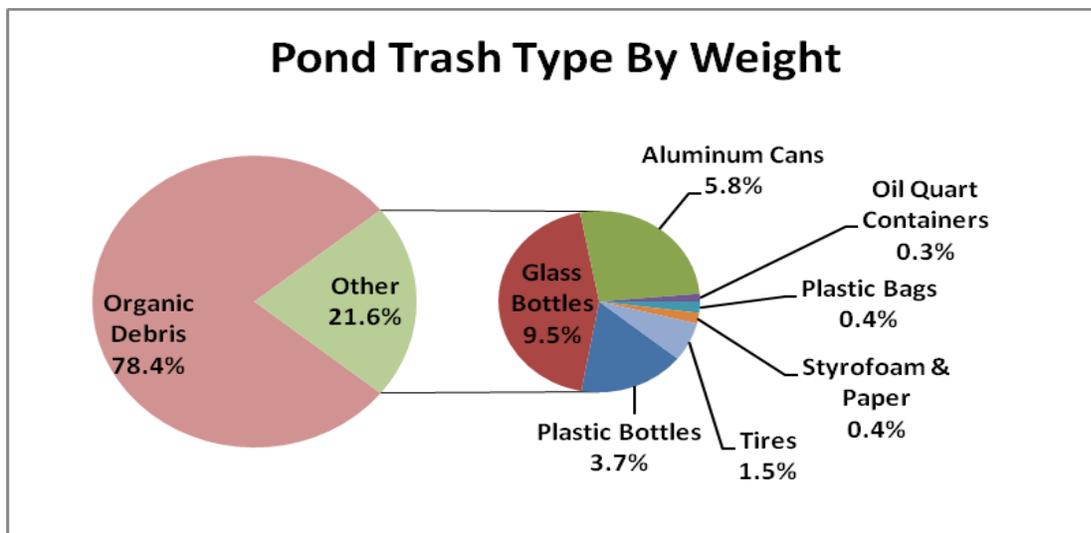
Figure III-E4. Pond Trash Collected in FY12 by Type

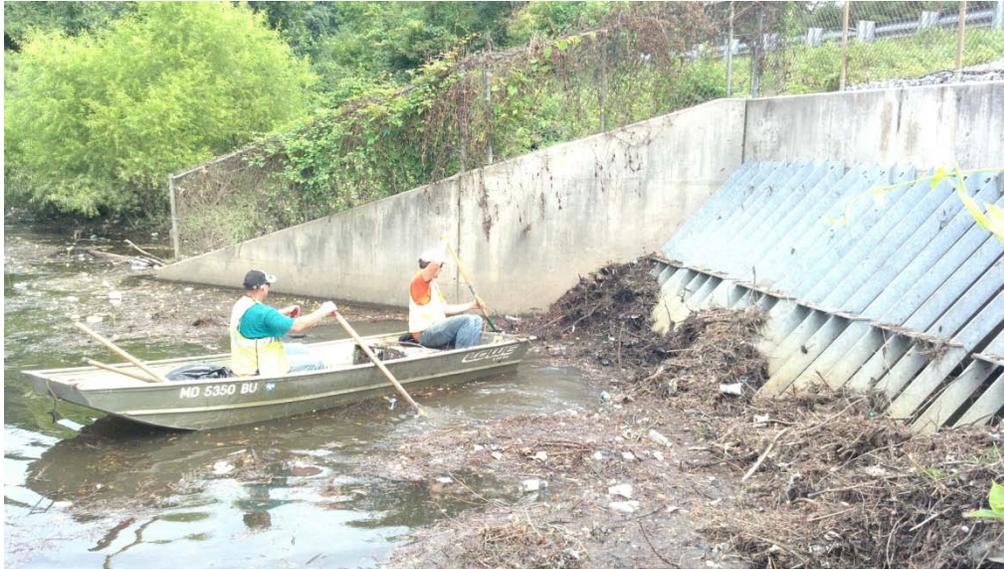
Figure III-E5. Contractors Removing Trash from County Regional Stormwater Management Facilities

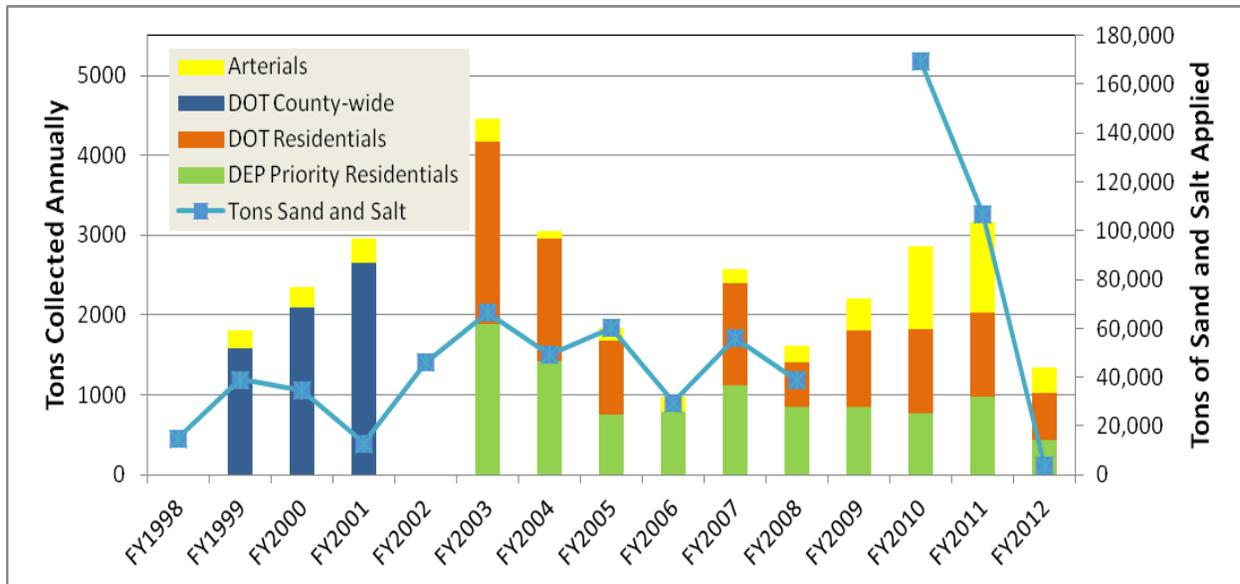
Figure III-E9. Tons of Material Applied During Winter Activities and Collected by Street Sweeping 1998-2012

Figure III-E9 shows the tons of materials removed annually by street sweeping based on route type for records available, from 1999 to present. The tons of sand and salt applied were not reported for FY09 and FY10. In 2002, no County street sweeping was conducted due to lack of funding. The amount of material removed seems directly related to the amount of de-icing material applied, which is largely determined by the amount of winter precipitation. More snow and ice increases the need for application of sand to the roads, which then becomes more available for collection during street sweeping. The winter of 2011-12 was very mild and relatively little sand was applied to the roads, resulting in less material removed in all route categories

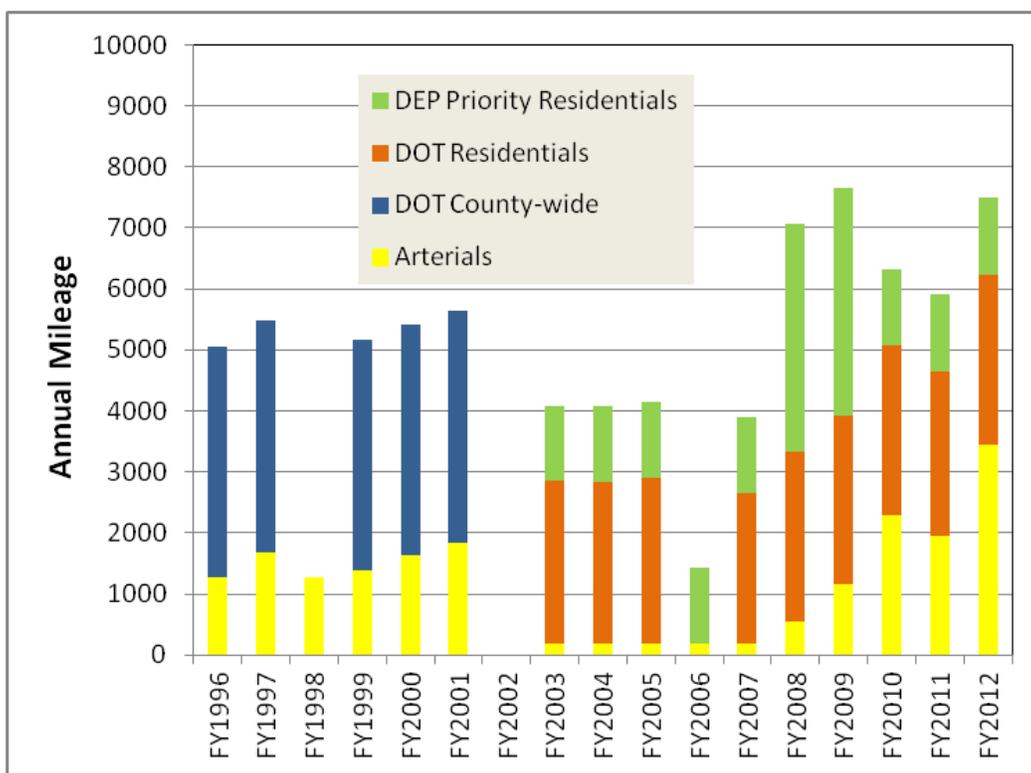
Figure III-10. Annual Montgomery County Street Sweeping Mileage 1996-2012

Figure III-E10 below shows the mileage swept per year by route category. In FY12, the increase to twice per month for the arterial routes resulted in an increase in total miles swept. More miles were swept in FY12 than any prior year except for FY09. A further increase is forecast for FY13 as DEP continues to fund arterial route sweeping twice per month.

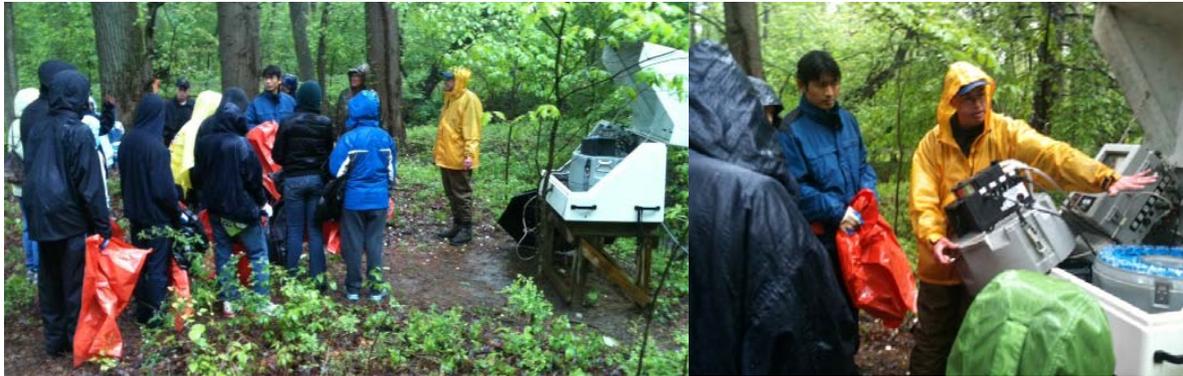
Figure III-E12. Contractor and Staff Educating Residents/Volunteers on the Stormwater Monitoring Equipment in Breewood

The DEP is implementing multi-faceted efforts, including project implementation, monitoring, and watershed education and outreach in the Breewood Tributary to meet the Permit requirement for watershed restoration (see Section III.H.1). The DEP held an Earth day cleanup in FY12. For this event, staff utilized volunteer services and had approximately 15 participants despite significantly wet weather. The DEP worked with the M-NCPPC Weed Warrior program to remove invasive plants and trash on parkland, collecting 24 bags of debris. The event also included a walking tour of the Breewood tributary, a demonstration of stormwater monitoring equipment (Figure III-E12) and a rain barrel raffle.

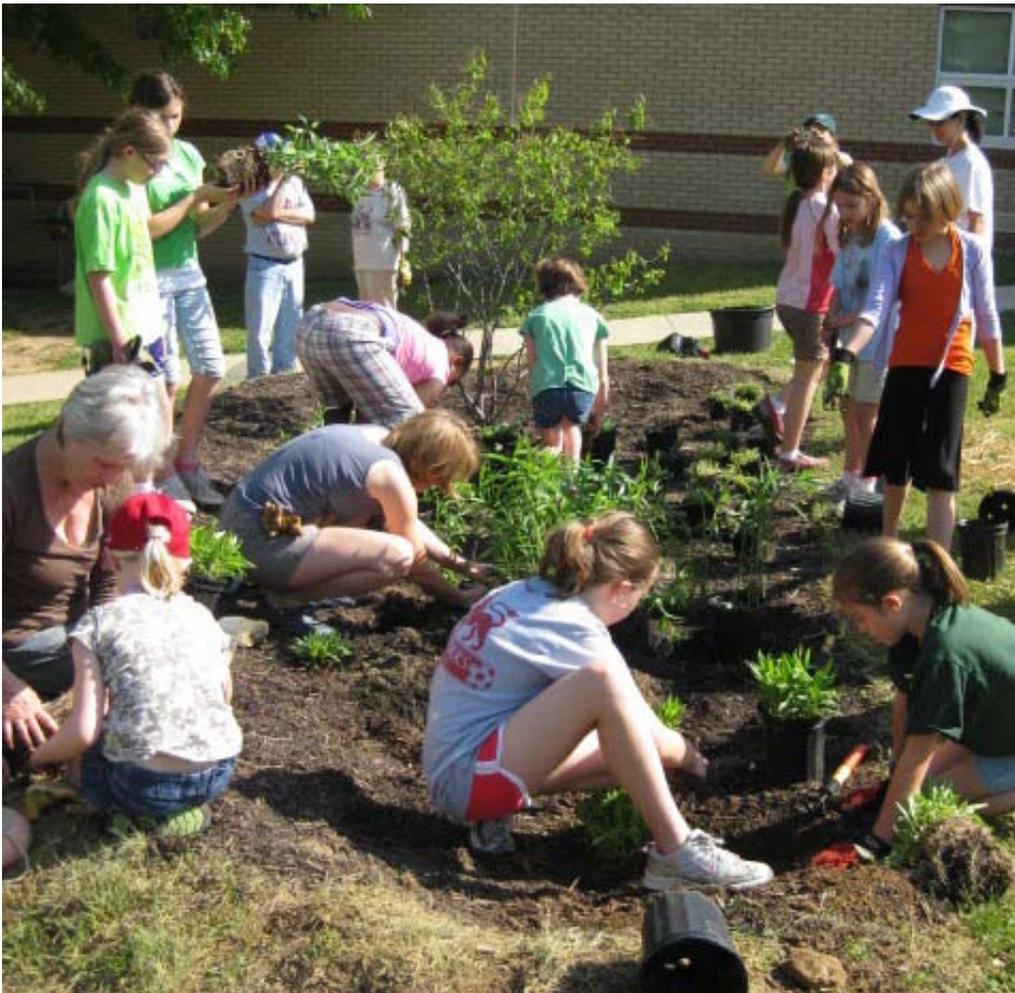
Figure III-E14. Students at Pine Crest Elementary Installing a Rain Garden

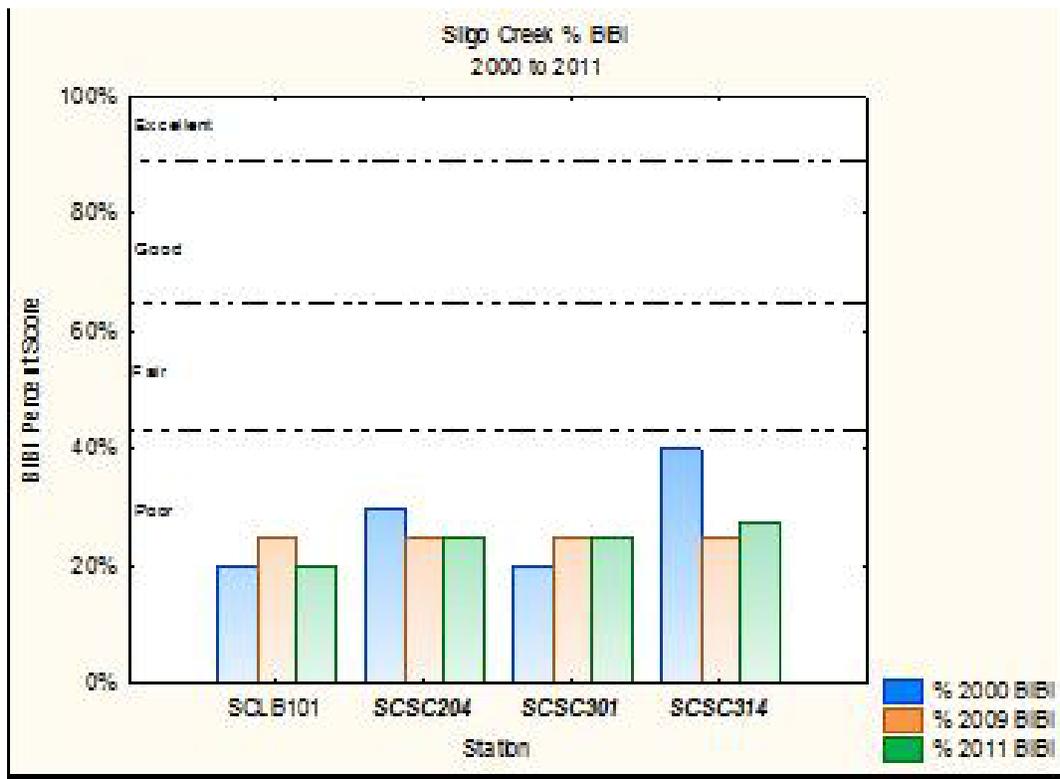
Figure III-F3. BIBI Percentages at Sligo Creek Stations from 2000-2011

The percentages of BIBI Scores in the Sligo Creek watershed were all in the poor category for the sites monitored Figure III-F3. Despite the more than 20 years of restoration efforts, these stations have not displayed a substantial change in BIBI scores over the study period. Nor was there any obvious trend for improving scores over years among these four stations.

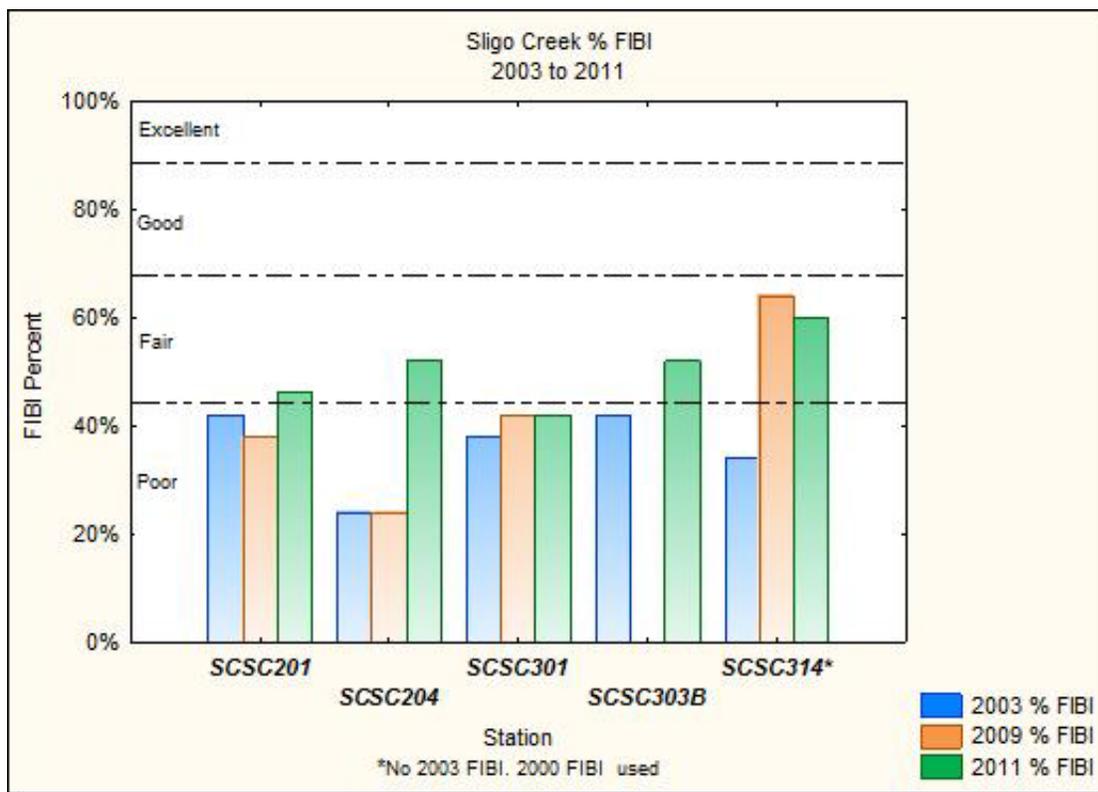
Figure III-F4. FIBI Percentages at Sligo Creek Stations, 2003-2011

Three stations had their highest score in 2011 among the three monitoring periods. Increased scores can be partially attributed to an increase in the number of Riffle/Benthic insectivores, which increased from 7% in 2000/2003 to 26% in 2011. The Tessellated Darter, Longnose Dace and Blue Ridge Sculpin were collected in limited numbers in 2000/2003. The Tessellated Darter and Longnose Dace were encountered with greater regularity during 2011, but no Blue Ridge Sculpin were found at the monitored stations.

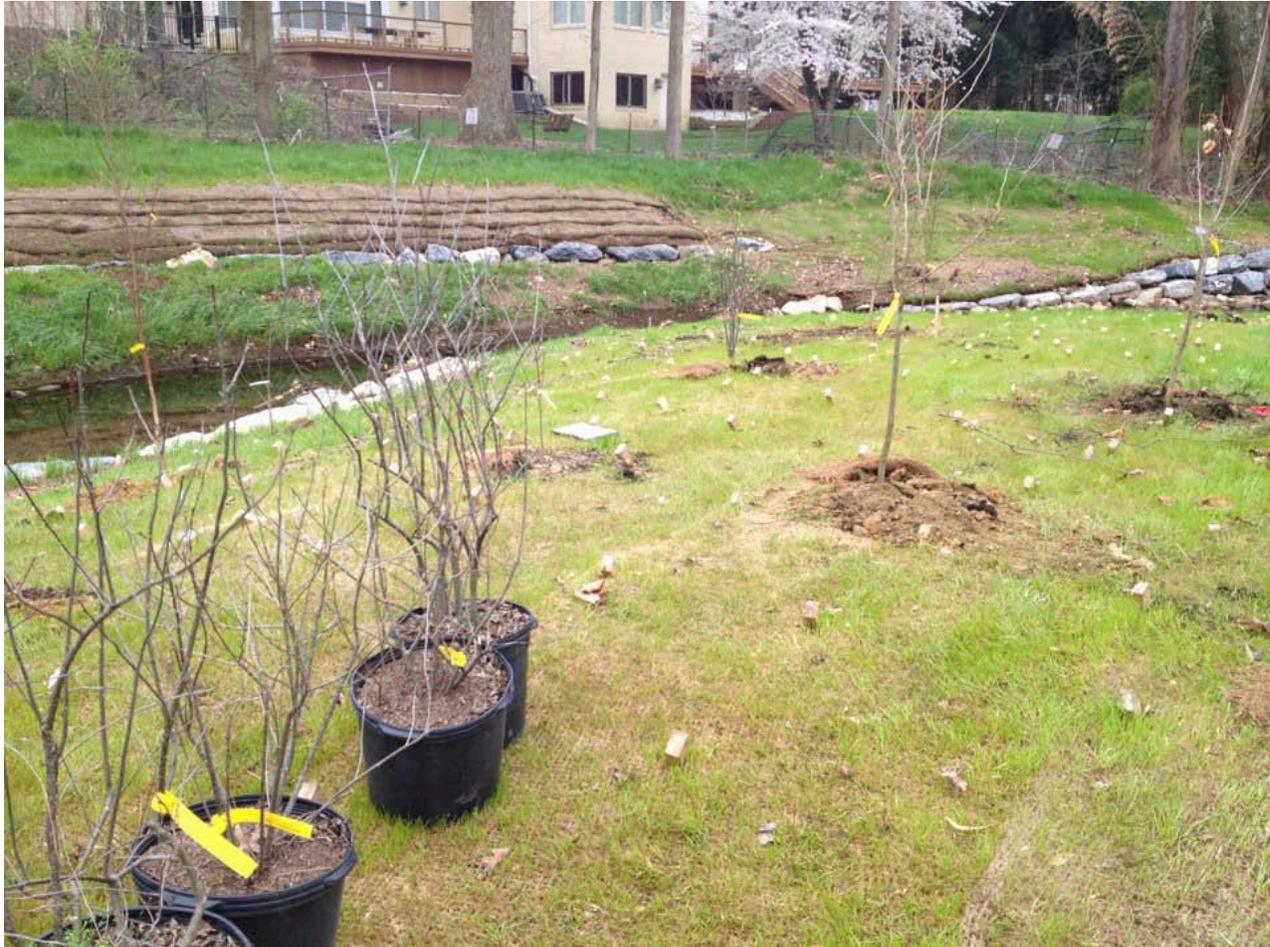
Figure III-G2. Lower Booze Creek Stream Restoration Project Under Construction (Photo taken: 3/22/12)

Figure III-G2 below shows the FY12 stream restoration project close to completion in Lower Booze Creek of the Cabin John Watershed. At this point, riparian area plantings were underway.

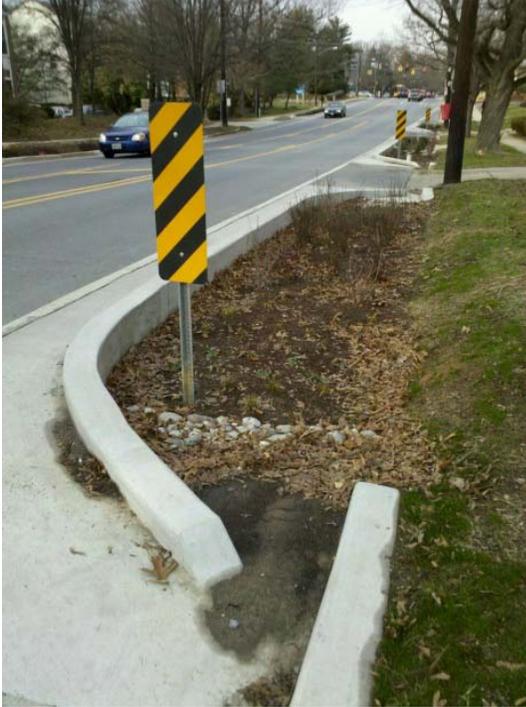
Figure III-G3. Completed Arcola Avenue Green Streets Curb Extensions (Photo taken 12/22/11)

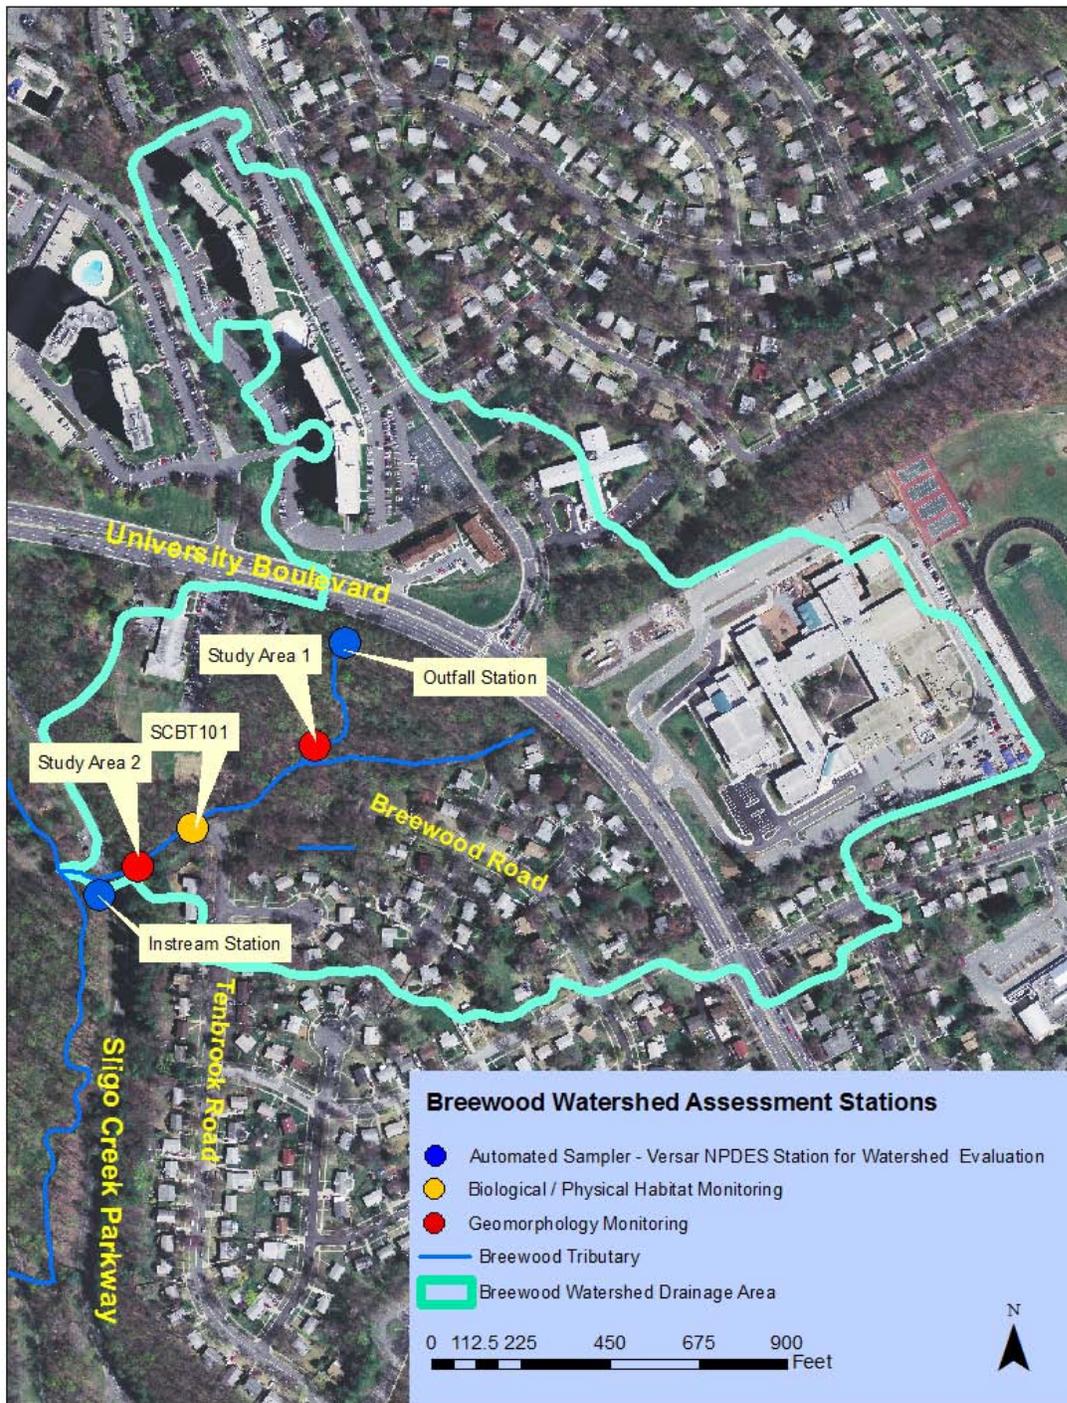
Figure III-H2. Locations of Stream Chemistry, Biological, Physical Habitat and Geomorphology Monitoring Stations, Breewood Tributary of Sligo Creek.

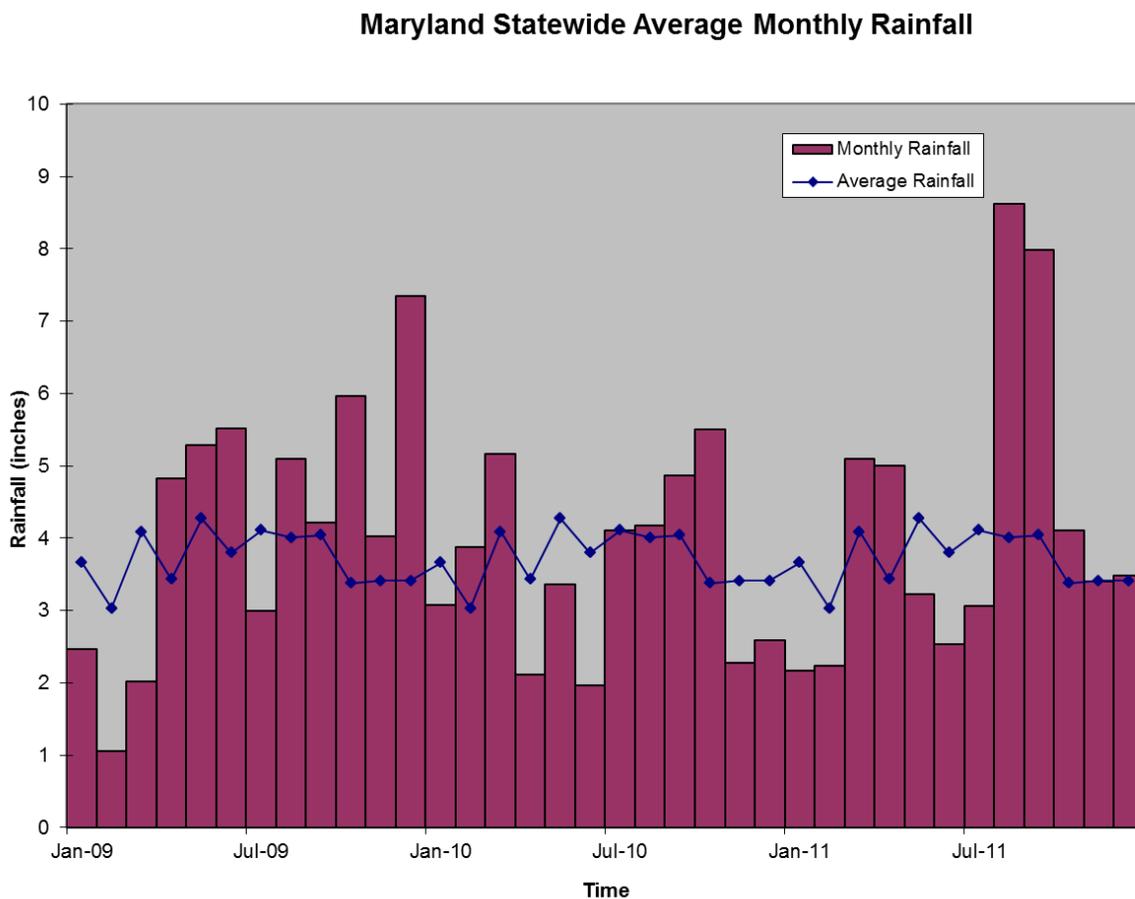
Figure III-E3. Statewide Maryland long-term monthly average rainfall (1971-2000) and statewide average rainfall for each individual month 2009-2011 (Northeast Regional Climate Center, 2009-2011).

The region experienced 13.8% higher rainfall amounts during 2009 than in an average year. Conversely, in 2010, rainfall was 3.6% less than in an average year. Annual rainfall returned to above average amounts (14.1% above average) in 2011. The higher than normal total quantity of rainfall for 2011 included local contributions from the remnants of Hurricane Irene (August 27) and Hurricane Lee (September 5-10), which respectively resulted in 115% and 98% higher monthly totals in August and September for Maryland. A plot of statewide average rainfall measured during 2009-2011 is shown in Fig. III-H3.

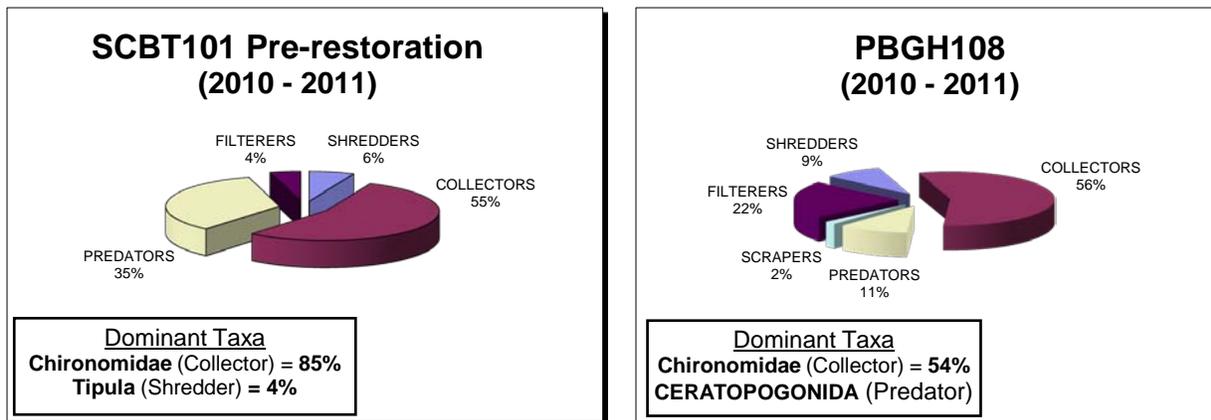
Figure III-H4. Functional Feeding Group Comparison in the Breewood Tributary (SCBT101) and in the Good Hope Tributary (PBGH108).

Figure III-H4 shows the average proportion of each FFG at SCBT101 and in a reference stream reach, the Good Hope tributary to Paint Branch (PBGH108). The benthic community of PBGH108 was rated *good* in 2010 and *fair* in 2011. Note that the relative percentage of predator taxa decreases and the percentages of filterer, shredder, and scraper taxa increases with an increase in benthic community rating.

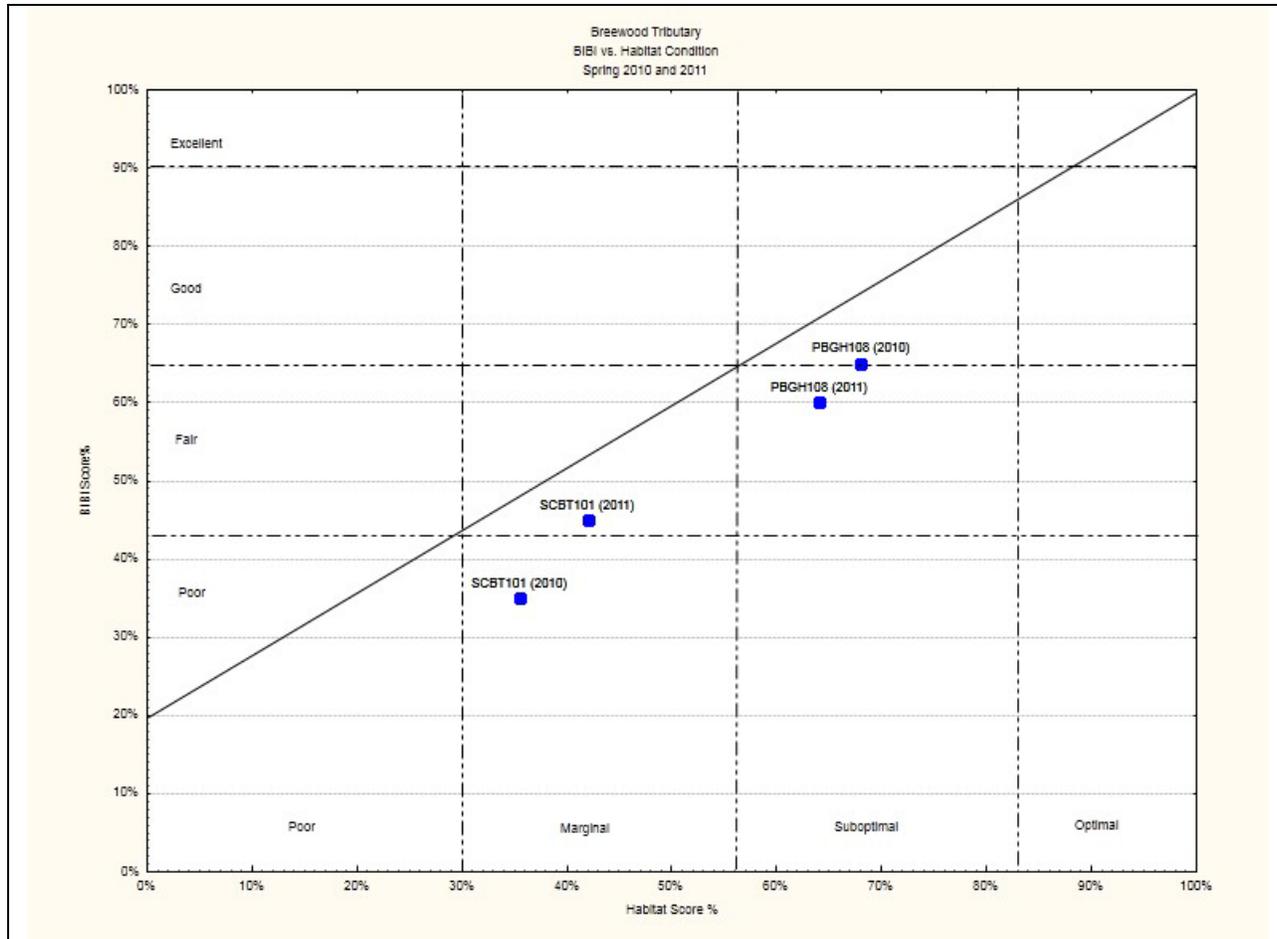
Figure III-H5. BIBI vs. Habitat Condition at Breewood Tributary and Reference Stream, Spring 2010 and 2011.

Figure III-H5 shows a comparison of the Breewood tributary BIBI and habitat conditions with those in the Paint Branch reference stream reach in Spring of 2010 and 2011.

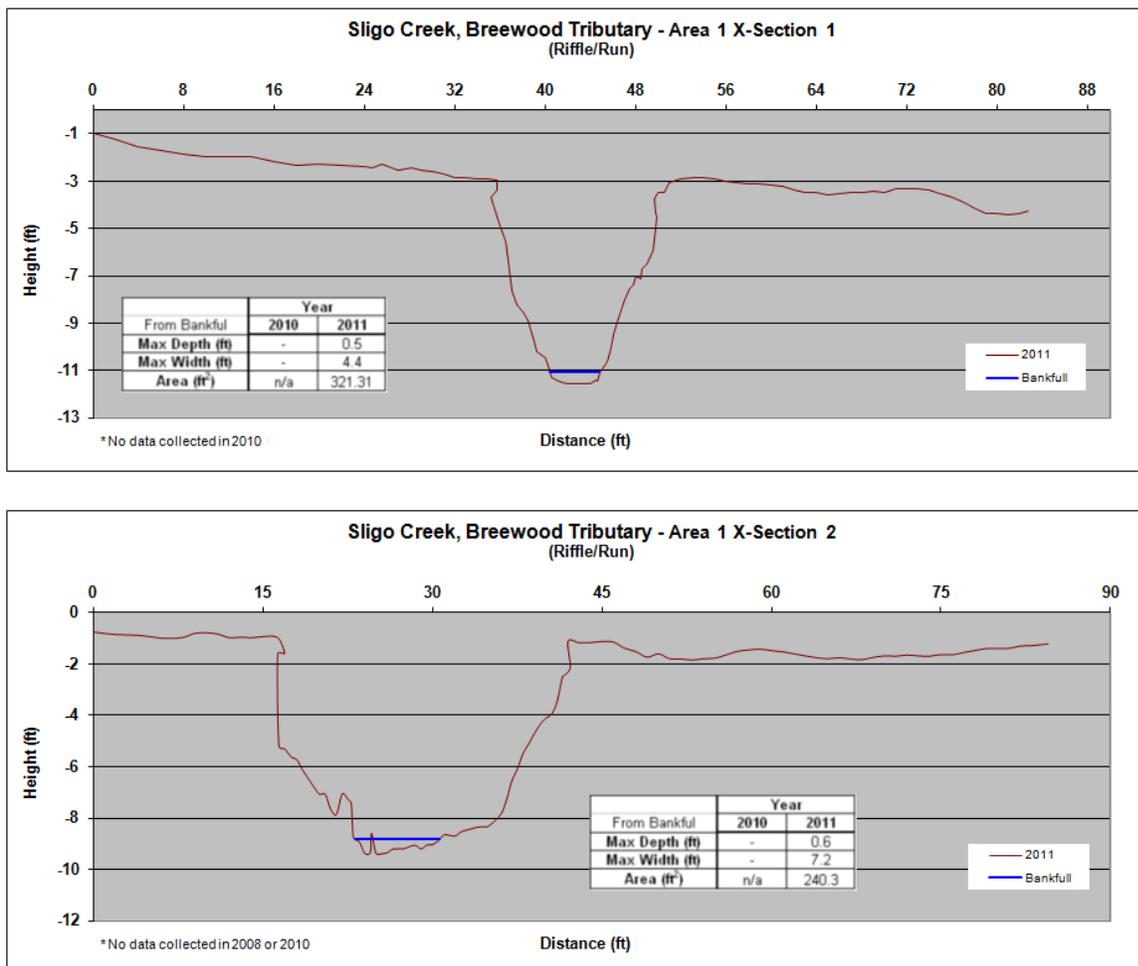
Figure III-H6 provides representative cross section views of Study Area 1. The average particle size of the channel substrate below the bankfull channel height was 0.062mm, which is classified as fine sand. This area of the stream is predominated by riffles and runs (riffles accounted for 39% of the reach surveyed and runs accounted for 38% of the reach surveyed). The results of the survey indicate a degraded channel with low sinuosity, and high erosion potential.

Figure III-H6. Representative Cross Sections From Breewood Tributary, Study Area 1.

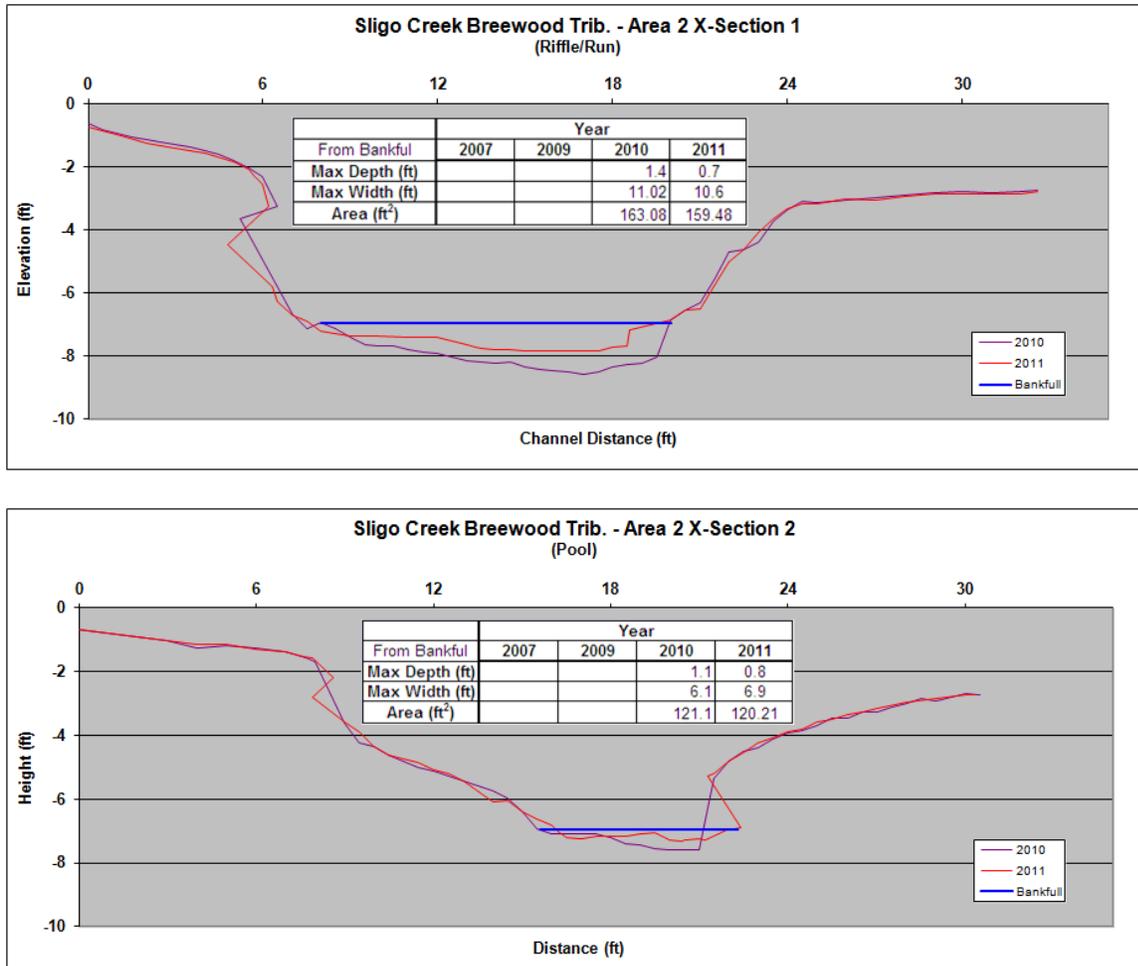
Figure III-H7 provides representative cross section views of Study Area 2. The average particle size of the channel substrate below the bankfull channel height was 2.8mm in 2010, which is classified as very fine gravel. In 2011 the average particle size of the channel substrate below the bankfull channel height was 12mm, which is classified as medium gravel. This area of the stream is predominated by riffles, which accounted for 54% of the reach surveyed in 2010 and 50% of the reach surveyed in 2011. The results of the survey also indicate a degraded channel with low sinuosity, and high erosion potential.

Figure III-H7. Representative Cross Sections From Breewood Tributary, Study Area 2.

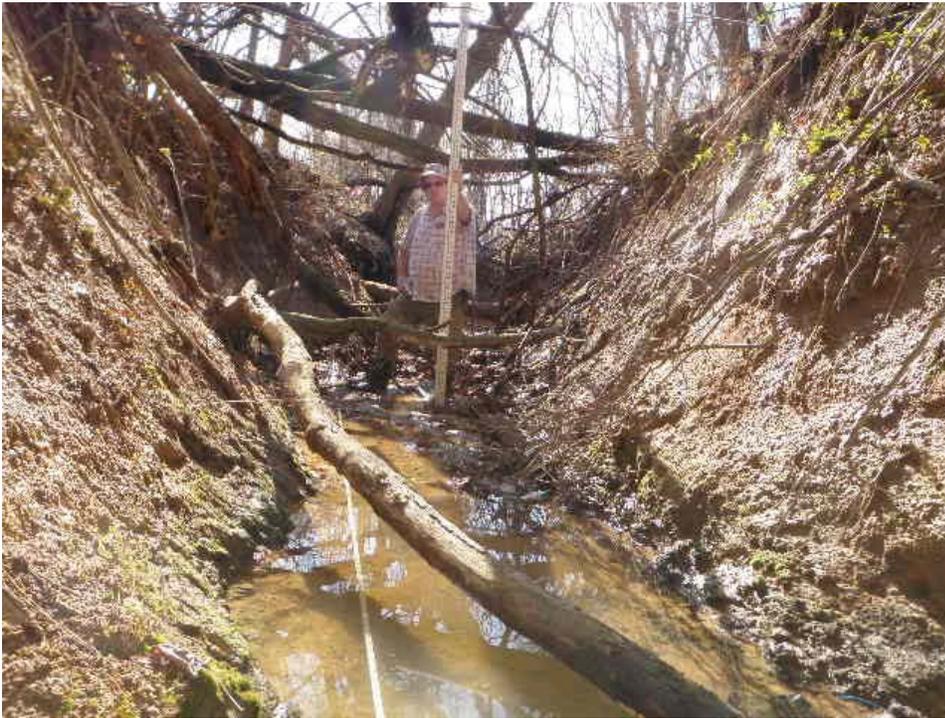
Figure III-H8 provides a photograph of a representative cross-section with Study Area 1, demonstrating the severe down-cutting that has occurred in this part of the Breewood tributary.

Figure III-H8. Downstream View of Sligo Creek, Breewood Tributary, Study Area 1- Cross Section 1.

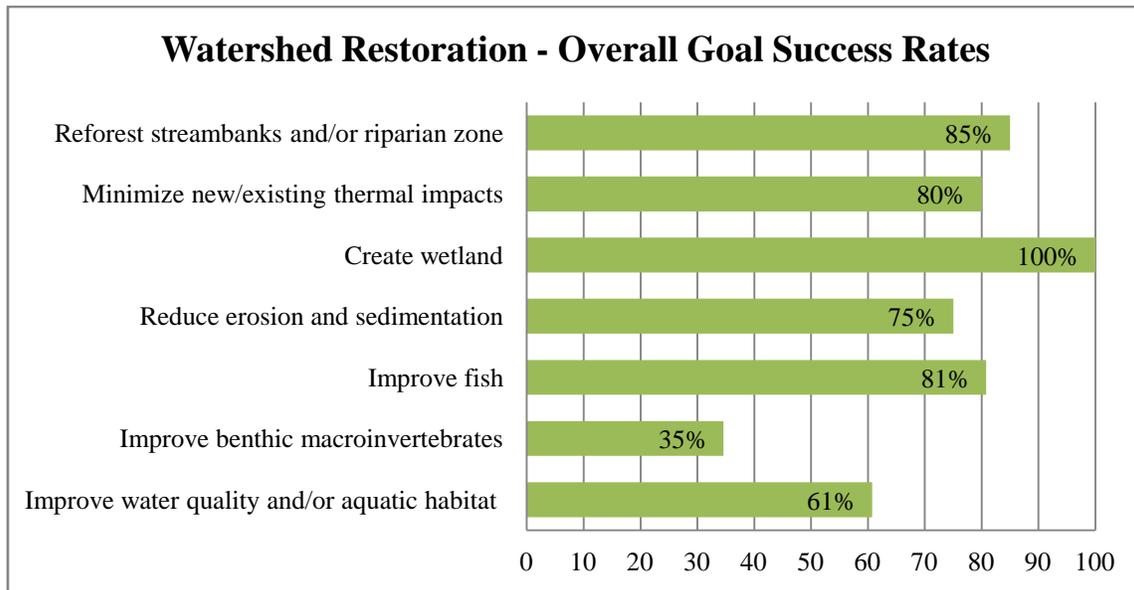
Figure III-H9– Relative Success of Watershed Restoration Project Goals for Projects Highlighted in FY11 and FY12 MS4 NPDES Reports. (Percent Success = Sum of all numeric scores divided by the sum of total possible scores for each goal in Table 1.2.11).

The County's watershed restoration projects were generally successful in achieving their goals. However, as shown in Figure III-H9, certain goals were more easily and more quickly achieved than others. Wetland creation had the highest success rate (100%), and improvement in the benthic macroinvertebrate communities had the lowest success rate (35%) through FY12.

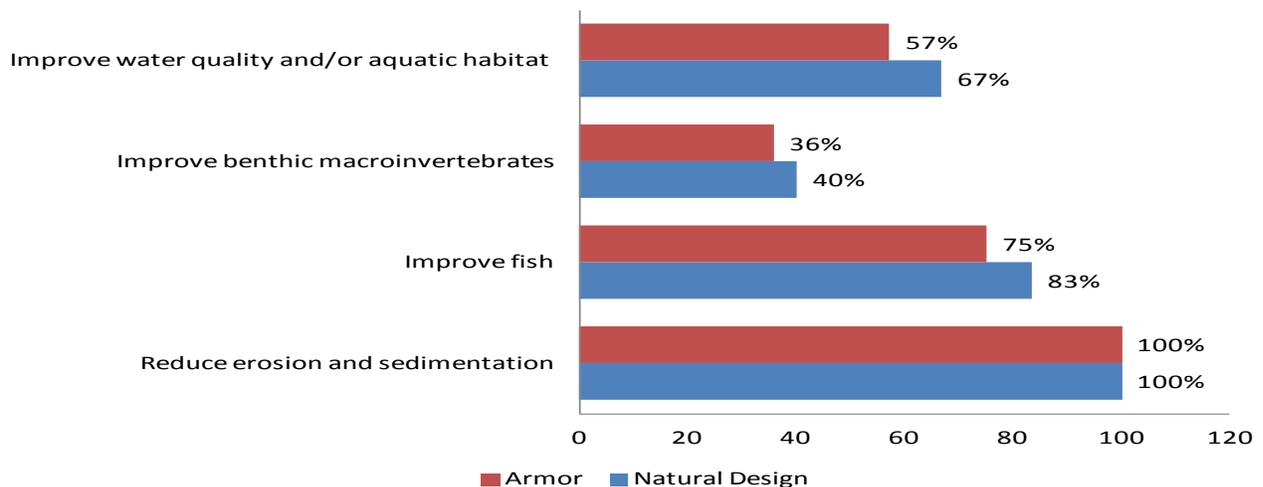
Figure III-H10. Relative Success of Stream Restoration Project Goals for Different General Restoration Design Approaches.

The DEP observed a slight difference in overall success between the projects built with natural channel versus armor design (Figure III-H10), with natural channel design slightly more successful in achieving the restoration goals.

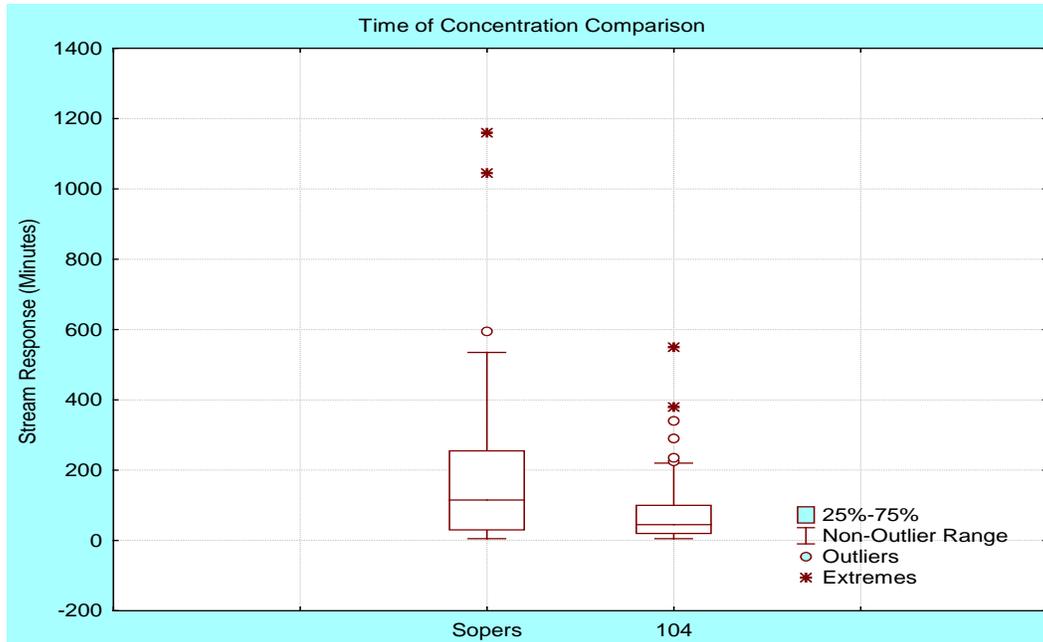
Figure III-H12. Comparison of Time of Concentration (TOC) at the control area (LSLB101) stream gage and at the test area (LSLS104) stream gage for rainfall greater than 1/2" in 24 hours.

During the construction period (October 1, 2007 thru September 30, 2011), the TOC was evaluated at the control area stream gage (LSLB101) and at the test area stream gage (LSLS104). On average, the test area tributary responded twice as fast as the control area for the same range of storms exceeding ½" of rainfall (see Figure III-H12).
