Annual Report for FY12

NPDES Municipal Separate Storm Sewer System Permit

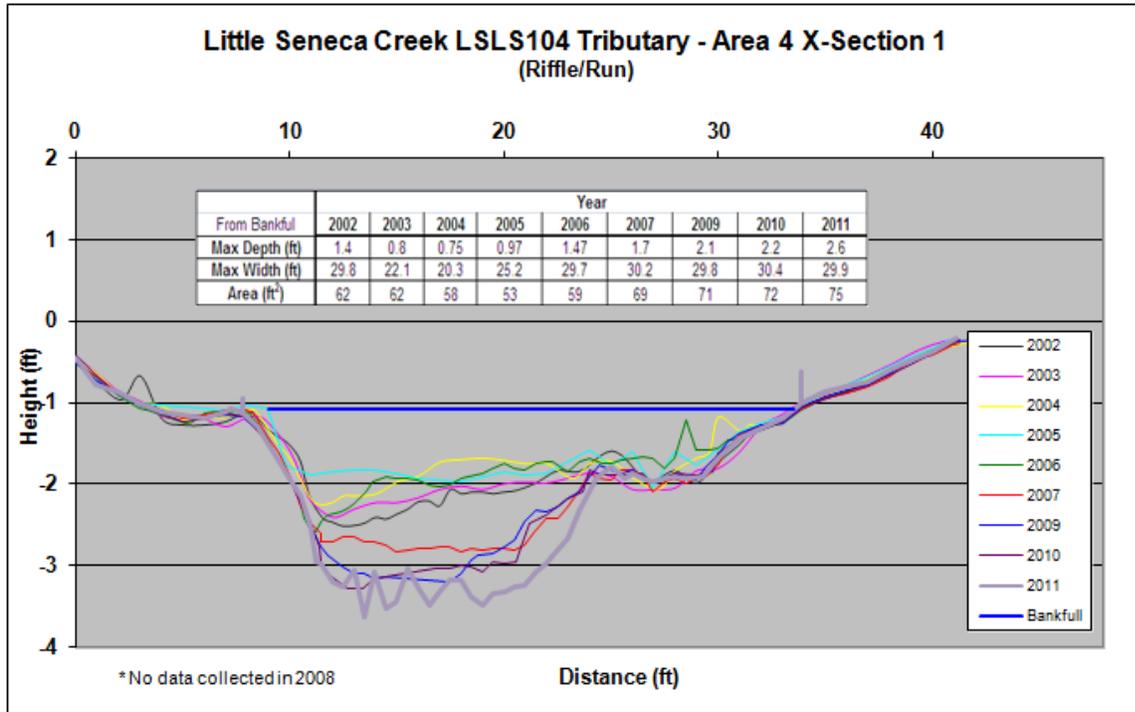
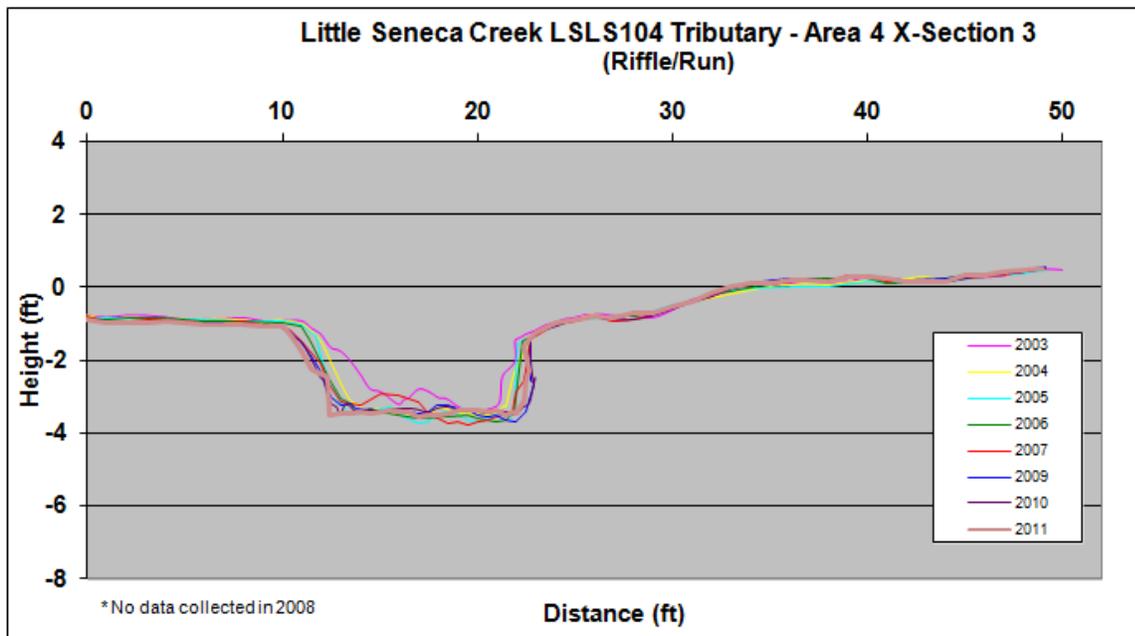
Figure III-H14. Representative cross sections from the test area (LSLS104), cross section location 4 (most downstream location). Cross sections are both measured in riffle/run features.

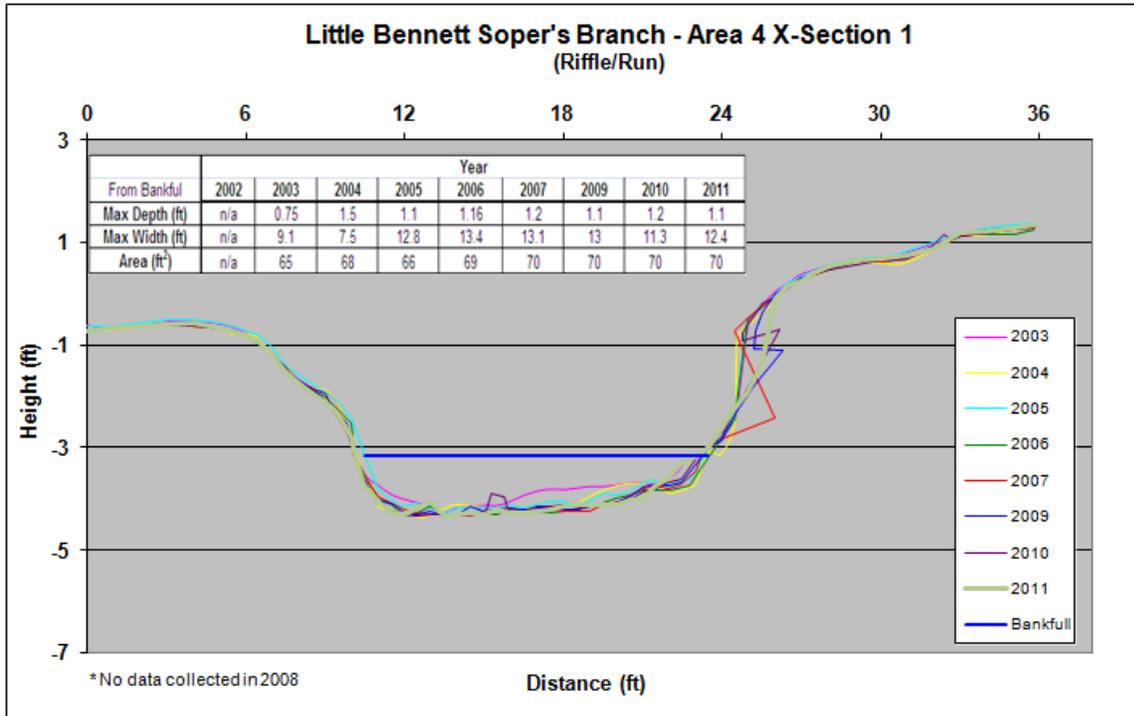
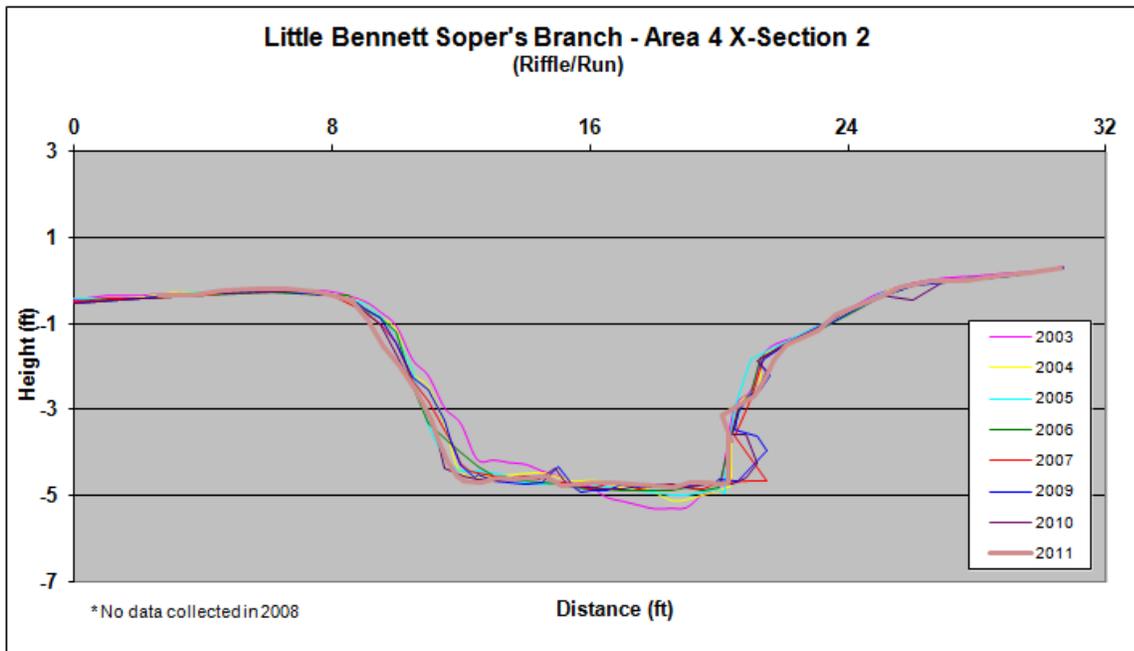
Figure III-H15. Representative cross sections from the control area, cross section location 4 (most downstream location). Cross sections both measured in riffle/run features.

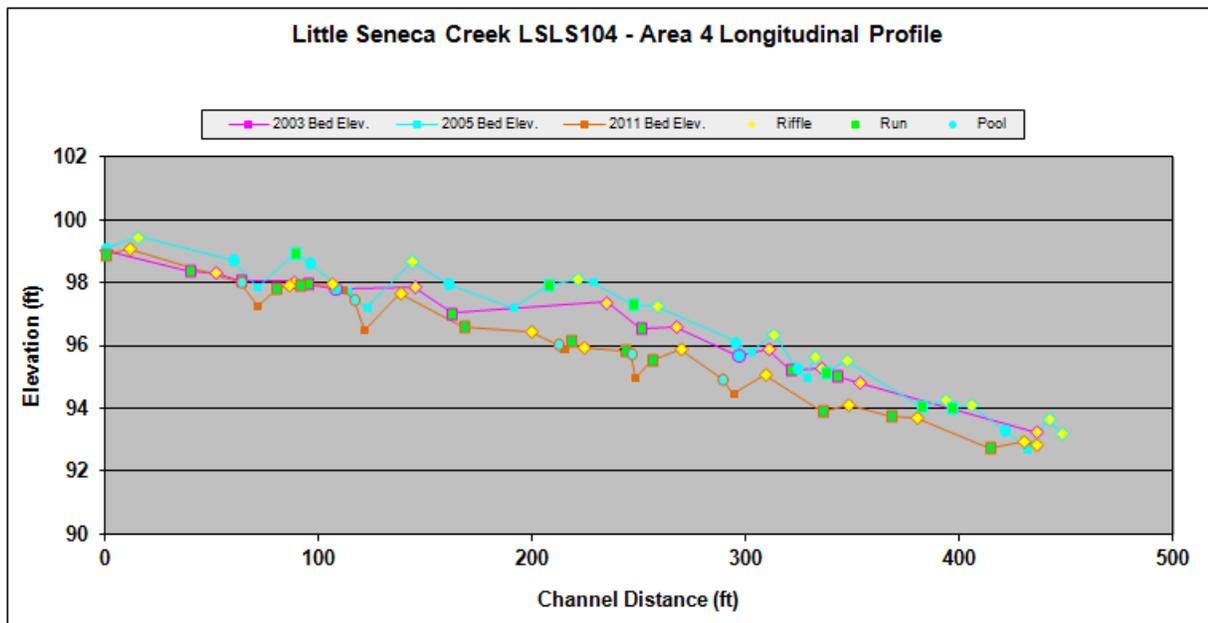
Figure III-H16. Longitudinal profiles test area (LSLS104), cross section location 4 (most downstream location).

The results presented are preliminary as the ESC control devices have not all been converted to SWM structures. Post-construction monitoring has not yet been completed. However, from the preliminary results it appears that the construction phase of development has impacted the test area channel morphology as evinced by straightening, down-cutting, and enlargement of the channel.

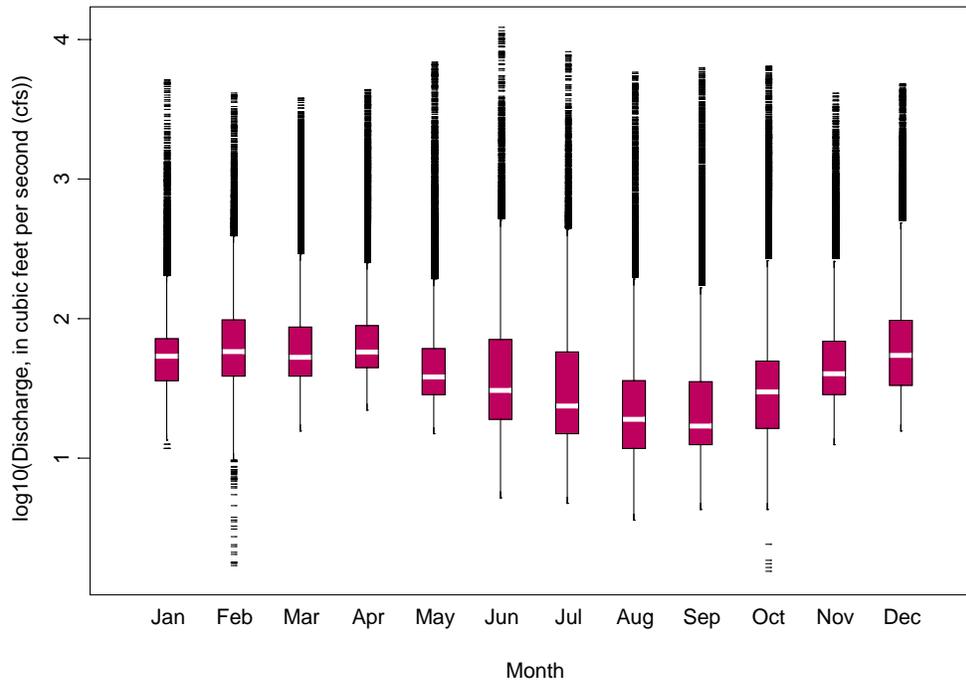
Figure III-J2. Boxplots of Monthly Summaries of 15 Minute Interval Discharge Data for the Northeast Branch of the Anacostia River (USGS Station 01649500) for Water Years 2005-2011

Figure III-J2 shows a summary of the monthly discharge data for the Northeast Branch of the Anacostia. This station is downstream of the DEP supported station on Lower Paint Branch.

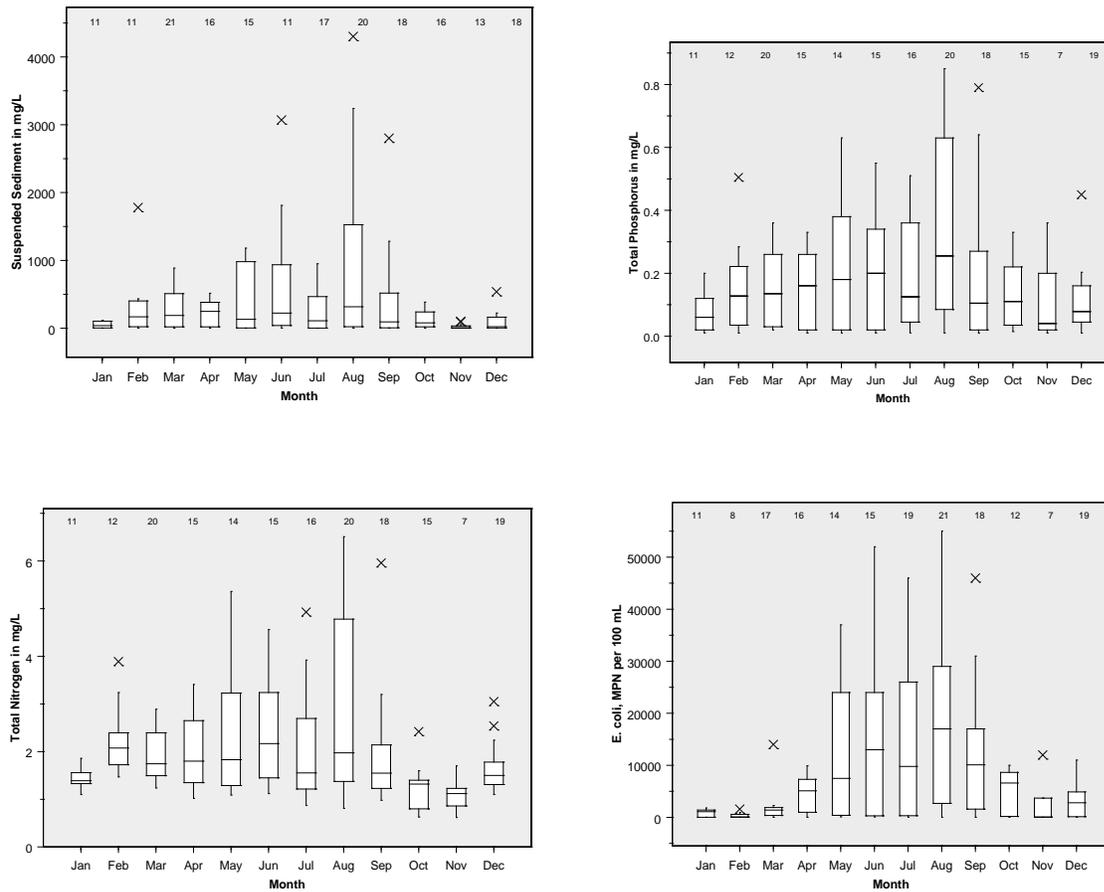
Figure III-J3. Boxplots of monthly summaries of discrete water-quality data for Paint Branch near College Park, MD (USGS Station 01649190) for water years 2008 to 2011. Concentrations of (A) suspended sediment in mg/L, (B) total nitrogen in mg/L, (C) total phosphorus in mg/L, and (D) *E. coli* in most probably number of viable cells.
