Special Protection Area Program Annual Report 2003

PREPARED BY THE MONTGOMERY COUNTY DEPARTMENT OF ENVIRONMENTAL PROTECTION IN COOPERATION WITH THE DEPARTMENT OF PERMITTING SERVICES AND THE MARYLAND-NATIONAL CAPITAL PARK & PLANNING COMMISSION

SPECIAL PROTECTION AREA PROGRAM ANNUAL REPORT FOR 2003

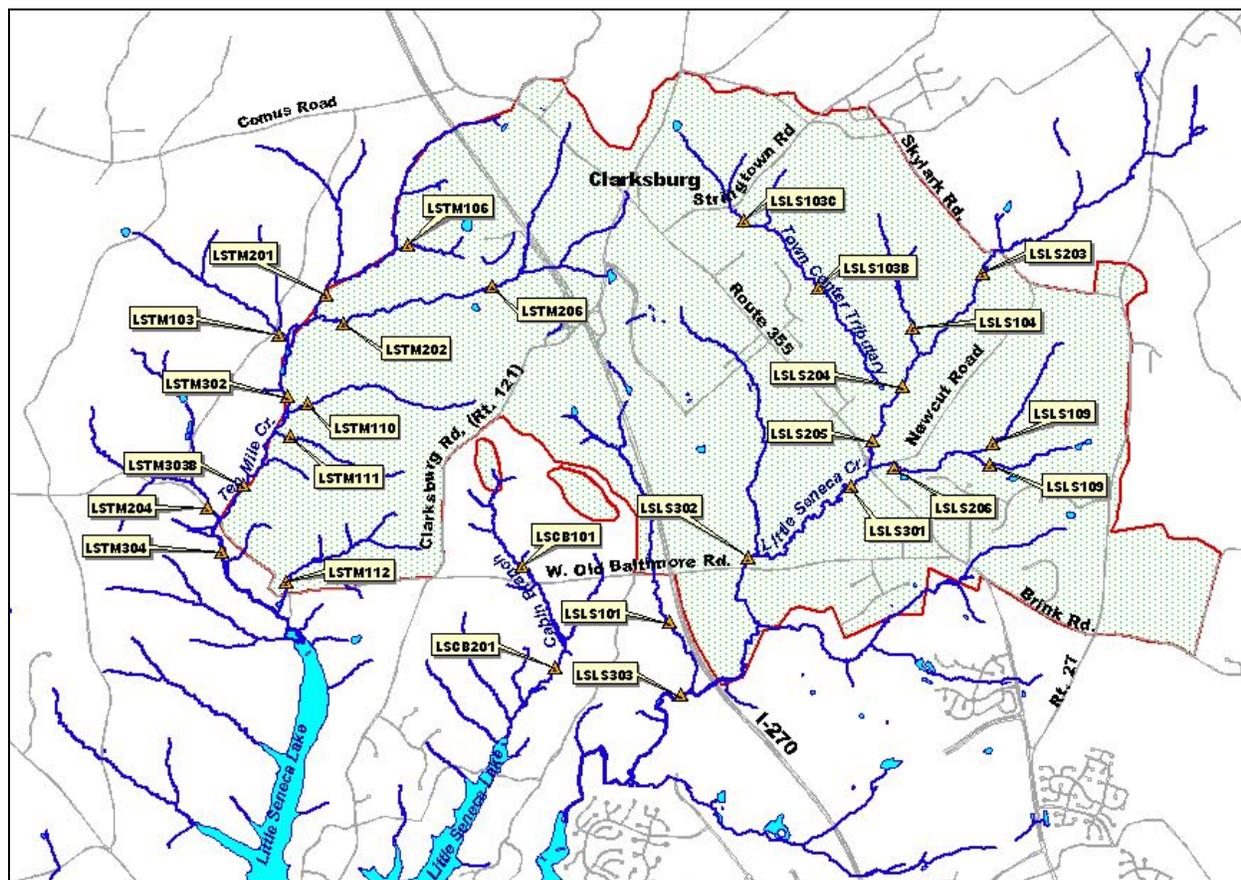
Figure 4 Clarksburg Special Protection Area - stream monitoring station locations

Stream monitoring in Clarksburg SPA began in 1994 and is done on an annual basis at most of the twenty seven (27) stations shown in Figure 4. During 2003, biological monitoring was completed at all twenty seven stations and water temperature loggers were deployed at eight (8) stations.

just downstream of Stringtown Road; and 2) LSL103B, located in the lower portion of the tributary (Figure 4). Results from these two stations are used to track stream conditions as development proceeds in the Clarksburg town center area.

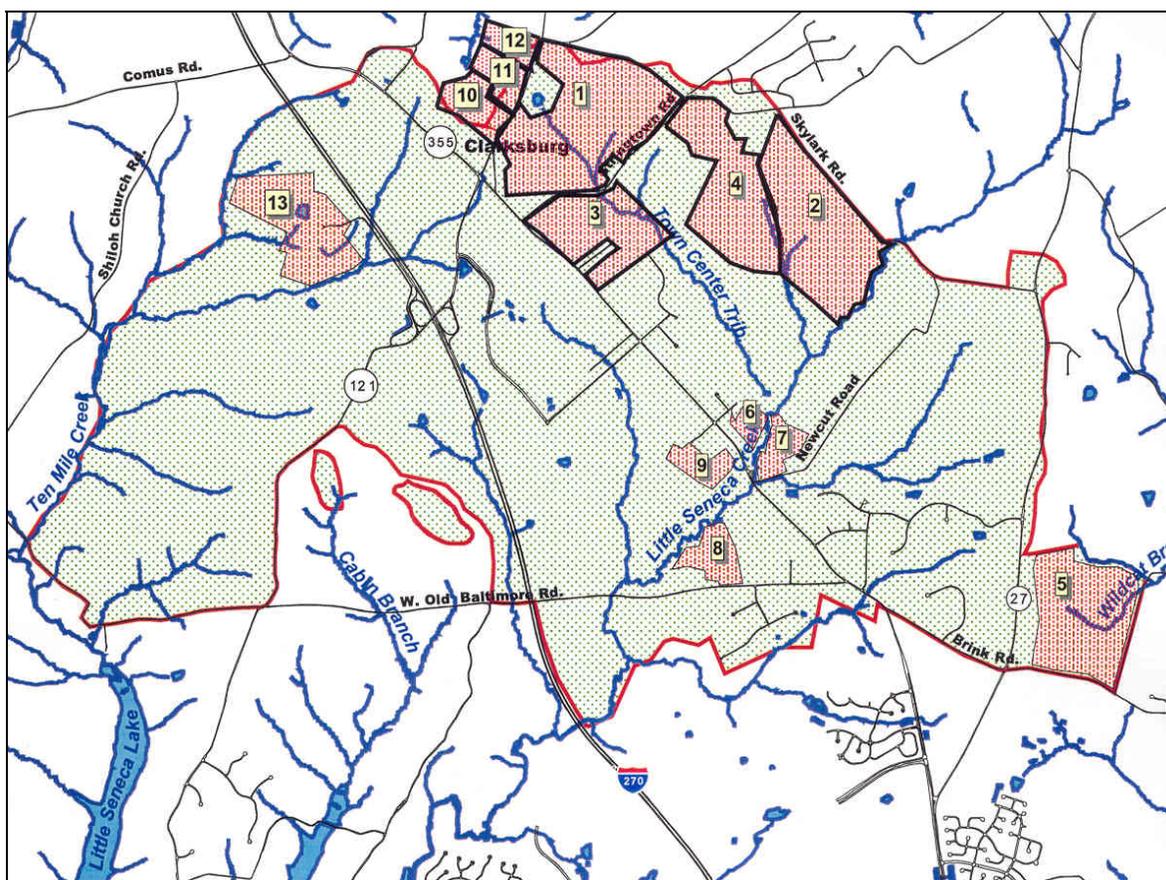
Figure 5 Development projects currently under construction or just recently completed are shaded in red.

Construction activity during 2003 occurred in the following areas in the Clarksburg SPA (see Figure 5 for locations): 1) Clarksburg Town Center; 2) Greenway Village, Phase I (Skylark Rd. on north side of Little Seneca Cr.); 3) Highlands of Clarksburg; 4) Clarksburg Village, phase I (southeast corner of Stringtown and Piedmont Roads); 5) All Souls Cemetery; 6) Running Brook Acres; 7) Timbercreek; 8) Martens property, phase I; 9) Clarksburg Middle School; 10) Clarksburg Ridge; 11) Catawba Manor; 12) Parkside. The Clarksburg Detention Center (13) was completed in April 2003.

Construction on the Greenway Village, Highlands of Clarksburg, Clarksburg Village, Clarksburg Ridge, Catawba Manor and Parkside projects did not begin until mid or late in the year of 2003 and would not have influenced stream condition during the spring when benthic macroinvertebrates are sampled.

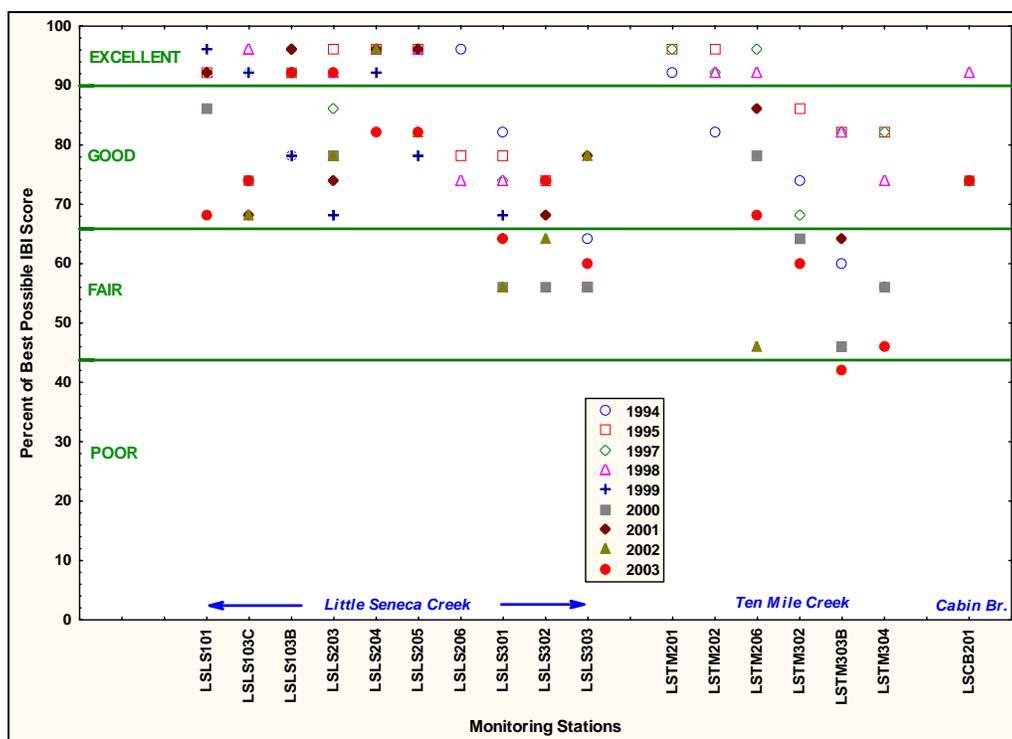
Figure 6 Fish monitoring results from the Clarksburg SPA.

Generally, fish monitoring results from 2003 indicate little change in community health from previous years. IBI scores from Little Seneca Creek are within the range of scores from previous years at most monitoring stations (Figure 6). Exceptions include LSL101 (located along a small un-named tributary that flows parallel to I-270) and LSL204 (located on the mainstem of Little Seneca Creek upstream of Rt. 355), where IBI scores were lower but still remained in the "good" range. Lower IBI scores at these stations are due, primarily, to an increase in the proportion of pollution tolerant fish species (e.g. Blacknose dace). This kind of minor change in the fish community is often a part of the natural variation observed from year to year and could be related to the 2002 drought. It is presumed that this change in community composition will be temporary as the fish community upstream at LSL203 and downstream at LSL205 remained consistent with prior years.

In Ten Mile Creek and Cabin Branch, three of the four stations sampled in 2003 also received fish IBI scores equal to or lower than any year previous (Figure 6). Because there has been minimal land disturbance in these watersheds, low IBI scores here are believed to be related to natural variation and the drought of 2002. Much of the Ten Mile Creek mainstem went completely dry during the summer of 2002. All fish species observed in Ten Mile Creek prior to the drought were observed in 2003 demonstrating the resiliency of the fish community and the ability to quickly re-colonize a stream in the absence of additional man-made impact.

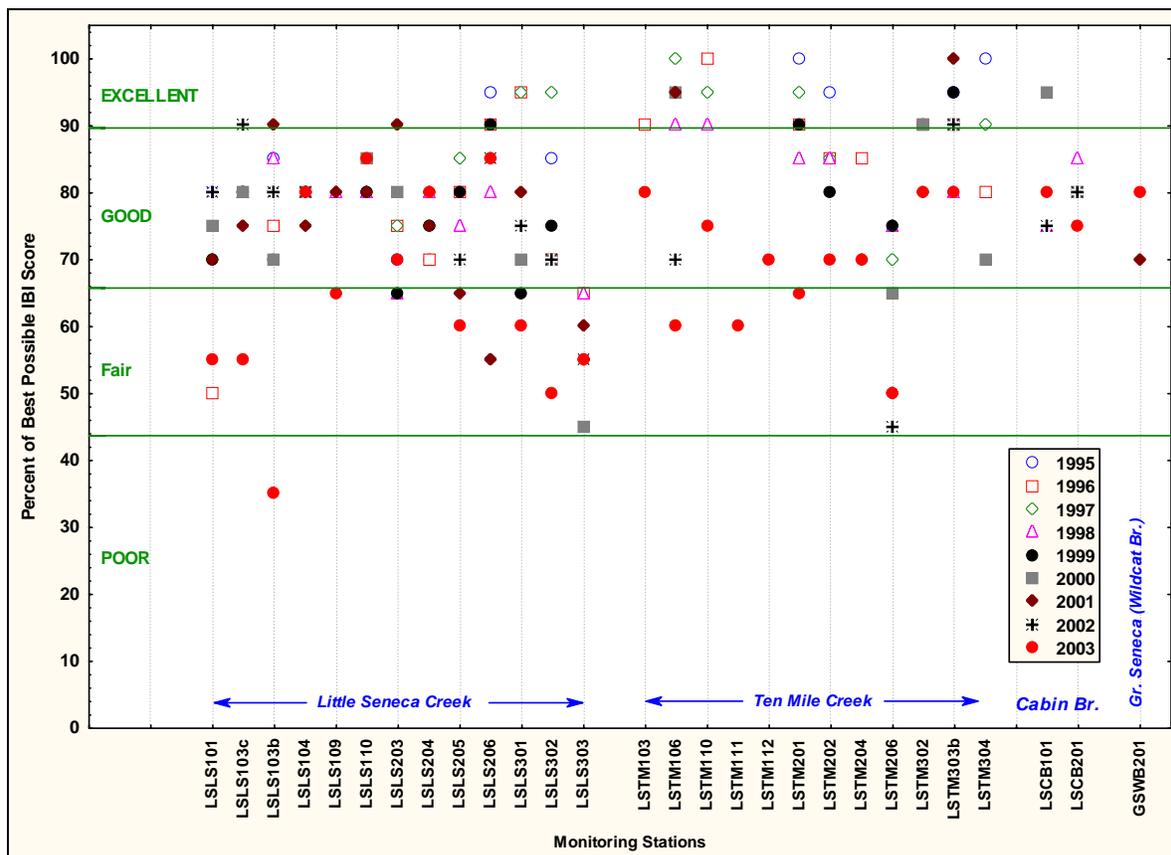
Figure 7 Benthic macroinvertebrate monitoring results from Clarksburg SPA.

Benthic macroinvertebrate monitoring results from 2003 show many monitoring stations in both Little Seneca and Ten Mile Creeks scored lower than any previous year (Figure 7). This again is largely a reflection of the extremely stressful conditions caused by the drought of 2002. Stressful drought conditions in area streams peaked during the summer months of 2002 and therefore are not fully reflected in benthic macroinvertebrate samples collected during the spring of 2002.

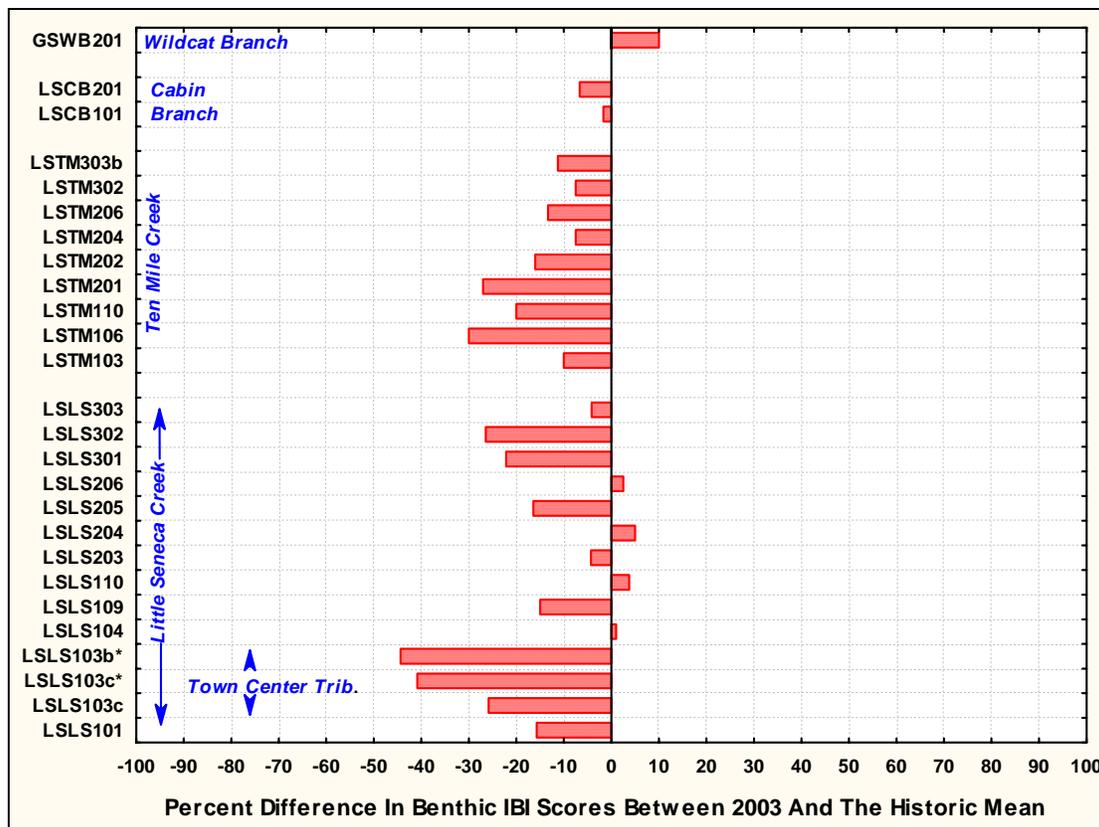
Twenty one (21) of the twenty six (26) stations monitored during 2003 received lower IBI scores than the historic mean at each station (Figure 8). The degree of negative change was greatest in the Town Center Tributary (discussed further in the Clarksburg Town Center section below). Other areas where negative change was high include LSL101 and LSL301.

Figure 8 Departure of 2003 benthic macroinvertebrate IBI scores from the historic mean (1995 - 2002). Results from monitoring stations with asterisks are from samples collected after a water main break on the Clarksburg Town Center construction site.

Monitoring stations most impacted by construction activities in the spring 2003 are LSL103c, LSL103b and LSTM106. Departure from the historic mean (1995 – 2002, 7 years of natural variability) is greatest at these three stations. The level of impairment beyond that observed at other stations is presumably related to construction and associated land disturbance activity within the drainage area to these three stations.

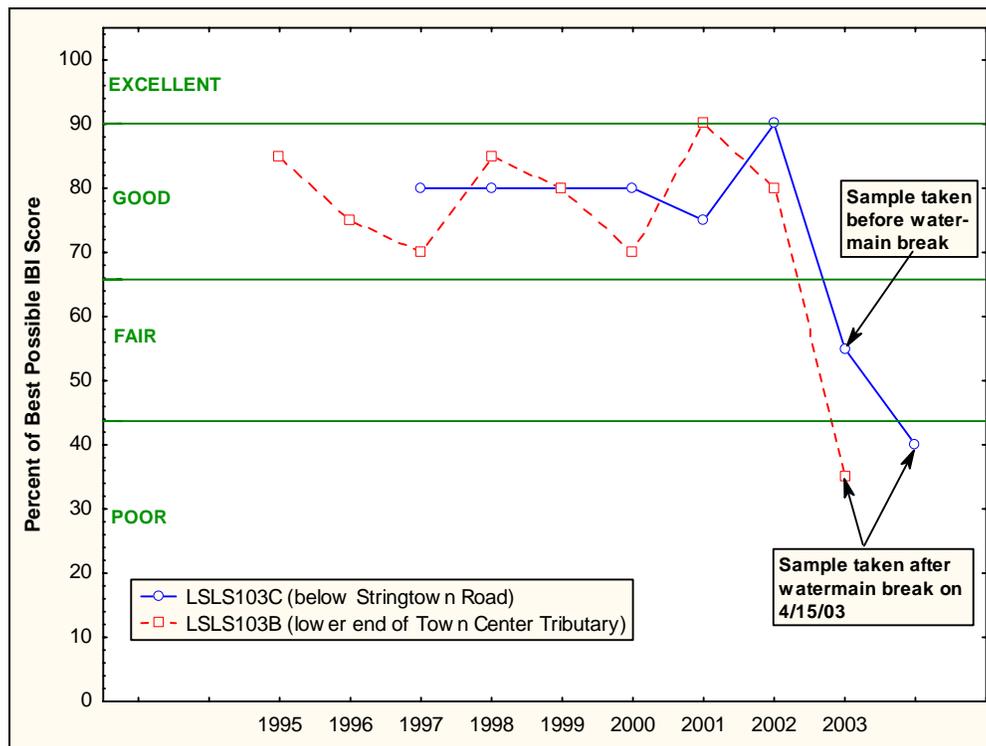
Figure 9 Benthic macroinvertebrate IBI scores from the Town Center Tributary

There was a water main break at the Town Center on April 14, 2003 that resulted in a large volume of chlorinated water flowing down the Town Center Tributary. DEP had collected a benthic macroinvertebrate sample at LSL103C prior to the break on 4/7/03. An additional sample was taken after the break to determine if the incident caused any detectable harm. Results do show an impact as IBI score dropped by fifteen percent from fair to poor (Figure 9). Downstream, at LSL103B no sample was collected before the water main break so 2003 results reflect all impacts (water main break, construction activities and the 2002 drought).

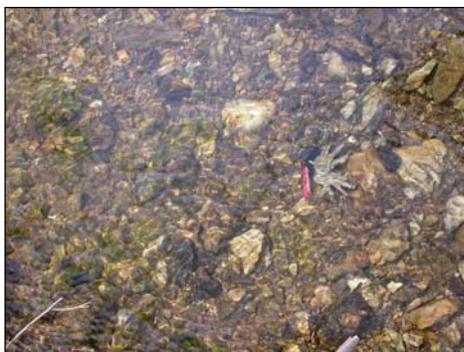
Figure 10 1999

Additionally, DEP has observed increased amounts of fine sediment on the stream bottom in the Town Center Tributary (Figures 10 – 13) beginning in 2001. Sediment control measures are in place and inspected routinely. However, considering the large area of land disturbance on the Town Center and surrounding properties, keeping fine sediments out of the stream is difficult and has not been achieved so far. Sediment input to the Town Center Tributary during 2001 was found to originate from a stream stabilization project being constructed in the stream channel and not from the development site. However, since then, the source of sediment is from development activities. Muddy water is routinely observed running out of the three development projects on the north side of Clarksburg Road and into Kings Pond and ultimately to the stream. Stormwater runoff and associated sediment from much of the construction area was well managed for many of the smaller storm events. However, it's during the larger storm events when most of the sediment enters the stream.

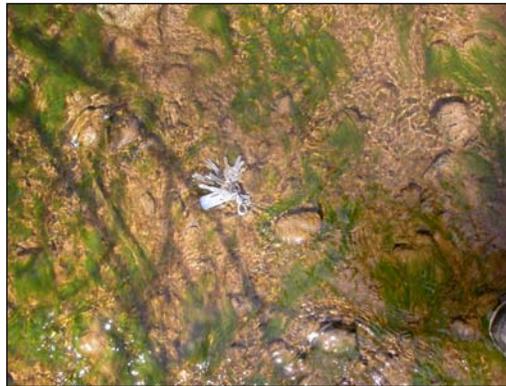
Figure 13 2003

The increased sediment in the stream has facilitated higher rates of algae growth (figure 13) which also has an influence on water quality. The concentration of dissolved oxygen will

BMP monitoring data has shown increased concentrations of sediment leaving sediment traps during larger storm events. This is because the sediment traps can only hold so much water, when storage capacity is reached muddy water flows freely out the riser structure to the stream.

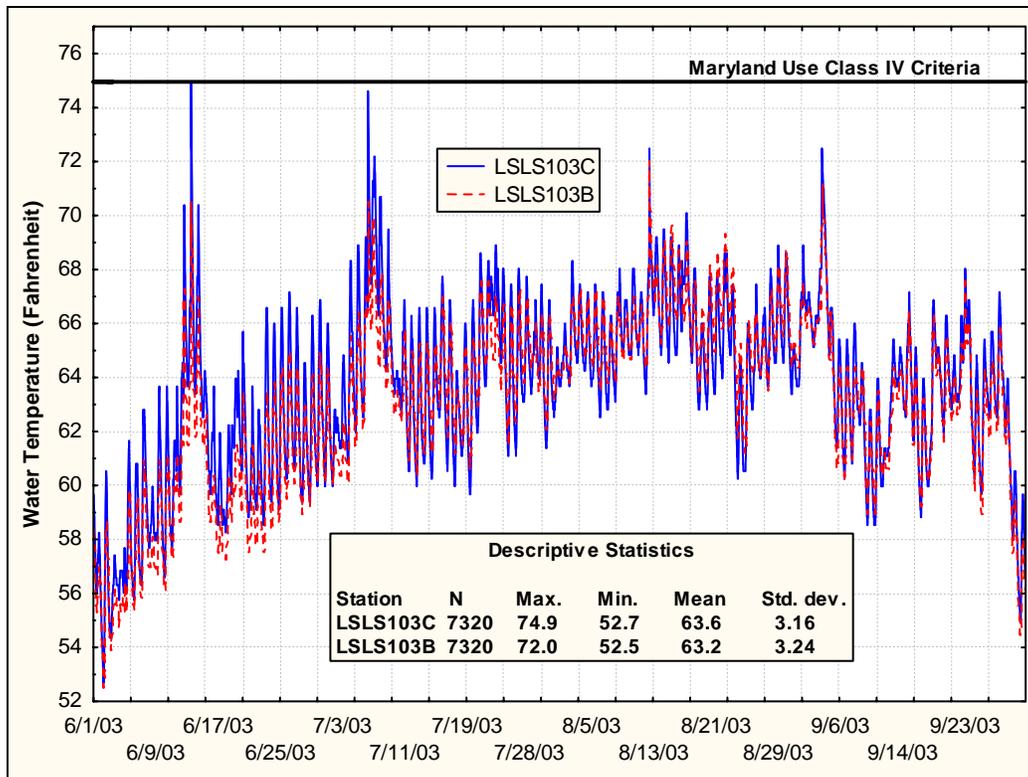
Figure 15 Water temperature data from the Town Center Tributary

Temperature spikes were more pronounced at LSL103C because this station is closer to the sediment ponds. Further downstream at LSL103B the spikes were ‘dampened’ by additional cool water input from several small tributaries.

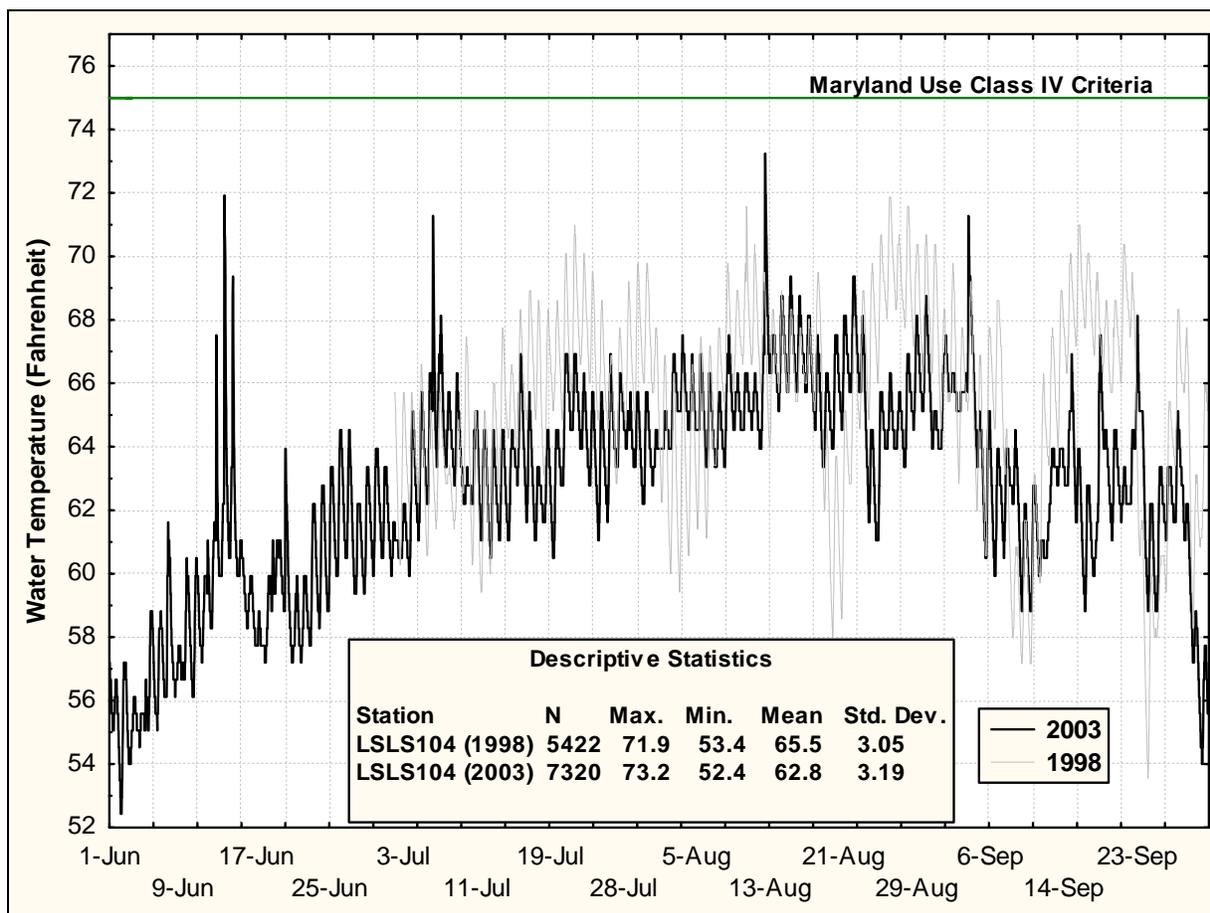
Figure 16 Stream temperature data from monitoring station LSL104

A temperature logger was placed in the lower portion of this tributary at LSL104. Results show water temperature remained below the Use Class IV criteria of 75⁰ F throughout the summer of 2003. However, like results from the Town Center tributary there are several brief temperature spikes that occurred. Comparing results from 2003 with 1998 makes it apparent that these temperature spikes are a new phenomenon (Figure 16). Sediment ponds on construction phases I and II of the Greenway Village are the likely source of temperature spikes.

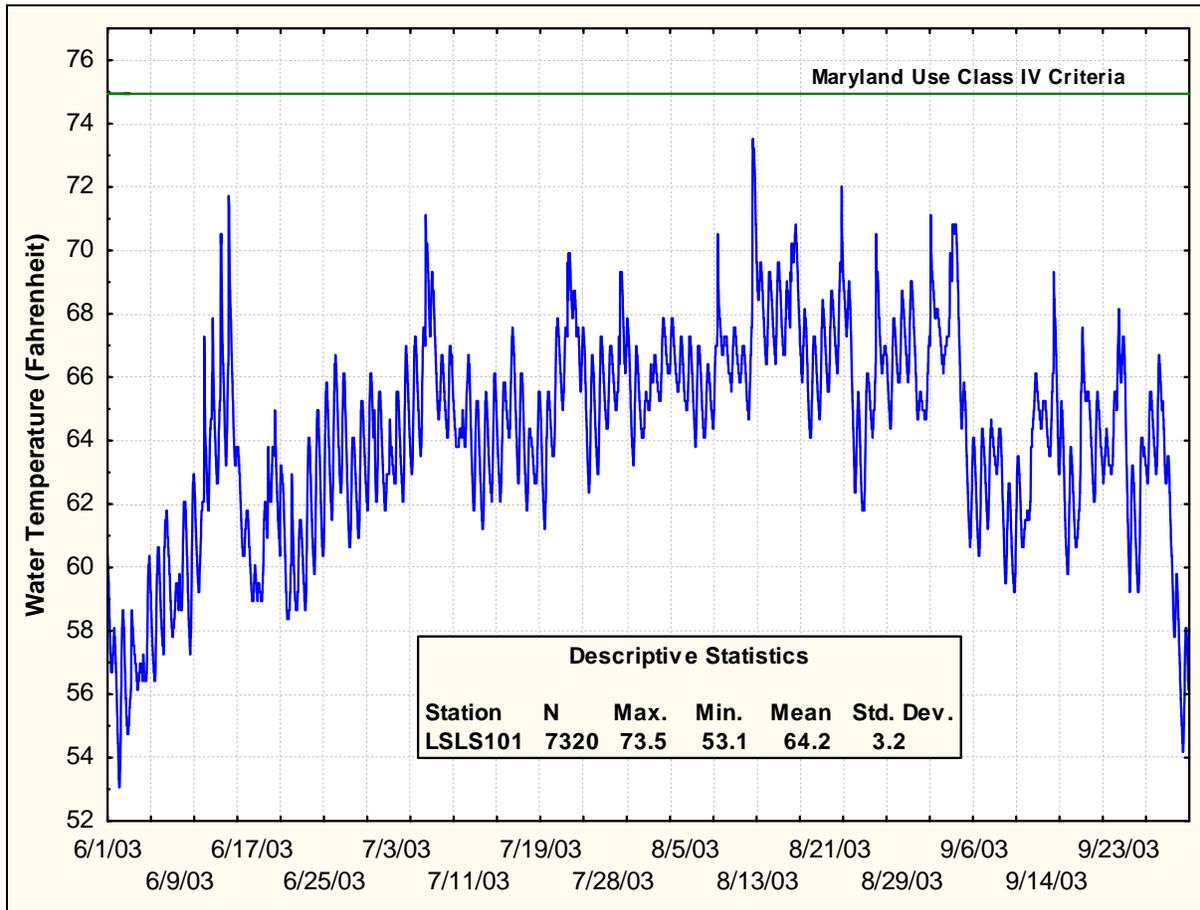
Figure 17 Stream temperature data from LSLS101

The I-270 tributary originates in the Gateway 270 Industrial Park, flows under and then parallel with I-270 to the west. Monitoring station LSLS101 is located downstream of West Old Baltimore road. Results from a temperature logger placed at LSLS101 show stream temperature remained below the Use Class IV criteria of 75^o F throughout the summer of 2003 (Figure 17).

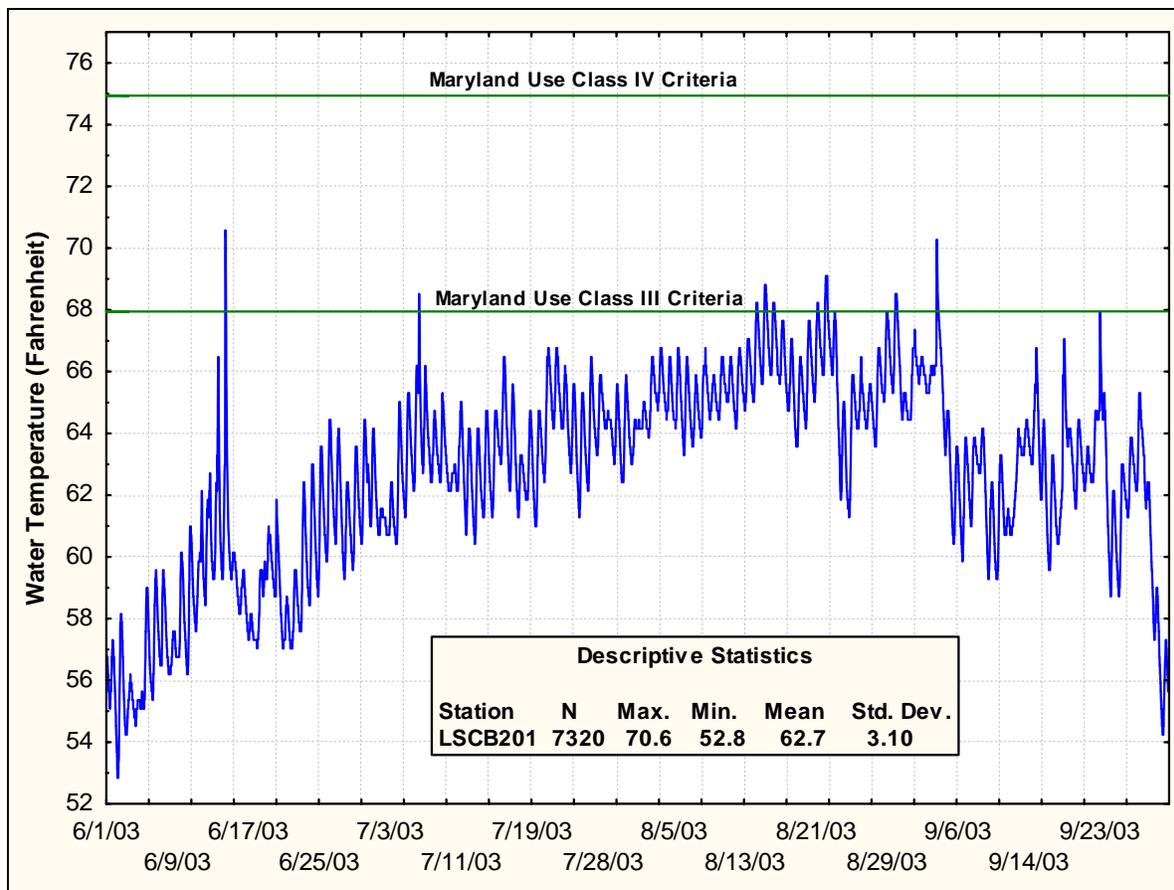
Figure 18 2002 Temperature Data from Cabin Branch – LSCB201

During the summer of 2003 water temperature again was generally below the Use Class III criteria (Figure 18). Although this stream is designated by Maryland as Use Class I, water temperature is clearly well below Class I criteria of 90⁰ F. Maintaining these low water temperatures is very important in preserving the biological health of Cabin Branch and is a performance goal on the Cabin Branch Neighborhood development.

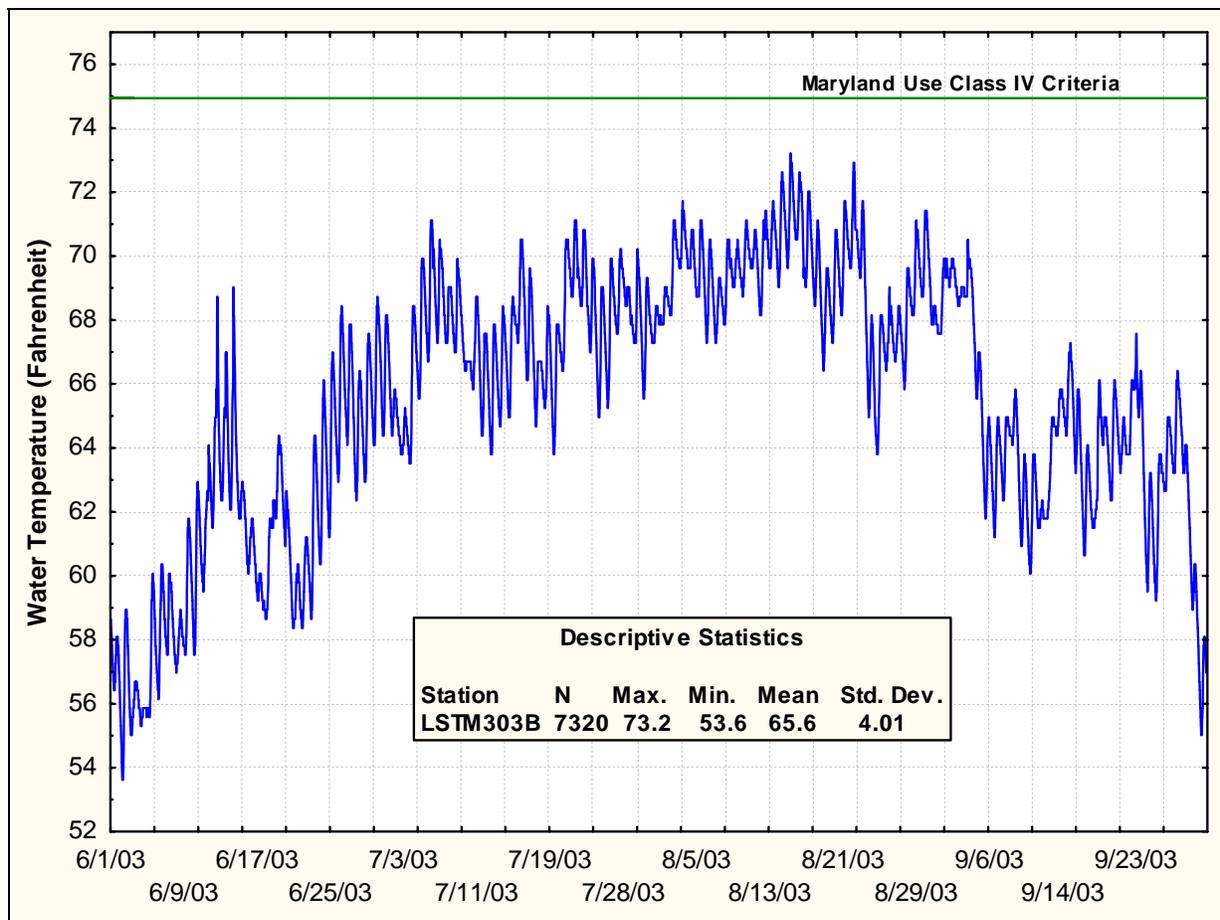
Figure 19 Stream temperature data from Ten Mile Creek - mainstem

Results from LSTM303B show stream temperature remained below the Maryland Use Class IV criteria throughout the summer of 2003 (Figure 19). Mean water temperature was higher than any other area in the Clarksburg SPA. This is likely due to differences in stream channel characteristics between Ten Mile Creek and Little Seneca Creek. In Ten Mile Creek the stream channel tends to be wide and shallow. This allows the stream to warm up more as there is greater exposure to warm ambient air temperatures.

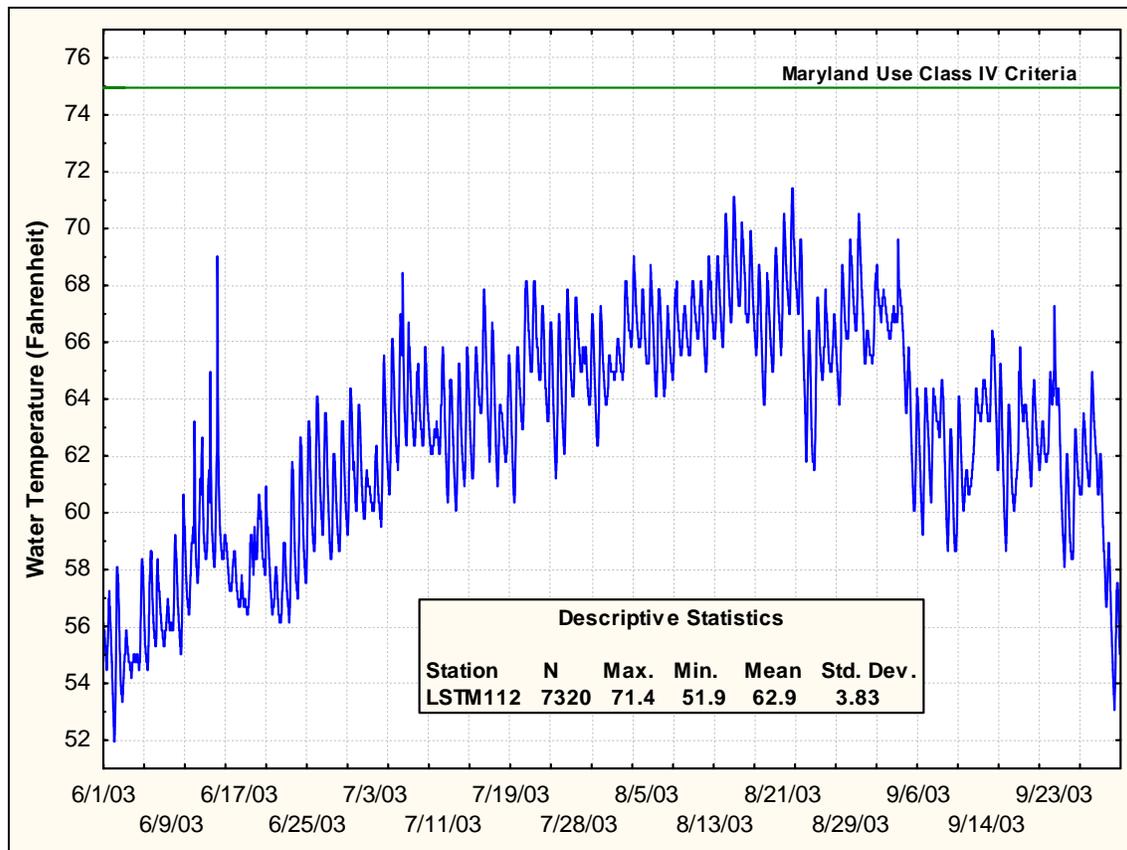
Figure 20 Stream temperature data from Ten Mile Creek – tributary

Results from LSTM112 show water temperature was cooler than most other areas in the Clarksburg SPA (Figure 20). 2003 is the first year data was collected from this fairly large tributary to Ten Mile Creek. Benthic Macroinvertebrate sampling revealed good biological condition. Monitoring results from 2003 help establish baseline conditions before this small subwatershed develops in the future.

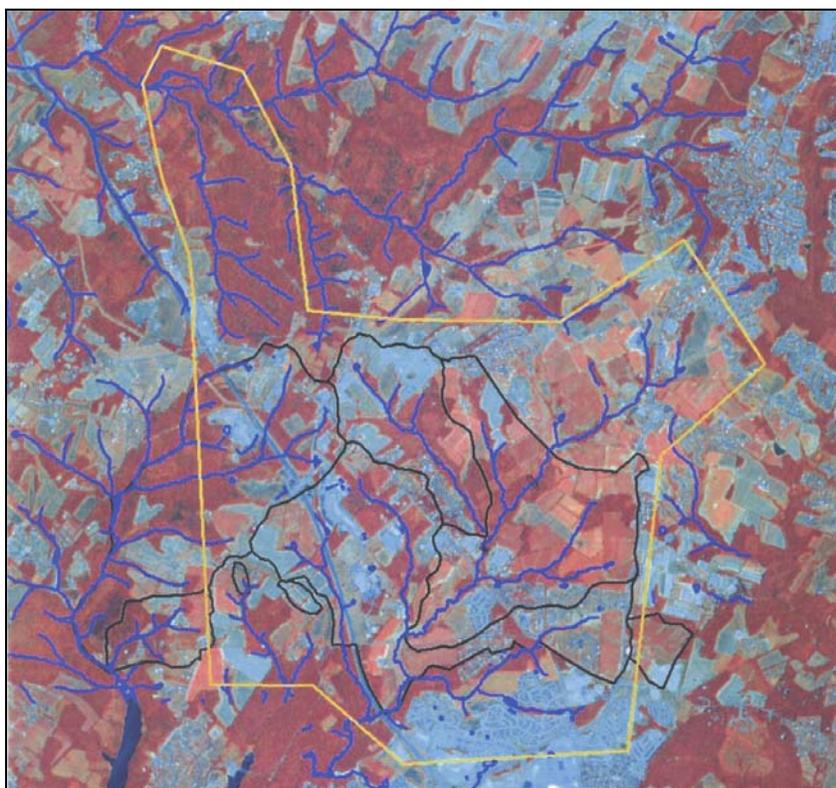
LIDAR data was collected over the area delineated in Figure 21 which includes most of the Clarksburg SPA. The area to the north, Sopers Branch - a tributary to Little Bennett Creek, was included as a positive control (ie, minimal land disturbance).

Figure 21 Area from which LIDAR data was collected in Dec. 2002, includes all of Little Seneca Creek watershed (upstream of I 270), a portion of Little Bennett Creek water shed (Sopers Branch) to the north and a portion of Ten Mile Creek to the west.

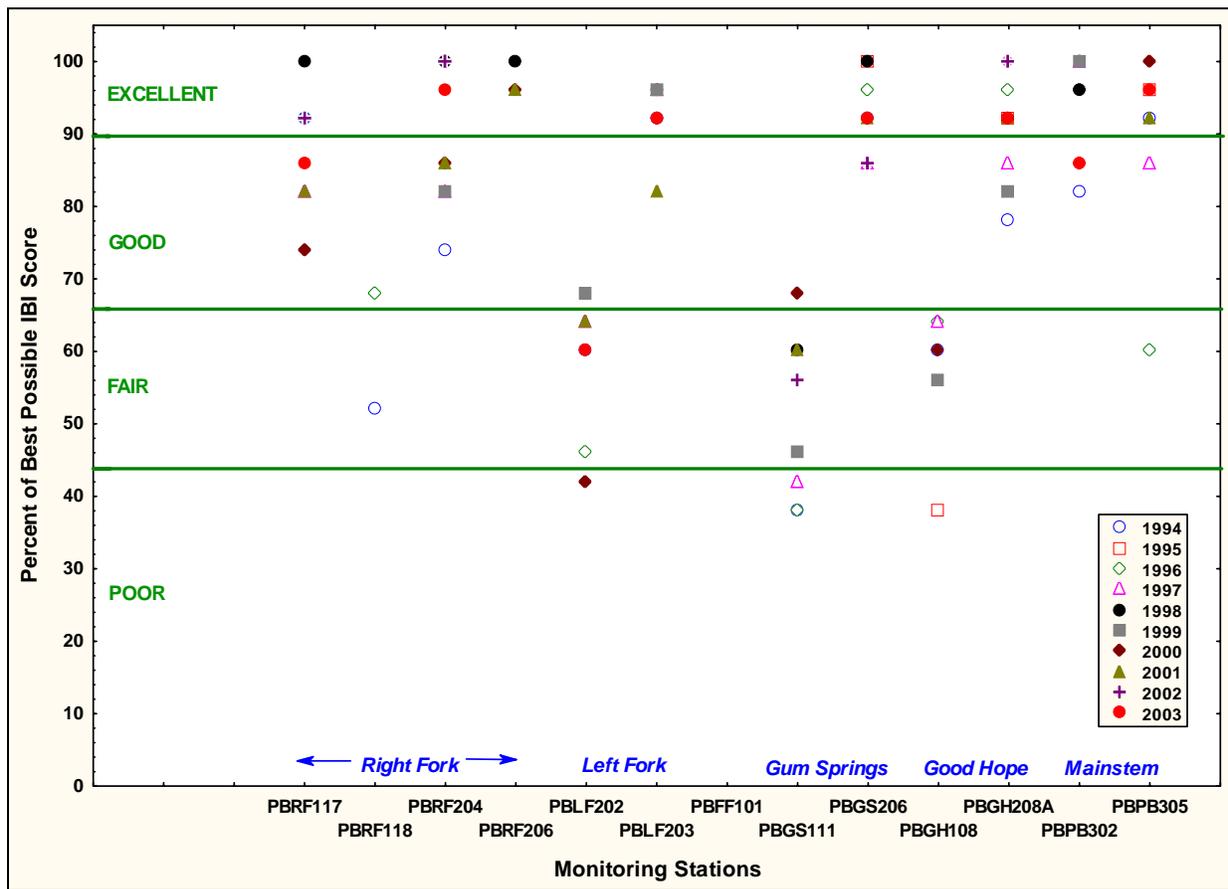
Figure 24 Fish Monitoring Results

The rest of the fish community also exhibited some response to drought conditions, mostly by reduced numbers of individuals. However, the diversity of the community (number of species, i.e. taxa richness) remained intact which is why IBI scores from 2003 are similar to previous years (Figure 24).

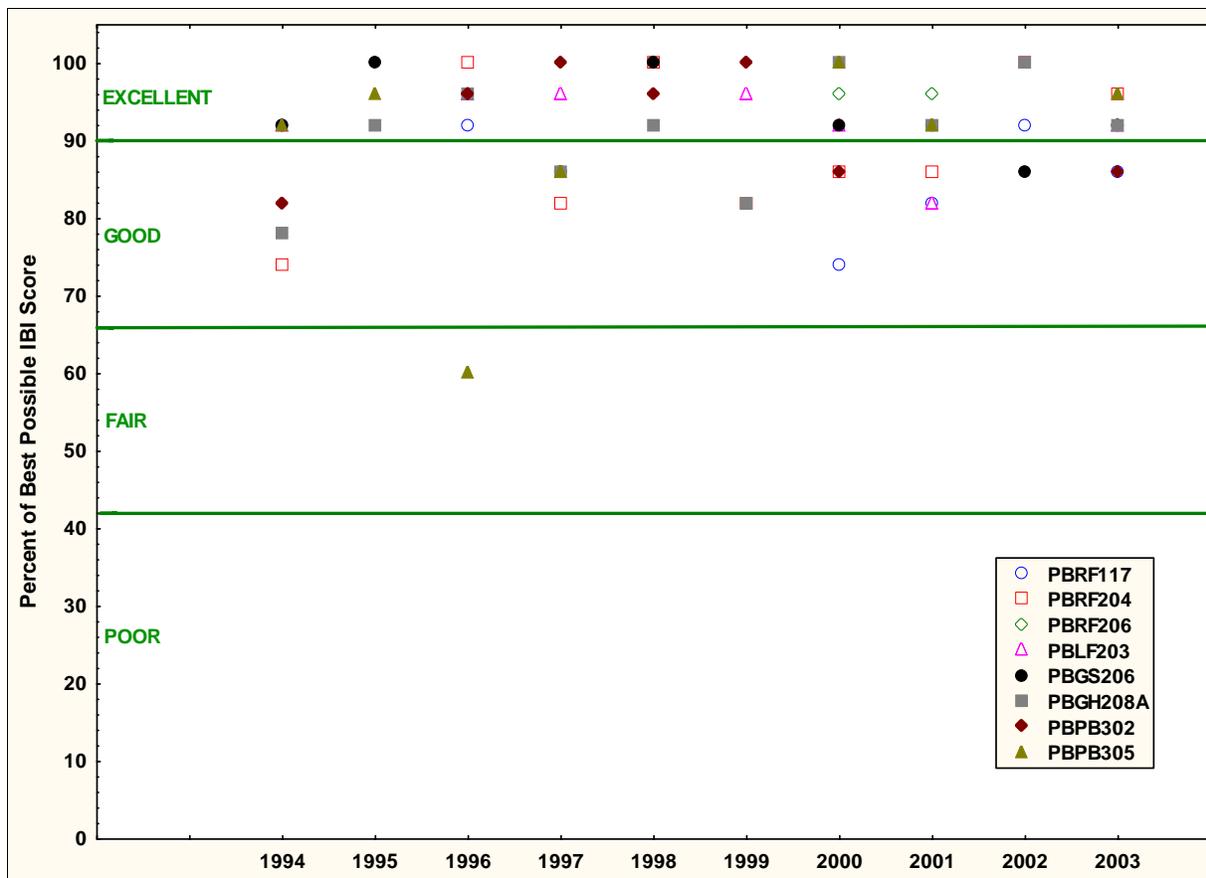
Looking at fish IBI scores plotted over time shows how little the overall health of the fish community has changed during the period of 1994-2003 (Figure 25). Community health (as measured by IBI score) at three monitoring stations located in headwater areas of tributaries is not as good as the rest of Paint Branch simply because of the small stream size and habitat constraints in these areas.

Figure 25 Time series plot of fish IBI scores - excluding monitoring stations located in the headwater areas of tributaries, ie. PBLF202, PBGS111 and PBGH108

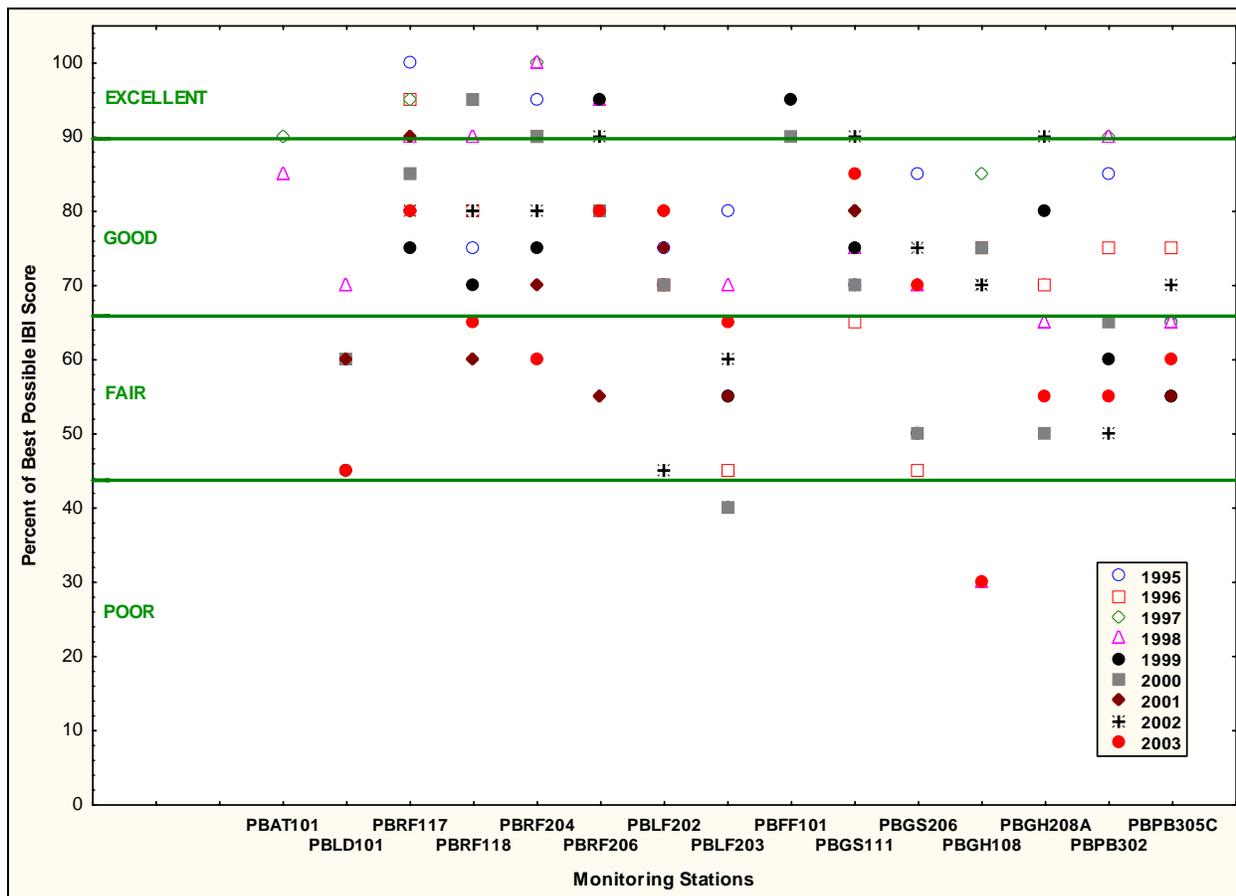
Figure 26 Benthic Macroinvertebrate Monitoring Results - All BIBI Scores

Results of benthic macroinvertebrate sampling indicate that some impact to the community occurred between 2002 and 2003 at several monitoring stations. Although 2003 IBI scores were within the range of scores from previous years, many stations were near the lower end of that range (Figure 26) and one station (PBRF204) was lower than any other year. Results from this station, located in the Right Fork, are discussed further in the Right Fork section below. Lower than normal benthic IBI scores from 2003 throughout most of the Paint Branch SPA are likely a reflection of stressful drought conditions that occurred during 1999 and 2002.

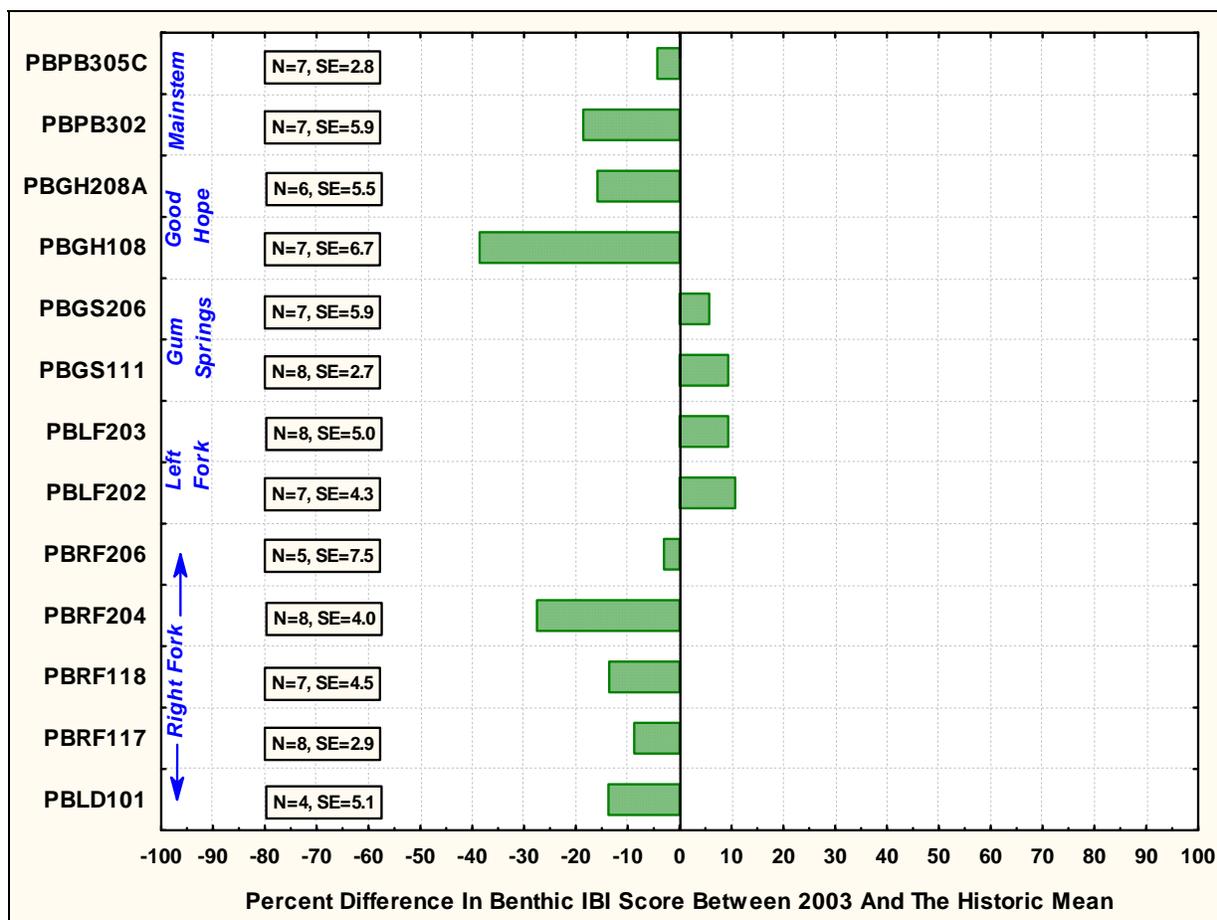
benthic macroinvertebrate community downstream at PBGH208A where the 2003 IBI score was considerably lower than the historic average (Figure 27). DEP will continue to monitor the biological health of the Good Hope in 2004 to determine if the impairment persists.

Figure 27 Departure of 2003 benthic IBI scores from the historic mean at each monitoring station. Bars extending into the negative portion of the graph indicate that benthic IBI Scores from 2003 are lower than the historic (1995 – 2002) average. The number of samples (N) and the standard error (SE) of the mean are also given.

As reported in previous SPA annual reports biological monitoring results from the Right Fork sub-watershed suggest a decline in benthic macroinvertebrate community health has occurred. The decline is observed only in the benthic macroinvertebrate community and not the fish. Monitoring results from 2003 support this observation as IBI scores were lower than the historic mean at all five monitoring stations in the Right Fork (Figure 27).

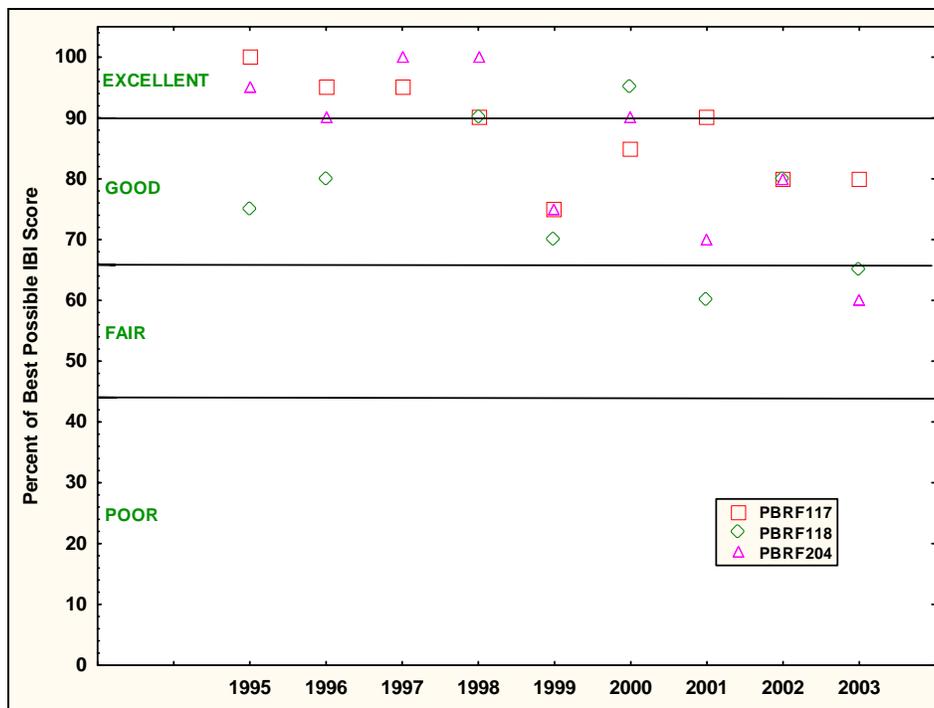
Figure 29 Time series plot of benthic macroinvertebrate monitoring results from the Right Fork

Results of benthic macroinvertebrate sampling from three Right Fork stations with a longer monitoring history indicate a slight decline in community health beginning in 1999 (Figure 29). Since 1999 results have been variable as the community responds to the presence and absence of stressors in this small stream. Stressors include: stream flow, water quality (ie. water temperature, dissolved oxygen concentration) and sediment washed into the stream channel. Prior to 1999 the benthic IBI scores did vary from year to year but remained in the good / excellent range. Stressors, prior to 1999, consisted of normal annual variation in stream flow and water temperature. The drought, which extended from 1999 to 2002, caused unusually stressful conditions in all streams and certainly contributed to variable biological conditions found in the Right Fork. However, the added impacts from construction activities combine with natural stressors to increase impacts to the streams biological community.

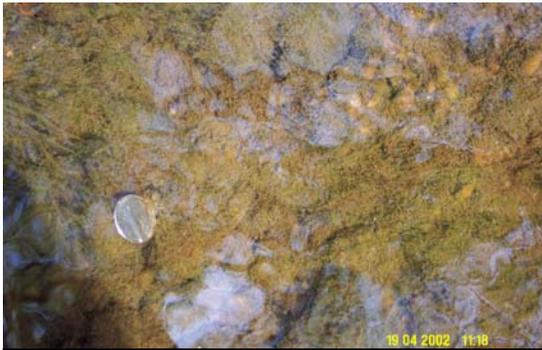
Figure 30 Sediment and Algae in Right Fork

Four other development projects have since begun construction in the Right Fork. Fine sediments washed off from construction sites have been observed in the Right Fork. There appears to also have been an increase in algae growth that may be related to the fine sediment (Figures 30 and 31). Sediment washing off the land often carries with it nutrients, particularly from areas previously under agricultural use, which supply nourishment for algae growth in the receiving stream. The sediment and algae fill in the spaces under and around the stones on the stream bottom restricting biological colonization in this important stream habitat.

The extent to which changes in the benthic community are a reflection of drought or development impact is hard to say with certainty. What is certain is that impacts from development projects, thus far, are construction related and have more to do with increased sediment input to the stream. The increased level of sediment control required in SPA's may have reduced the amount of sediment getting into streams but has not completely eliminated it. Construction related impacts, although significant, are temporary. Sediment that enters the stream from construction sites will move through the stream channel network. A true assessment of how well the SPA program, along with zoning laws, protect the Right Fork can not be made until several years after construction is complete and stormwater management has had time to function as designed. At that point in time, program assessment will depend on how the streams biological health compares to baseline conditions established between 1995 and 1998.
